Bailey, Heather

From: Larry and Ginny White <lgwhites@gmail.com>
Sent: Monday, August 14, 2023 4:56 PM
To: PLLCApplications
Subject: Meeting Agenda Item #79099

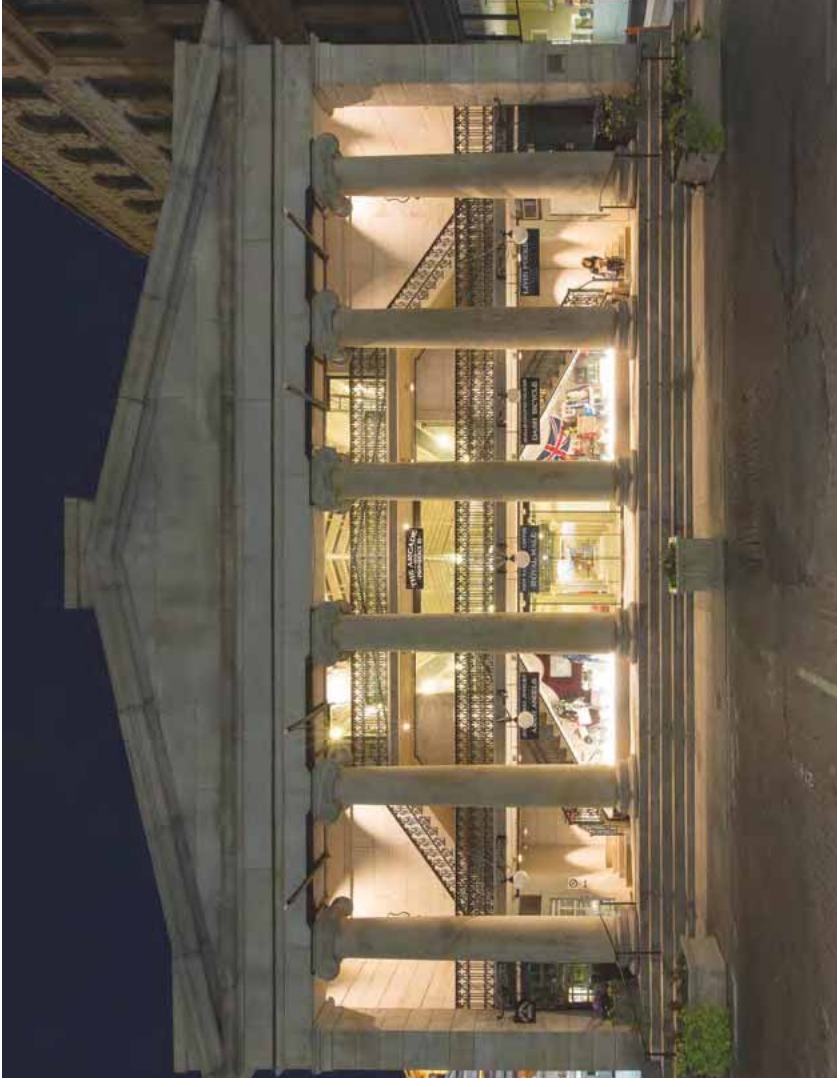
Standards for Rehabilitation

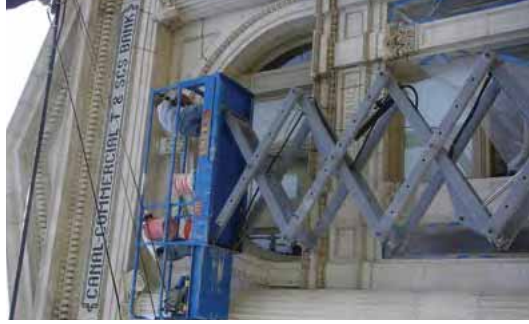
[1] An alkaline-based product is appropriate to use to clean historic marble because it will not damage the marble, which is acid sensitive.

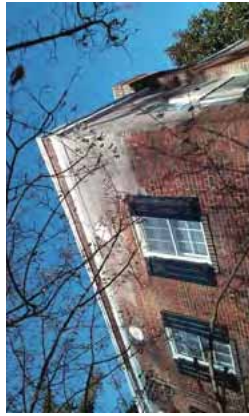
[3] Not Recommended:
The white film on the upper corner of this historic brick row house is the result of using a scrub or slurry coating, rather than traditional repointing by hand, which is the recommended method.

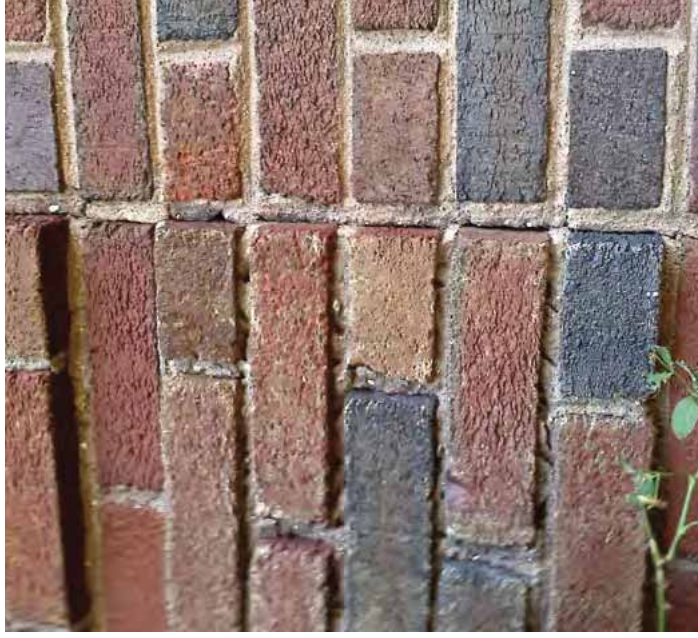
[4] Not Recommended:
The quoins on the left side of the photo show that high-pressure abrasive blasting used to remove paint can damage even early 20th-century, hard-baked, textured brick and erode the mortar, whereas the same brick on the right, which was not abrasively cleaned, is undamaged.

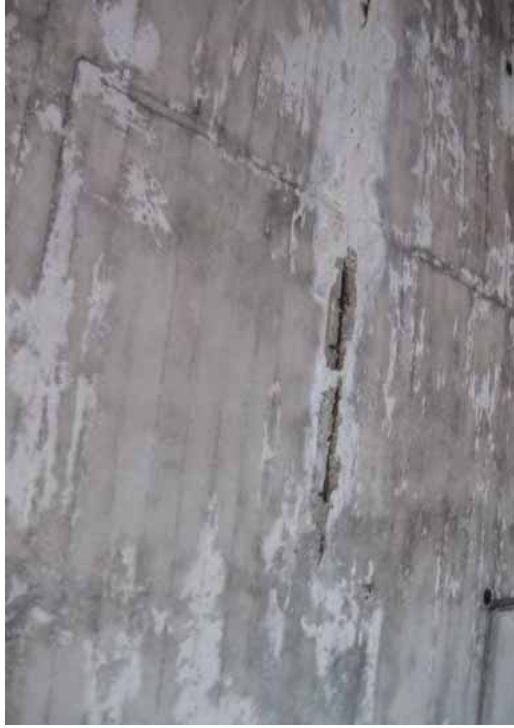
[5] Rebars in the reinforced concrete ceiling have rusted, causing the concrete to spall. The rebars must be cleaned of rust before the concrete can be patched.

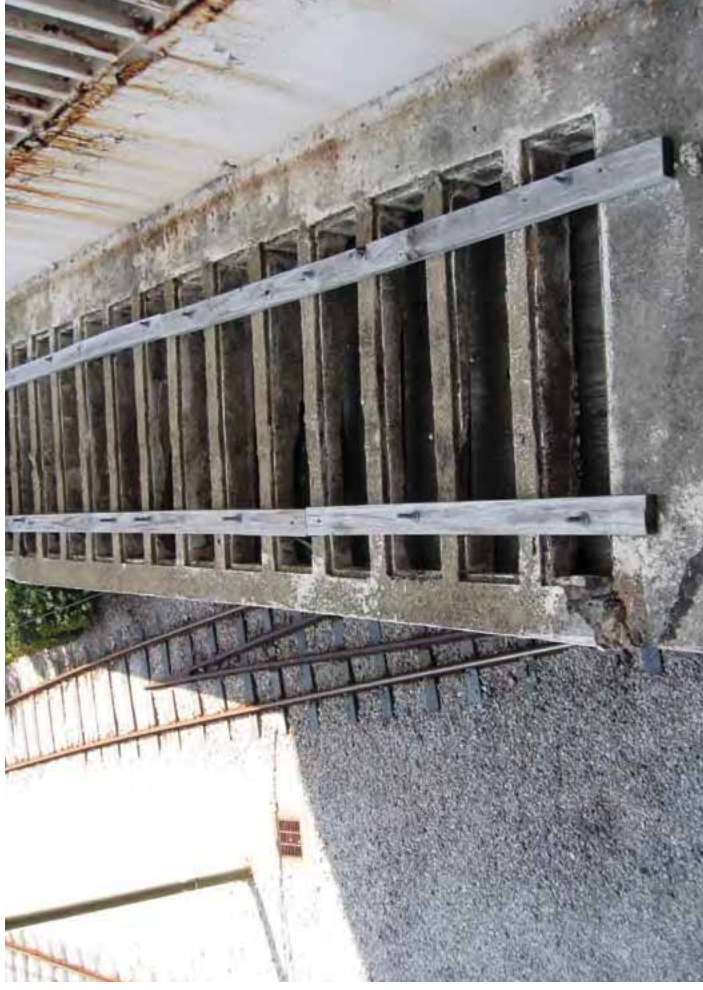
[6] Some areas of the concrete brise soleil screen on this building constructed in 1967 are badly deteriorated. If the screen cannot be repaired, it may be replaced in kind or with a composite substitute material with the same appearance as the concrete.

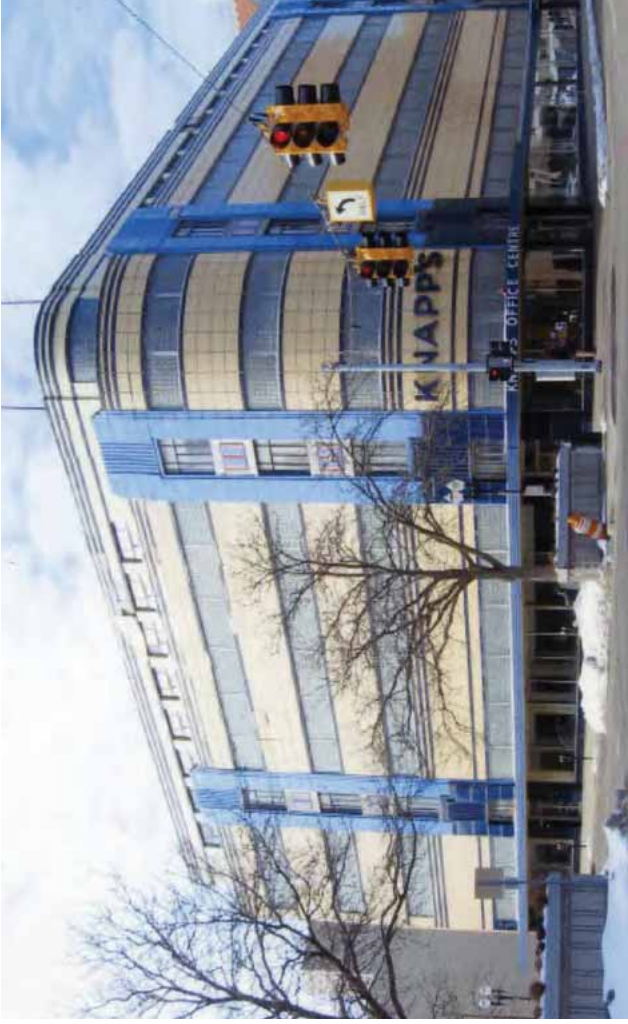
[7] (a) J.W. Knapp's Department Store, built 1937-38, in Lansing, MI, was constructed with a proprietary material named "Maul Macotta", made of enameled steel and cast-in-place concrete panels. Prior to its rehabilitation, a building inspection revealed that, due to a flaw in the original design and construction, the material was deteriorated beyond repair. The architects for the rehabilitation project devised a replacement system (b) consisting of enameled aluminum panels that matched the original colors (c). Photos and drawing (a-b): Quinn Evans Architects; Photo (c): James Haefer Photography.

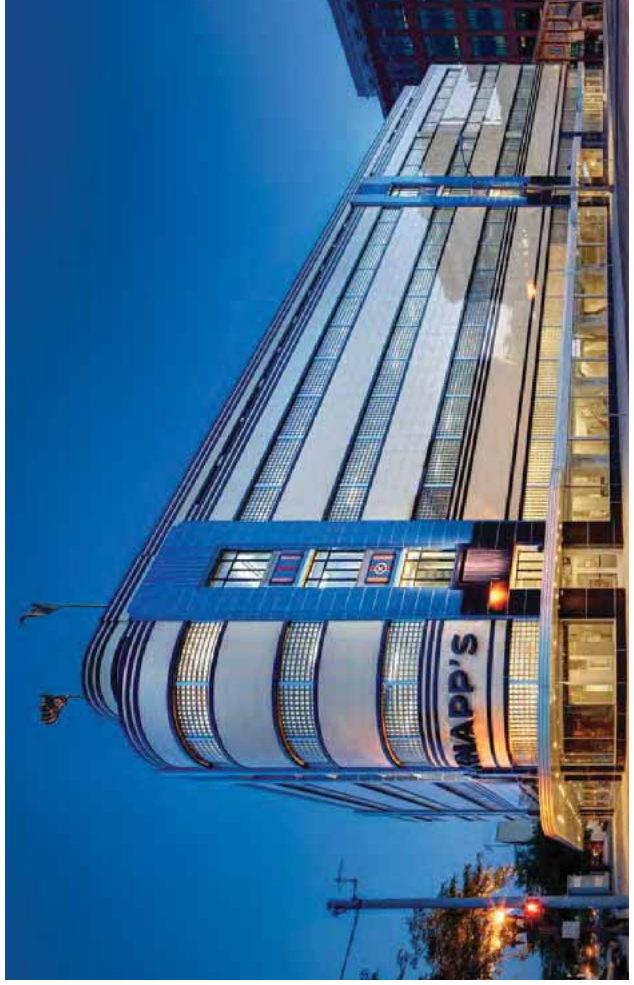
MASONRY: STONE, BRICK, TERRA COTTA, CONCRETE, ADOBE, STUCCO, AND MORTAR

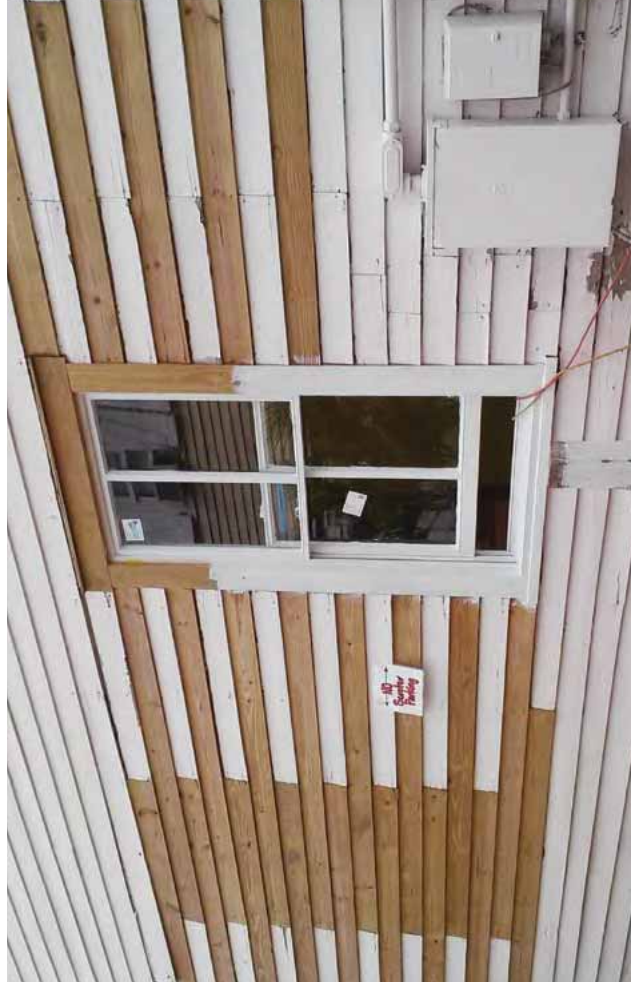
[8] Rotted clapboards have been replaced selectively with new wood siding to match the originals.

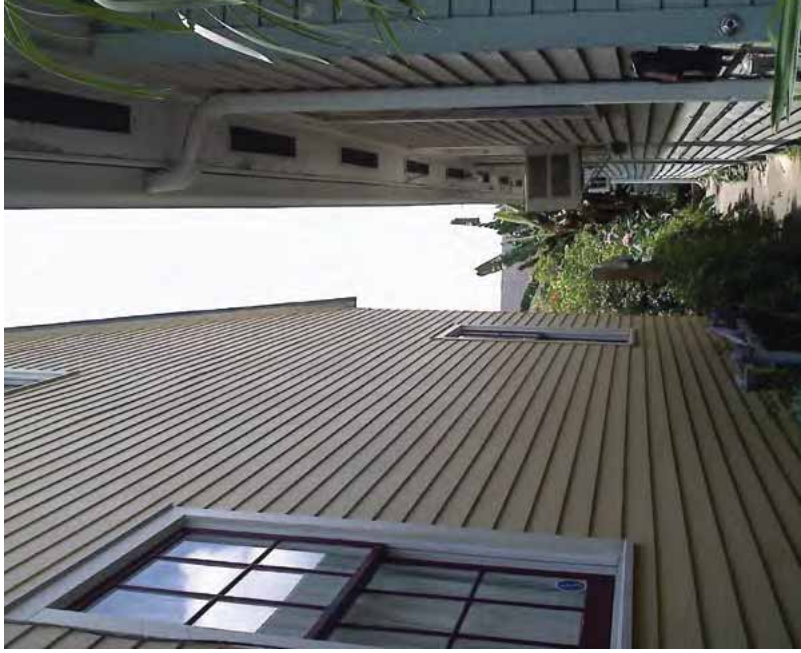
[9] Smooth-surfaced cementitious siding (left) may be used to replace deteriorated wood siding only on secondary elevations that have minimal visibility.

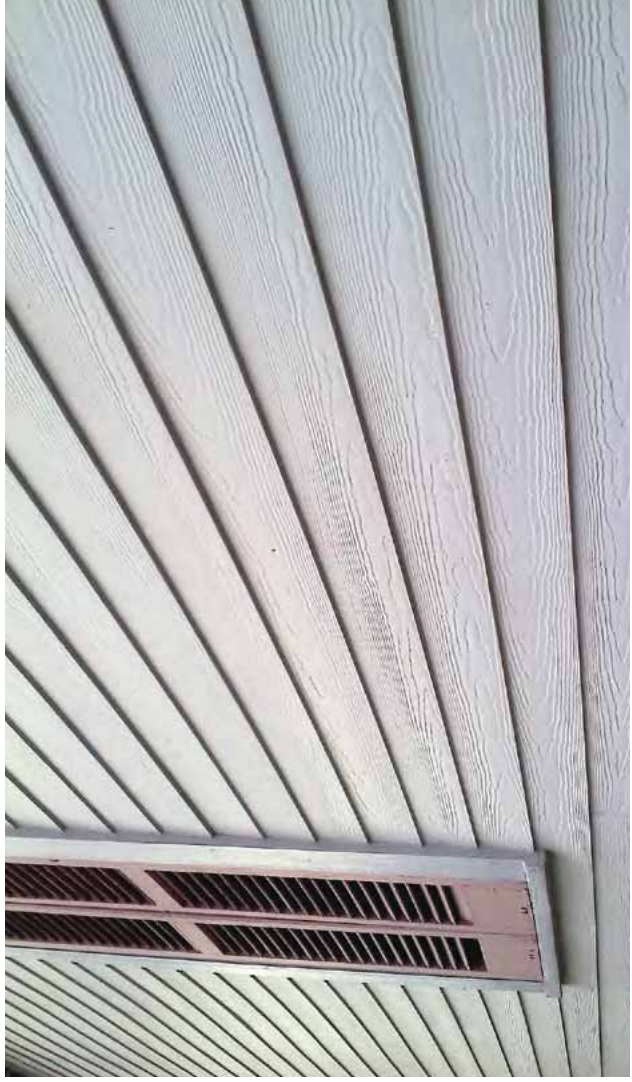
WOOD: CLAPBOARD, WEATHERBOARD, SHINGLES, AND OTHER FUNCTIONAL AND DECORATIVE ELEMENTS

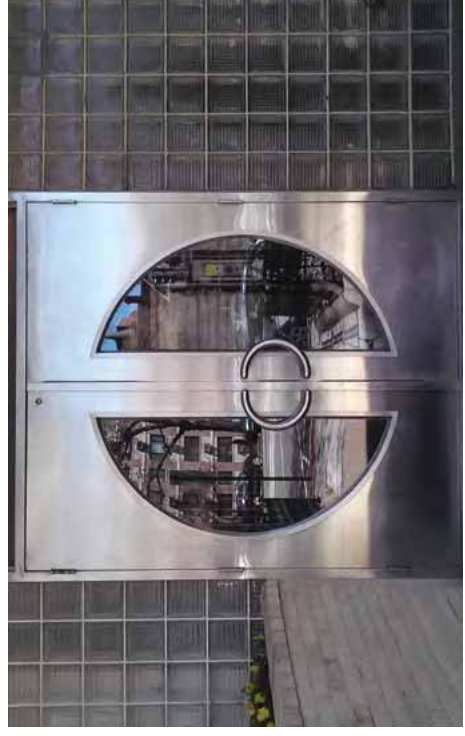
METALS: WROUGHT AND CAST IRON, STEEL, PRESSED METAL, TERNEPLATE, COPPER, ALUMINUM, AND ZINC

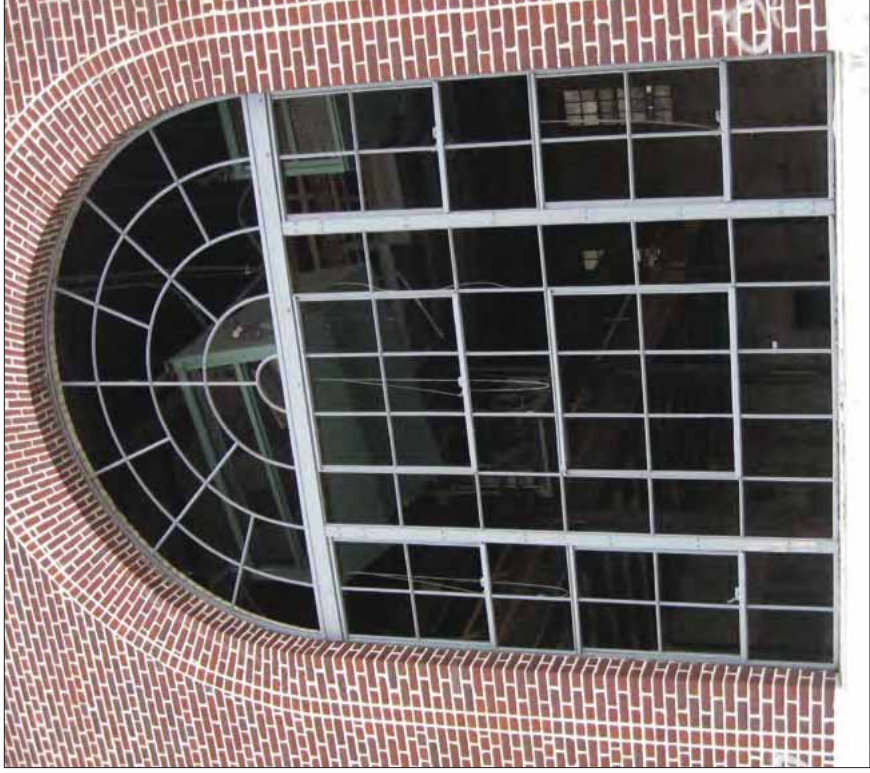
[12] This historic steel window has been cleaned, repaired, and primed in preparation for painting and reglazing.

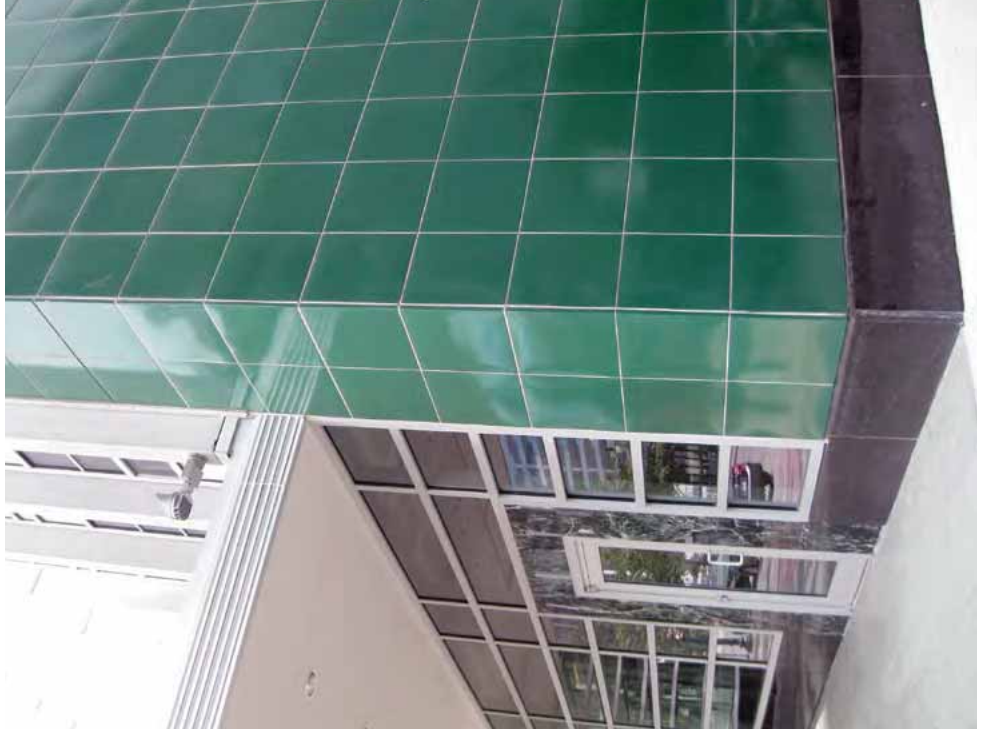
[15] New enameled-metal panels were replicated to replace the original panels, which were too deteriorated to repair, when the storefront of this early 1950s building was recreated.

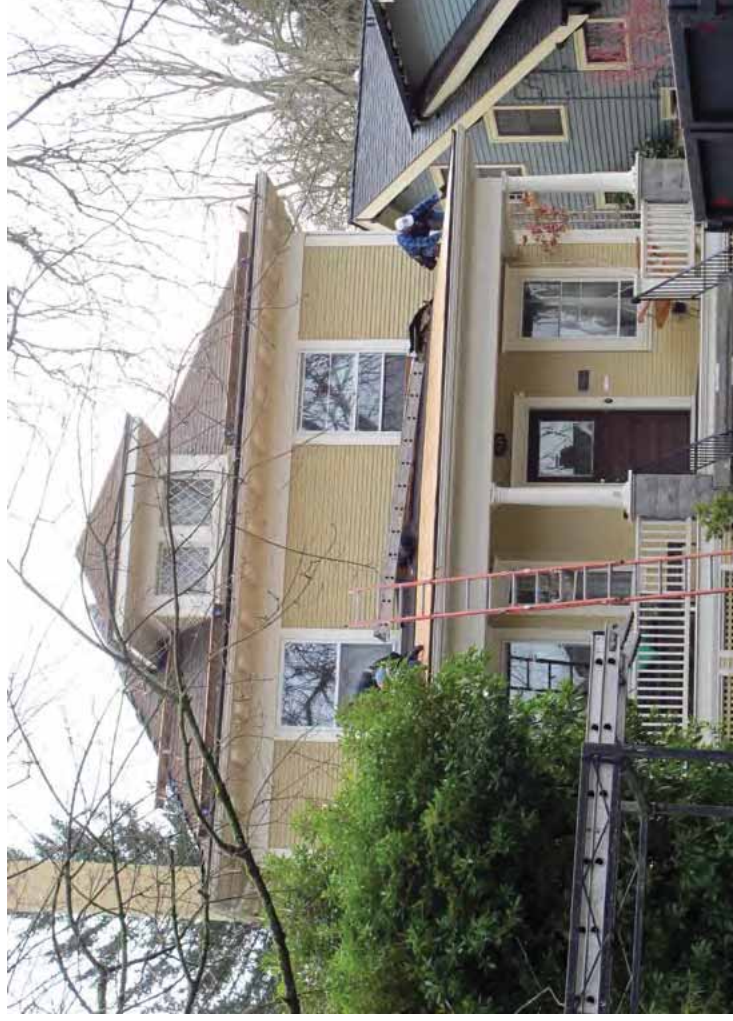
[16] The deteriorated asphalt shingles of this porch roof are being replaced in kind with matching shingles.

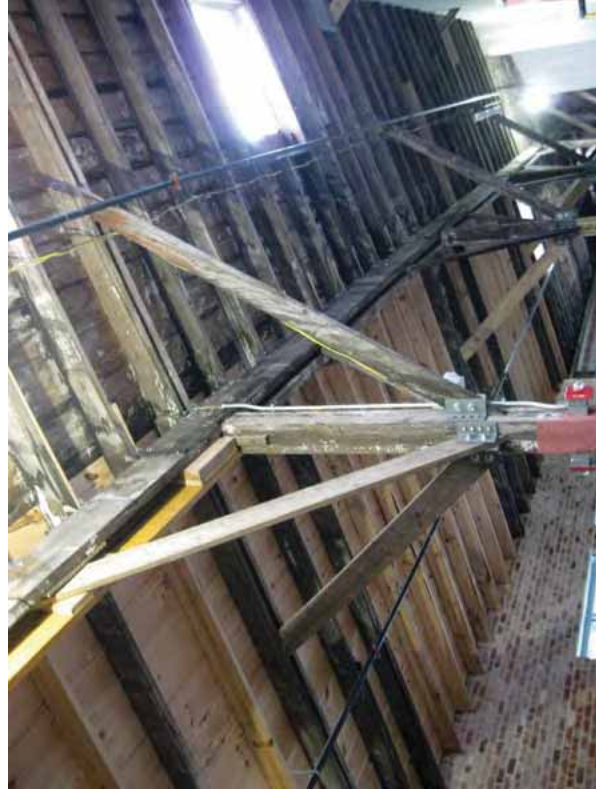
[17] New wood elements have been used selectively to replace rotted wood on the underside of the roof in this historic warehouse.

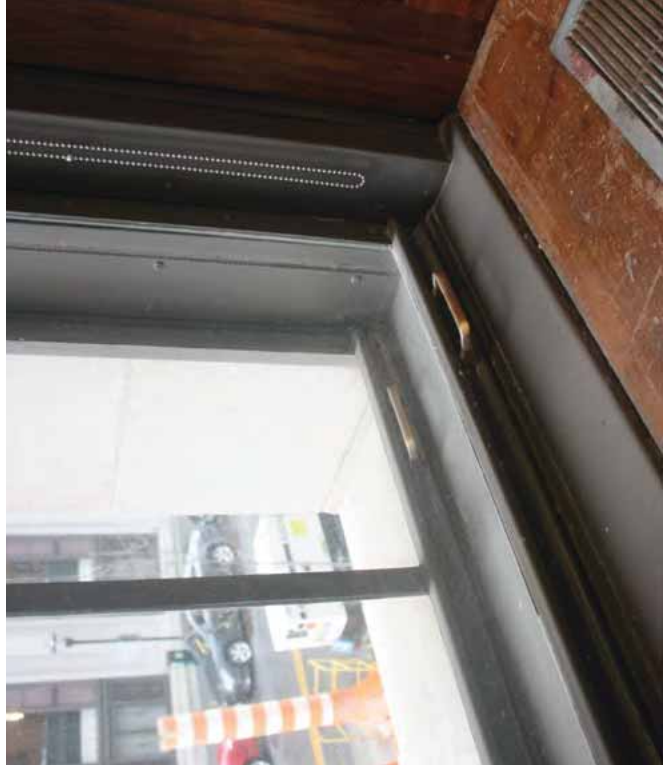
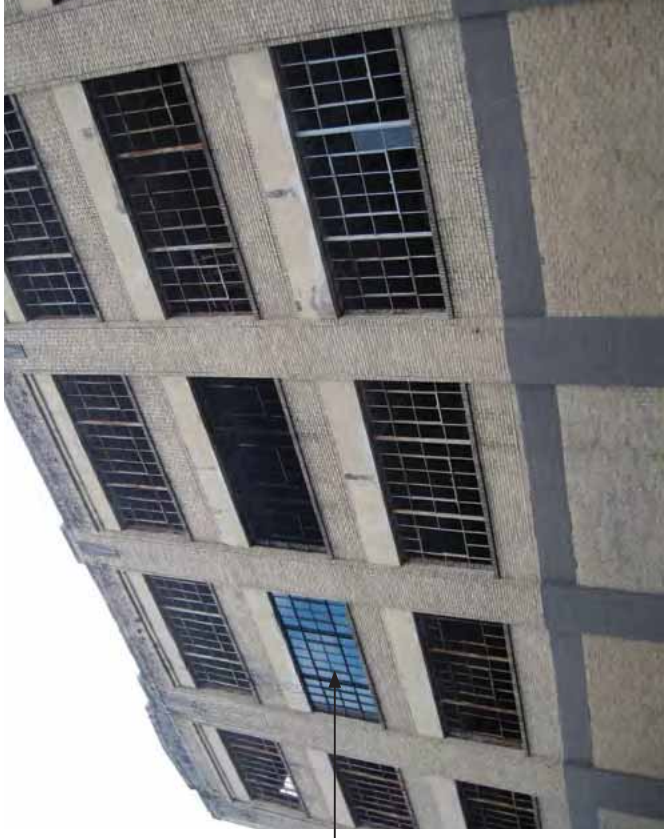
[18] The historic metal storm windows in this 1920s office building were retained and repaired during the rehabilitation project.

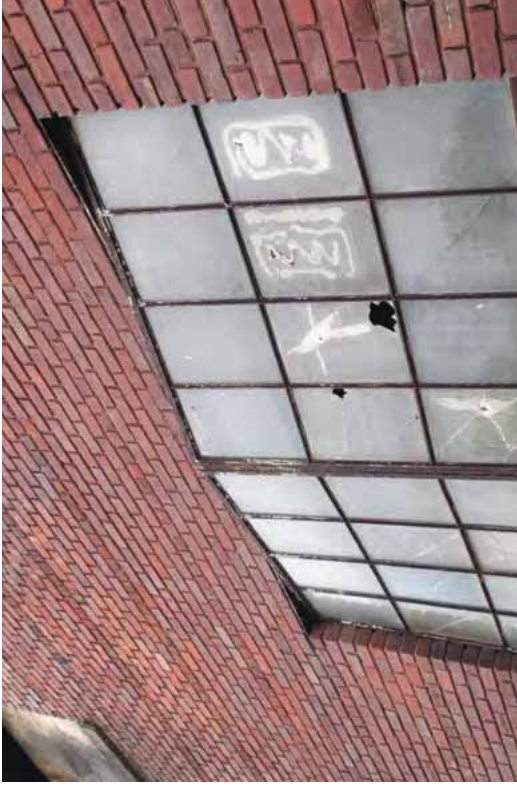
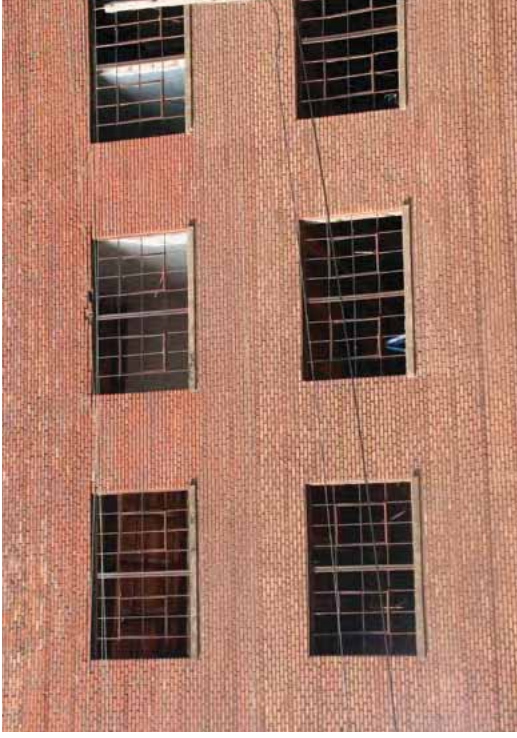
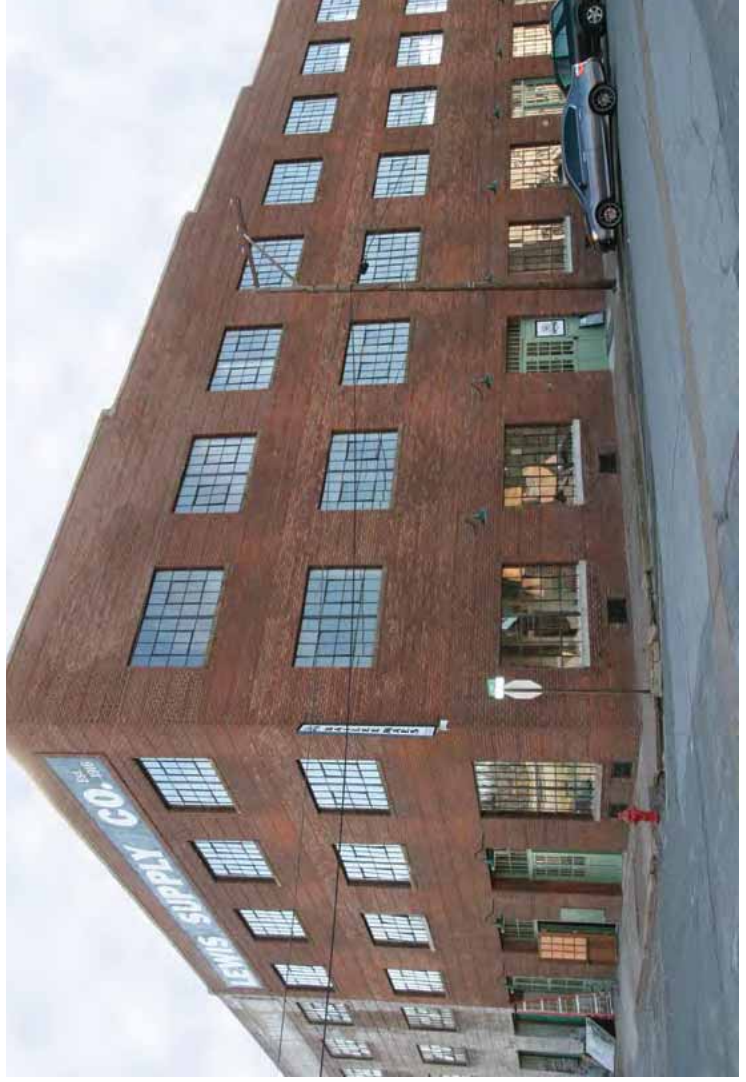
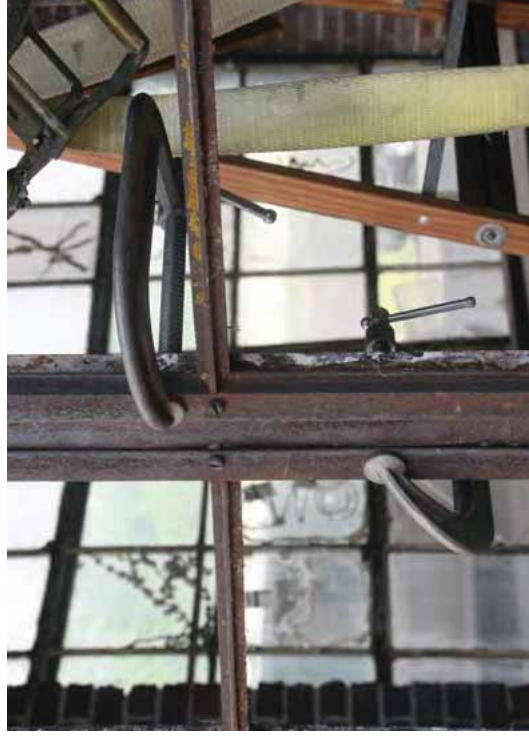
[20 a-d] The original steel windows in this industrial building were successfully repaired as part of the rehabilitation project (left).

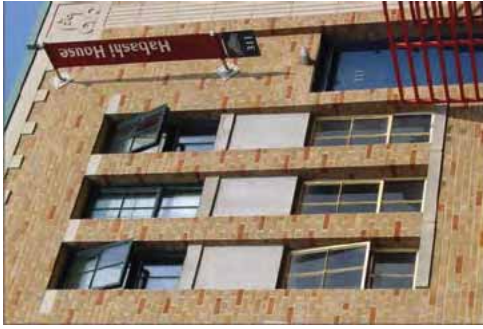
[21] The windows on the lower floor, which were too deteriorated to repair, were replaced with new steel windows matching the upper-floor historic windows that were retained.

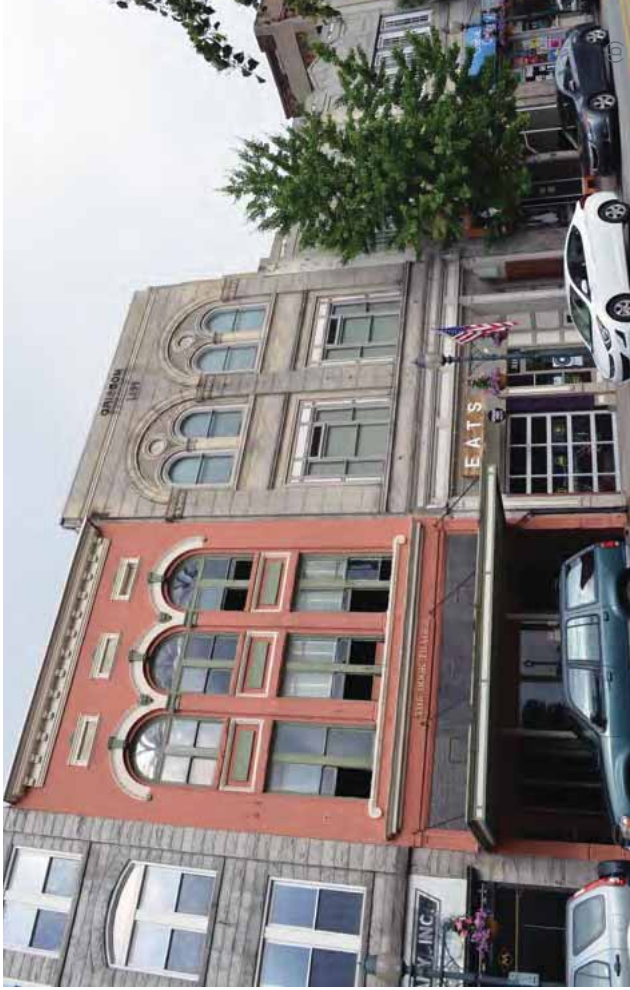
Installing replacement windows made from other materials that are not the same as the material of the original windows if they would have a noticeably different appearance from the remaining historic windows.

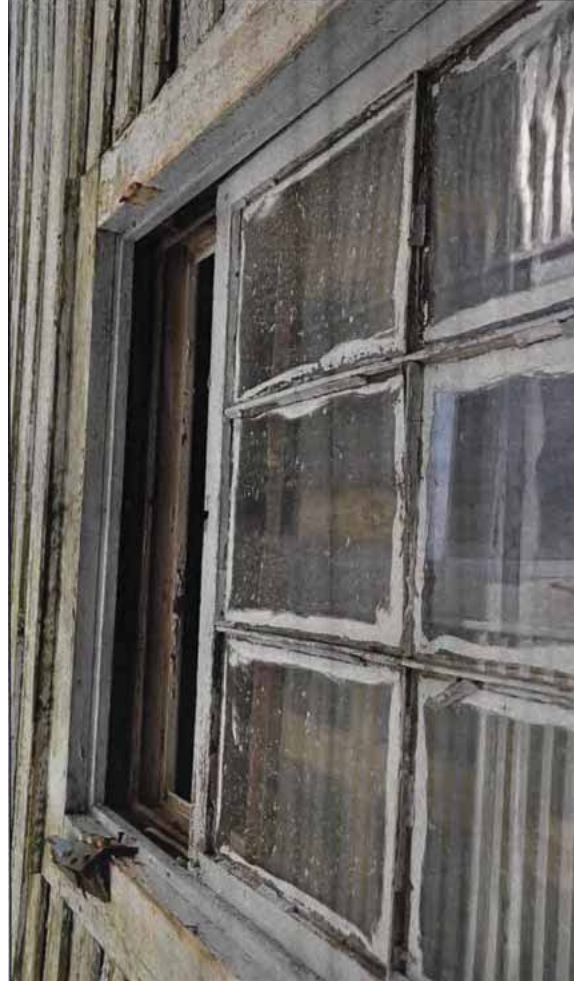
[231] (a) This deteriorated historic wood window was repaired and retained (b) in this rehabilitation project.

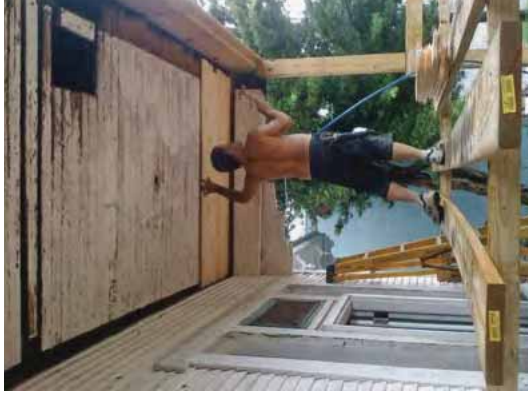
[24] Rotted boards in the beaded-board porch ceiling are being replaced with new matching beaded board.

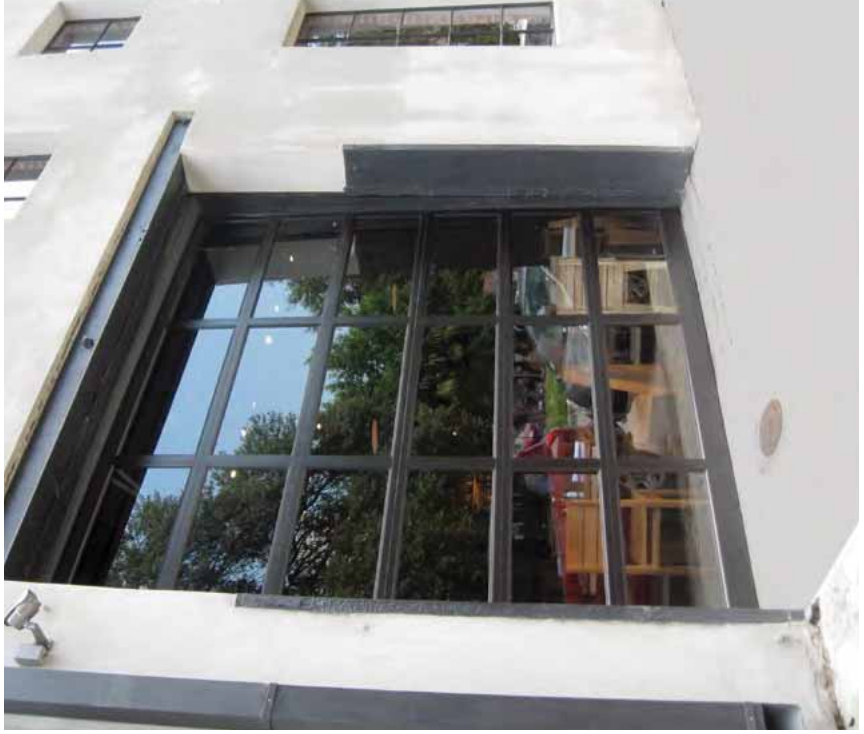
Replacing in kind an entire entrance or porch that is too deteriorated to repair (if the overall form and detailing are still evident) using the physical evidence as a model to reproduce the feature or when the replacement can be based on historic documentation. If using the same kind of material is not feasible, then a compatible substitute material may be considered.

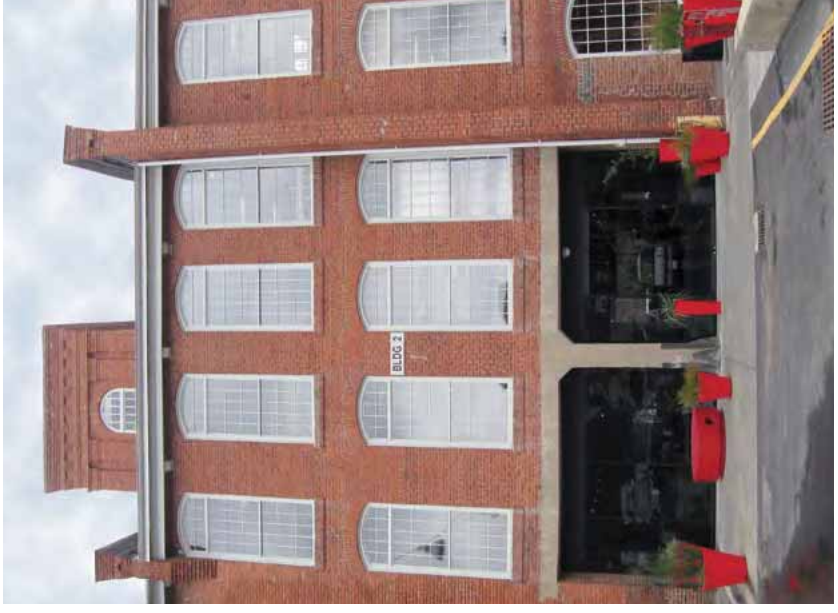
[25] The new infill designs for the garage door openings in this commercial building (a) converted for restaurant use and in this mill building (b) rehabilitated for residential use are compatible with the historic character of the buildings.

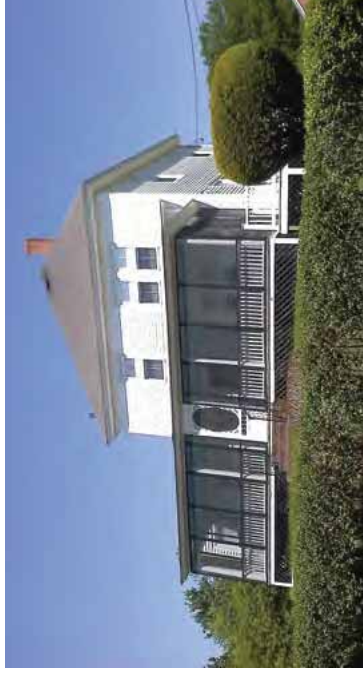
[26] **Not Recommended:** Installing a screened enclosure is never recommended on a front or otherwise prominent historic porch. In limited instances, it may be possible to add screening on a porch at the rear or on a secondary façade; however, the enclosure should match the color of the porch and be placed behind columns and railings so that it does not obscure these features.

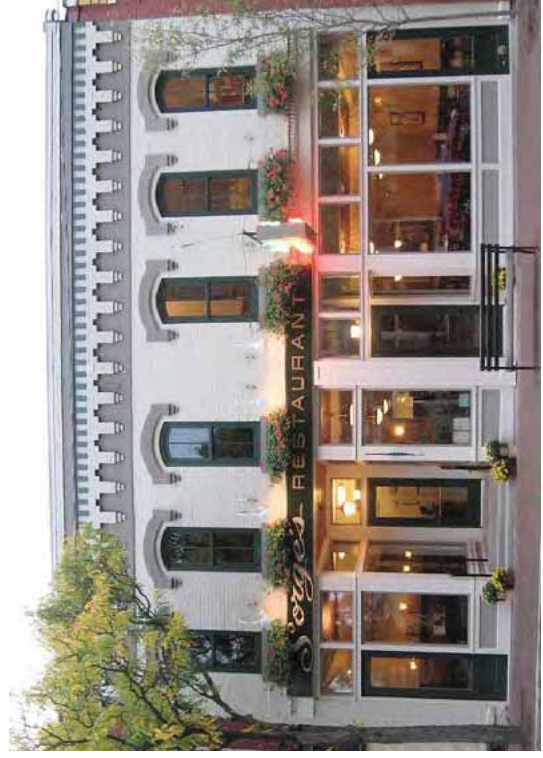
[28] This new storefront, which replaced one that was missing, is compatible with the historic character of the building.

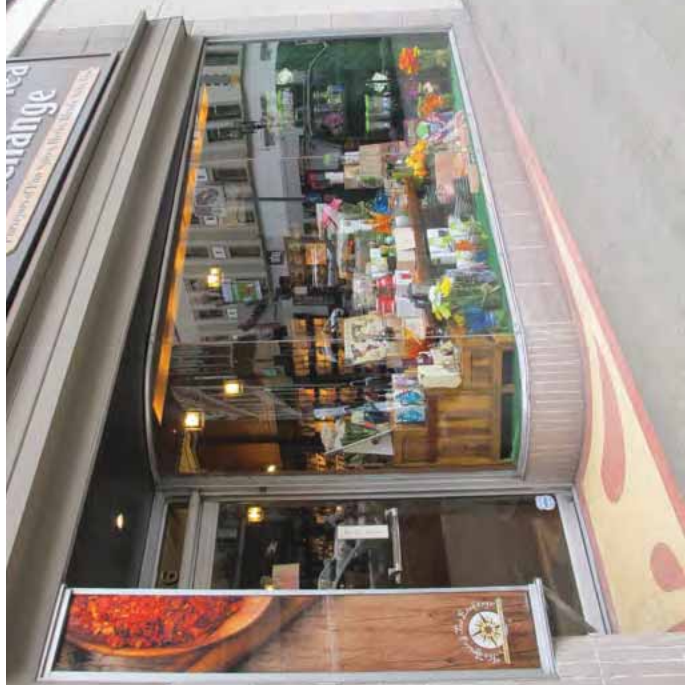
[27] This original c. 1940s storefront, with its character-defining angled and curved glass display window and recessed entrance with a decorative terrazzo paving, is in good condition and should be retained in a rehabilitation project.

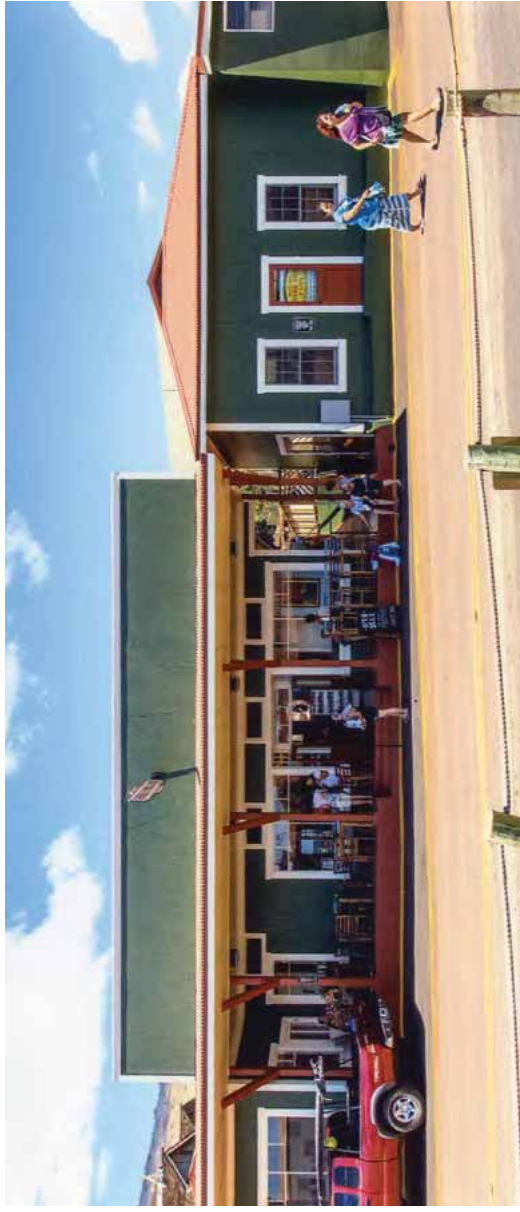
[29] The rehabilitation of the 1910 Māālaea General Store (a), which served the workers' camp at the Wailuku Sugar Company on the Hawaiian island of Maui, included the reconstruction of the original parapet (b).

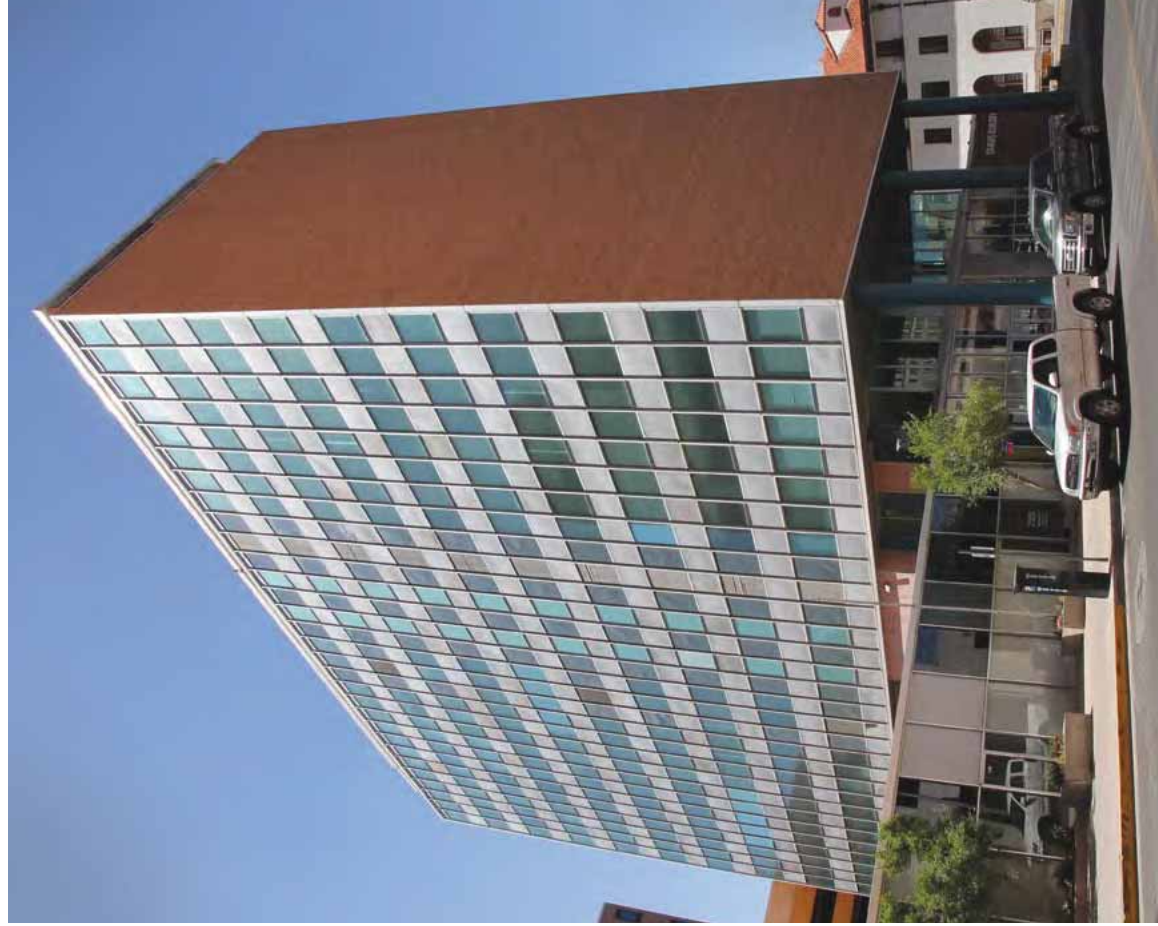
[30] Rather than replace the original curtain wall system of the 1954 Simms Building in Albuquerque, NM, with a different color tinted glass or coat it with a non-historic reflective film, the HVAC system was updated to improve energy efficiency. Photo: Harvey M. Kaplan.

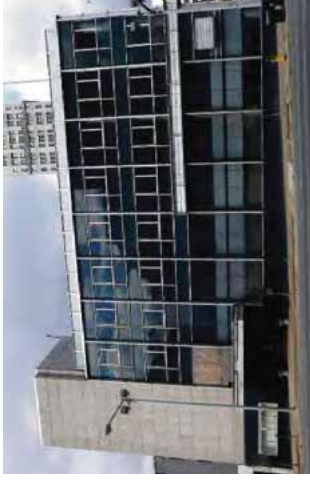
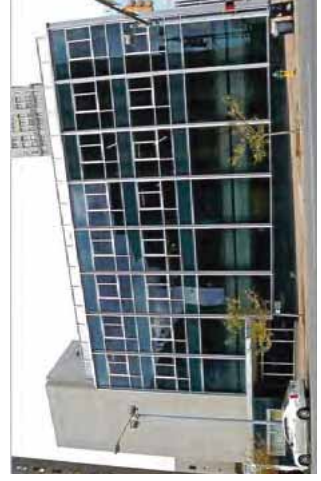
[31 a-c.] (a) The rehabilitation of the First Federal Savings and Loan Association building in Birmingham, AL, constructed in 1961, required replacing the deteriorated historic curtain wall system because the framing and the fasteners holding the spandrel glass and the windows had failed. (b) Comparative drawings show that the differences between the replacement system, which incorporated new insulated glass to meet wind-load requirements, and the original system are minimal. (c) The replacement system, shown after completion of the project, has not altered the historic character of the building.

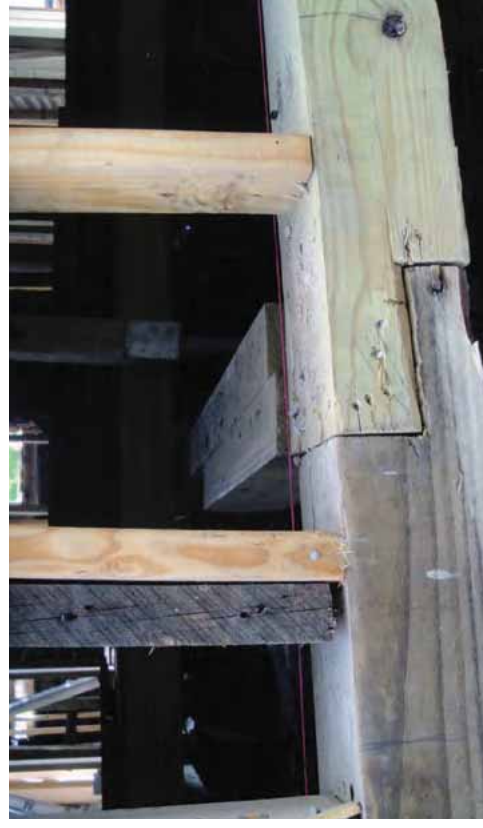
[33] Retaining as much as possible of the historic wood sill plate and replacing only the termite-damaged wood is always the preferred and recommended treatment.

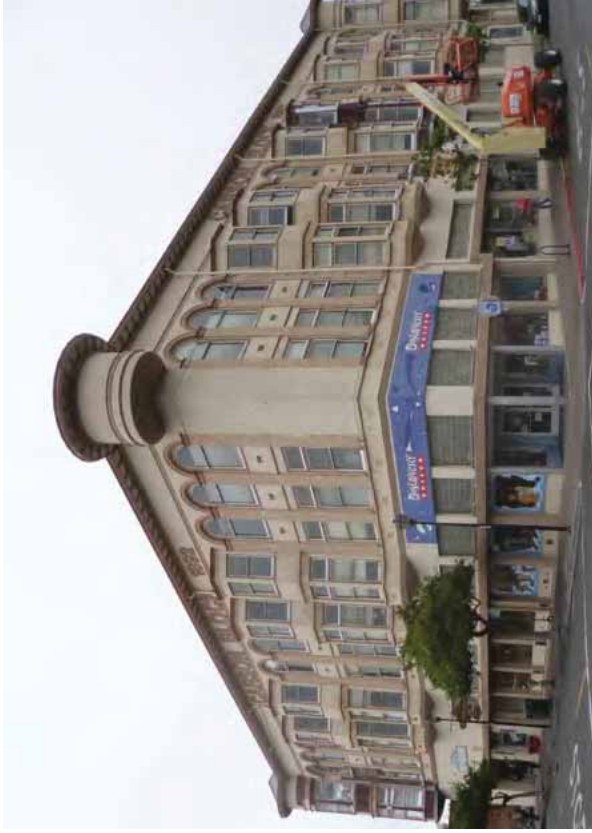
[32] (a-b) The rehabilitation of the 1892 Carson Block Building in Eureka, CA, for its owner, the Northern California Indian Development Council, included recreating the missing corner turret and sensitively introducing seismic reinforcement (C) shown here (opposite page) in a secondary upper floor office space. *Photos: Page & Turnbull.*

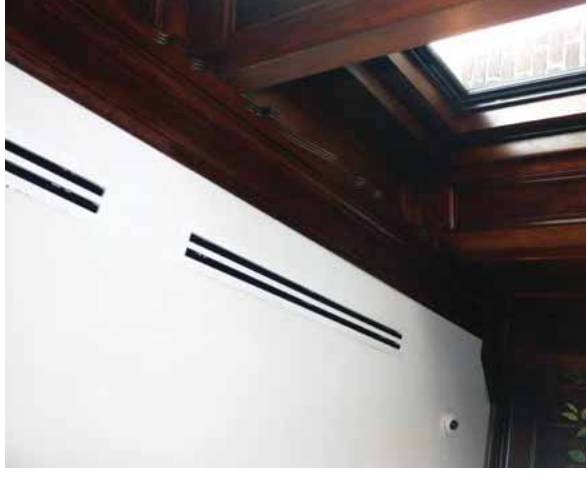
[34] The new ceiling ducts installed during the conversion of this historic office building into apartments are minimal in design and discretely placed above the windows.

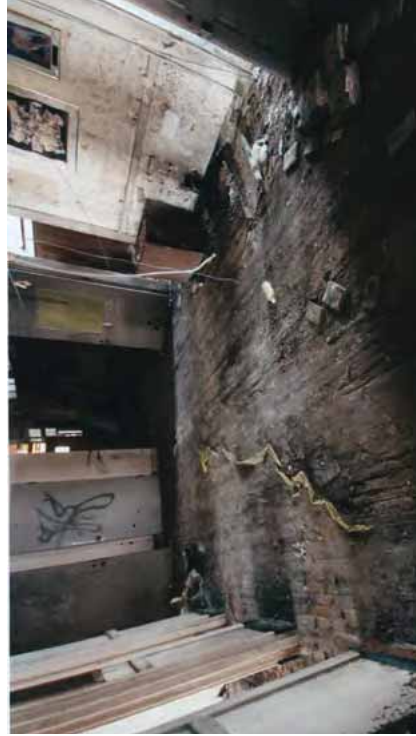
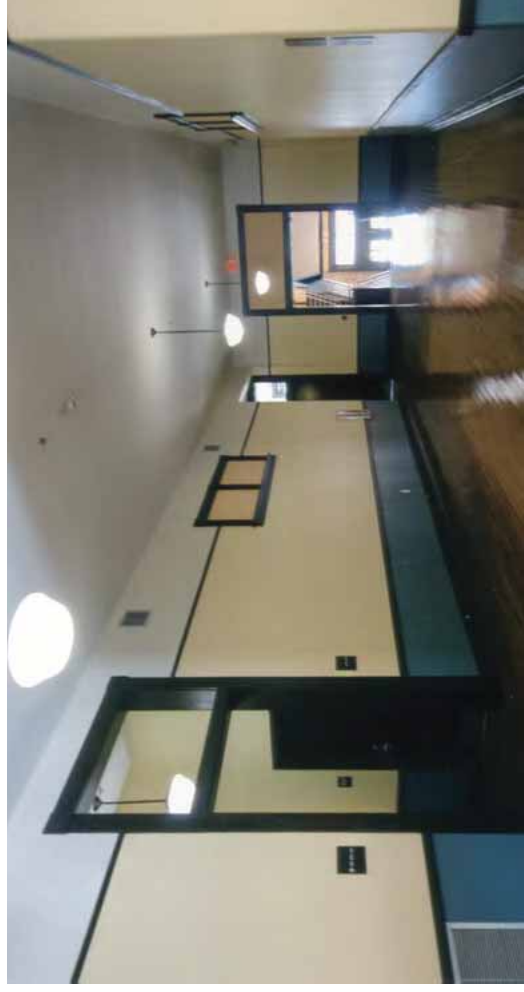
[35] (a) Although deteriorated, the historic school corridor, shown on the left, with its character-defining features, including doors and transoms, was retained and repaired as part of the rehabilitation project (b).

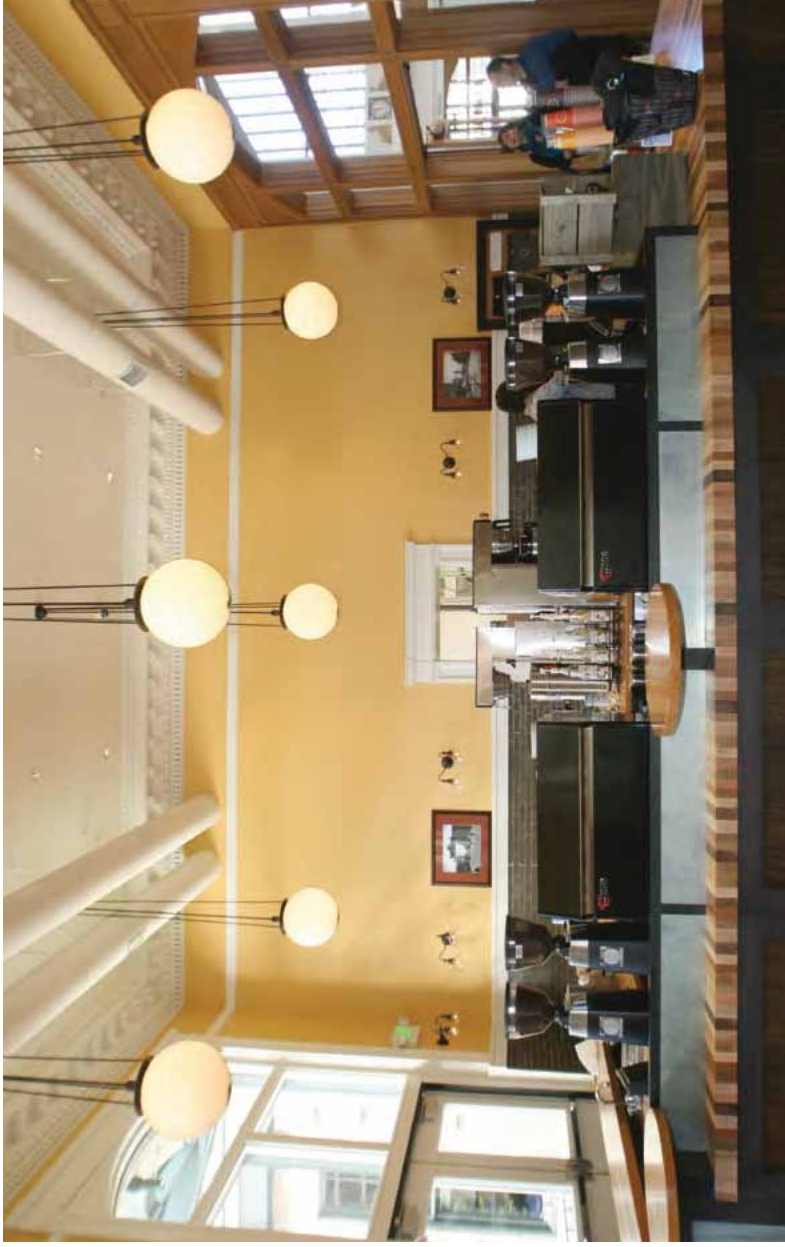
[37] Exposed and painted ducts were appropriately installed here in a retail space in Denver's historic Union Station after considering other options that would have impacted the ceiling height, or damaged or obscured the ornamental plaster crown molding. Photo: Heritage Consulting Group.

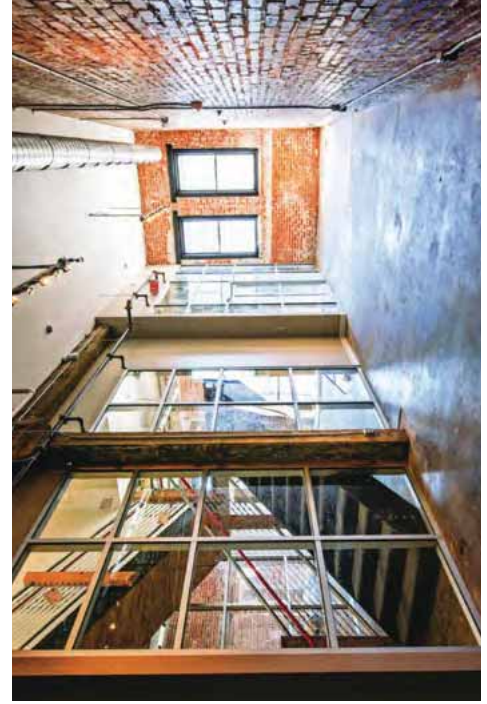
[38] The rehabilitation project retained the industrial character of this historic factory building, which included installation of a fire-rated, clear glass enclosure that allows the stairway, an important interior feature, to remain visible.
