Bailey, Heather

From: Larry and Ginny White <lgwhites@gmail.com>
Sent: Monday, August 14, 2023 4:56 PM
To: PLLCApplications
Subject: Meeting Agenda Item #79099

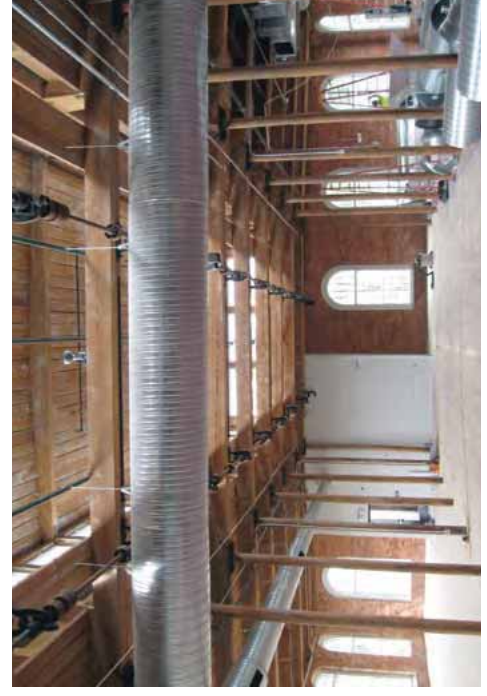
INTERIOR SPACES, FEATURES, AND FINISHES

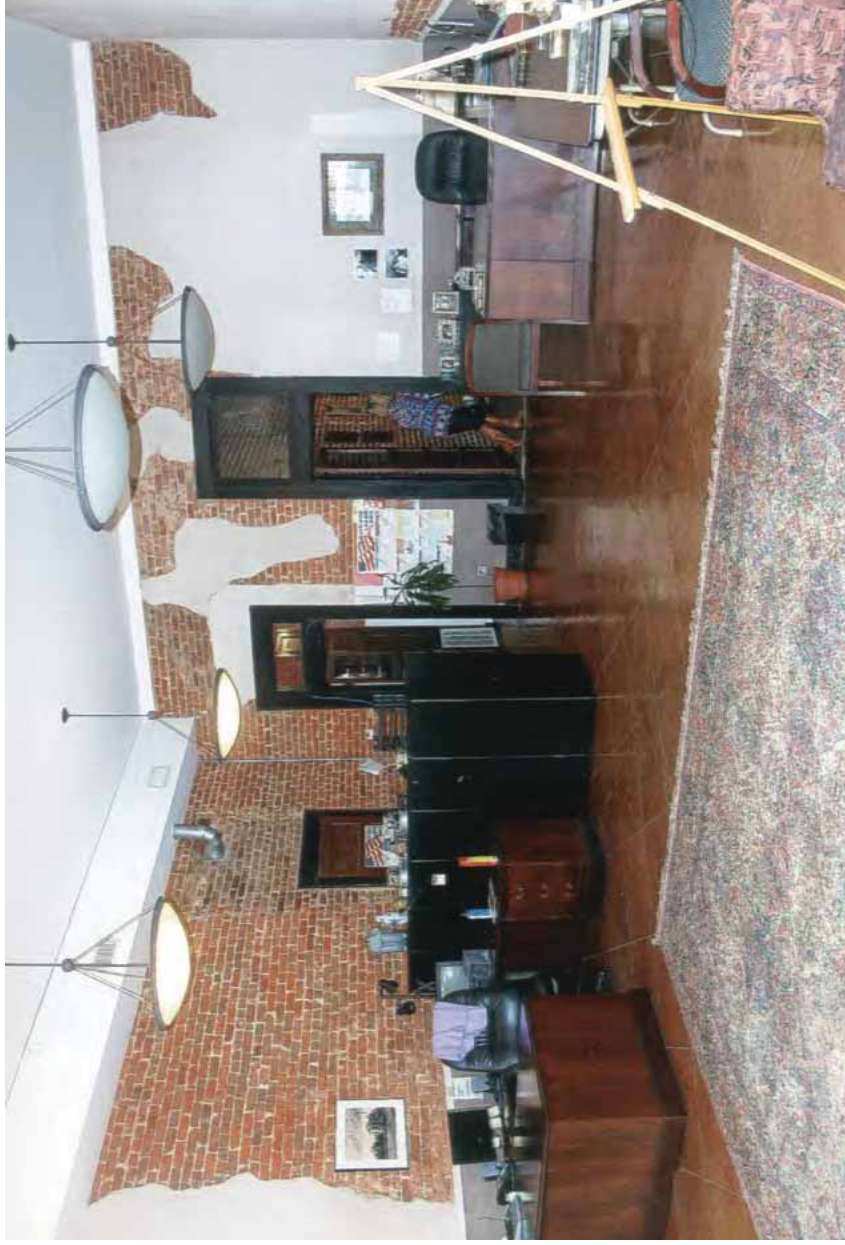
[41] Not Recommended:
Leaving fragments of deteriorated or “sculpted” plaster is not a compatible treatment for either finished or unfinished interior spaces.

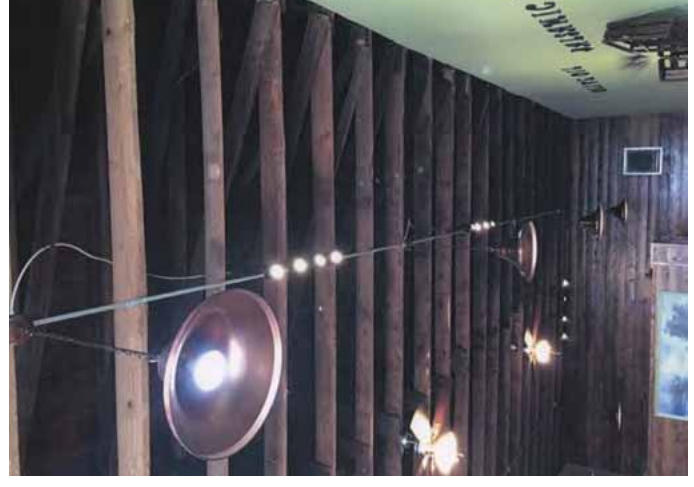
[40] Not Recommended:
Removing a finished ceiling and leaving the structure exposed in a historic retail space does not meet the Standards for Rehabilitation.

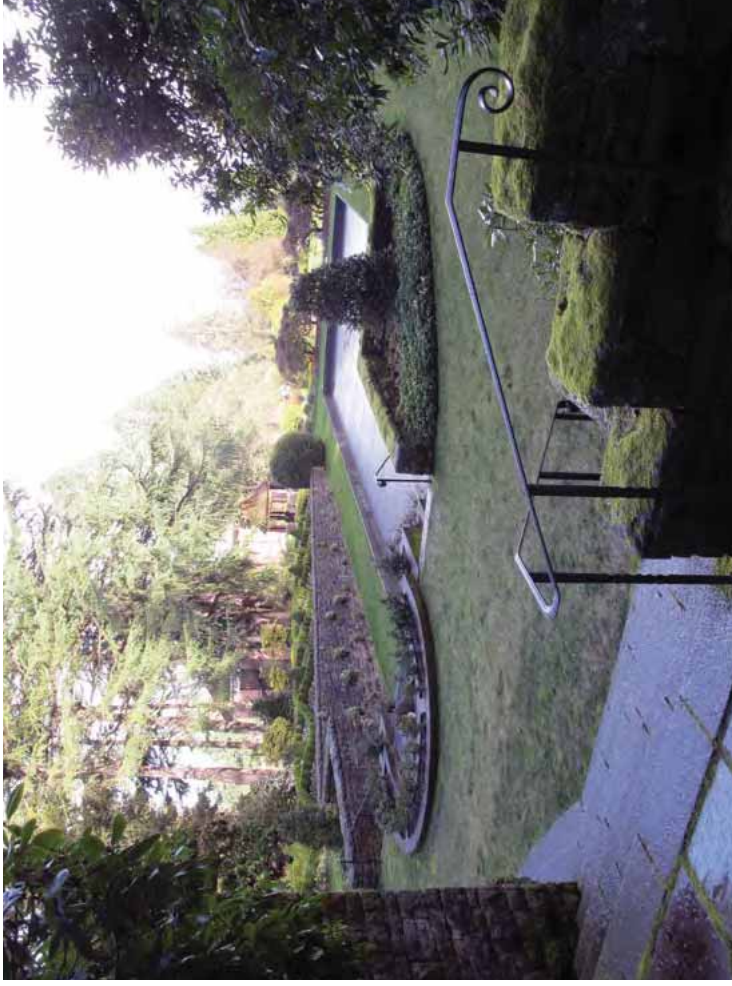
[42] This garden is an important character-defining landscape feature on this college campus.

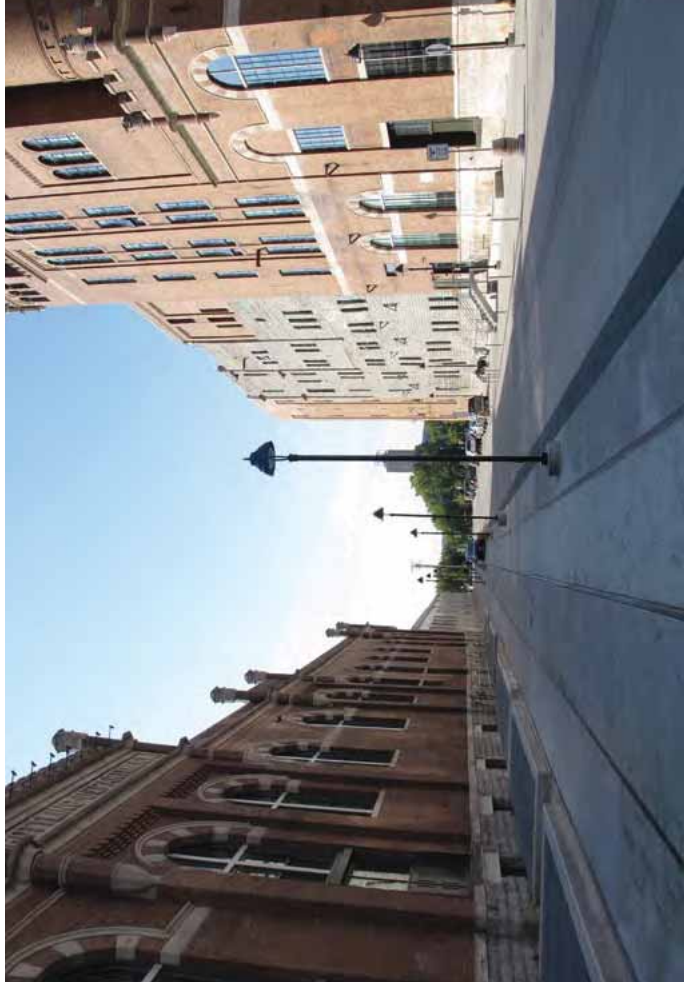
[43] The industrial character of the site was retained when this brewery complex was rehabilitated for residential use.

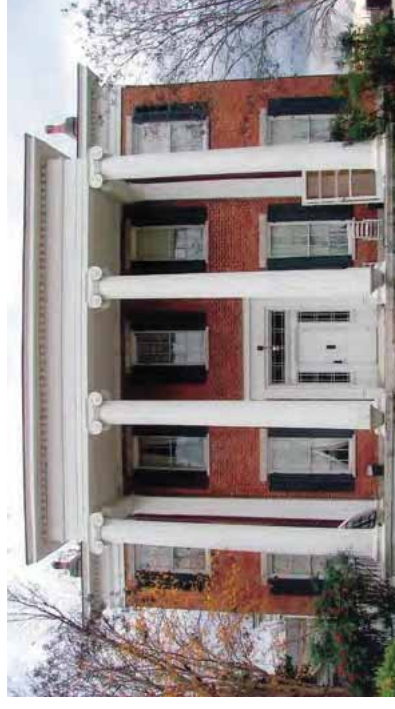
[44] **Not Recommended:** (a-b) The historic character of this plantation house (marked in blue on plan on opposite page) and its site was diminished and adversely impacted when multiple new buildings like this (#3 on plan) were constructed on the property (c).

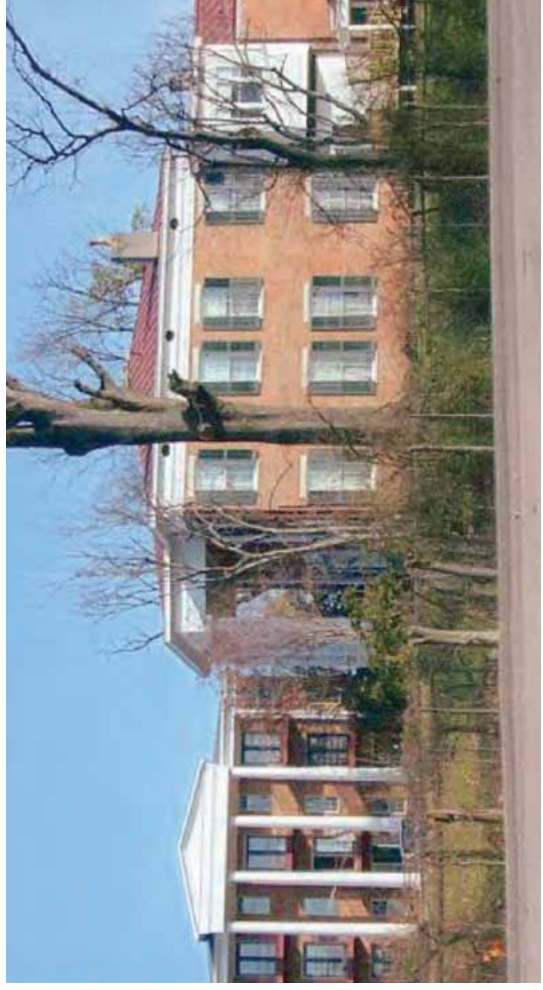
Adding conjectural landscape features to the site (such as period reproduction light fixtures, fences, fountains, or vegetation) that are historically inappropriate, thereby creating an inaccurate appearance of the site.

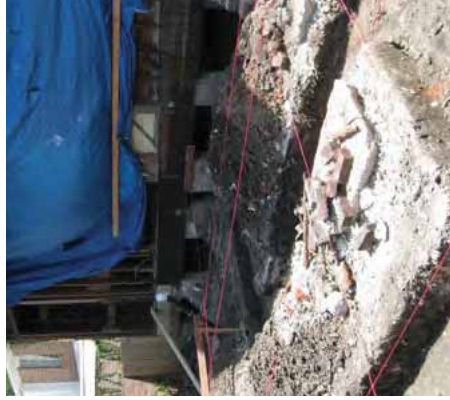
[45] Undertaking a survey to document archeological resources may be considered in some rehabilitation projects when a new exterior addition is planned.

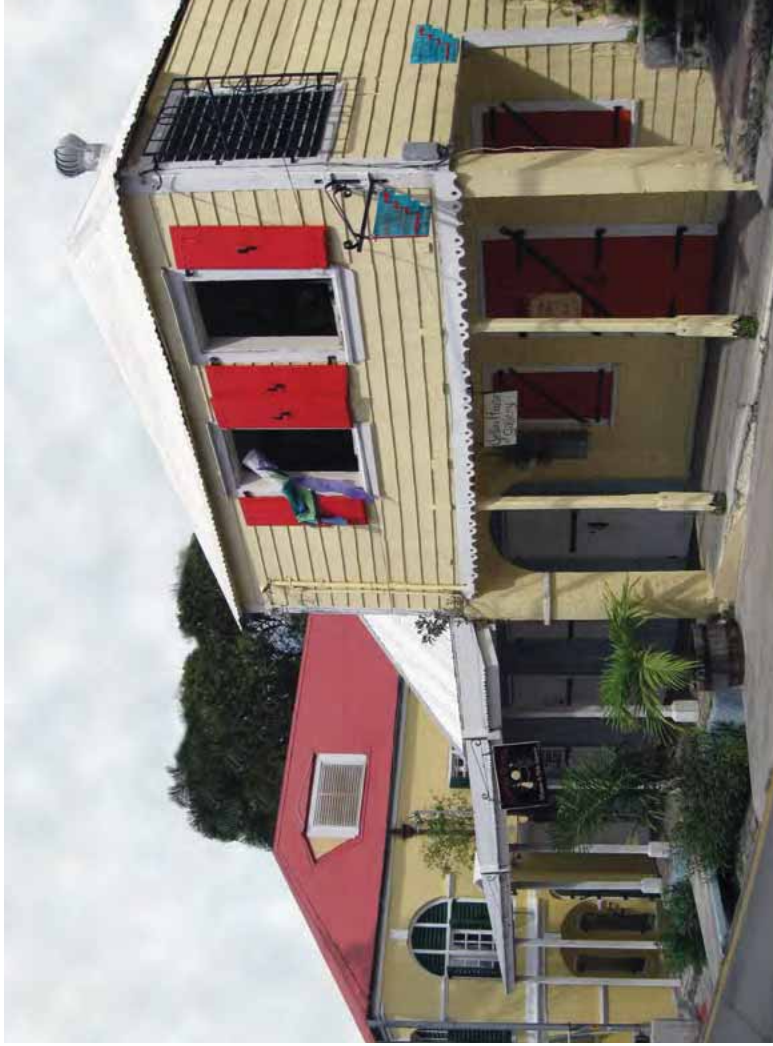
[46] The varied size, shapes, and architectural styles of these historic buildings are unique to this street in Christiansted, St. Croix, USVI, and should be retained in a rehabilitation project.

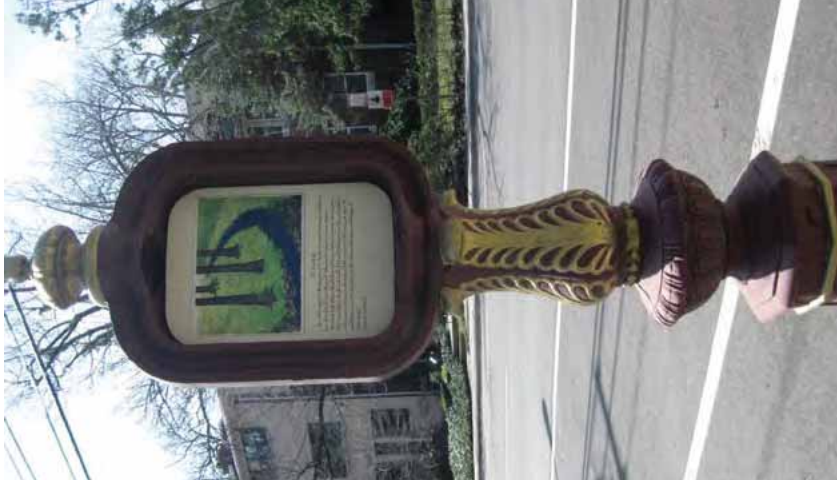
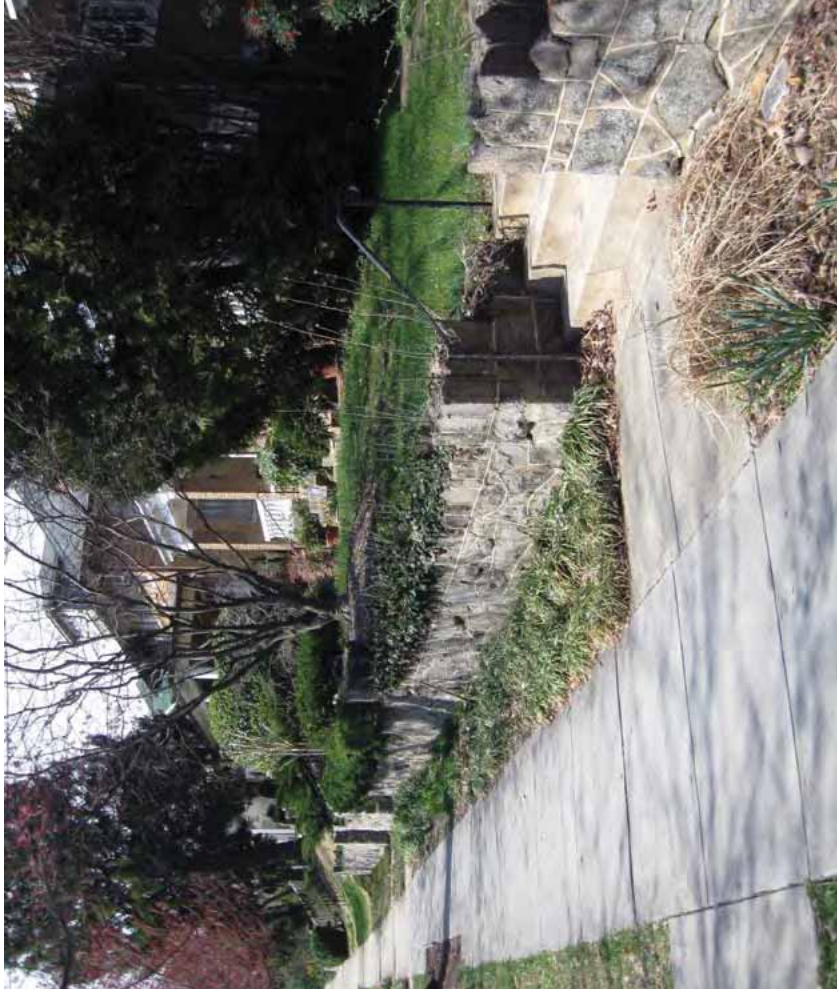
SETTING (DISTRICT / NEIGHBORHOOD)

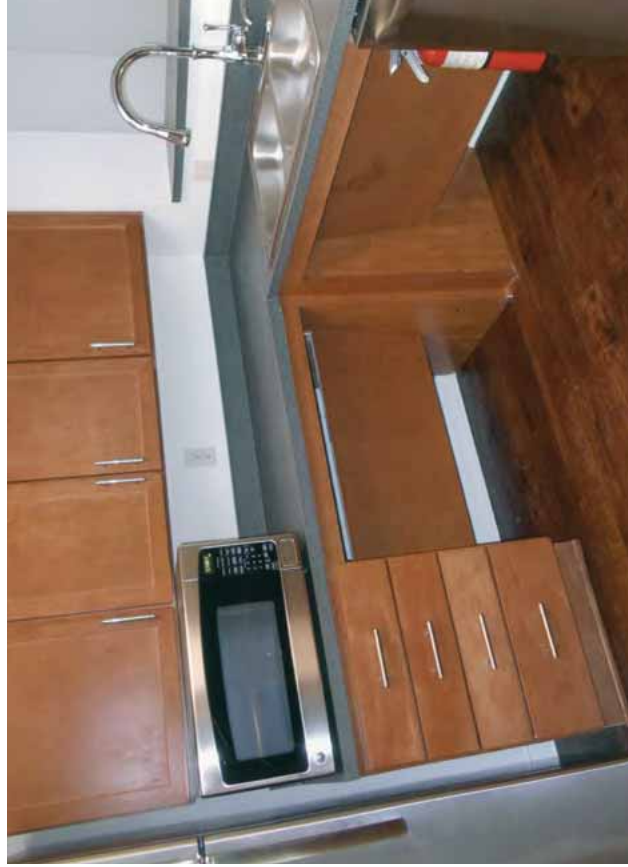
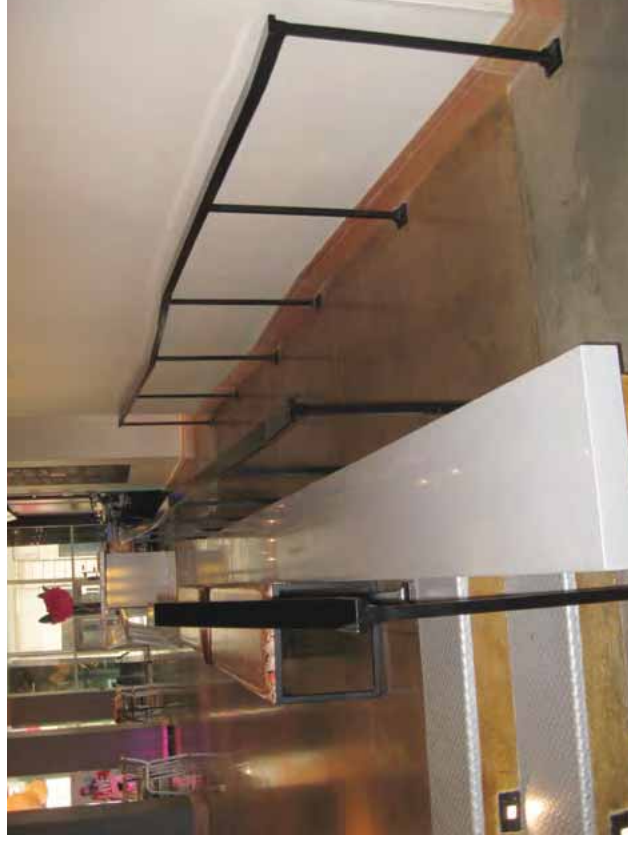
[51] A new interior access ramp with a simple metal railing is compatible with the character of this mid-century-modern building.

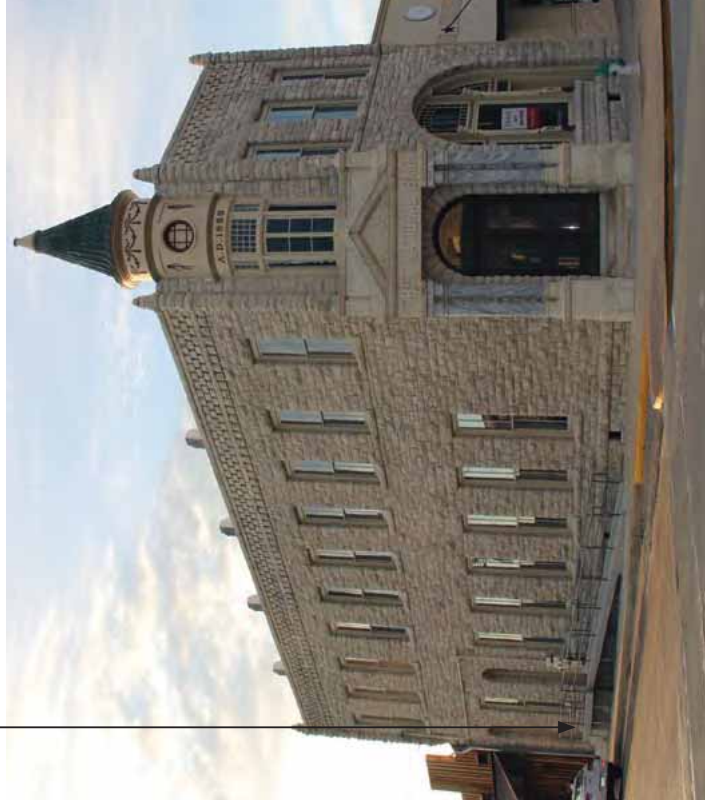
[53] This entrance ramp (right) is compatible with the historic character of this commercial building.

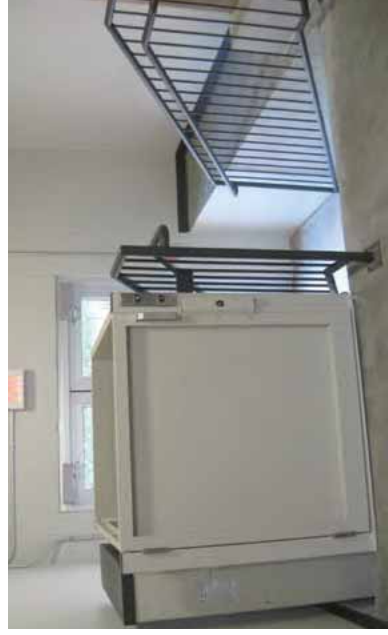
[55] The lift is compatible with the industrial character of this former warehouse.

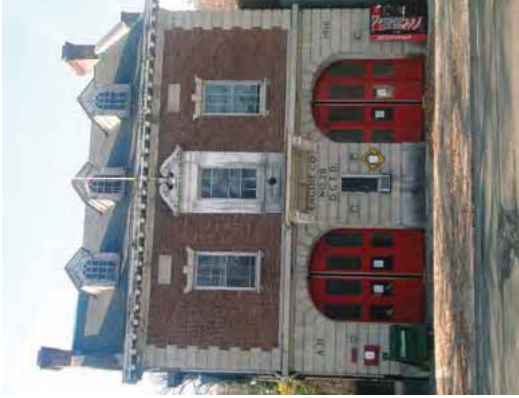
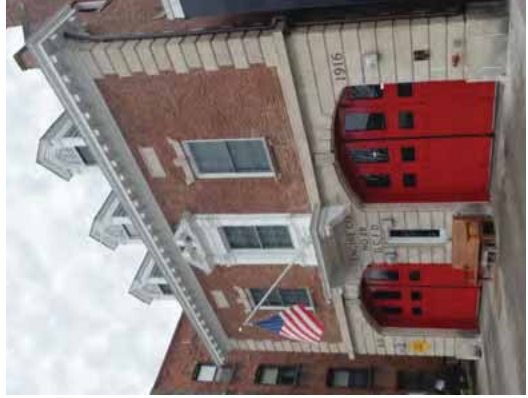
[56 a-b] In order to continue in its historic use, the door openings of this 1916 Colonial Revival-style fire station had to be widened to accommodate the larger size of modern fire trucks. Although this resulted in some change to the arched door surrounds, it is minimal and does not negatively impact the historic character of the building. (a) Above, before; Photo: Fire and Emergency Medical Services Department (FEMS), Washington, D.C.; below, after.

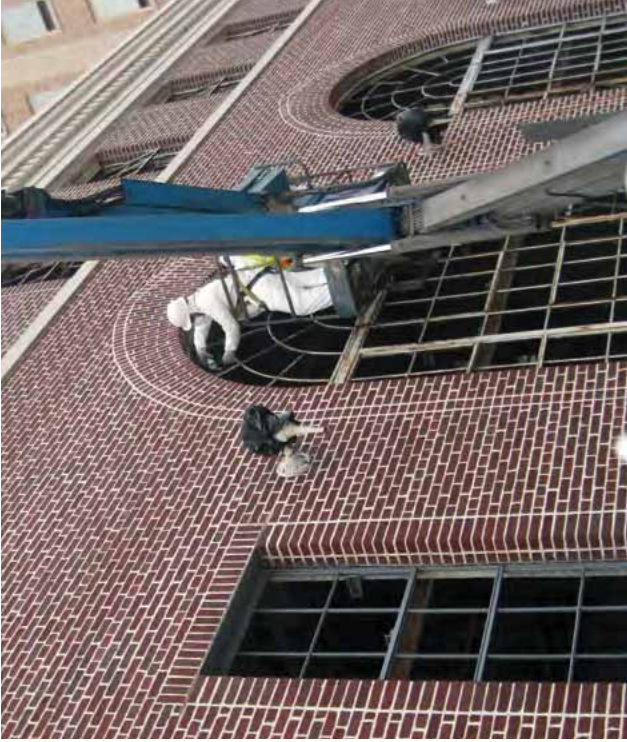
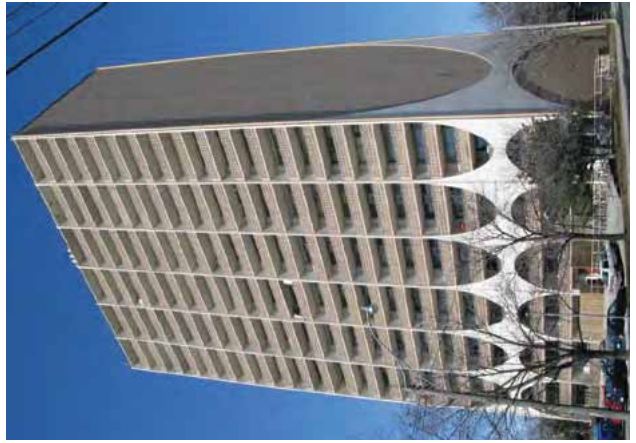
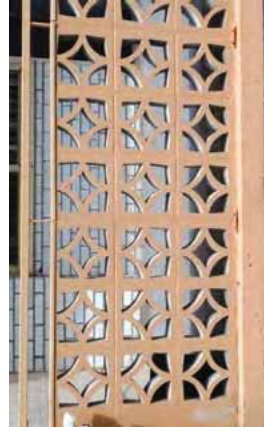
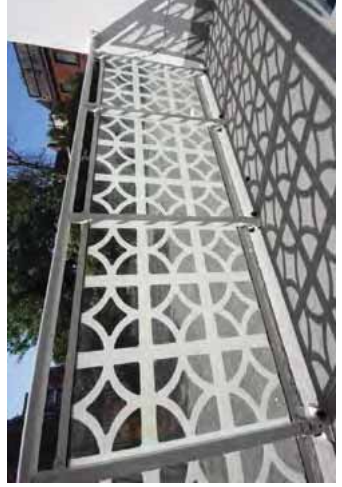
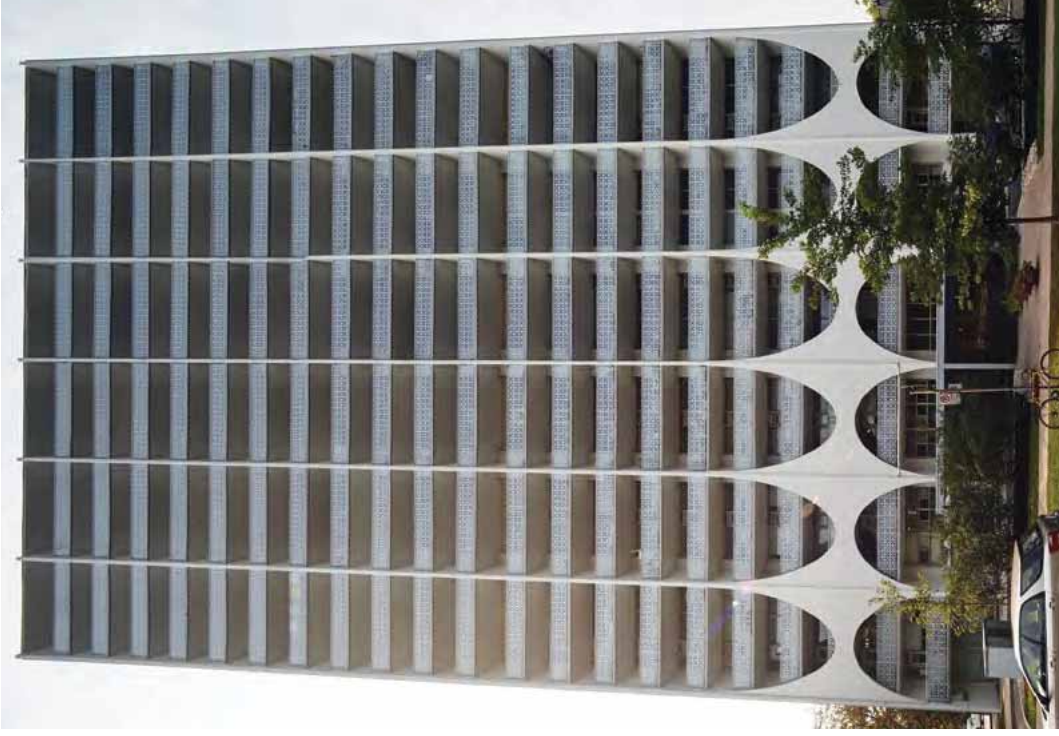
[59] (a-b) The decorative concrete balcony railings on this 1960s building did not meet life-safety code requirements. They were replaced with new glass railings with a fritted glass pattern matching the original design—a creative solution that satisfies codes, while preserving the historic appearance of the building when viewed from the street (c-d). Photos: (a, b, d) ERA Architects, Inc.; (c) Nathan Cyprys, photographer.

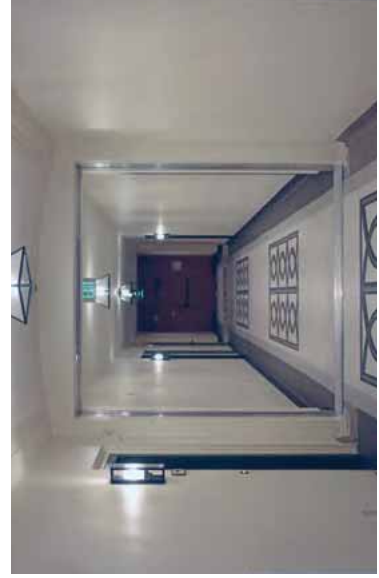
[58] Fire doors that retract into the walls have been installed here (not visible in photo) preserve the historic character of this corridor.

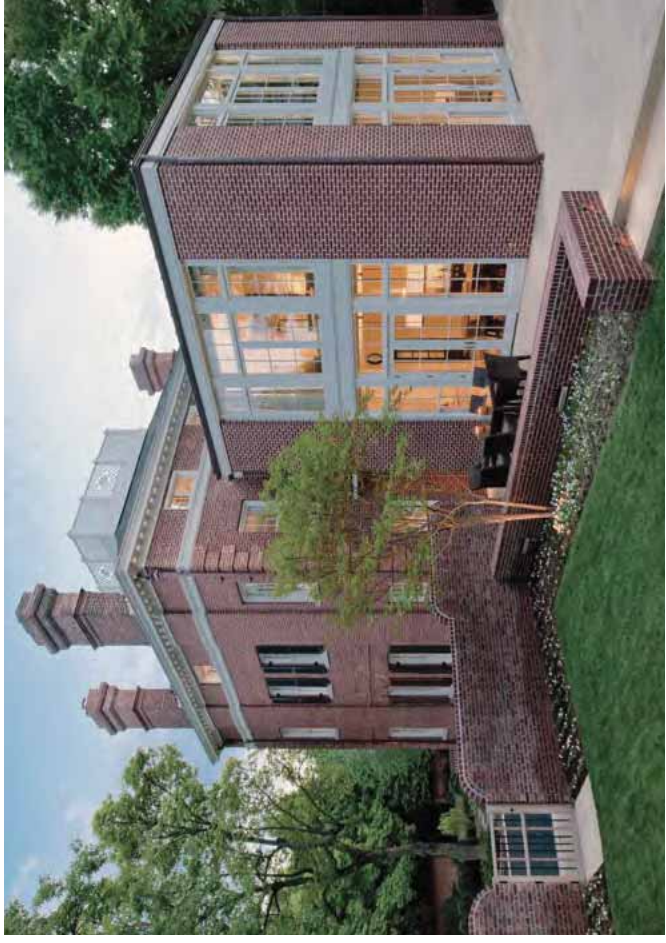
NEW EXTERIOR ADDITIONS TO HISTORIC BUILDINGS AND RELATED NEW CONSTRUCTION

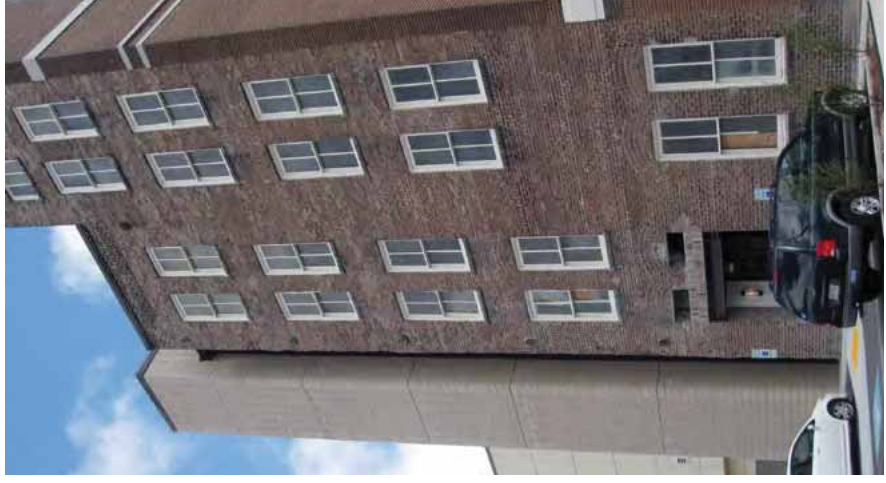
[62] The stair tower at the rear of this commercial building is a compatible new addition.

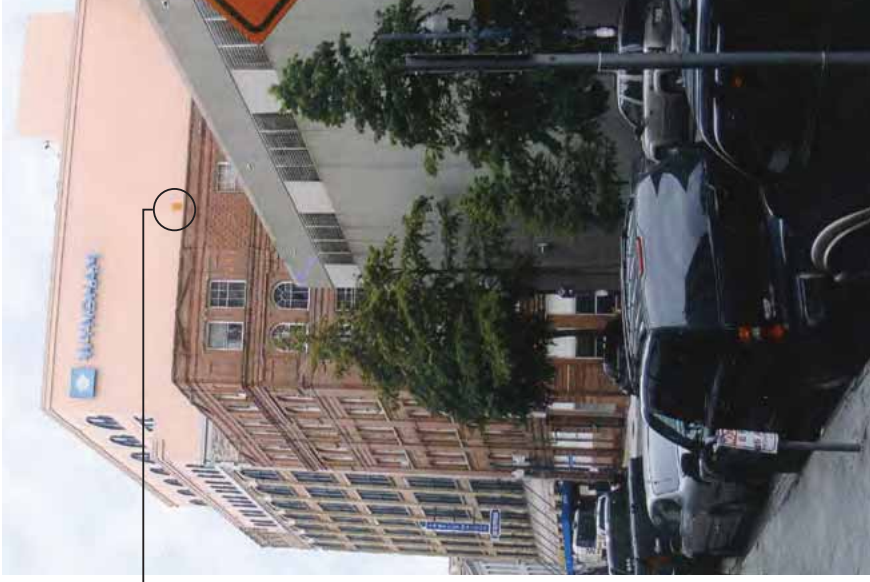
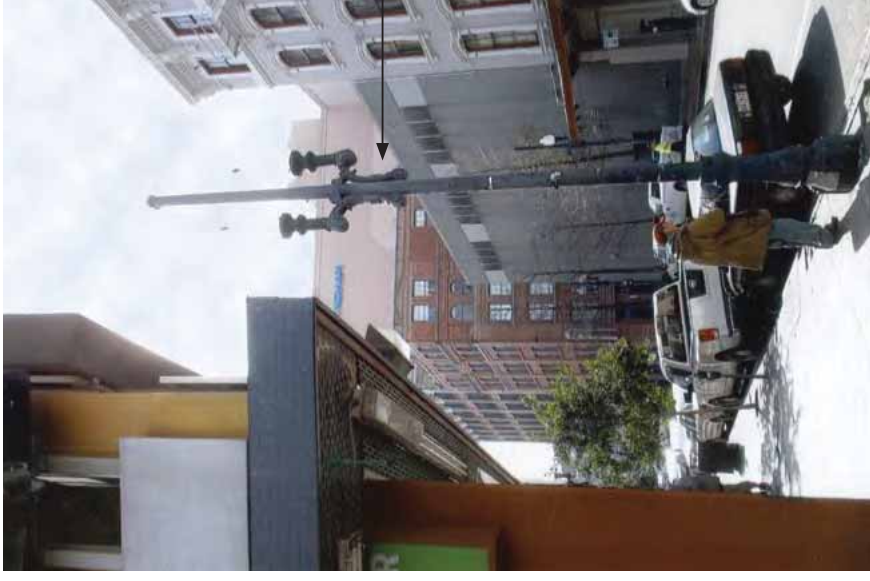
NEW EXTERIOR ADDITIONS TO HISTORIC BUILDINGS AND RELATED NEW CONSTRUCTION

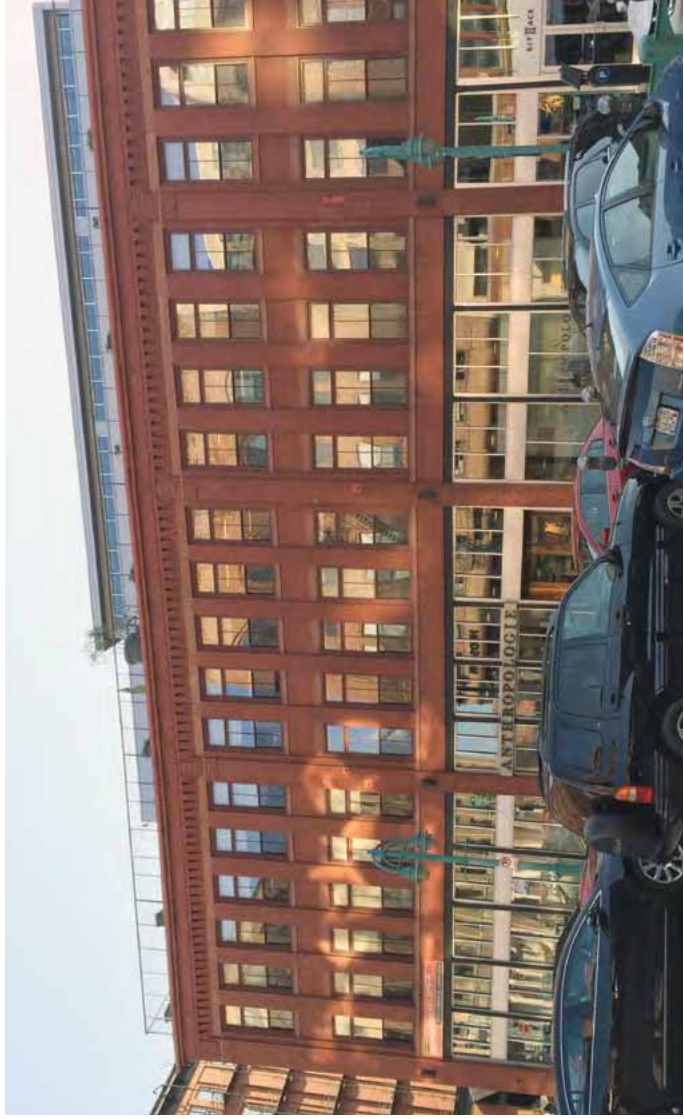
[64] Not Recommended: It is generally not appropriate to construct a rooftop addition on a low-rise, two- to three-story building such as this, because it negatively affects its historic character.

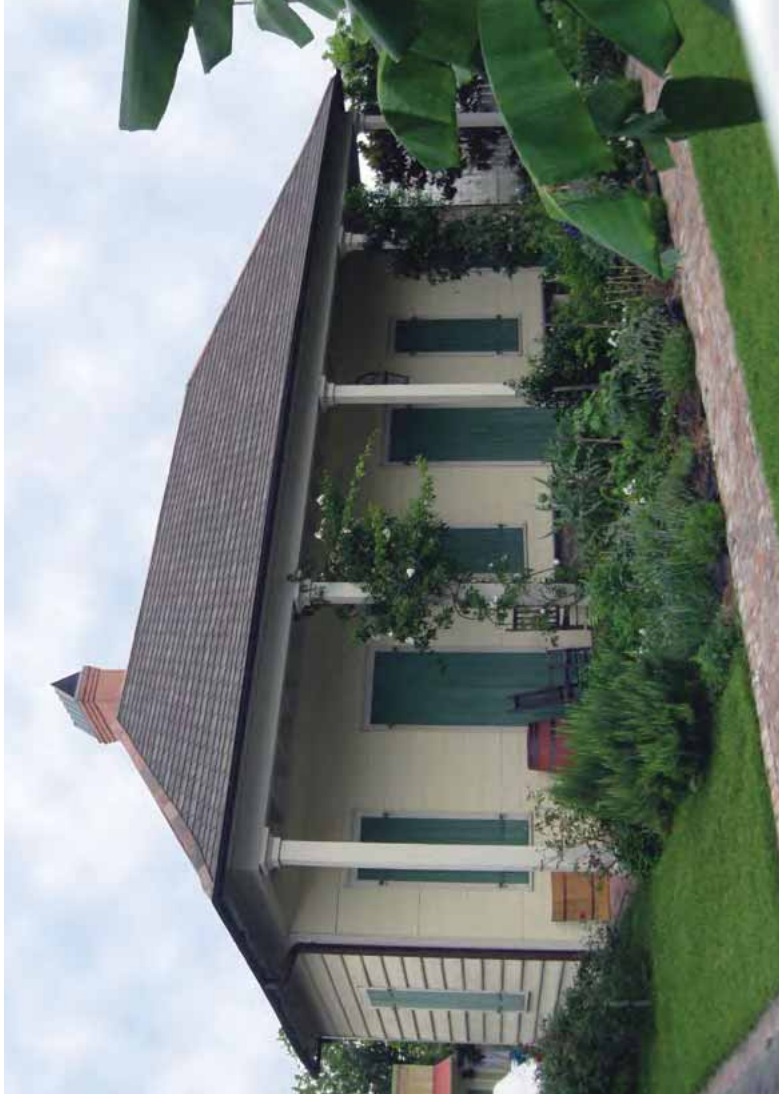
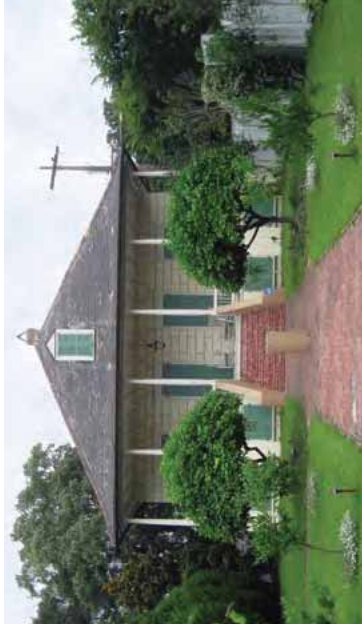
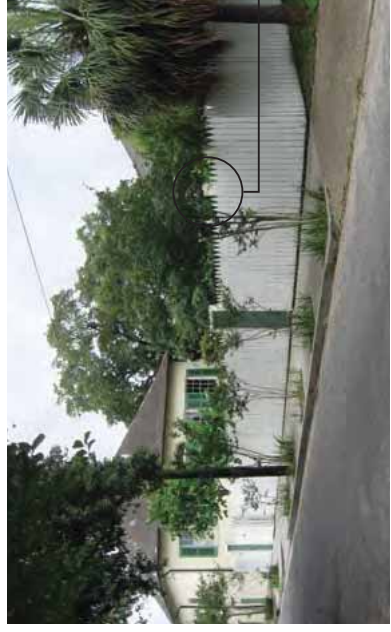
NEW EXTERIOR ADDITIONS TO HISTORIC BUILDINGS AND RELATED NEW CONSTRUCTION
