Certificate of Appropriateness for  
2122 Regent St

September 16, 2019

# Proposed Work

- Replacement of 12 original windows
  - Replacements are wood interior, fiberglass exterior
  - Same design as original

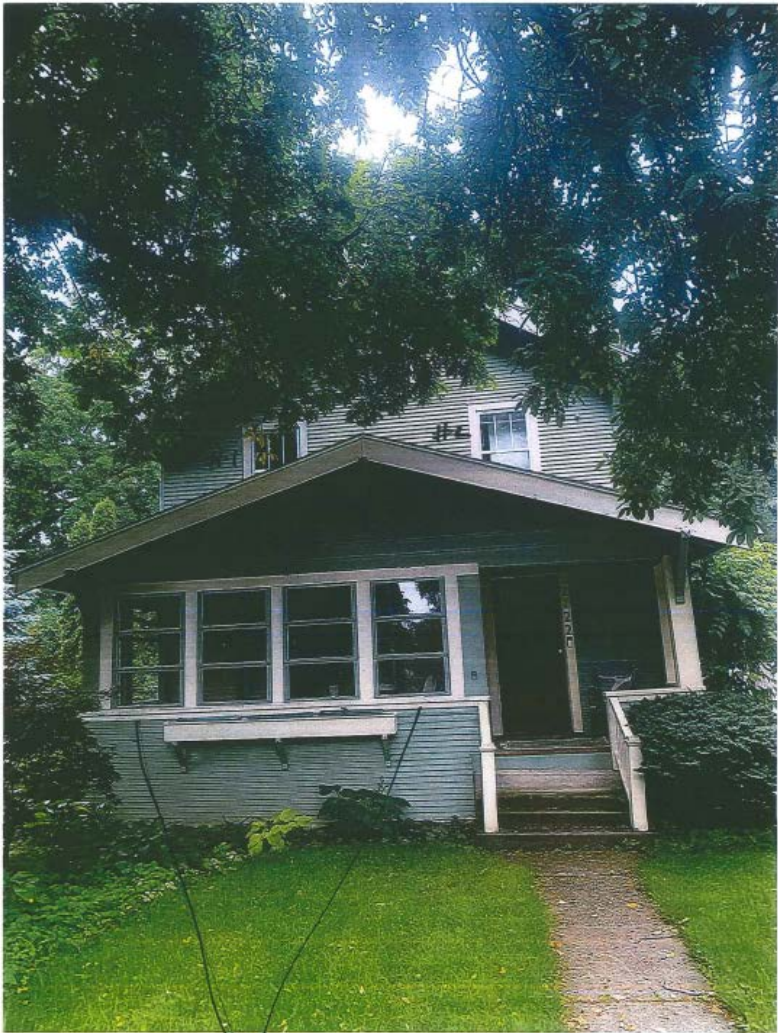
RIGHT ELEVATION

\* NOT DOING R  
~~Porcht activities #1~~

\*All windows on whole  
house will have a whole  
exterior

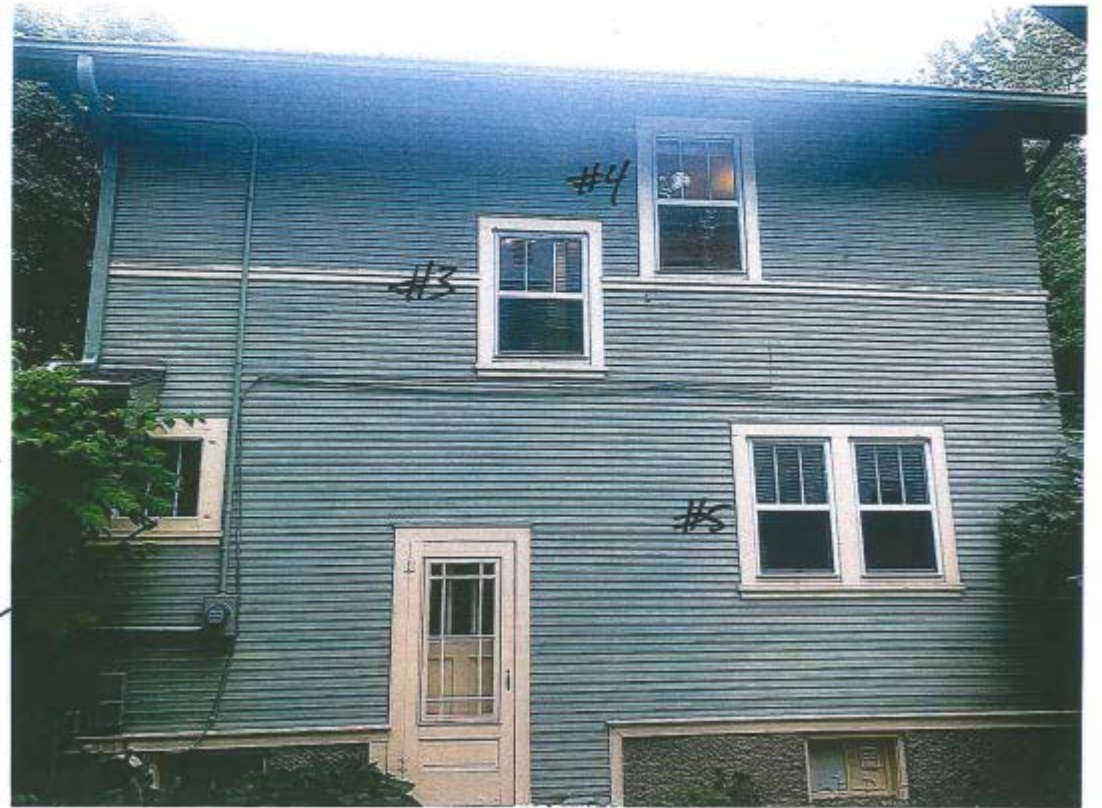
LEFT ELEVATION

Not  
Replacing

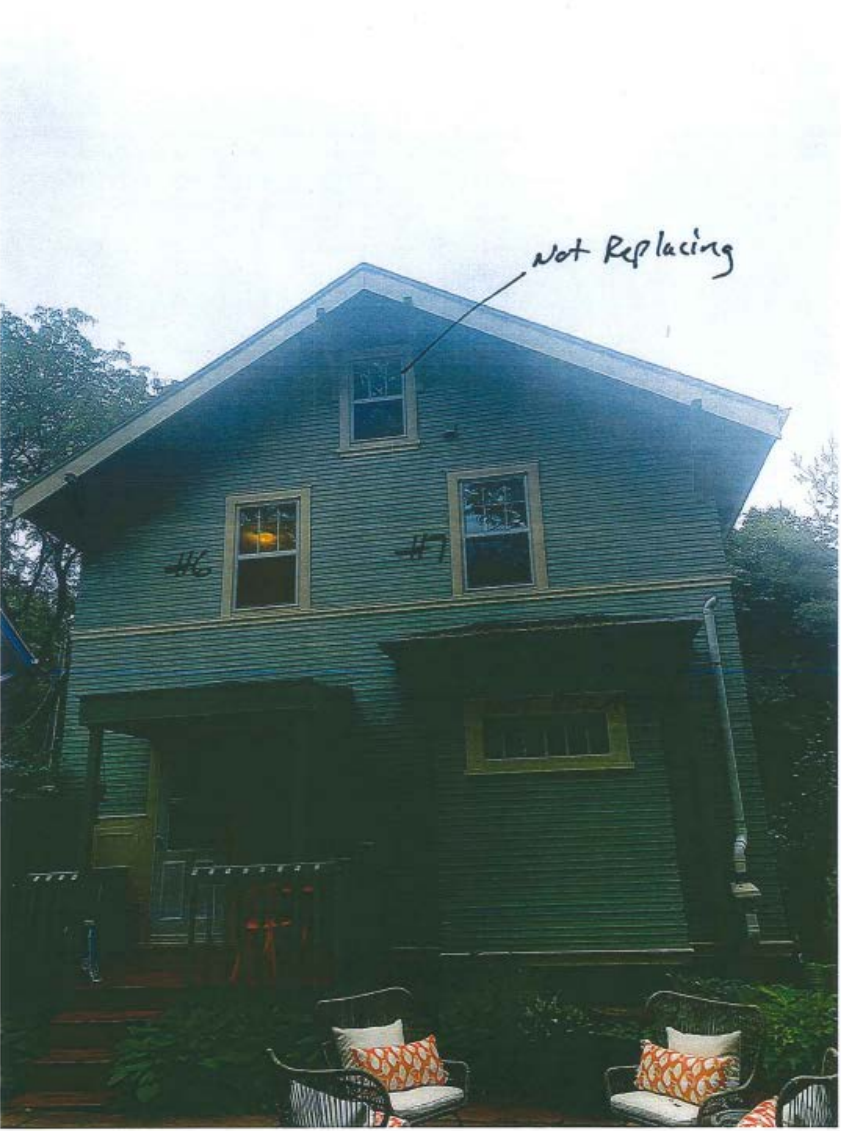
Bedroom

Not Replacing

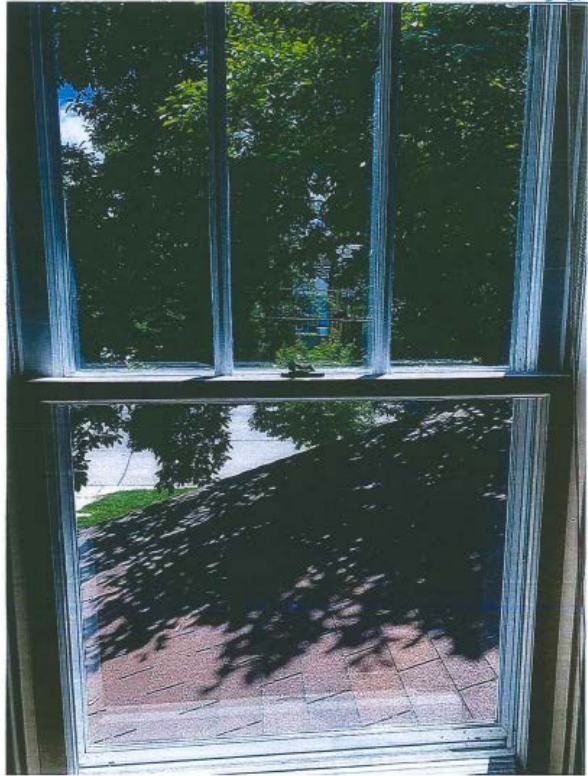
Bedroom

inside view of windows
