# TID 40 - Blight Study

June 16, 2009

City of  
Madison,  
Wisconsin

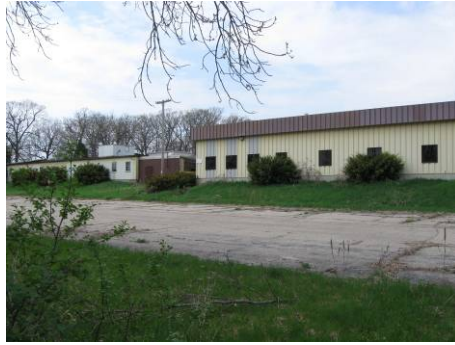
**Score: 40.8**

Walls and cladding worn and discolored; lawn not maintained; piles of brush and abandoned equipment visible from the street

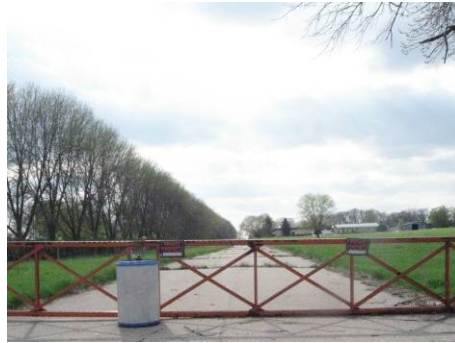
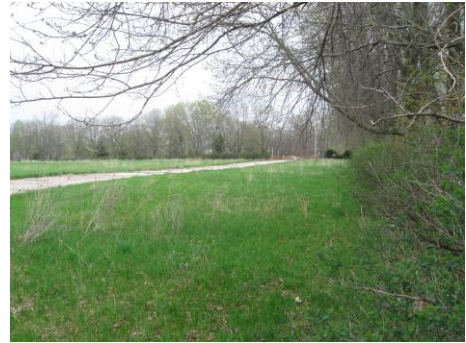
**Parcel 2**

**Score: 36.8**

Vacant lot, lawn not maintained; structural deterioration of the drive; shabby and rusting gate

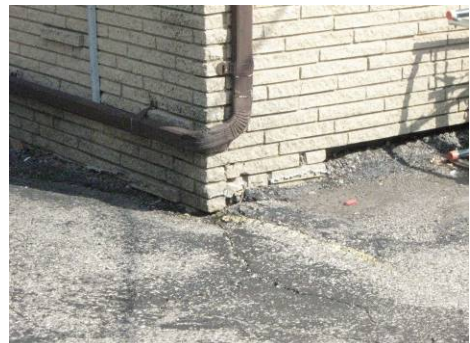
Water damage to walls, roof, and porch; structural damage to walls; pavement deteriorating; limited lawn maintenance

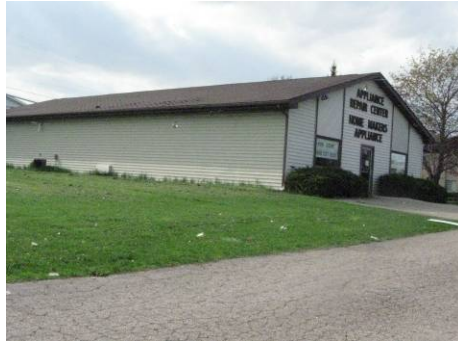
**Score: 30.7**

Missing siding, structural damage to roof, majority of front fence missing, poorly covered graffiti; 8 code violations in the past 5 years

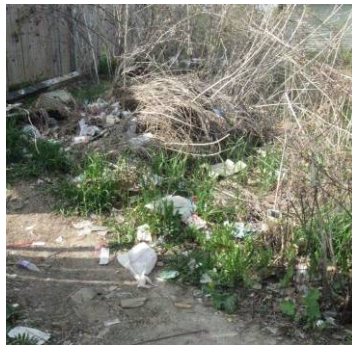
#### **Parcel 37**

**Score: 38.6**

Paint peeling from siding in many places; signs on building crooked; pavement in poor condition; dumpsters not screened; litter; weeds; broken glass, etc; 24 code violations in the past 10 years

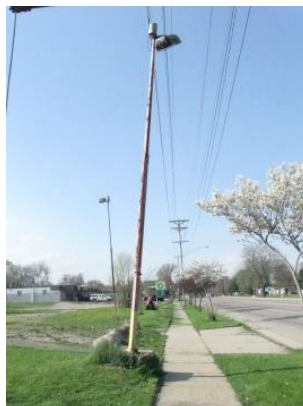
#### **Parcel 38**

**Score: 49.6**

Vacant parking lot; light poles in poor conditions; pavement in poor condition

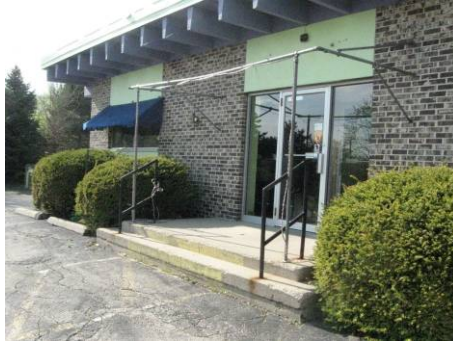
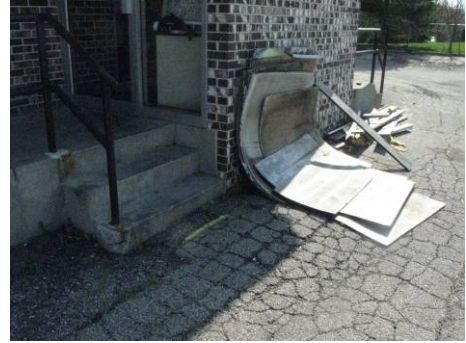
**Parcel 42**

**Score: 30.3**

Vacant; missing canopy; roof in poor condition; fascia warped; no screening; shed falling apart; pavement and stairs in poor condition; piles of junk

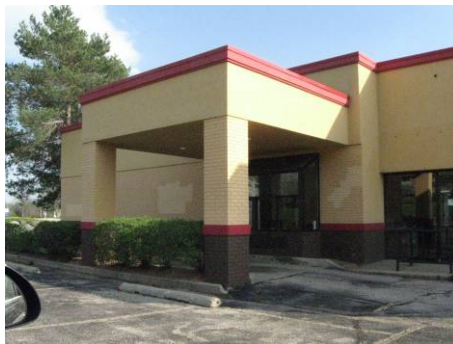
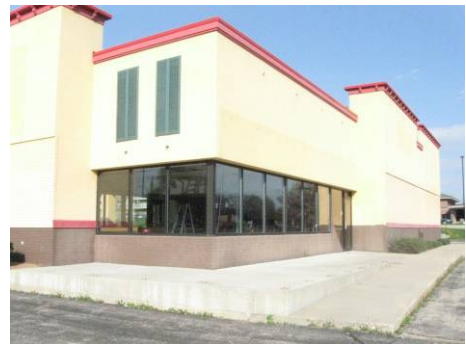
**Parcel 49**

**Score: 39.9**

Vacant; mismatched paint; canopy missing; no railing along raised patio; screening in poor condition; pavement in poor condition

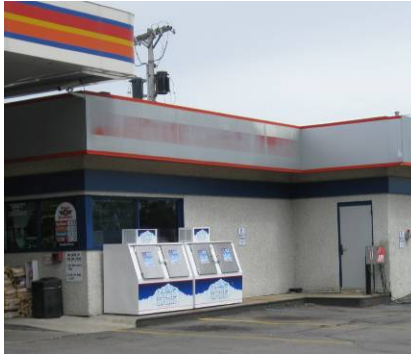
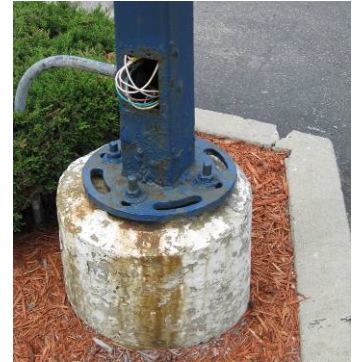
**Score: 44.9**

Roof canopy faded, discolored; exposed wires near sidewalk; car wash doors and frames in poor condition and appearance, dead bushes

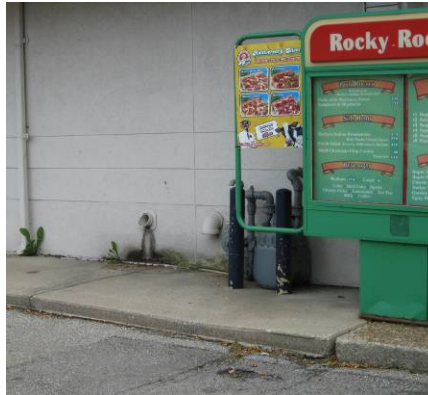
Parking lot in poor condition; roof trim in poor condition; inoperable door; unscreened dumpster; rotting shed

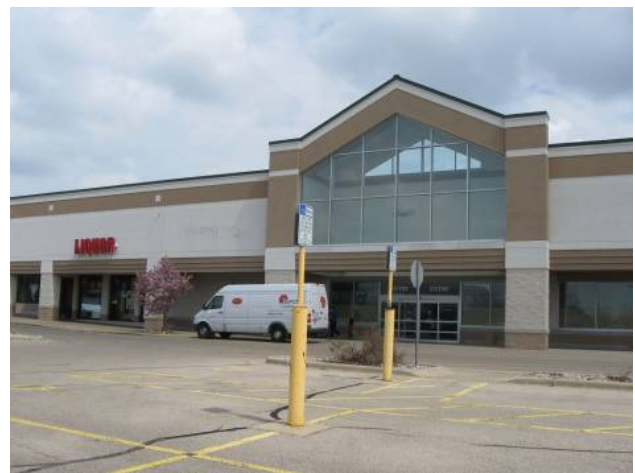
#### **Parcel 54**

Lot utilization and occupancy both deficient; walls and cladding display remnants of old signage; dead or dying landscaping

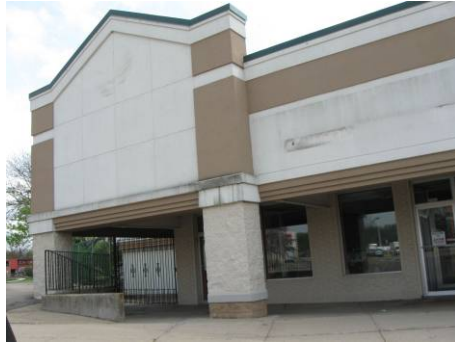
**Score: 44.5**

Vacant; water damage to foundation and walls; insufficient screening of dumpsters; missing signage; weeds; graffiti; 20 code violations in past 10 years

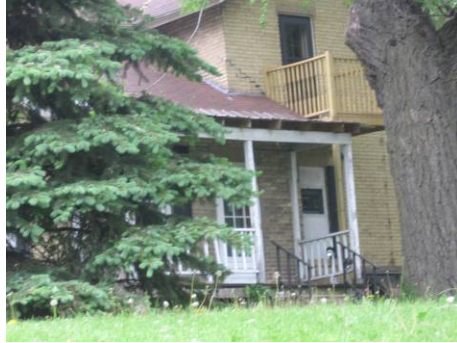
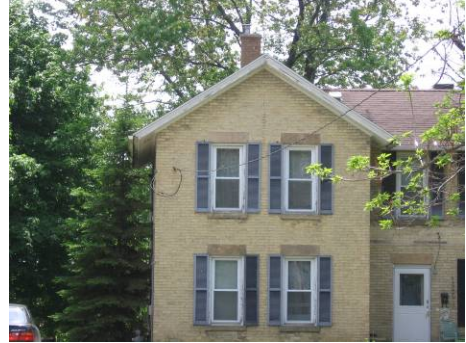
**Score: 52.6**

Large crack in corner of brickwork; worn and weathered shingles; eaves and sills rotted; weeds; dead landscaping

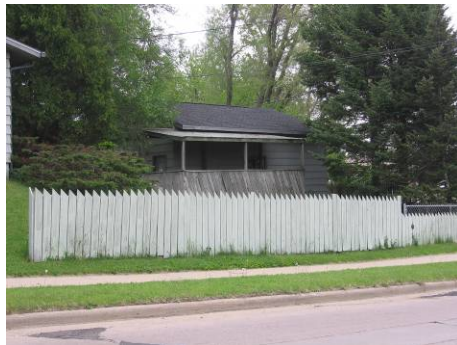
#### ***Parcel 41***

**Score: 52.9**

Discoloration of foundation and siding; front steps deteriorating; accessory structure missing gutters and needs to be stained; weeds

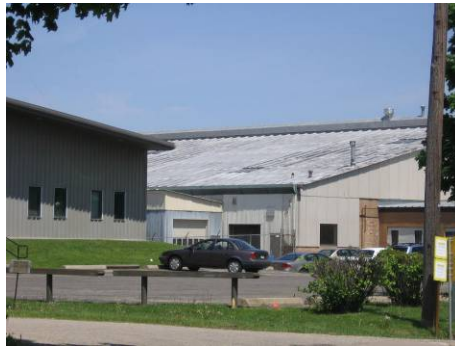
**Score: 50.2**

Structural and cosmetic deficiencies of the walls and roof; minor parts of the roof and walls missing; canopy and sign deteriorating

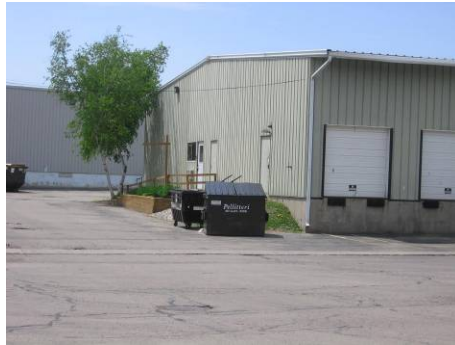
**Parcel 58**

**Scoring: 51.4**

Pavement damaged and cracking; dumpsters not screened; cosmetic problems with the walls, foundation, and exterior doors

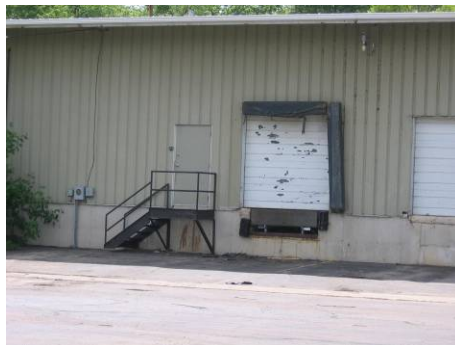
**Parcel 59**

**Score: 44.7**

Deteriorating pavement; cosmetic problems with the foundation and walls; paint peeling; doors dented, dumpster not screened

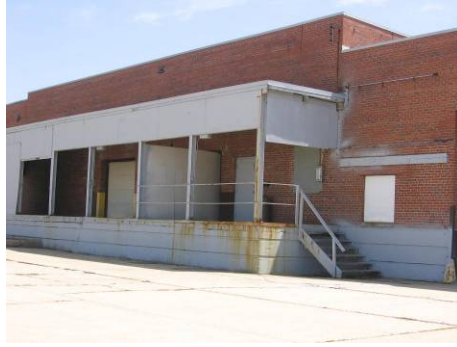
**Parcel 74**

**Score: 45.1**

Foundation, walls, and porch structural deficiencies; entire building has cosmetic problems; graffiti

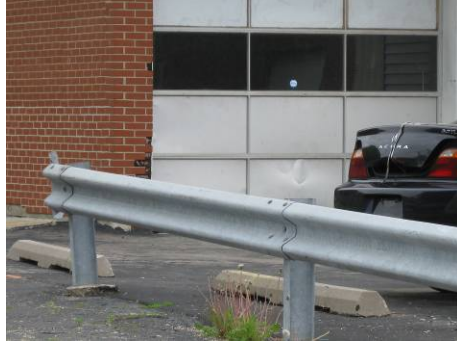
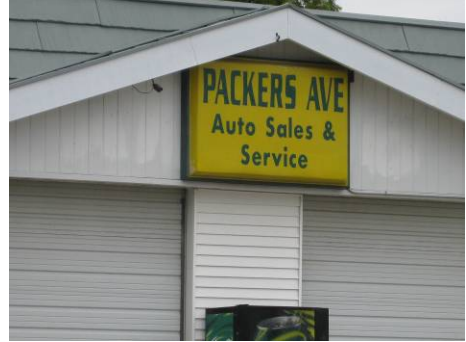
**Score: 43.1**

Doors dented; siding paint discolored; bricks missing; weeds

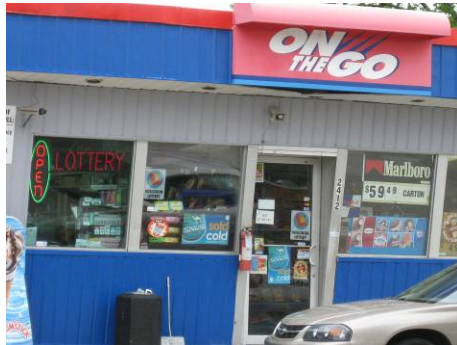
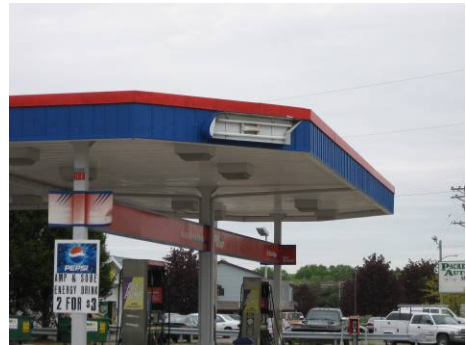
#### **Parcel 81**

**Score: 51.4**

Soffit rotted; missing portions of signage; pavement pitted; litter; scaffolding stored in parking lot

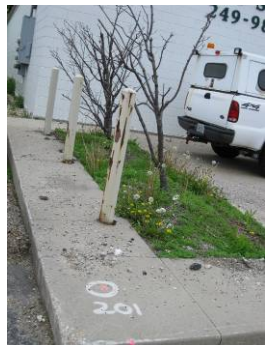
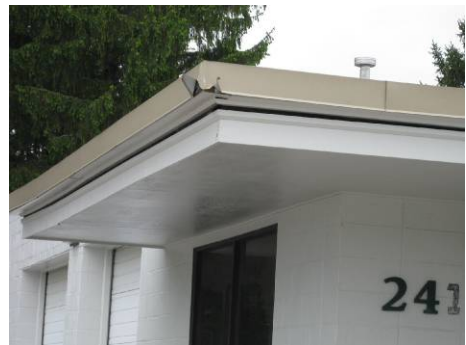
#### **Parcel 86**

**Score: 55.7**

Dumpsters not screened; missing numbers in the address sign; dead trees; weeds; pavement cracking; standing water; rusting truck parked along sidewalk

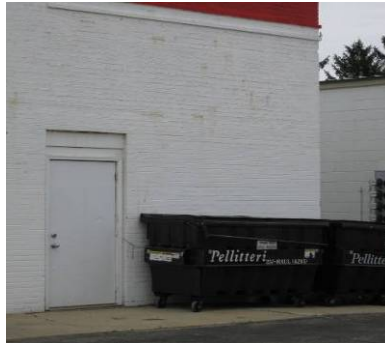
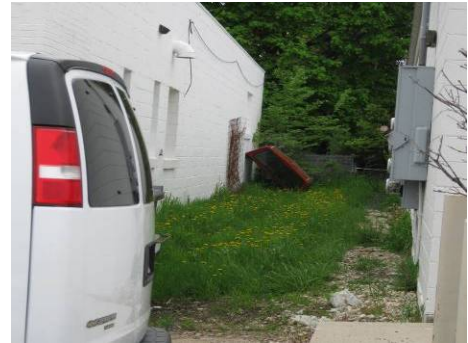
**Parcel 87**

**Score: 51.0**

Dumpsters and outdoor storage not screened, terrace in poor condition, discoloration and water staining on facade

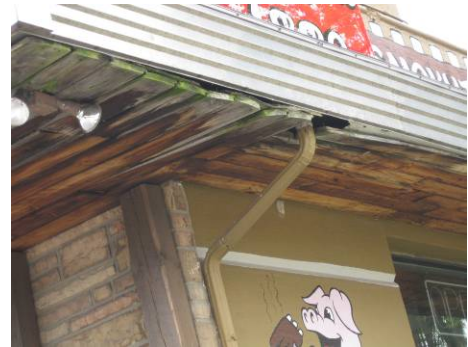
Paint peeling; walls cracking and mildewing; windows boarded up and/or cemented over; soffit rotting; doors missing trim; weeds

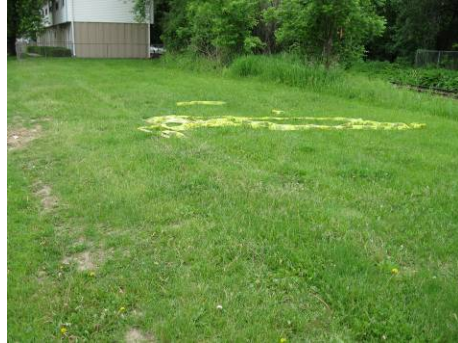
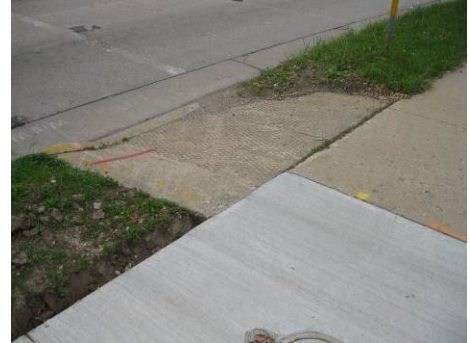
**Score: 48.7**

Small vacant lot;  
garbage; erosion and  
debris on crosswalk  
ramp

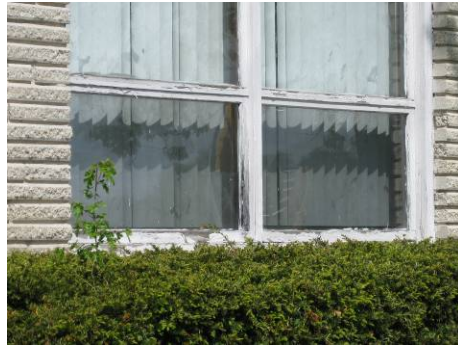
**Parcel 97**

**Score: 49.8**

Water damage to  
siding and window  
sills; front stoops  
sinking; pavement  
pitted; weeds in  
bushes, soffits water  
damaged

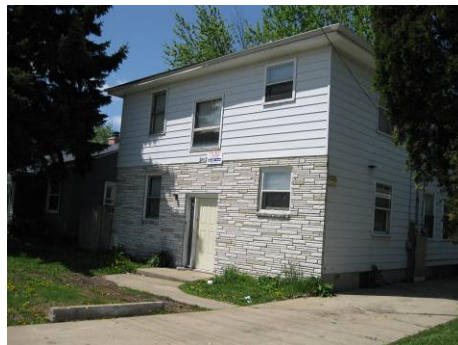
**Parcel 104**

**Score: 38.1**

Walls, roof, and  
windows have  
cosmetic problems  
and missing pieces;  
water damage; trash;  
lawn overgrown and  
weedy

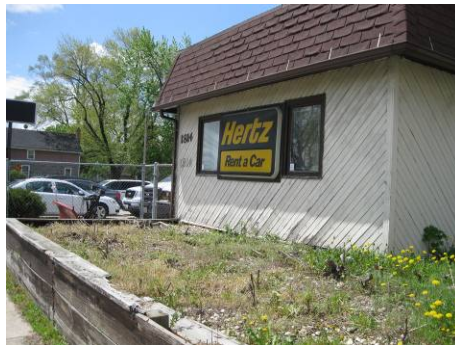
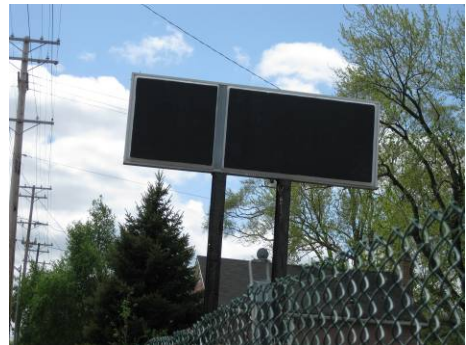
**Score: 39.8**

Water damage; paint peeling; missing sign; pavement cracked and pitted; flowerbeds weedy and neglected

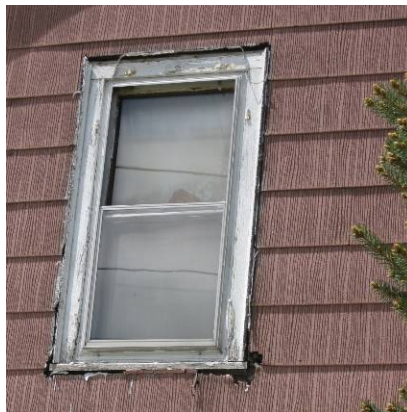
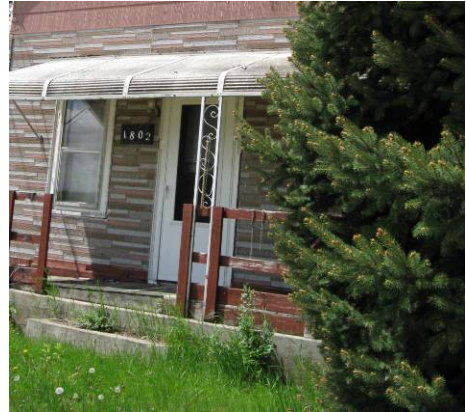
Missing portions of walls and windows; structural problems with porch, chimney, stairs; no front walk; yard not maintained; severe mildew and rot problems

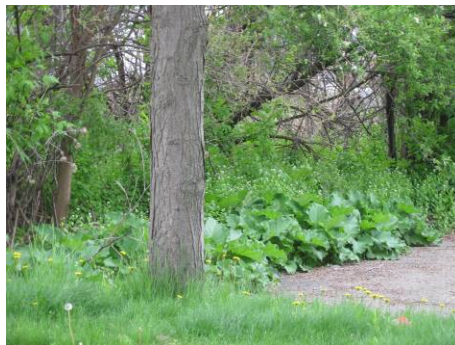
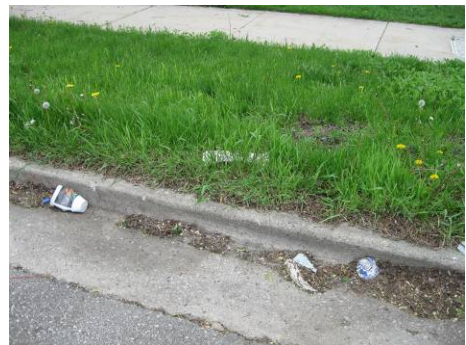
**Score: 43.5**

Vacant lot/driveway; overgrown; litter; pavement damaged

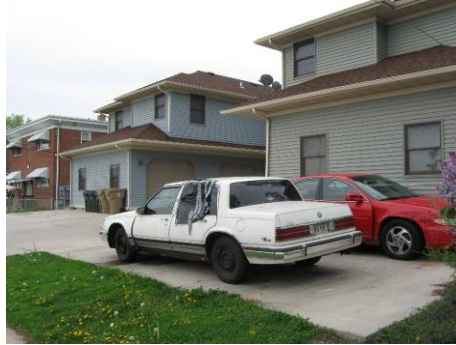
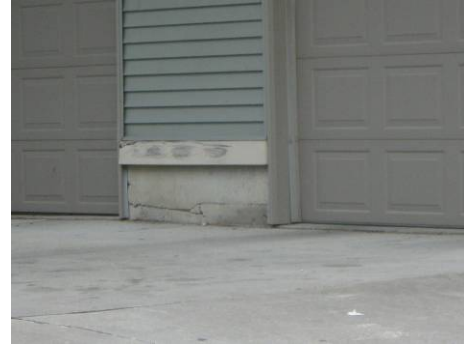
**Score: 55.5**

Foundation cracking; siding dirty and marred; garbage and debris in gutter and roof; porch sagging; weeds; inoperable vehicles

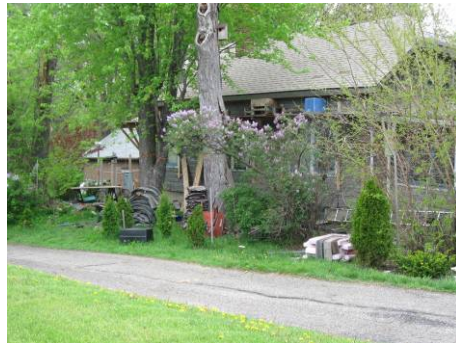
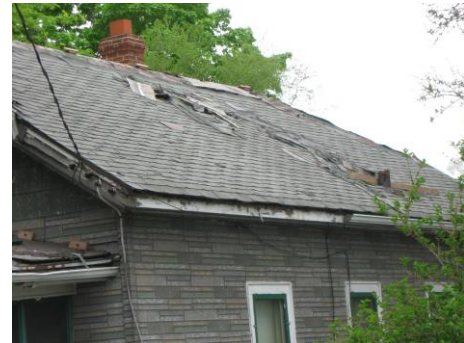
#### ***Parcel 134***

**Score: 39.1**

Missing parts of roof; paint peeling; many elements rotting; piles of trash and debris in yard

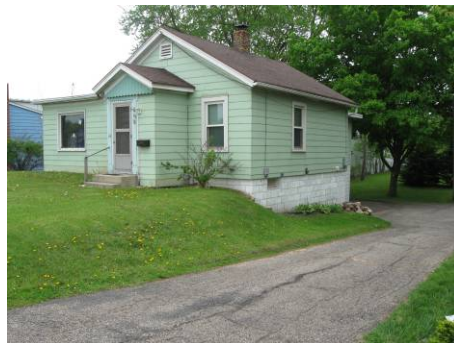
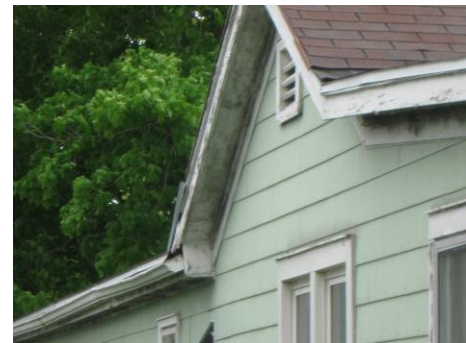
#### ***Parcel 135***

**Score: 53.7**

Roof, fascia, window frames, and door all showing signs of rot; driveway cracked; landscaping dying

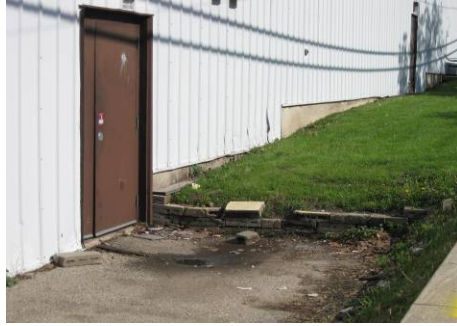
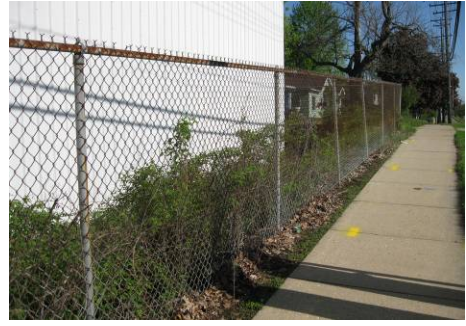
**Parcel 136**

**Score: 47.2**

Incompatible bulk and use; siding damaged, trash in front yard, unscreened mechanicals with exposed wires, fence and retaining wall in poor condition

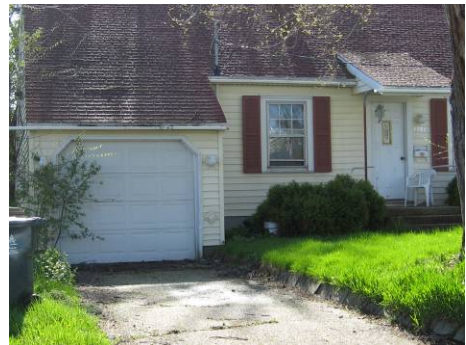
**Parcel 147**

**Score: 31.4**

House vacant; damaged front door; yard overgrown; trash in yard; paint peeling; storm windows askew

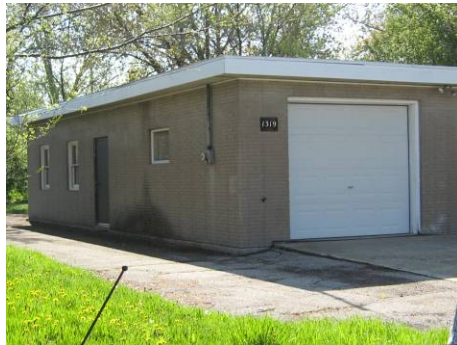
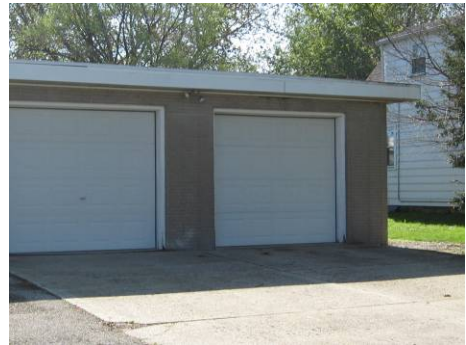
**Parcel 148**

**Score: 37.0**

Building vacant; water damage to walls; flashing coming loose from roof; pavement degraded and draining toward building

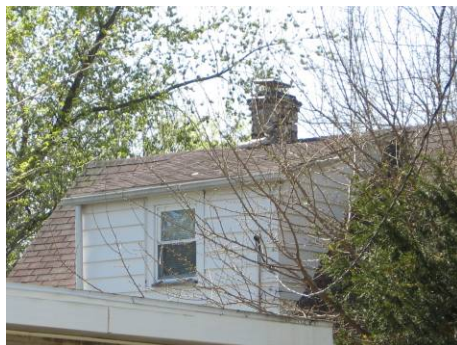
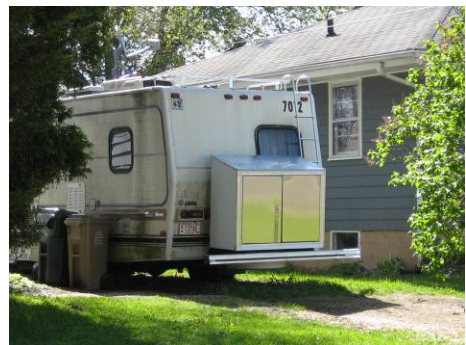
**Parcel 151**

**Score: 47.0**

Walls and roof damaged; no railing on exterior stairs; shingles curling; inoperable vehicle in the driveway

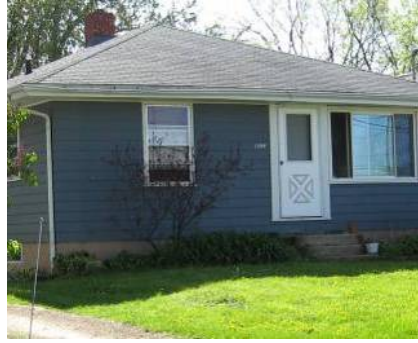
**Parcel 153**

**Score: 45.8**

Shingles curling;  
gutters bent; garage  
missing a door and  
cladding or paint; no  
railing for front stoop

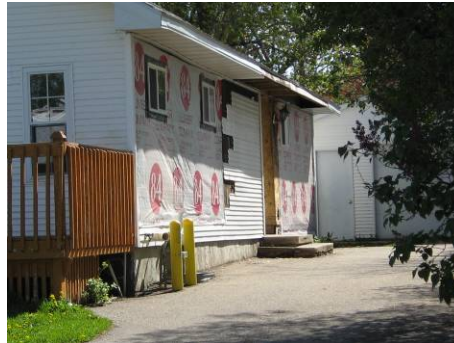
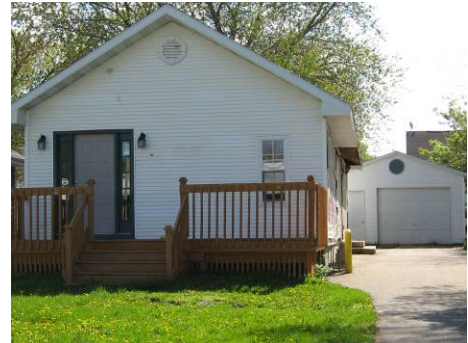
**Parcel 155**

**Score: 47.9**

Missing cladding;  
roof sagging; stairs  
settling; weedy and  
overgrown yard

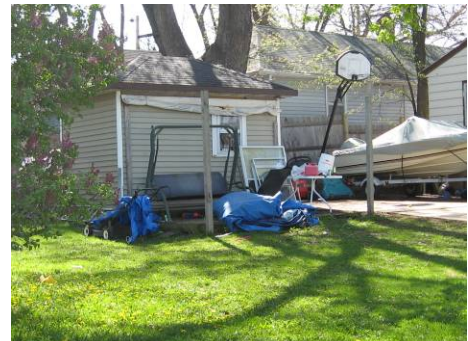
**Parcel 157**

**Score: 48.8**

Paint peeling; window frames,  
siding and fascia rotting;  
trash in yard;  
unscreened storage in back yard

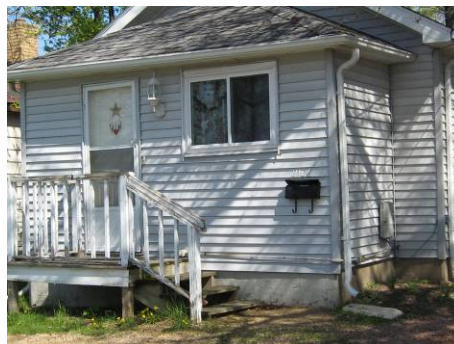
**Parcel 158**

**Score: 56.1**

Shingles degrading;  
porch in poor  
condition; driveway  
unpaved and  
rutted; landscaping,  
weedy

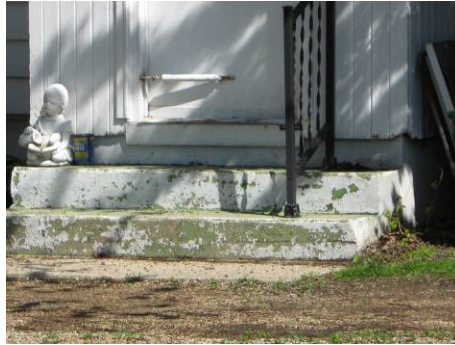
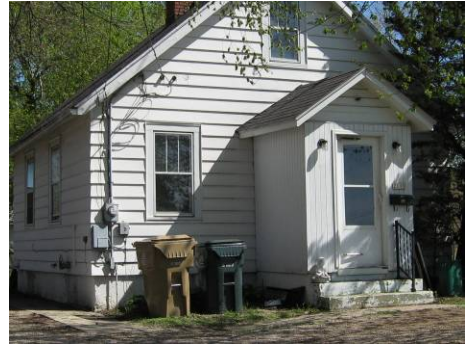
**Parcel 159**

**Score: 51.3**

Paint peeling;  
gutters falling off;  
fence falling over;  
junk in front yard

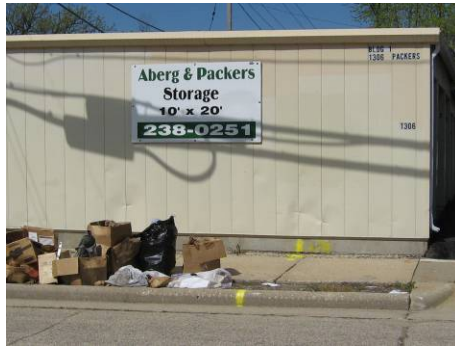
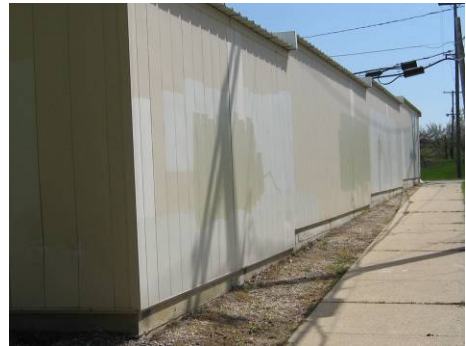
**Parcel 160**

**Score: 41.2**

Siding dented;  
different colors  
paint (covering  
graffiti); weeds;  
debris; piles of  
trash

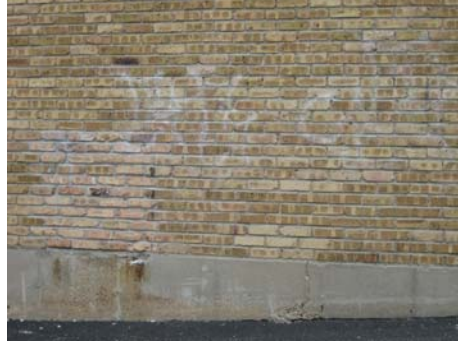
**Score: 59.6**

Pavement degraded, severely in places; graffiti on side of building; cracks in brickwork; dead bushes and unkempt landscaping

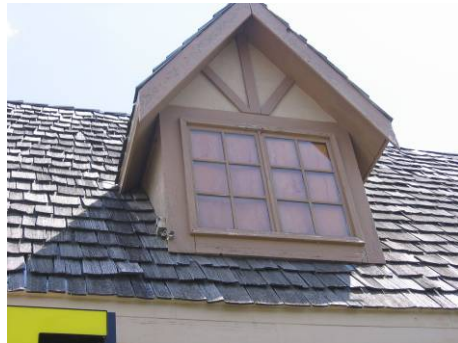
#### **Parcel 181**

**Score: 54.5**

Paint peeling; missing/damaged shingles; no screening in back; cracked pavement; stairs overgrown by bushes

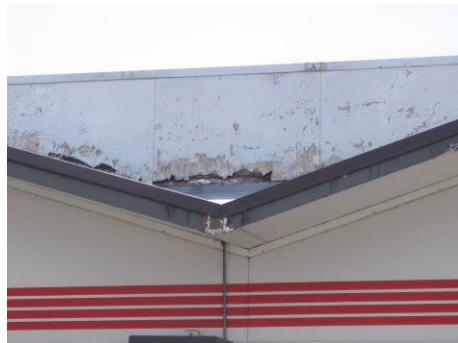
#### **Parcel 188**

**Score: 42.2**

Paint peeling; pieces rotting; graffiti; poor signage; safety hazards; litter; unscreened dumpsters

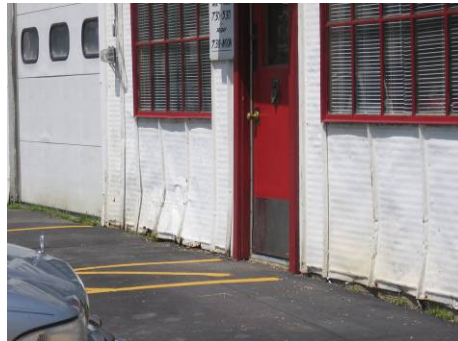
#### **Parcel 191**

**Score: 48.5**

Walls damaged and dirty; signage poor; no screening; parking lot gravelly; minor maintenance issues

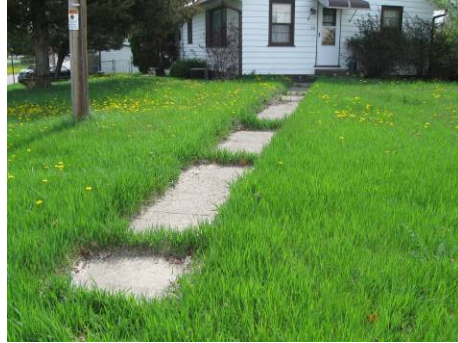
Score: 48.6

Overgrown front walk, water damage to soffits and siding, garage in very poor condition

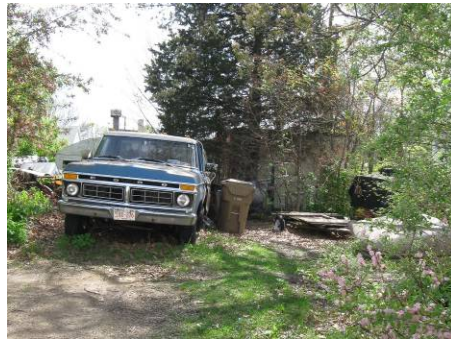
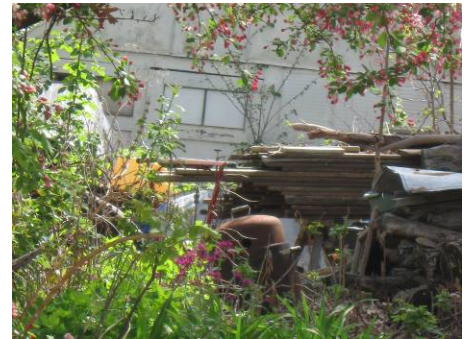
**Parcel 177**

Score: 21.3

Living unit is small metal building; walls and roof are rusted, dented; doors and windows appear to be sagging and degraded; significant junk and debris in yard

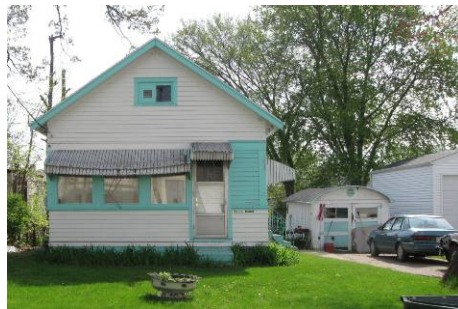
**Parcel 179**

Score: 45.9

Front awning collapsing; no front walk; driveway, steps, and garage in poor repair

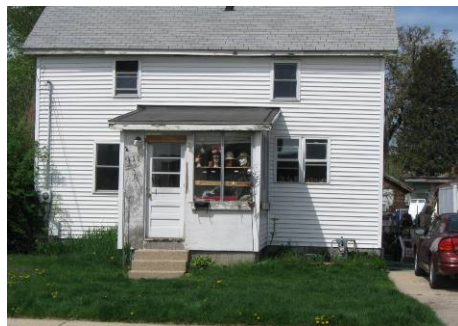
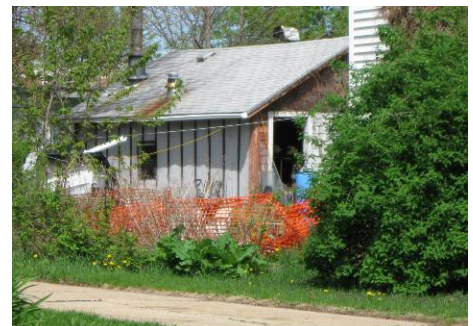
**Parcel 180**

Score: 52.6

Paint peeling from walls and porch, garage in very poor condition, lots of stuff stored in

driveway and back yard

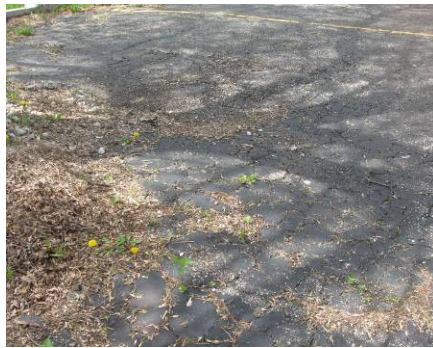
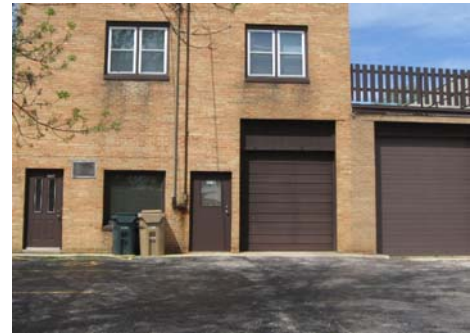
**Parcel 190**

**Score: 56.0**

Unoccupied; brickwork cracking and stained; pavement deteriorating; landscape overgrown; litter

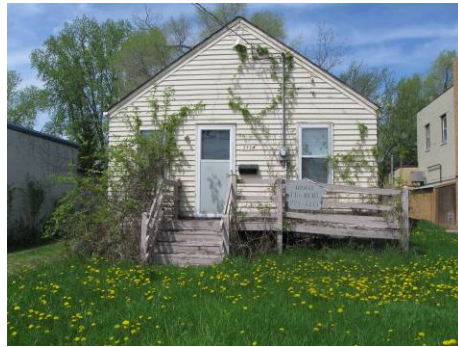
No front walk, landscape overgrown onto building, porch and roof in poor condition

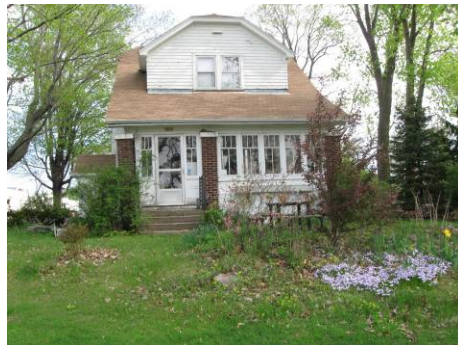
**Parcel 197**

No front walk, significant water damage to siding, yard overgrown

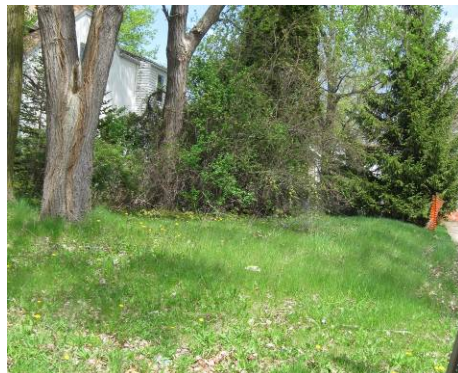
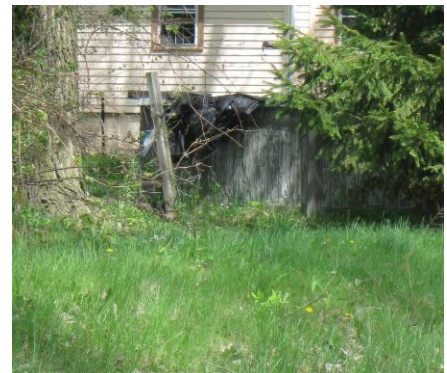
**Parcel 198**

Vacant parcel, no sidewalk, overgrown, trash and debris

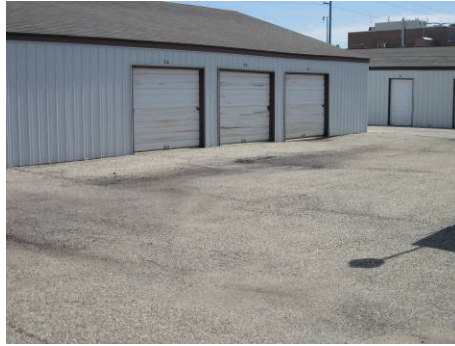
Structural damage to roof and walls; doors rusting; fence damaged; pavement degraded; safety issues

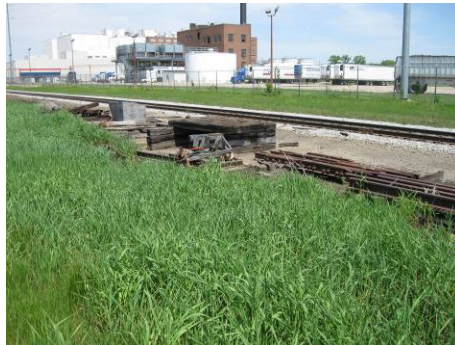
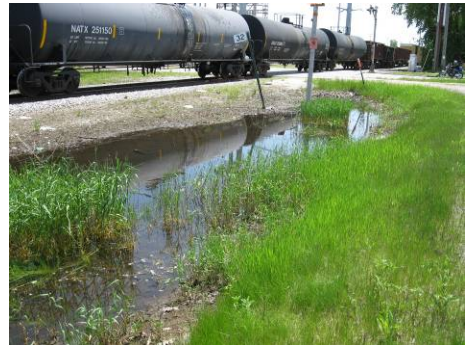
#### **Parcel 169**

Significant trash and debris; likely soil contaminants; significant stormwater ponding

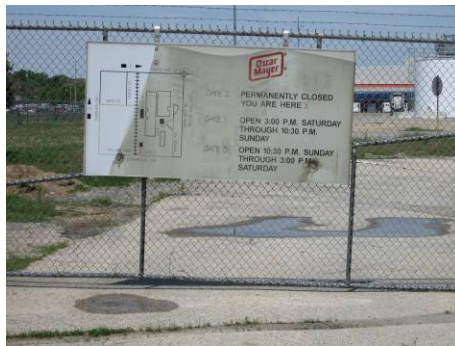
#### **Parcel 170b**

Signage in poor condition; pavement cracked and crumbling; landscaping degraded and abandoned; stormwater ponding

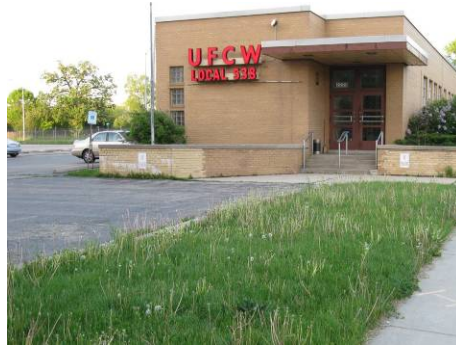
**Parcel 200**

Brickwork cracked;  
broken windows;  
shed in poor  
condition; signage  
worn and faded;  
dead landscaping

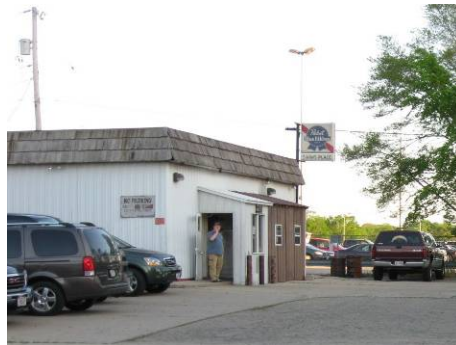
**Parcel 201**

Siding dirty;  
shakers and  
flashing rusted and  
degraded; paint  
peeling; debris and  
weeds in driveway  
and yard

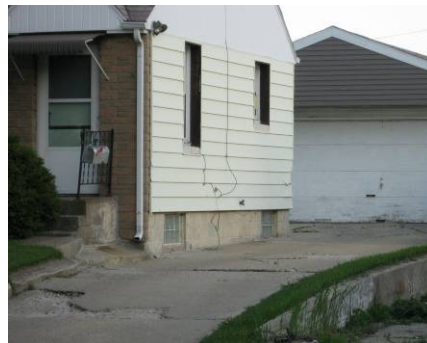
**Parcel 202**

Siding dirty; shingles  
worn; landscape  
overgrown; driveway  
in poor condition;  
garage deteriorating

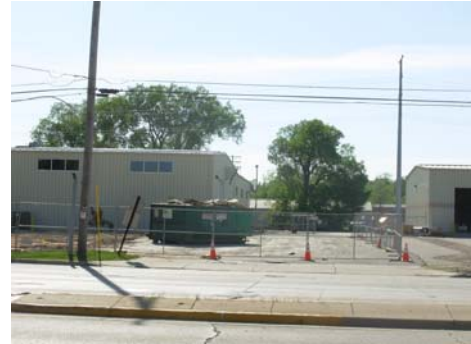
Too small for industrial use; fence falling over; pavement cracked

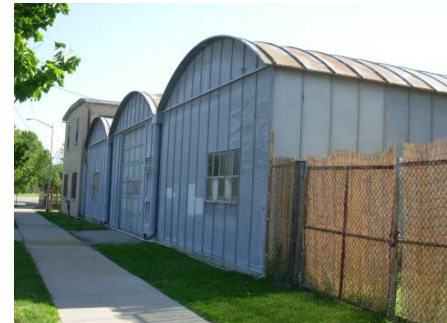
Cladding dented, graffiti painted over; door and window frames rusted; windows missing panes;

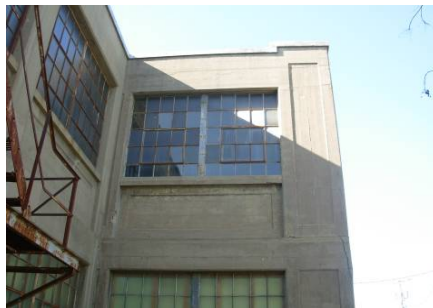
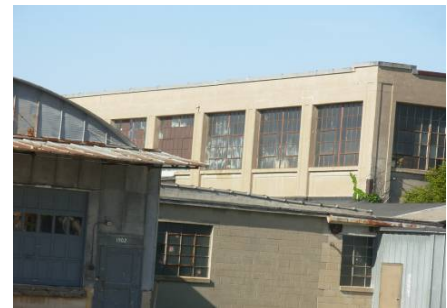
***Parcel 9***

Broken, boarded up, and painted over windows; cracks in masonry; spalling; vines on building and weeds in walkways; metal cladding dented

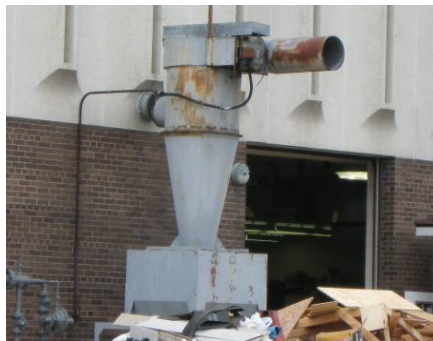
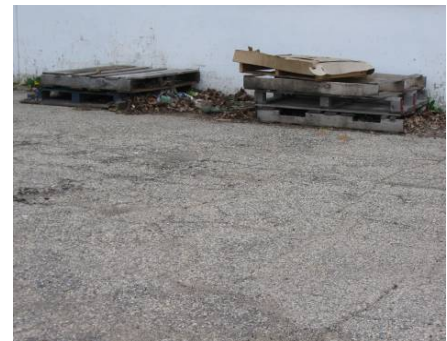
***Parcel 203***

Cladding dirty and discolored; overflowing dumpsters; pavement cracked and pitted; large piles of trash; litter

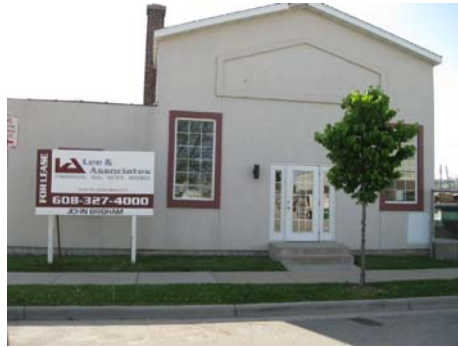
**Parcel 204**

Water damage to walls; missing signage; missing some fascia; overflowing dumpster; not screened; litter

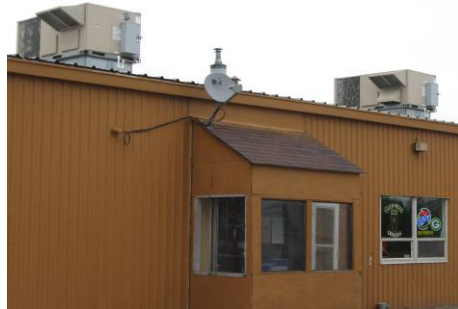
Cladding dented; different colors of paint; some signage missing; litter; trashcans not screened

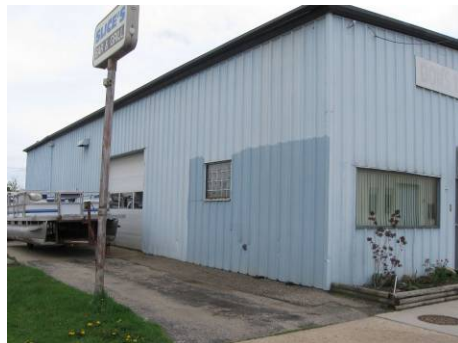
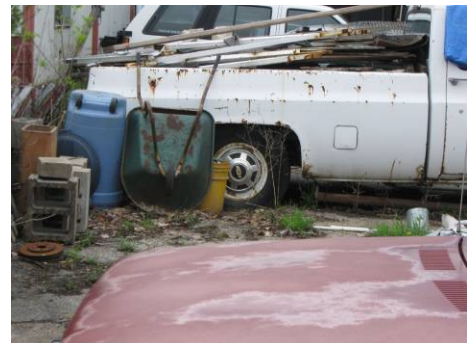
**Parcel 214**

Siding dented and mismatched paint; inoperable vehicles; trash along sides of building

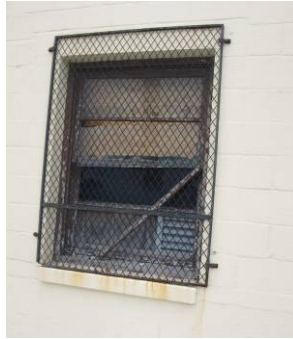
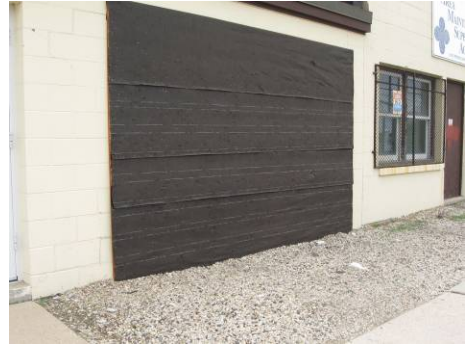
**Parcel 215**

Garage door covered by tar paper; broken window; rotting window frames; rusted grates over windows staining walls

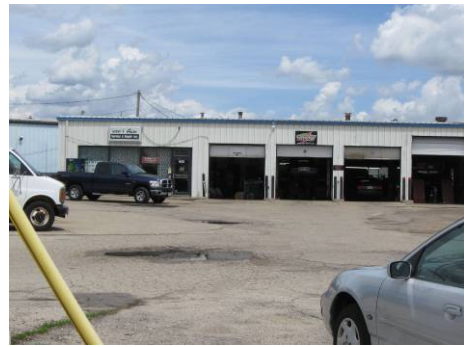
Cladding, windows, and doors showing cosmetic damage; parking lot pitted and cracked; piles of tires and trash; inoperable vehicles

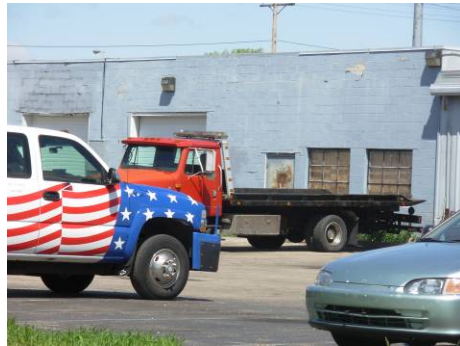
Paint peeling; concrete block walls cracked and settling; doors rusting; parking lot oil-stained; weeds in front

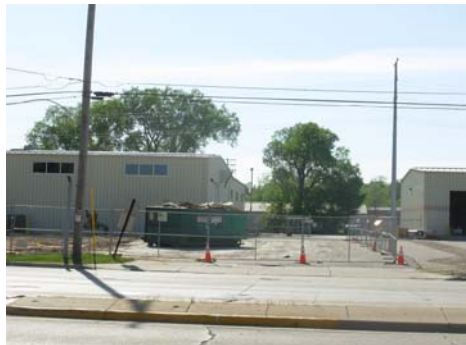
**Parcel 230 (right side of photograph)**

Fence falling down; cracks in pavement; debris

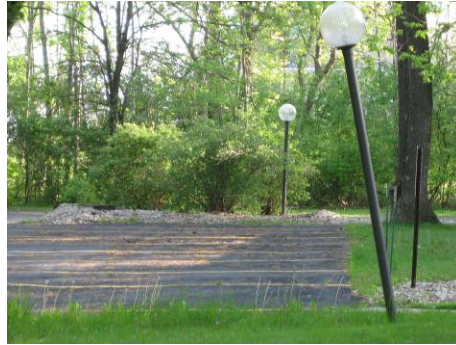
Water damage to siding, fascia, and shingles; debris and weeds in driveway and walks; lawn not well maintained; no public sidewalk along American Lane

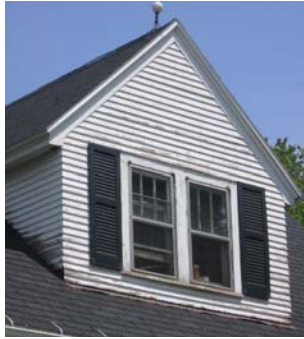
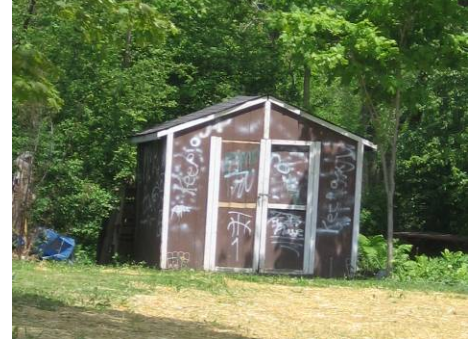
Paint peeling; flashing and siding deteriorating; graffiti on shed; no front walk

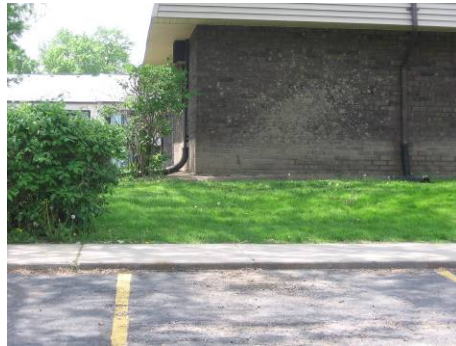
**Parcel 14**

Cladding dirty; graffiti; decking rotted; shed in poor repair; large holes and debris in driveway; needs lawn care; 115 code violations in past 5 years

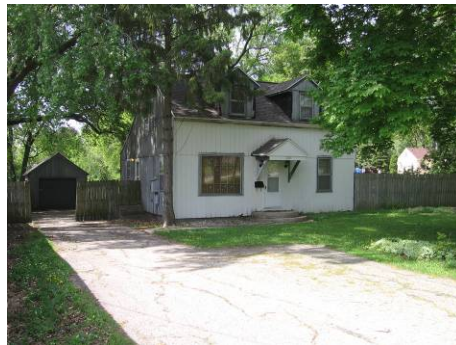
**Parcel 15**

Missing pieces of cladding and gutter; window frames and siding rotting; needs lawn care; driveway and walk in poor condition

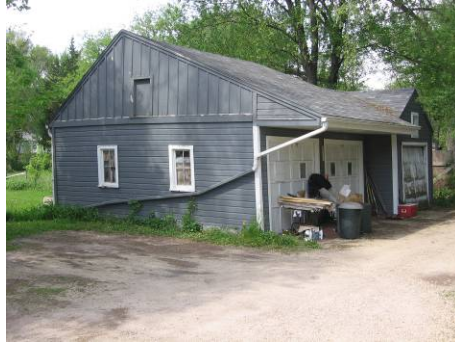
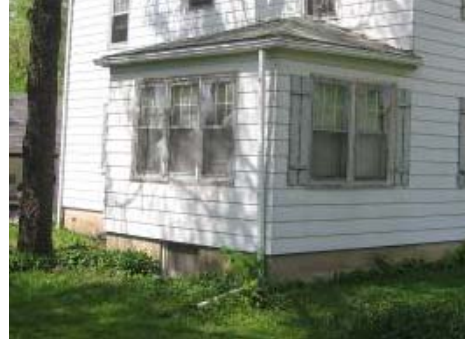
**Parcel 16**

Portions of windows and porch rotting; shingles degrading; shed in poor condition; needs lawn care; piles of debris; plastic hanging off windows

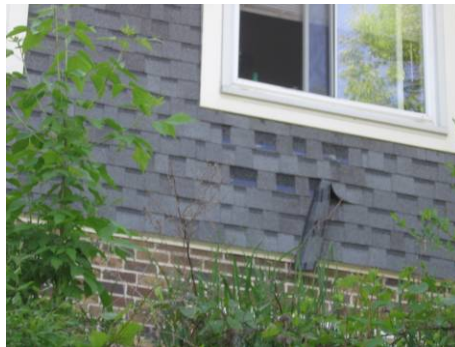
**Parcel 17**

Cladding and roof have cosmetic problems, missing shingles; dumpsters unscreened; cracks in pavement

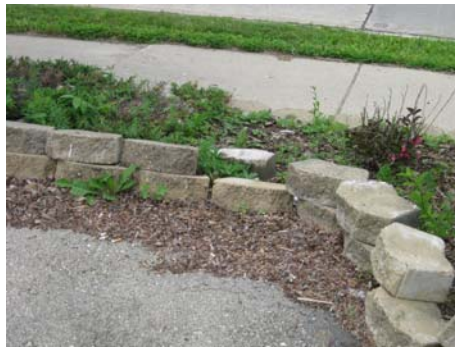
**Parcel 18**

Water damage to brickwork; parking lot in poor condition; no screening; litter; needs landscaping maintenance

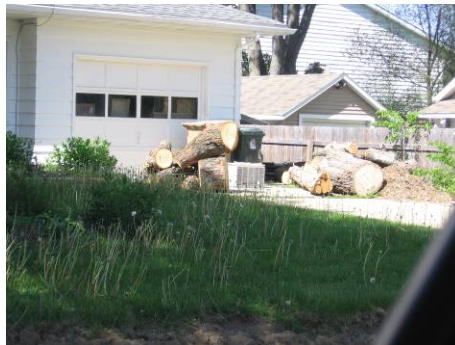
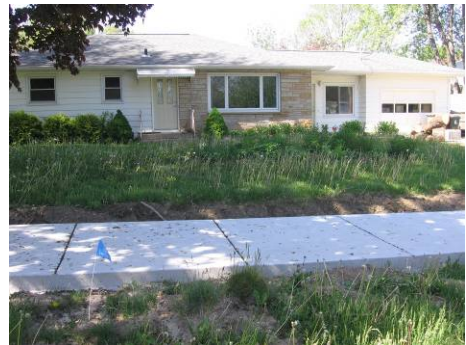
**Parcel 21**

Maintenance issues; siding loose; yard overgrown

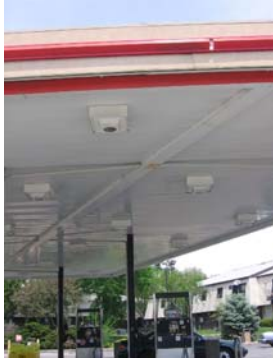
**Parcel 22**

Gutter broken; canopy rusting; base of columns rusting; dumpster enclosure missing boards; parking lot cracked; landscaping stone washing onto public sidewalk

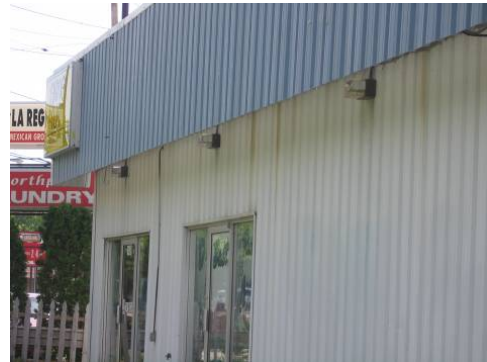
**Parcel 23**

Rust, holes and dents in cladding; guard rail rusted; weeds; sign rusted; batteries sitting outside

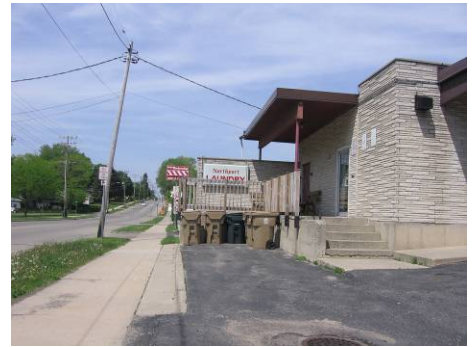
**Parcel 24**

Water damage to foundation; cladding dirty; window sealant problems; cracks in stairs; no screening; poor signage; weeds; trash

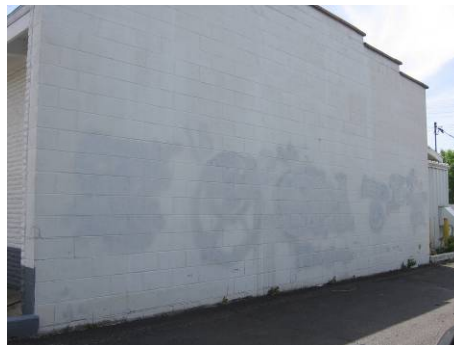
**Score: 48.0**

Graffiti; brick needs cleaning; rotting fascia; piles of debris and trash; weeds; cracked, stained pavement; dead bushes

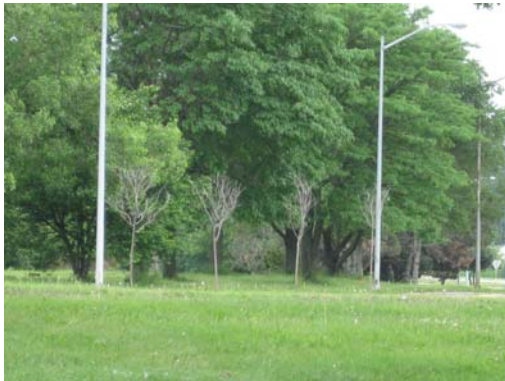
Dead trees in median, Packers Ave north of Hwy 30

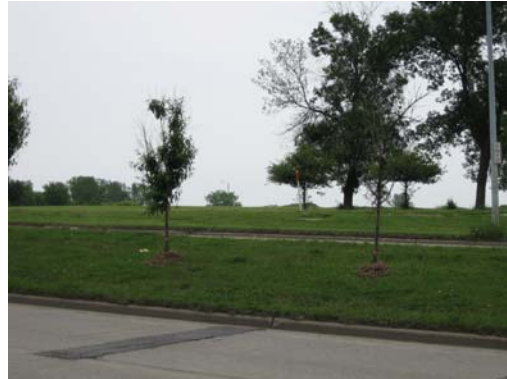
Dying trees in median, Packers Ave near International Lane

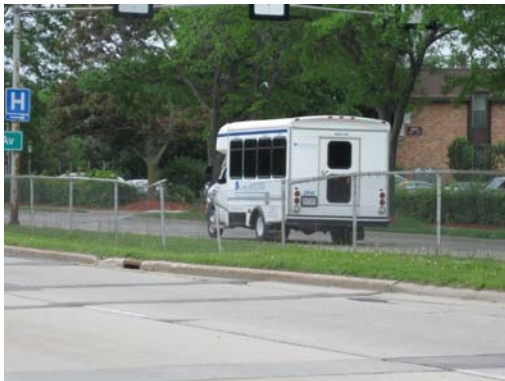
Broken fence in median, Northport Drive near Dryden Drive

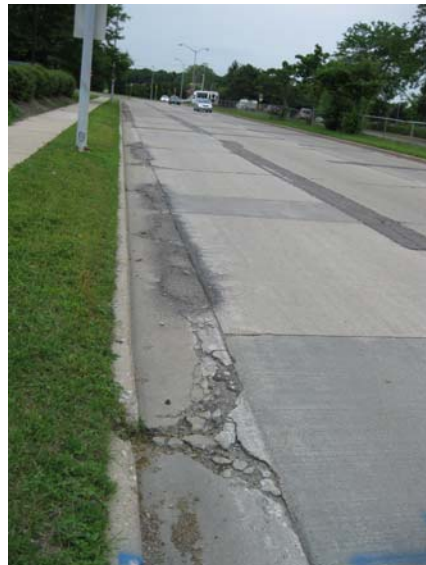
Patched and crumbling pavement, Northport Drive near Dryden Drive

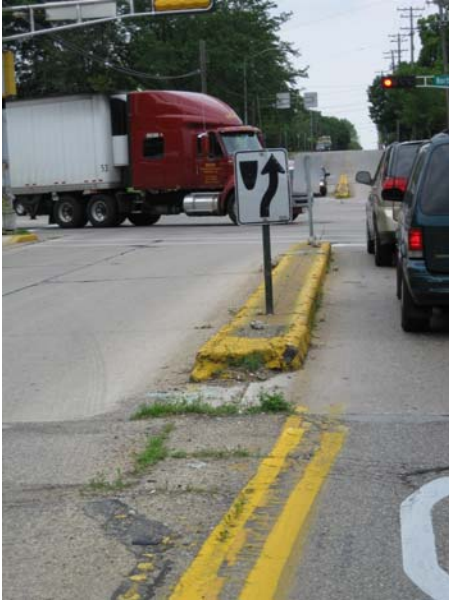
Crumbling median, Sherman Ave at Northport

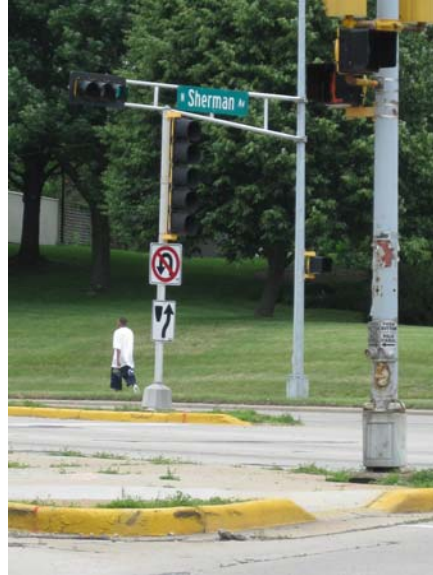
Weedy medians, rusty poles, Northport Drive at Sherman Ave.

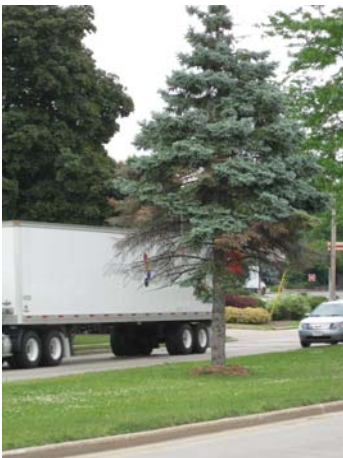
Tree with dead branches in median, Northport Drive near Troy Drive
