# TID 40 - Blight Study

June 16, 2009

City of  
Madison,  
Wisconsin

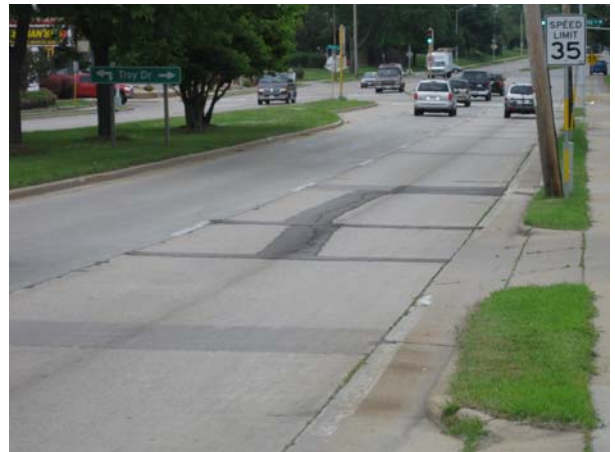
Cracked, patched pavement and leaning utility pole, Northport Drive near Troy
