West Washington Avenue at Southwest Commuter Path—Intersection Update

Presentation Preview

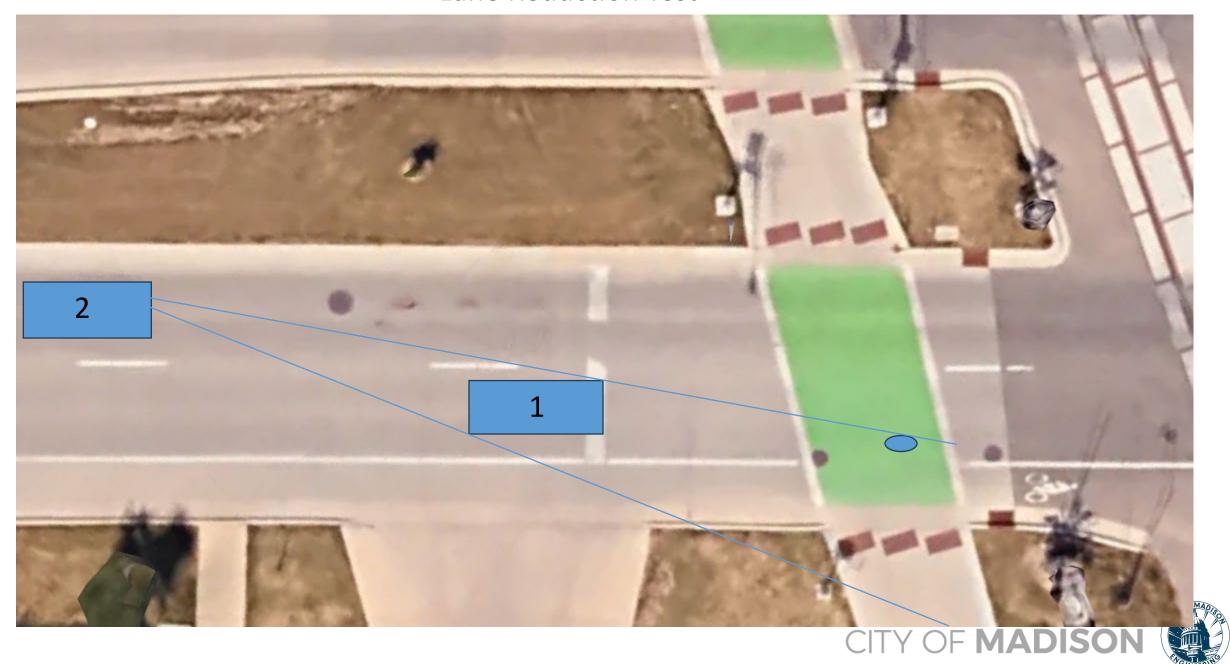
- Lane reduction test installed on Tuesday, September 3, 2024
- Response to four crashes during 20-day period
 - Review of crash history showed "dual-lane threat" in which one driver yields and the driver in adjacent lane does not yield to path user

- Feedback and Observations
 - Path users
 - Positive response. Feel safer. Better yielding by drivers
 - Drivers
 - Both positive and negative feedback
 - Additional delay
 - Longer queues, backing up into Bedford and into Regent/Proudfit intersections

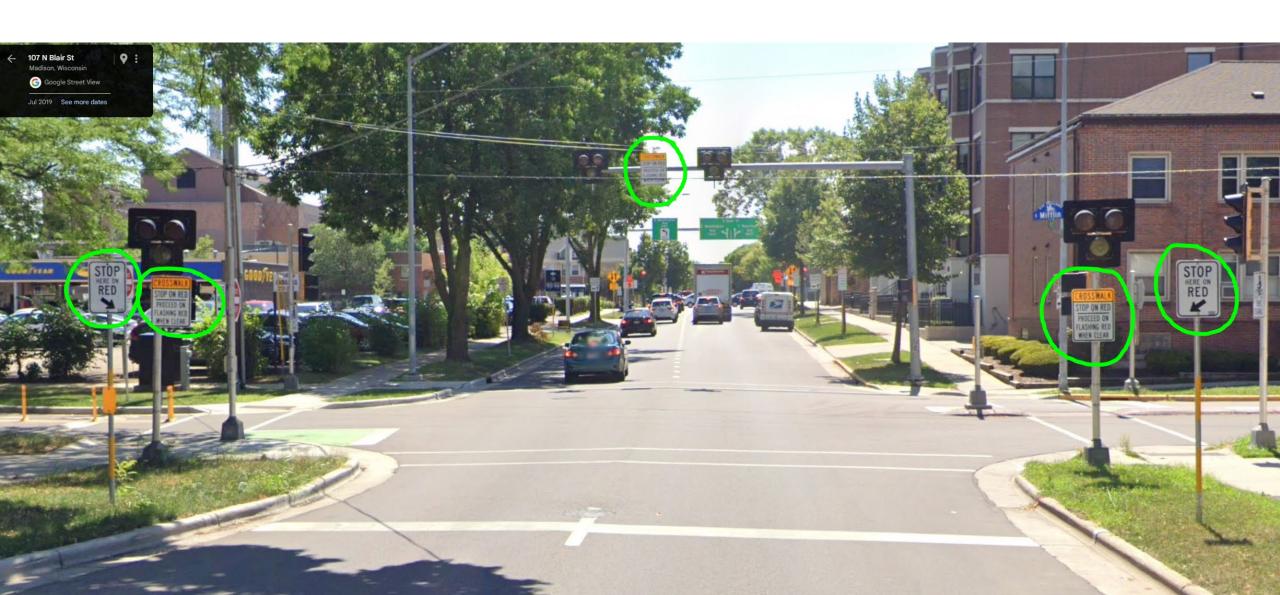
Pedestrian Hybrid Beacon

PHASES	PHASE 1	PHASE 2	PHASE 3	PHASE 4	PHASE 5
MOTORIST SIGNAL		FLASHING			FLASHING
MOTORIST ACTION	PROCEED WITH CAUTION	SLOW DOWN A PEDESTRIAN HAS ACTIVATED THE SIGNAL WITH THE PUSH BUTTON.	PREPARE TO STOP	STOP A PEDESTRIAN IS IN THE CROSSWALK	STOP PROCEED WITH CAUTION WHEN CLEAR
PEDESTRIAN SIGNAL				*	FLASHING 3
PEDESTRIAN ACTION	PUSH BUTTON TO CROSS	WAIT	KEEP WAITING	START CROSSING	FINISH CROSSING DO NOT START CROSSING DURING COUNTDOWN

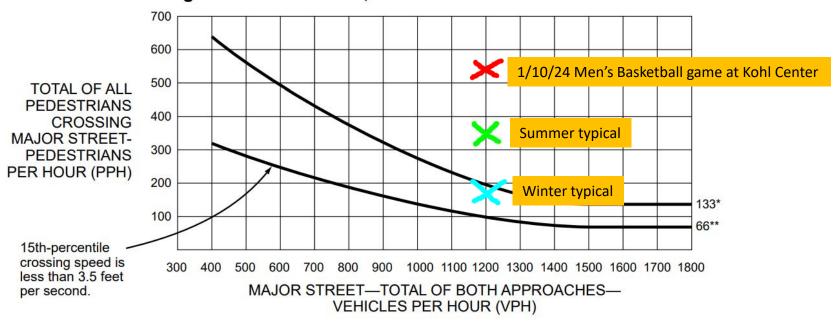
Figure 4C-6. Warrant 4, Pedestrian Peak Hour

^{* 133} pph applies as the lower threshold volume

^{** 66} pph applies as the lower threshold volume if the 15th-percentile crossing speed is less than 3.5 feet per second

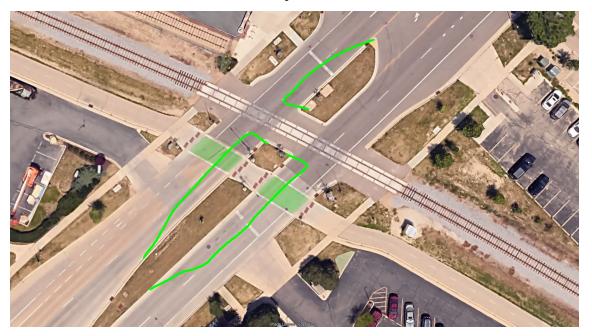
Removal of RRFB with permanent lane reduction

- Removes false sense of security
- Likely reduction in bicycle crashes
- Shorter, easier crossing for path users

- Still an uncomfortable crossing for path users
- Lower driver yield rates
- Fewer and shorter gaps in traffic
- Congestion and queuing to intersections on W Washington Ave with increased traffic volume
- Delays to drivers and to Metro Transit
- Expensive
- Additional rear-end crashes compared to signal
