Assured Wetland Delineation Report

Voit Farm Property

Town of Blooming Grove & City of Madison, Dane County, Wisconsin

August 3, 2022

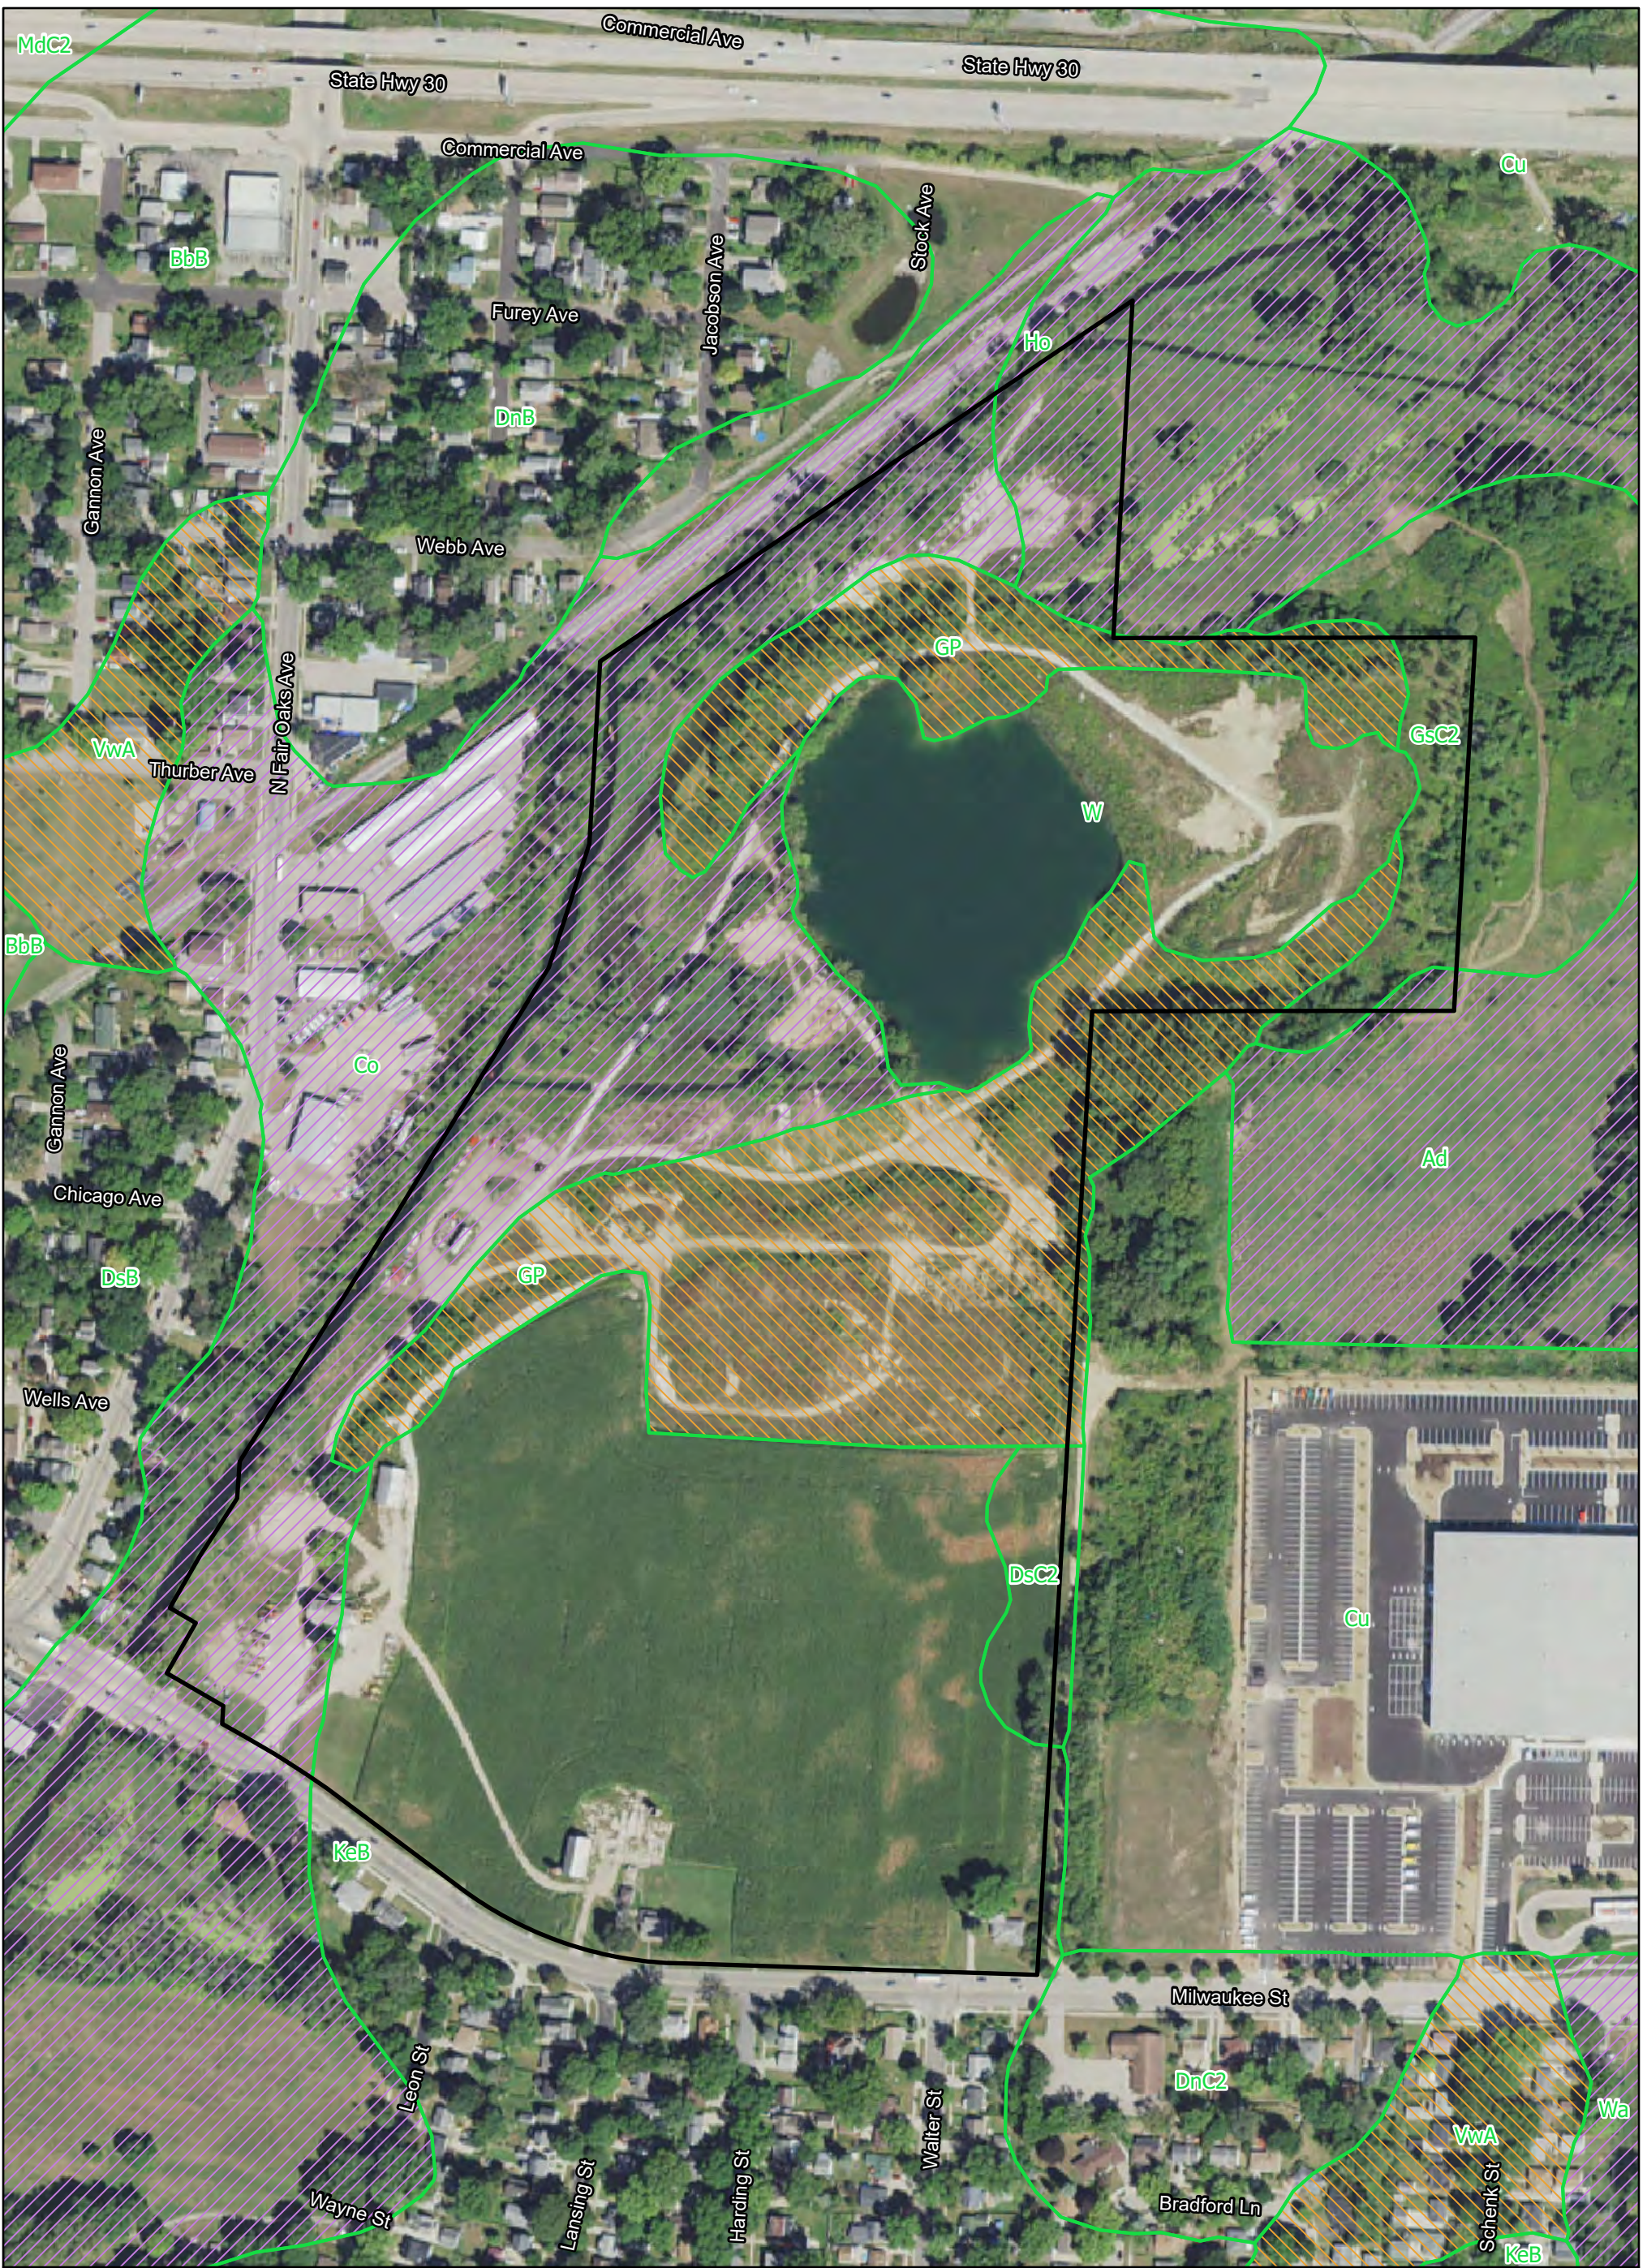
Figure 3. NRCS Hydric Soils
Voigt Farm Property
Project #20220700
T7N, R10E, S04 & 05
T Blooming Grove, C Madison
Dane Co

- Study Area (65.31 ac)
- NRCS Soil Survey Data**
- Hydric (100%)
 - Predominantly Hydric (85-99%)
 - Partially Hydric (16-84%)
 - Predominantly Non-Hydric (1-15%)
 - Non-Hydric (0%)

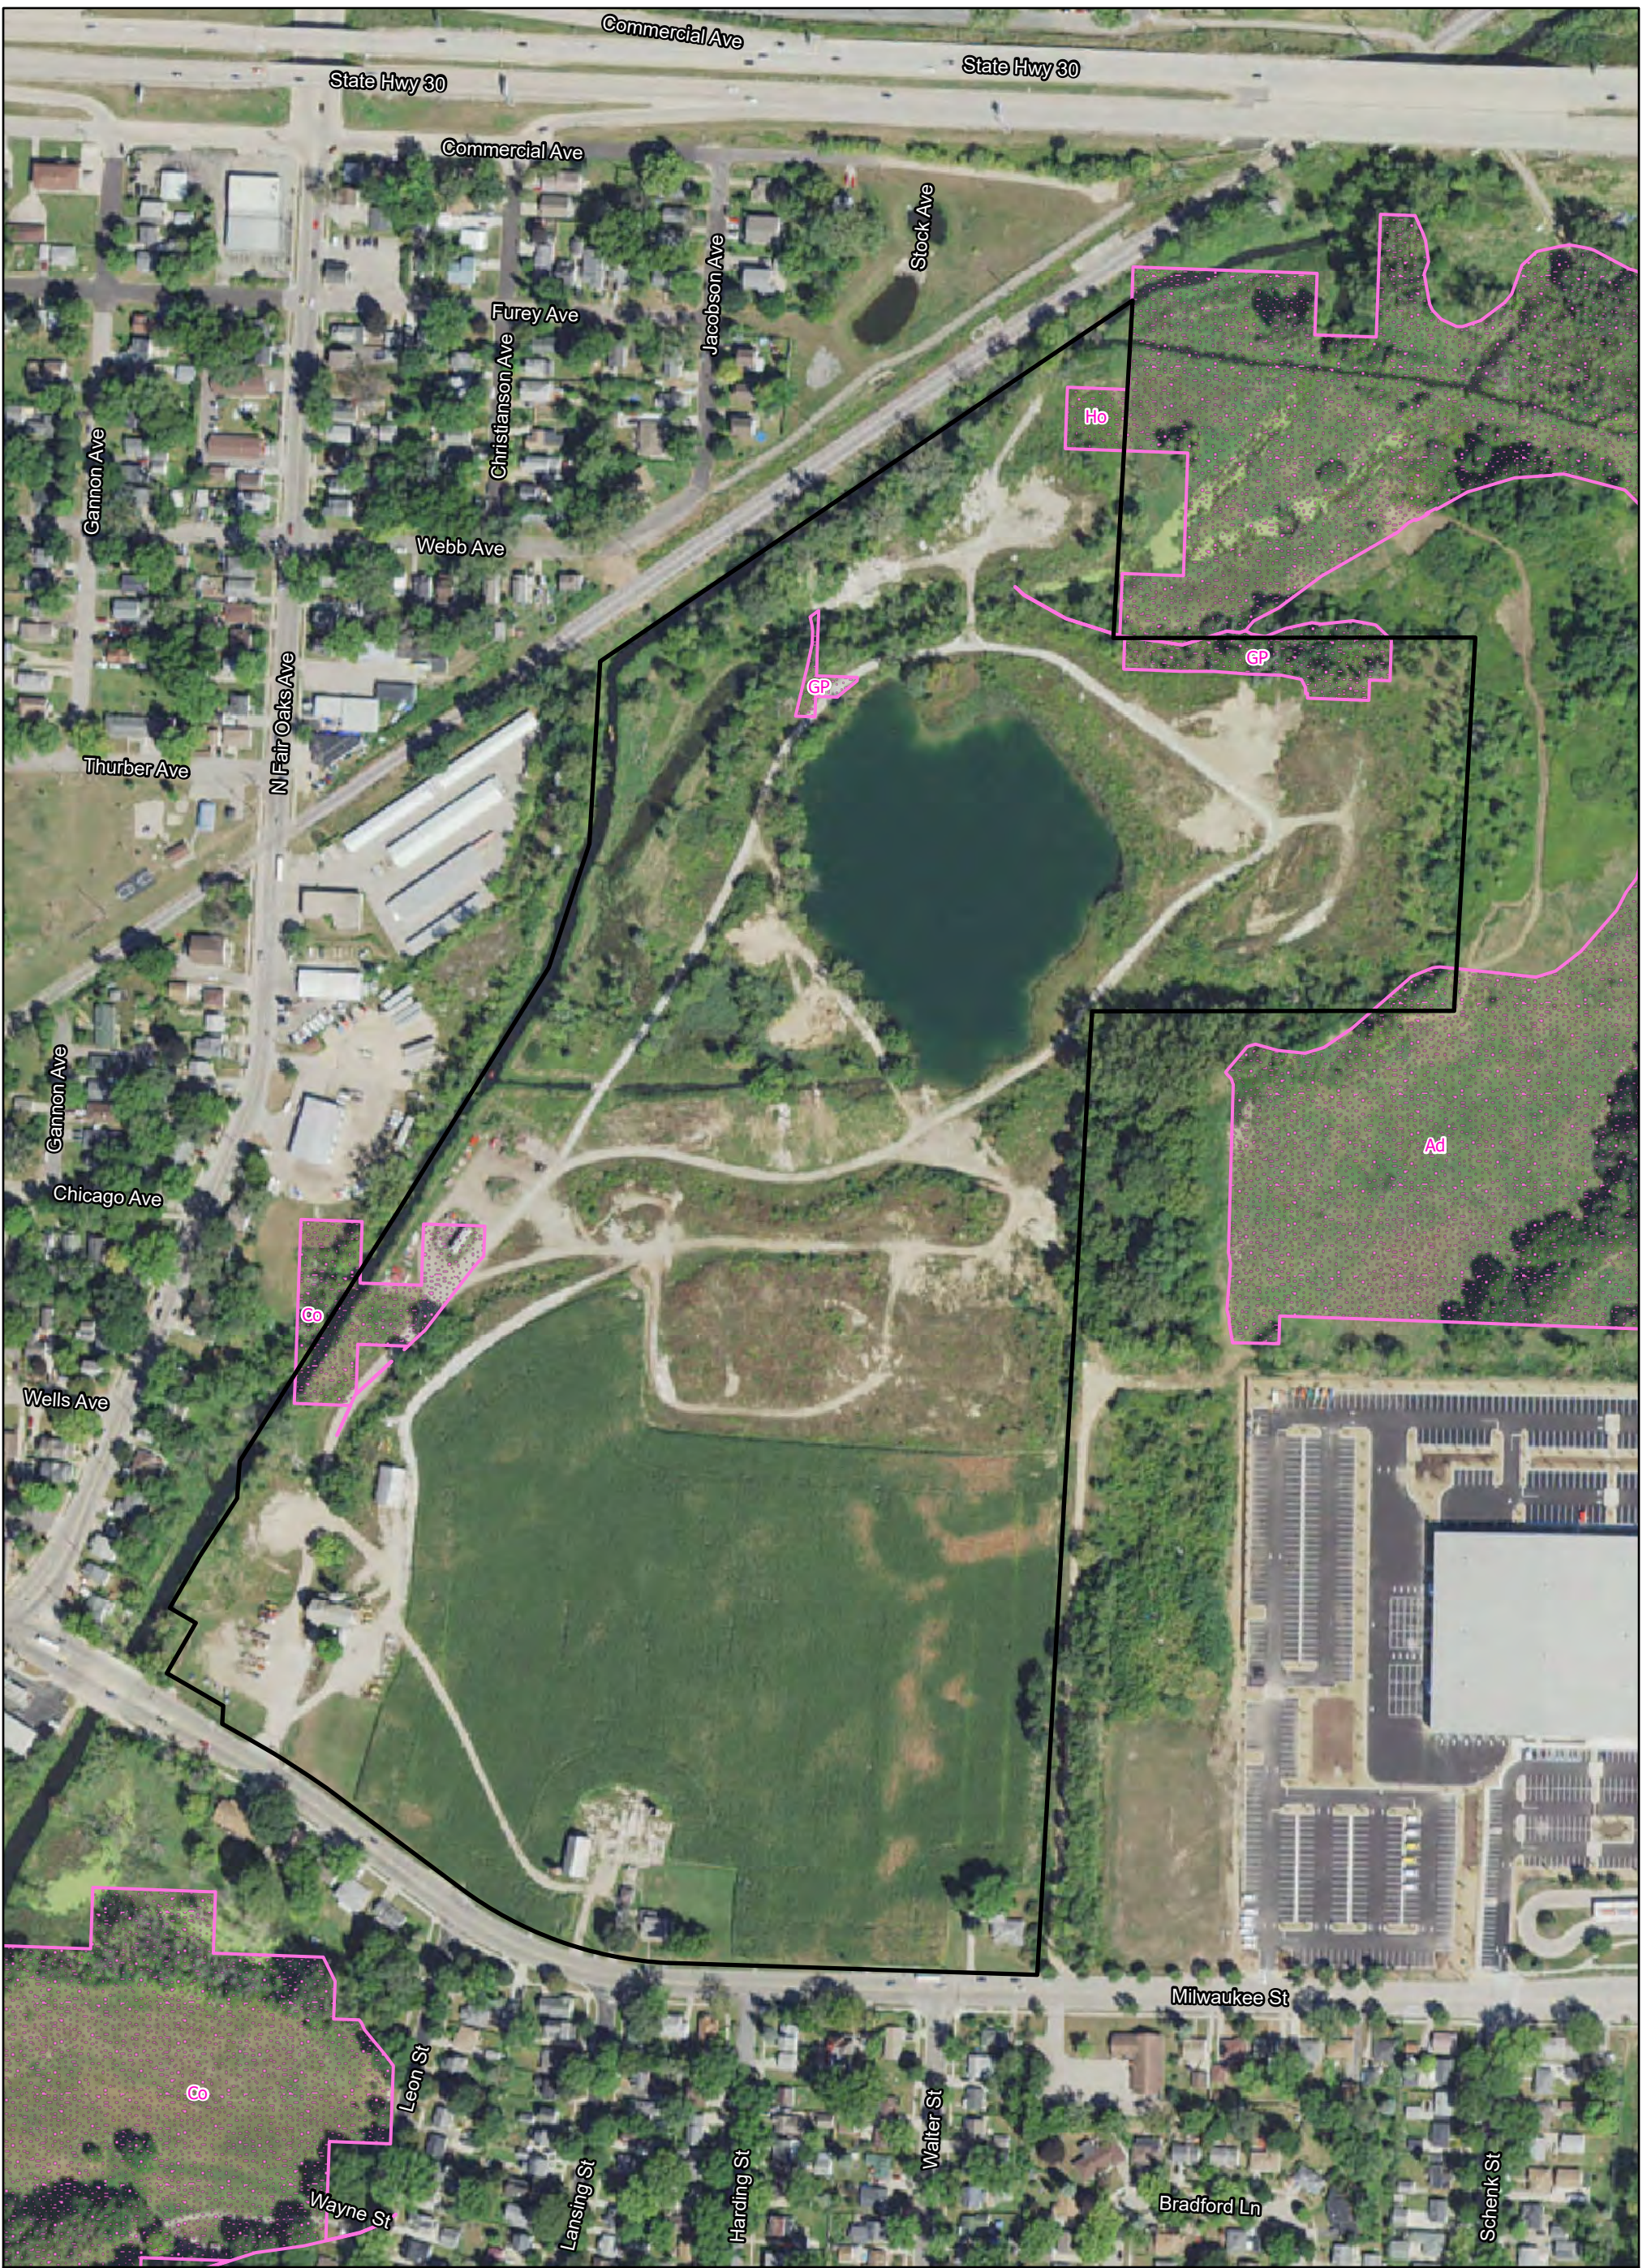
Figure 4. SWDV
 Wetland Indicators
 Voigt Farm Property
 Project #20220700
 T7N, R10E, S04 & 05
 T Blooming Grove, C Madison
 Dane Co
 2020 NAIP
 WDNR

- Study Area (65.31 ac)
- SWDV Wetland Indicators

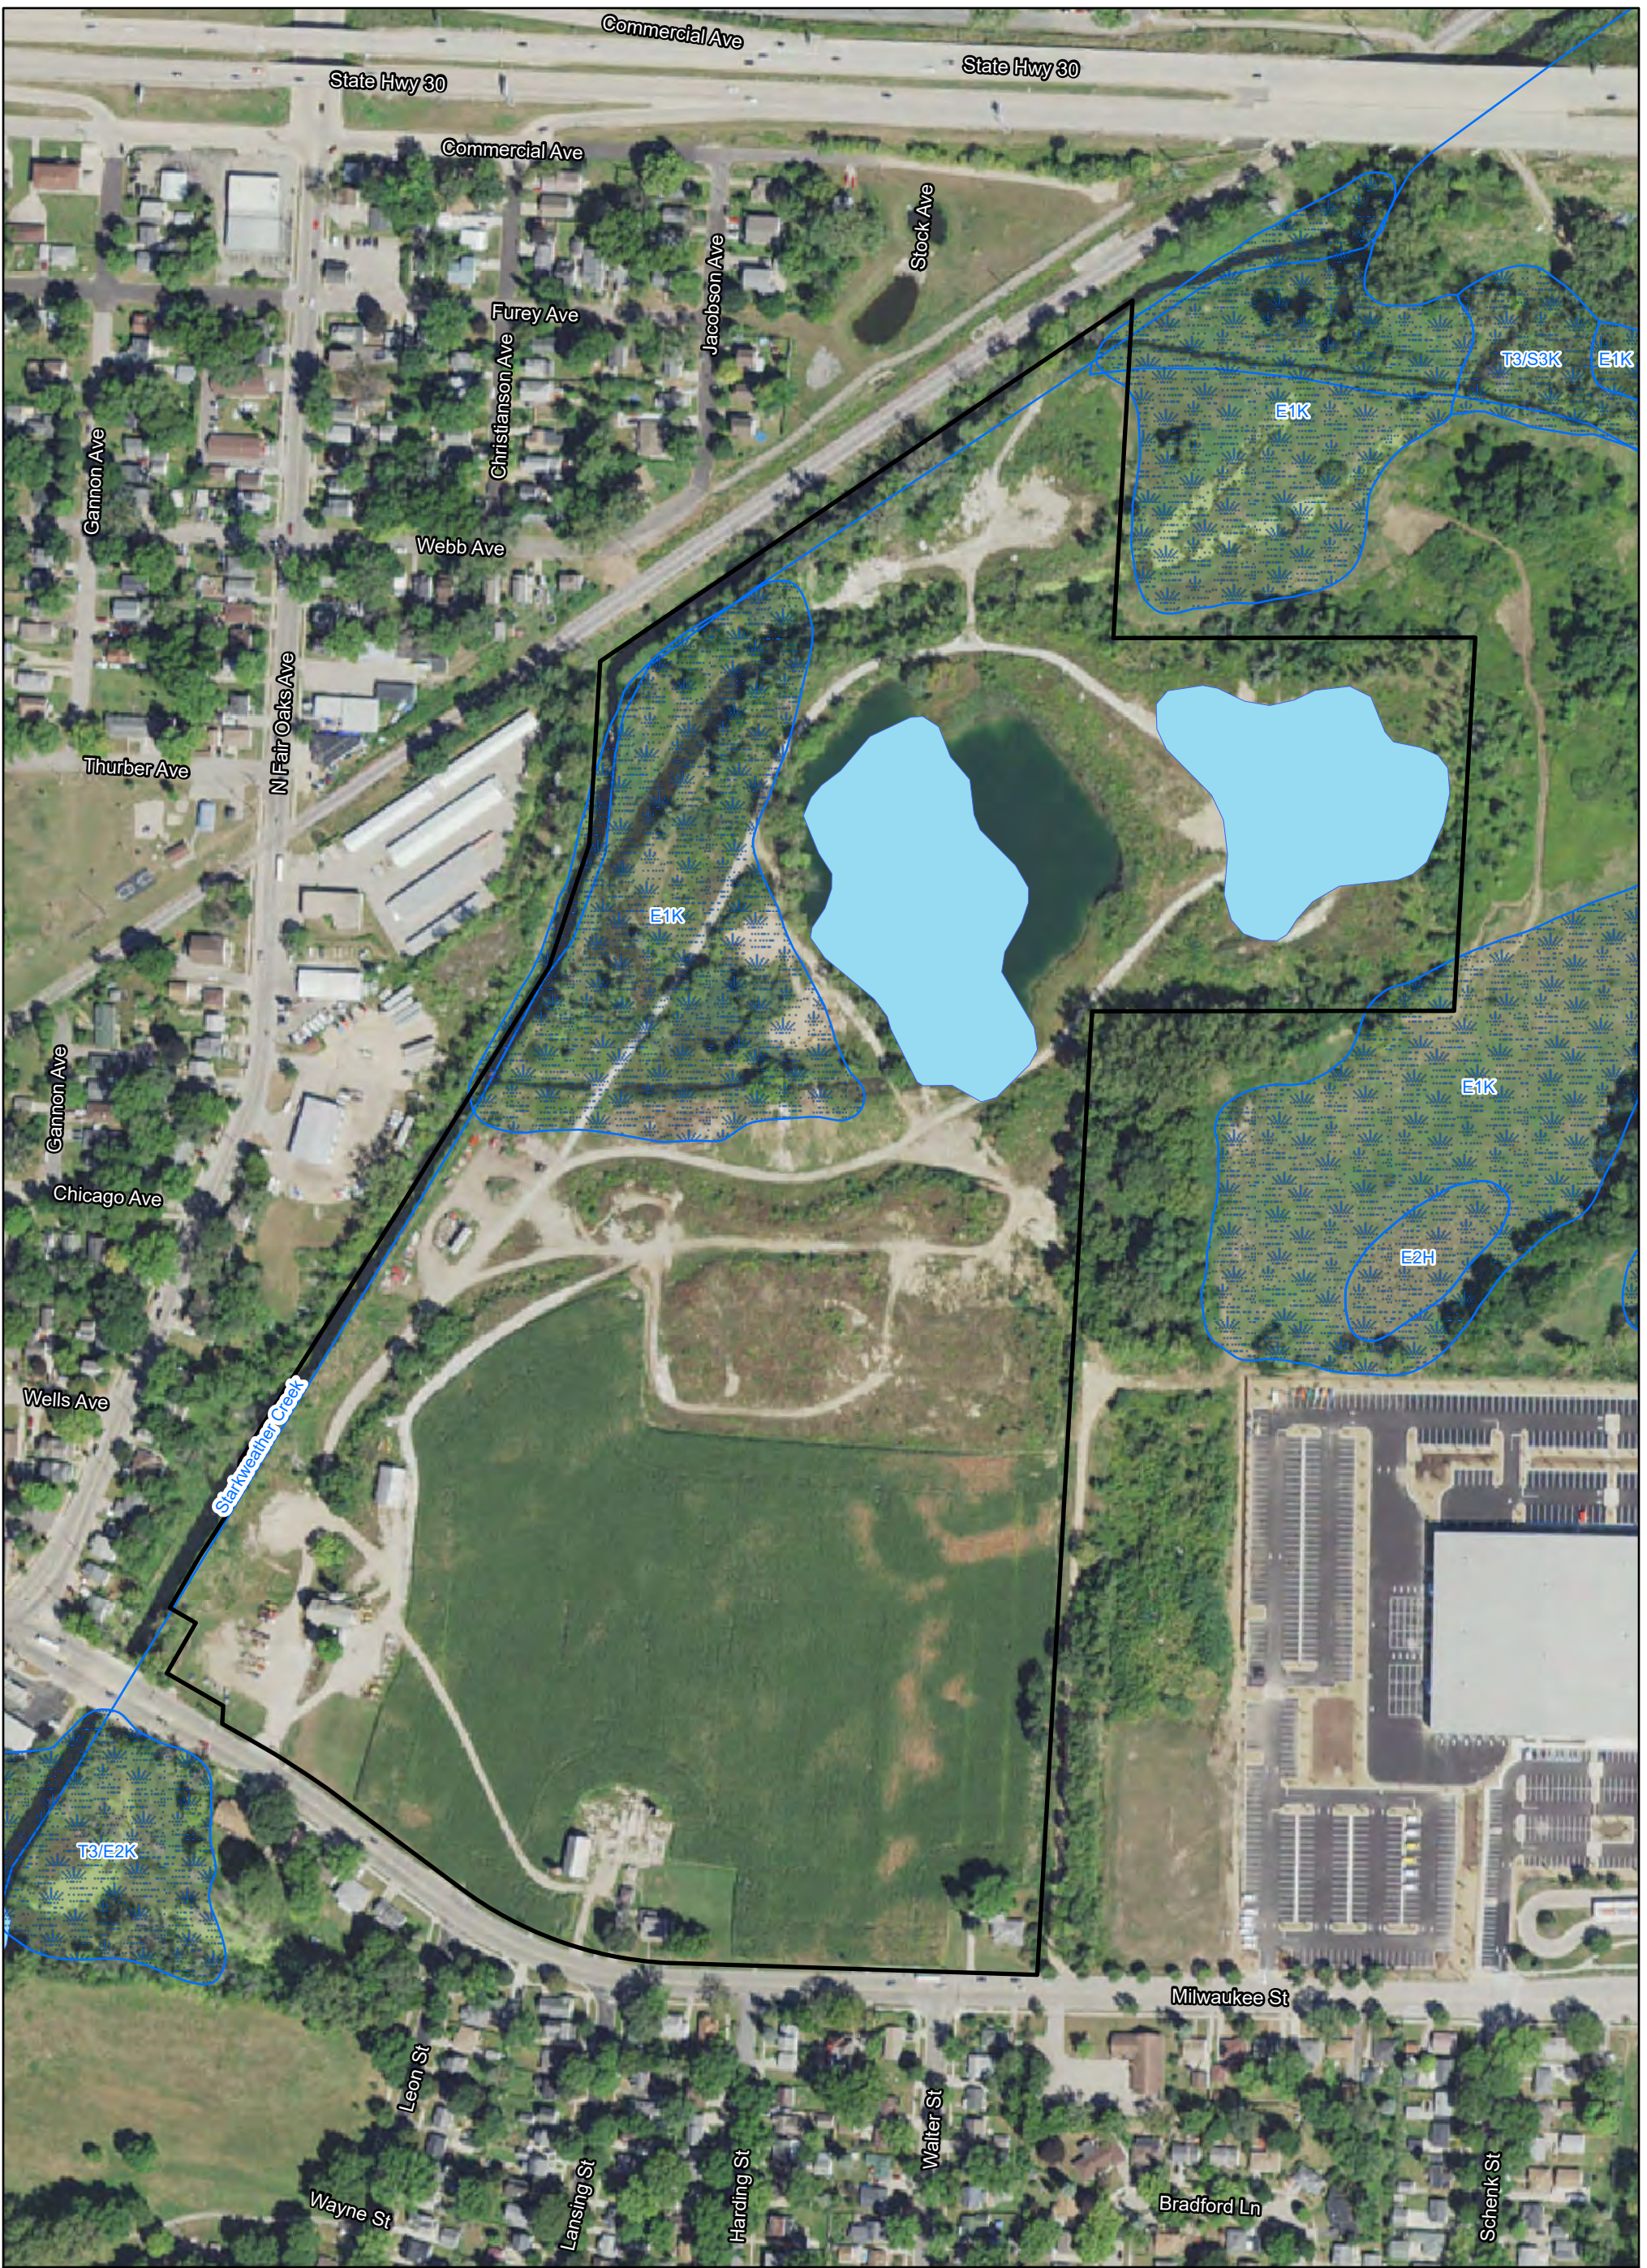
Figure 5. Wisconsin Wetland Inventory
 Voigt Farm Property
 Project #20220700
 T7N, R10E, S4 & 5
 T Blooming Grove, C Madison
 Dane Co

- Study Area (65.31 ac)
- WWI Wetland Polygons
- WWI Wetland Points
- NHD Waterway
- NHD Waterbody
