From: [DOLORES KESTER](#)
To: [Urban Design Comments](#)
Subject: Agenda item 3. Legistar 88916
Date: Wednesday, March 4, 2026 7:42:22 PM

An 800 foot long apartment building on the corner of Commercial Avenue facing Packers Ave. has been approved for the Oscar Mayer site. We neighbors of this project are requesting the Urban Design Commission to not approve this project until the following problems are addressed:

The Department of Natural Resources (DNR) considers the Oscar Mayer Former Filling Station East site closed, with continuing obligations. The Closure determination relates to petroleum contamination found to be present in the soil and groundwater during the site investigation. No further investigation or remediation is required at this time. However, you, future property owners, and occupants of the property must comply with the continuing obligations as explained in the conditions of closure in this letter. Read this letter closely to ensure that you comply with all conditions and other on-going requirements. Provide this letter and any attachments listed at the end of this letter to anyone who purchases, rents or leases this property from you.

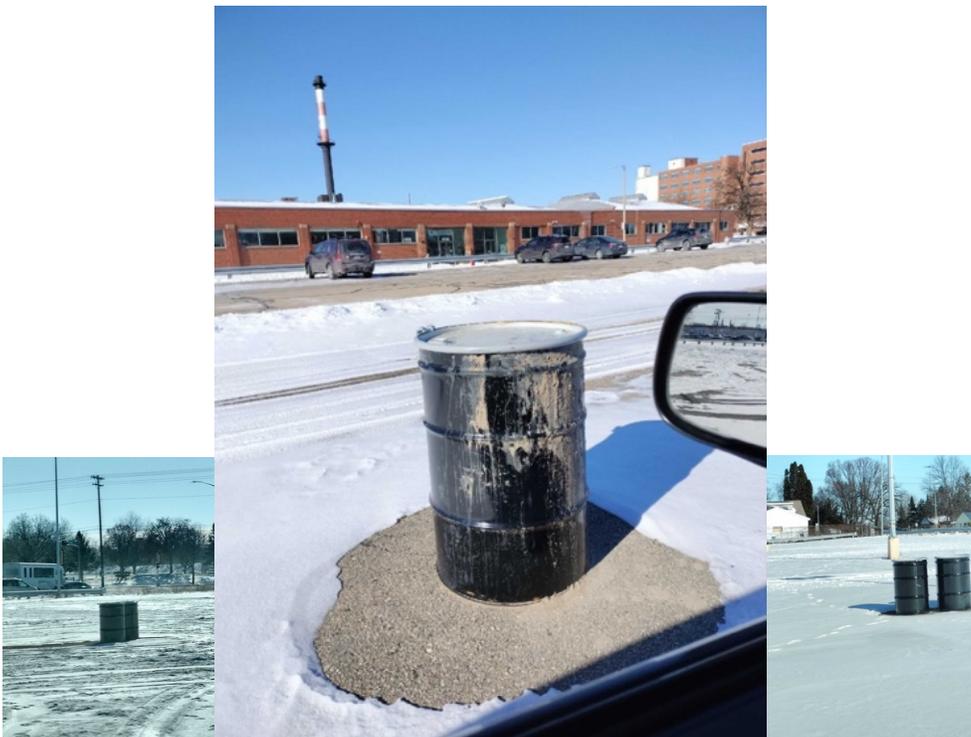
Photo date: January 29, 2026

The land owner and the developer's complete lack of regard for public safety is a loud and clear statement related to the lack of care this project team is taking on behalf of the residents in the area. We see it in the approach to testing of toxic chemicals and in the overall design of the proposed facility at the corner of Packers Highway and Commercial Avenue. Here are the drums of hazardous contaminated soil from the drilling operations.

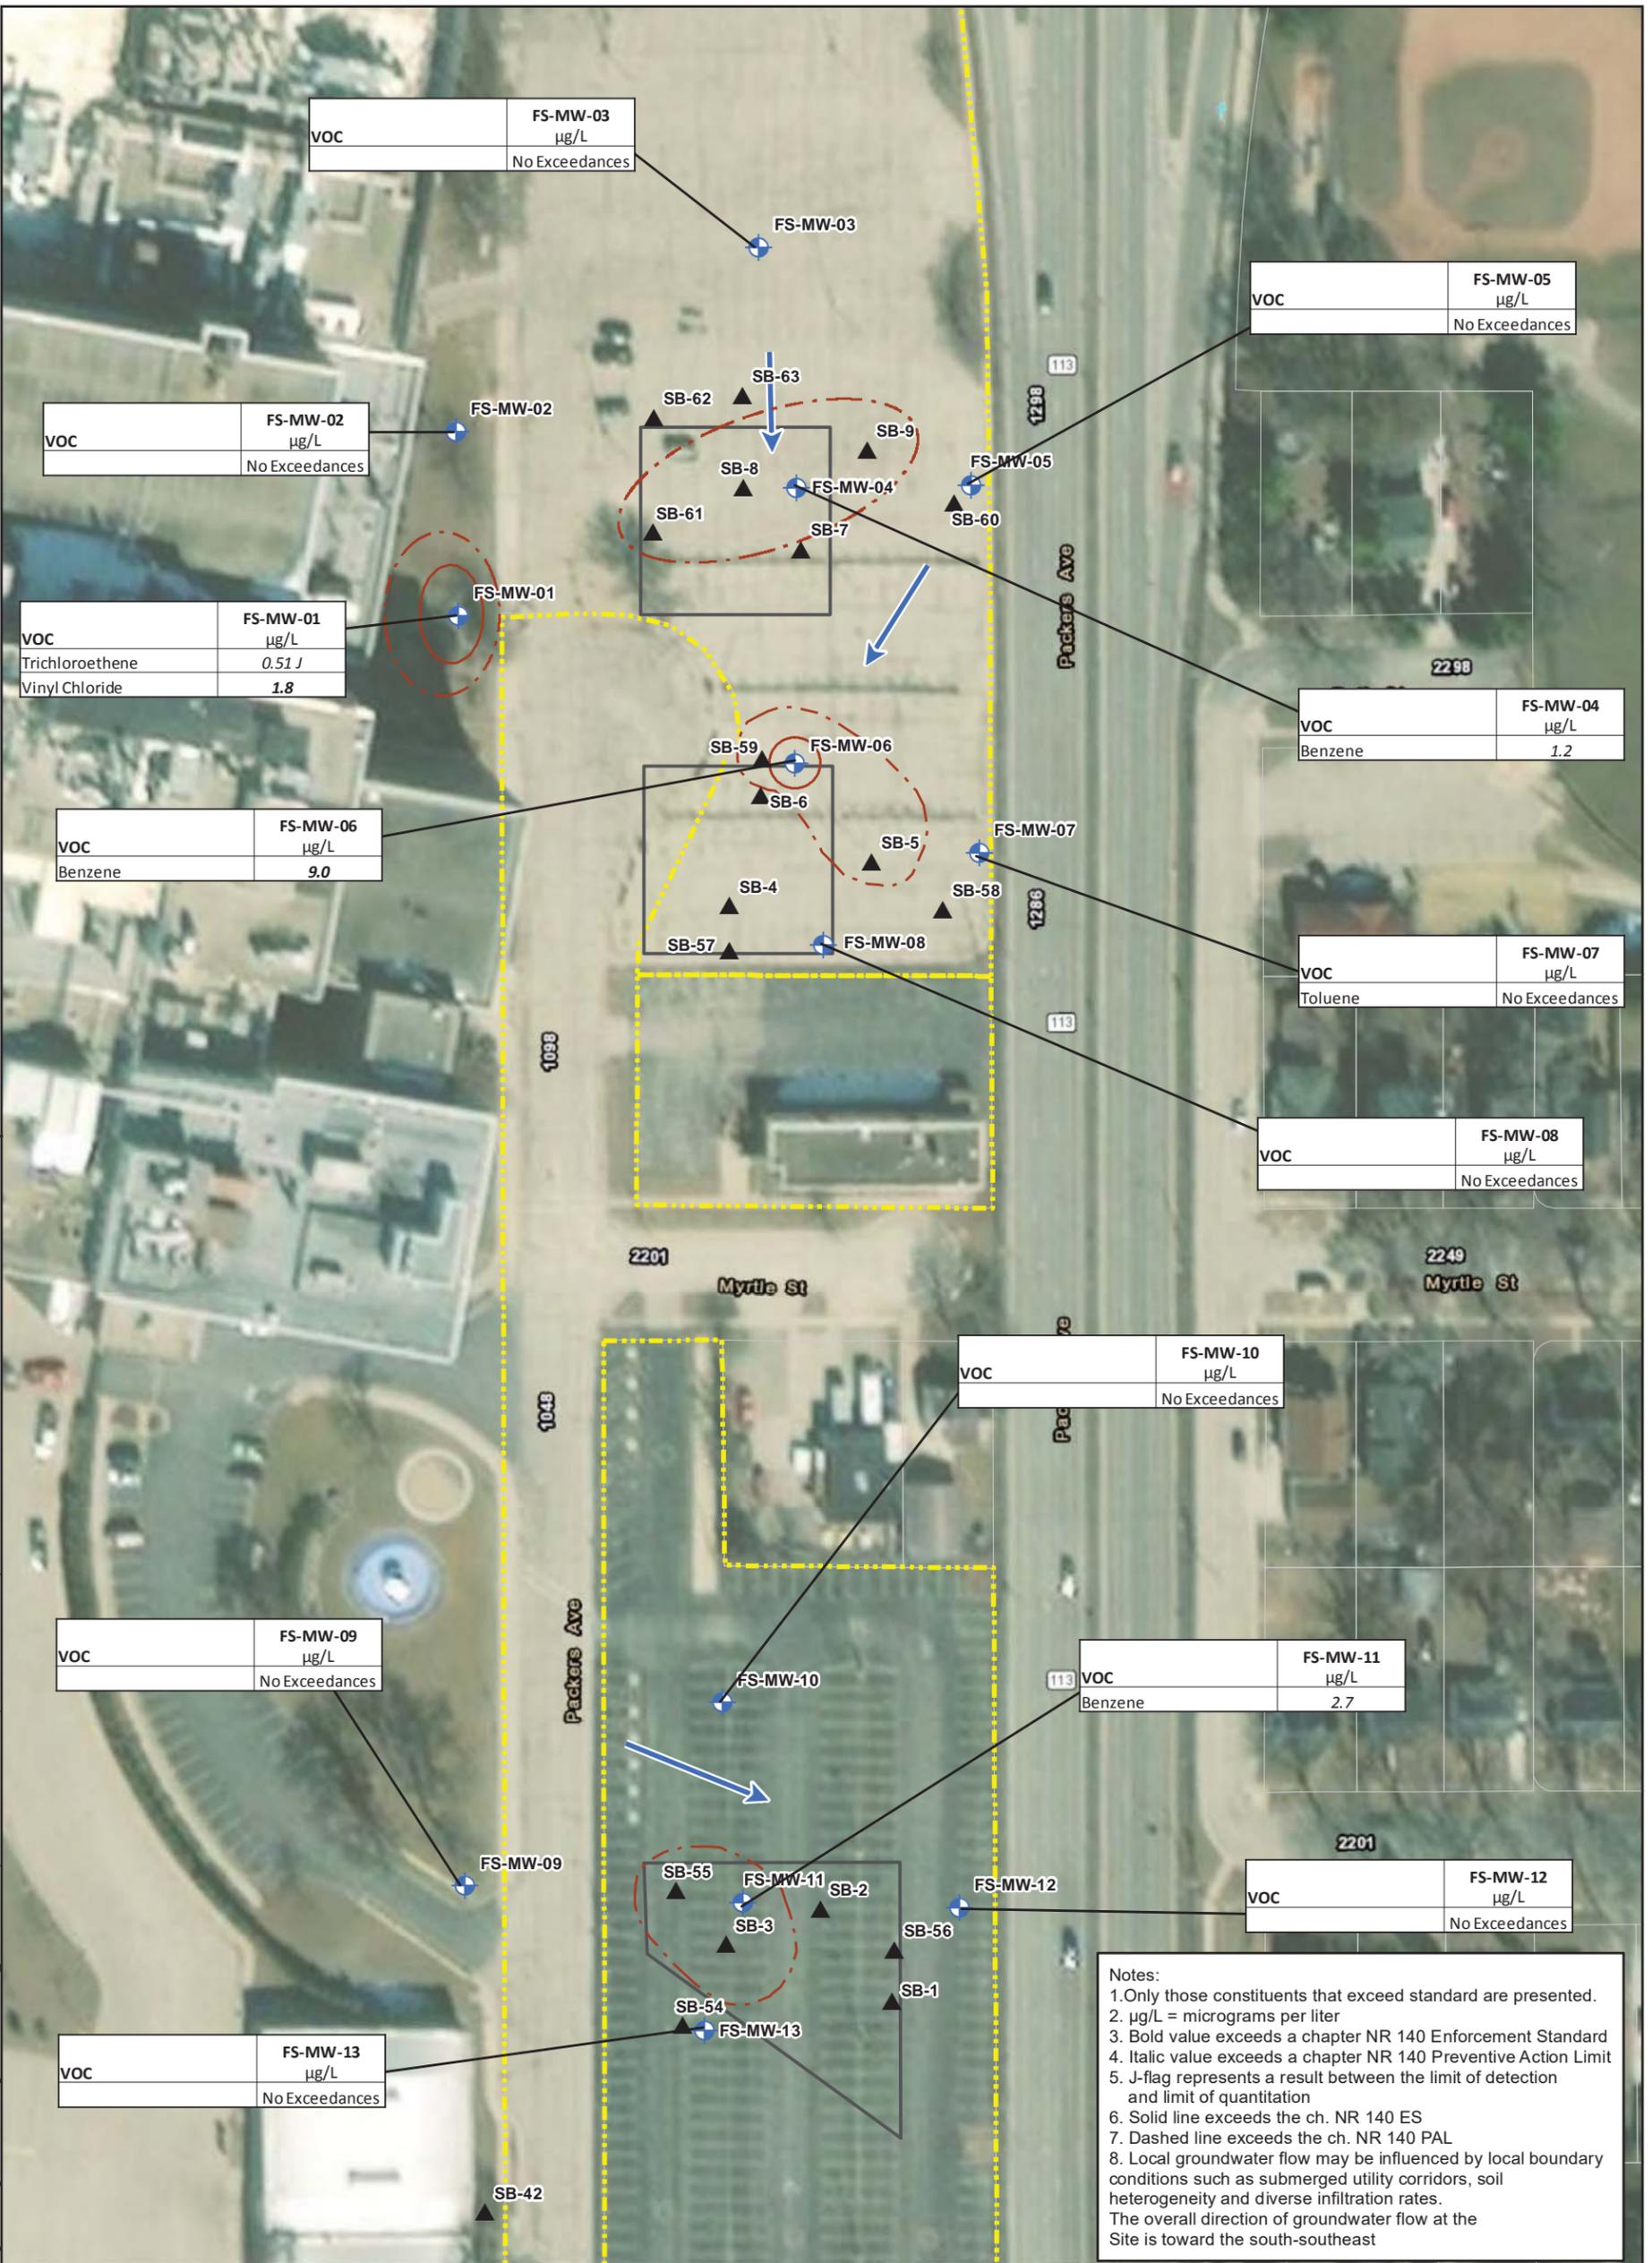
Figure B.3.b.2
Groundwater Contamination – VOCs
 Filling Station Area
 910 Mayer LLC
 910 Oscar Avenue
 Madison, Wisconsin
 Environmental Resources Management
 www.erm.com

1. Only those constituents that exceed standard are presented.
2. µg/L = micrograms per liter
3. Bold value exceeds a chapter NR 140 Enforcement Standard
4. Italic value exceeds a chapter NR 140 Preventive Action Limit
5. J-flag represents a result between the limit of detection and limit of quantitation
6. Solid line exceeds the ch. NR 140 ES
7. Dashed line exceeds the ch. NR 140 PAL
8. Local groundwater flow may be influenced by local boundary conditions such as submerged utility corridors, soil heterogeneity and diverse infiltration rates. The overall direction of groundwater flow at the Site is toward the south-southeast

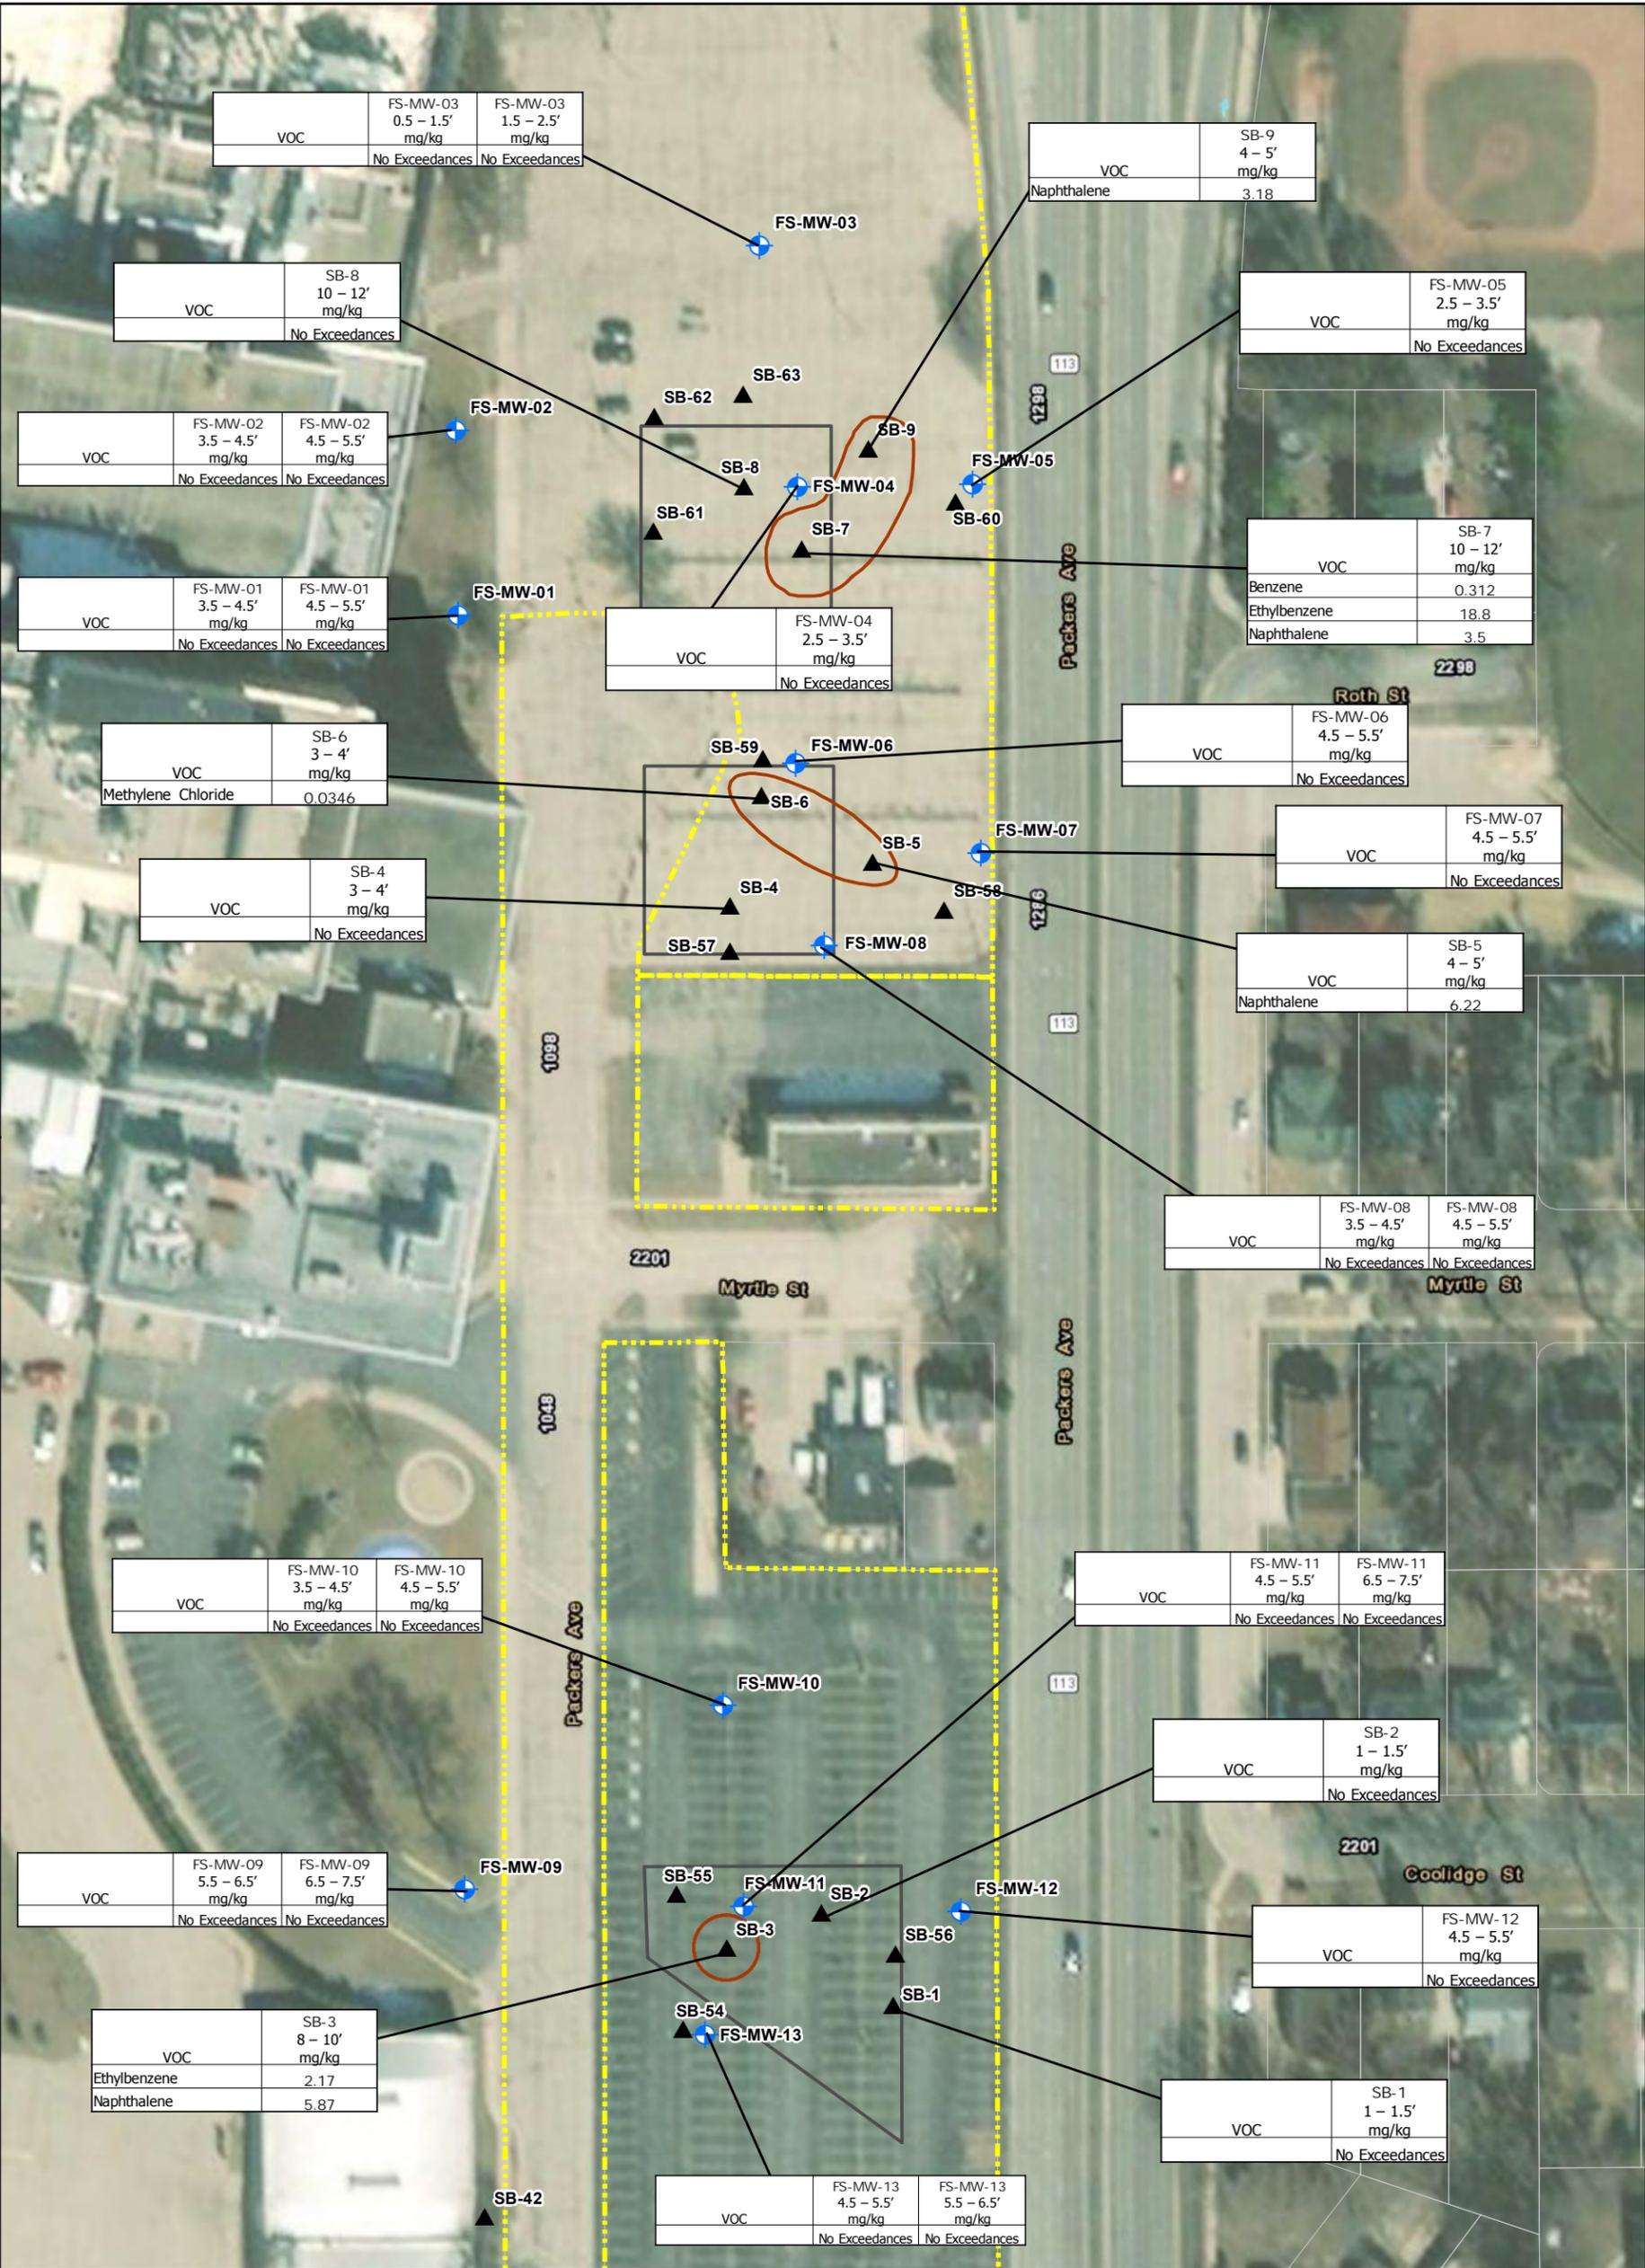
1. Bold value exceeds the soil to groundwater pathway
2. VOC = Volatile Organic Compound
3. There are no unsaturated soil VOC concentrations that exceed a direct contact RCL

Soil contamination remains in the area as indicated on the attached maps, Residual Soil Contamination - VOCs Figure B.2.a/b.2., dated 02/13/2020 and Residual Soil Contamination – SVOCs Figure B.2.a/b.3. and dated 02/14/2020. If soil in the specific locations described above is excavated in the future, the property owner at the time of excavation must sample and analyze the excavated soil to determine if contamination remains. If sampling confirms that contamination is present, the property owner at the time of excavation will need to determine whether the material is considered solid or hazardous waste and ensure that any storage, treatment or disposal is in compliance with applicable standards and rules. Contaminated soil may be managed in accordance with ch. NR 718, Wis. Adm. Code, with prior DNR approval.

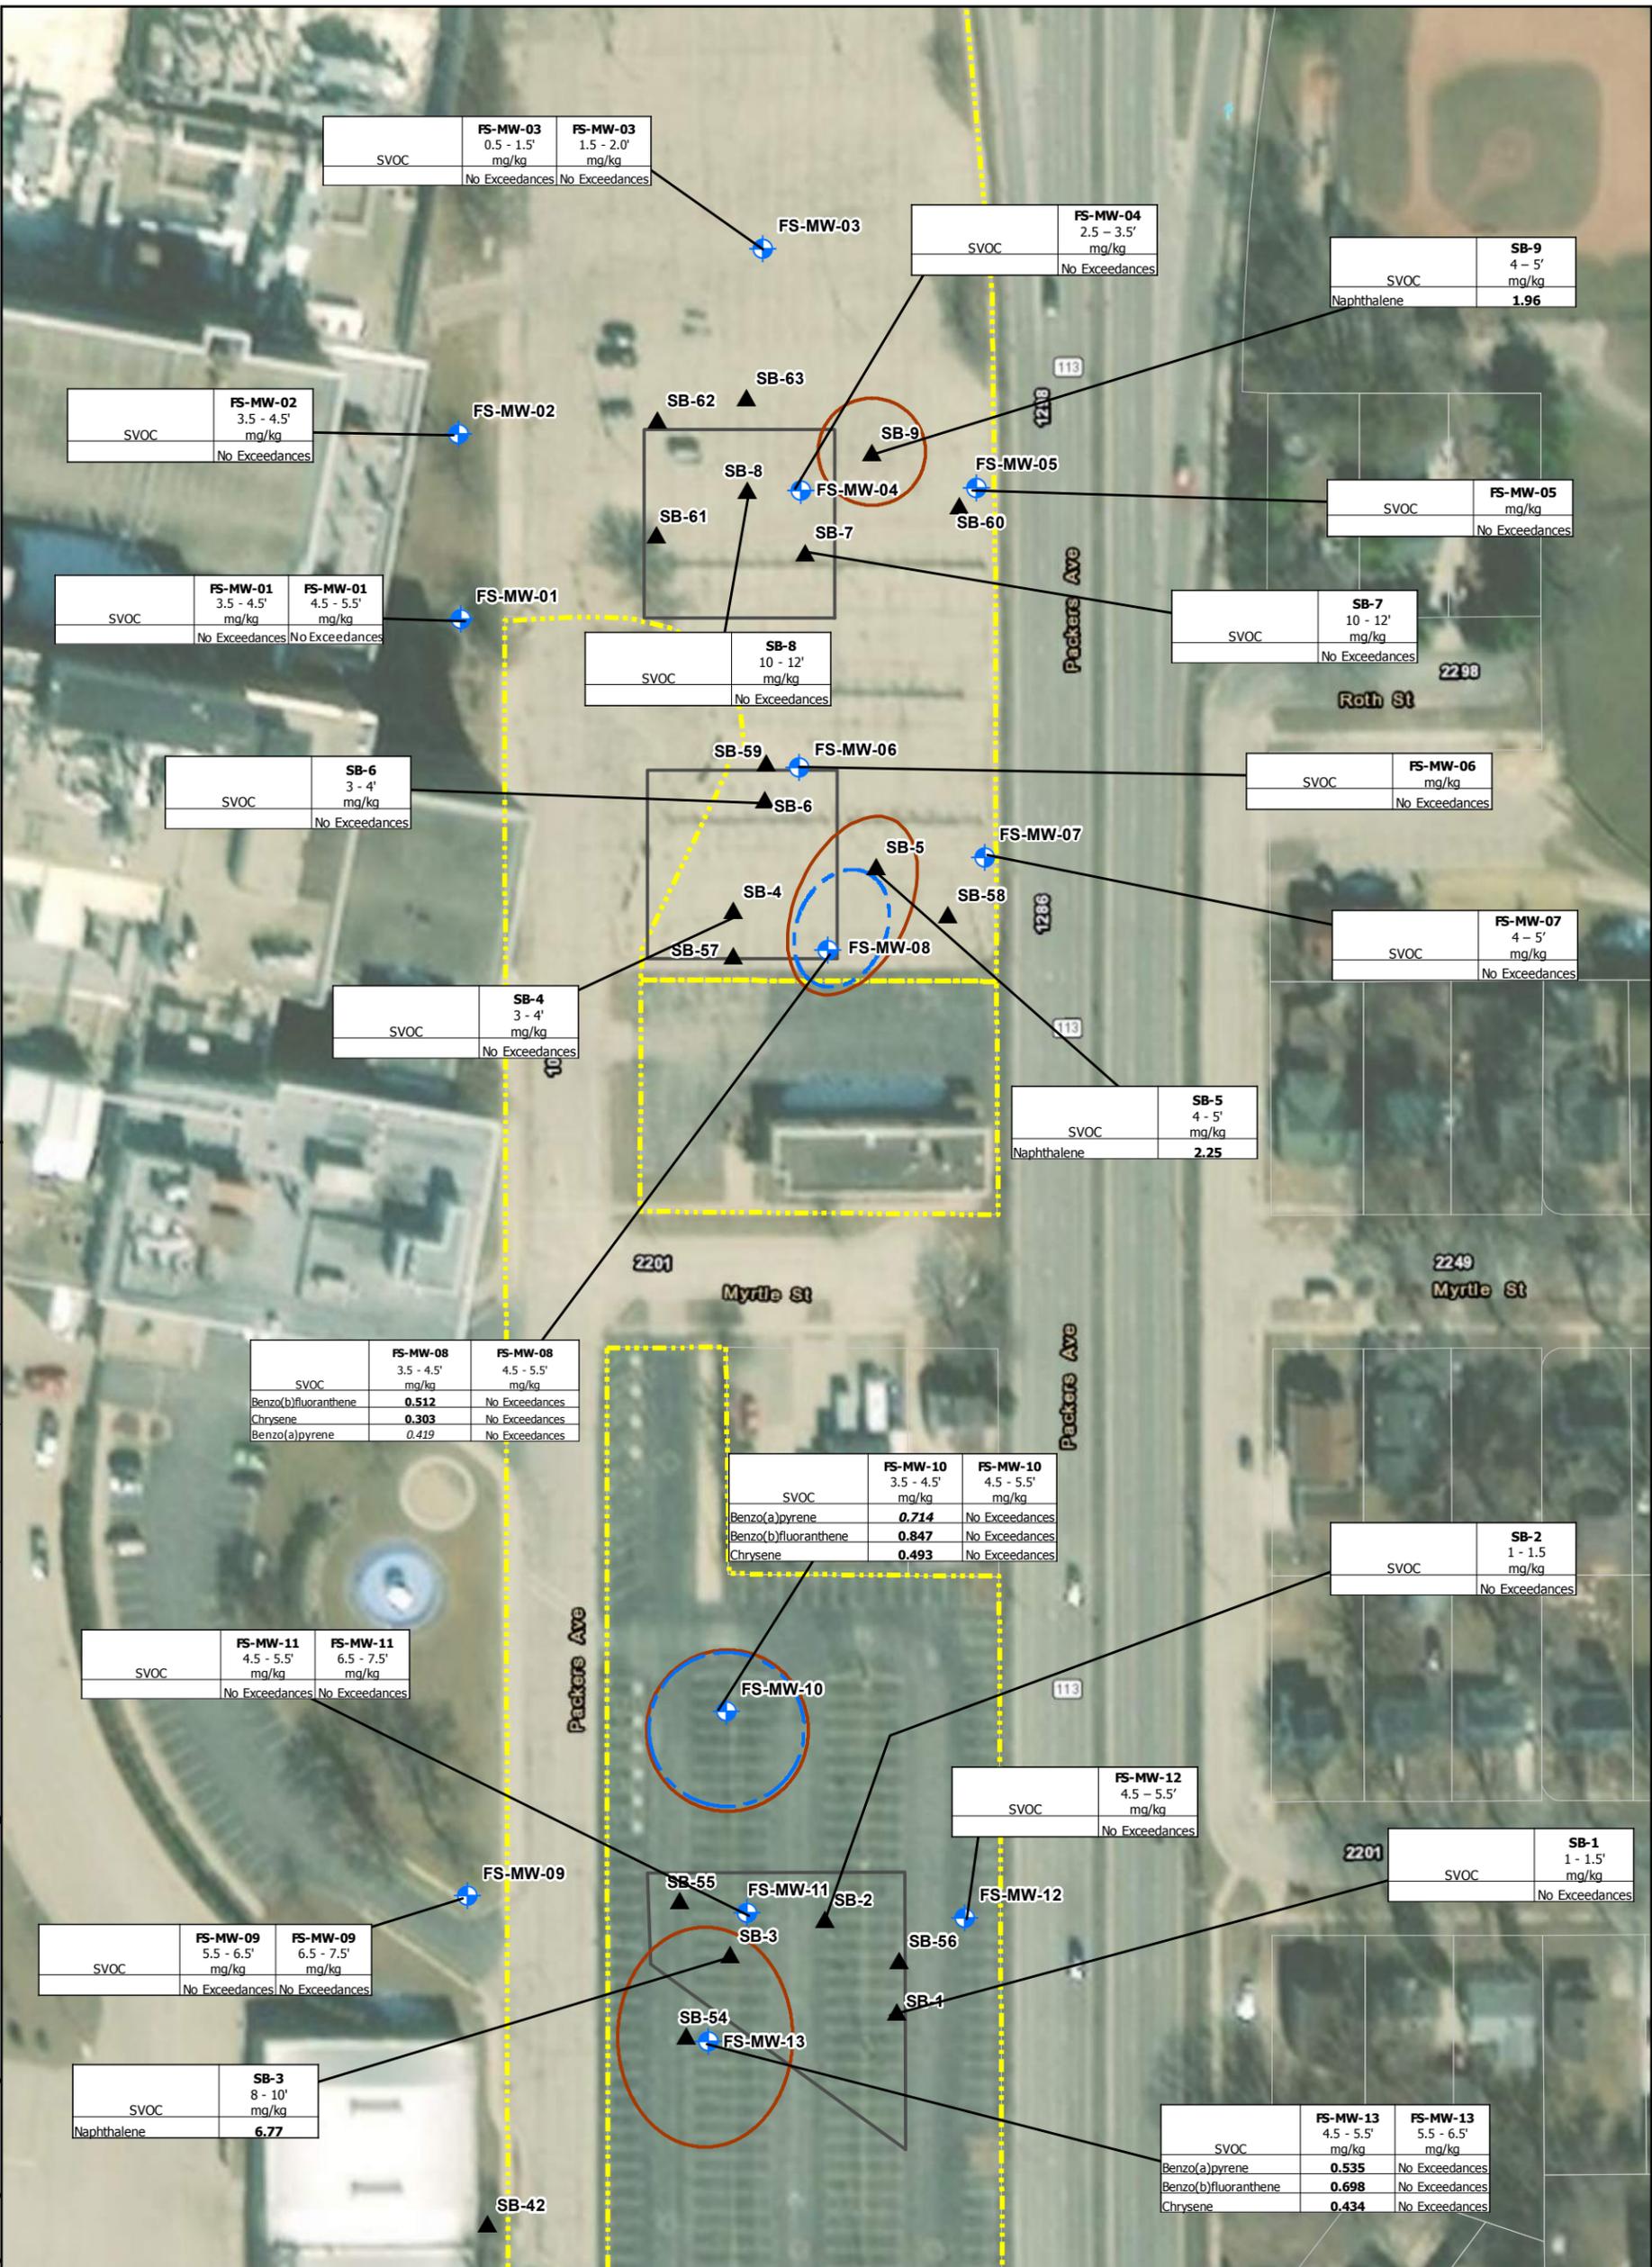
- ▲ Soil Boring Location
- ⊕ Monitoring Well Location
- Horizontal Extent of Soil SVOCs that Exceed a Soil to Groundwater Pathway RCL
- - - Horizontal extent of Soil SVOCs that Exceed a Non-Industrial Direct Contact RCL
- ▭ Historical Site Feature
- ▭ Parcel Boundary
- ▭ 910 Mayer Properties (Main Site)

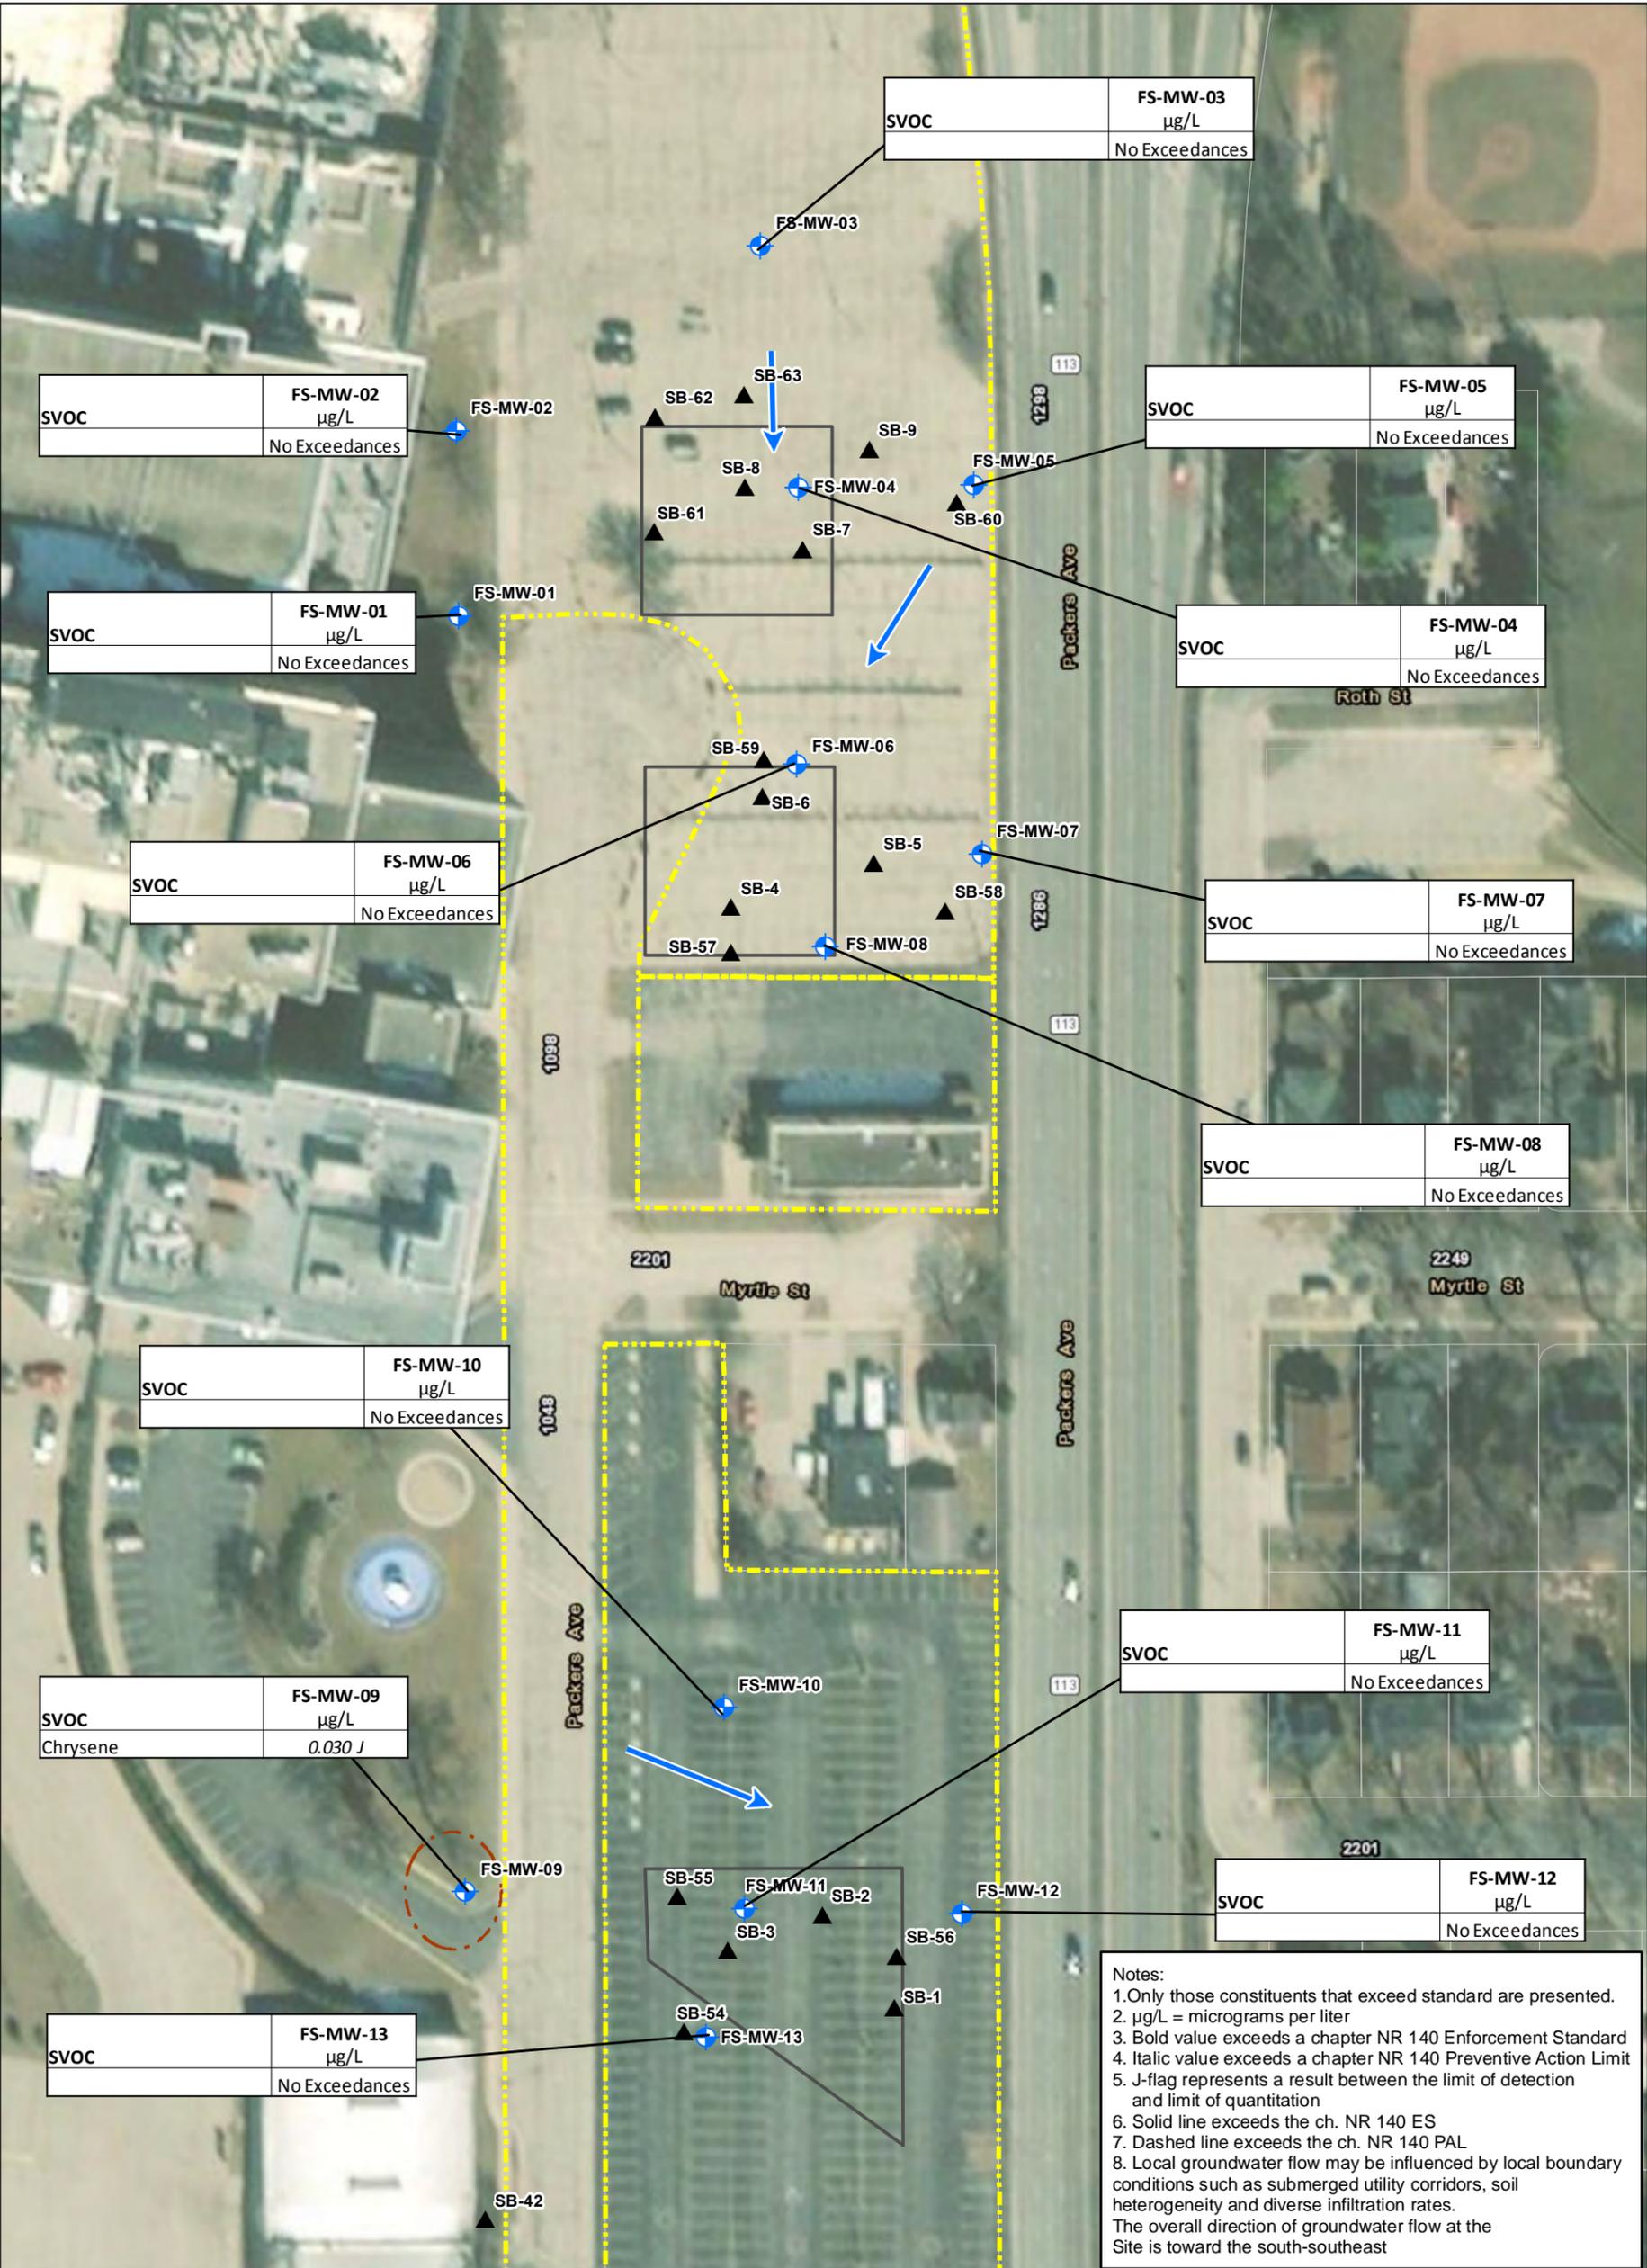
Figure B.3.b.3
Groundwater Contamination – SVOCs
 Filling Station Area
 910 Mayer LLC
 910 Oscar Avenue
 Madison, Wisconsin

1. Only those constituents that exceed standard are presented.
2. µg/L = micrograms per liter
3. Bold value exceeds a chapter NR 140 Enforcement Standard
4. Italic value exceeds a chapter NR 140 Preventive Action Limit
5. J-flag represents a result between the limit of detection and limit of quantitation
6. Solid line exceeds the ch. NR 140 ES
7. Dashed line exceeds the ch. NR 140 PAL
8. Local groundwater flow may be influenced by local boundary conditions such as submerged utility corridors, soil heterogeneity and diverse infiltration rates. The overall direction of groundwater flow at the Site is toward the south-southeast

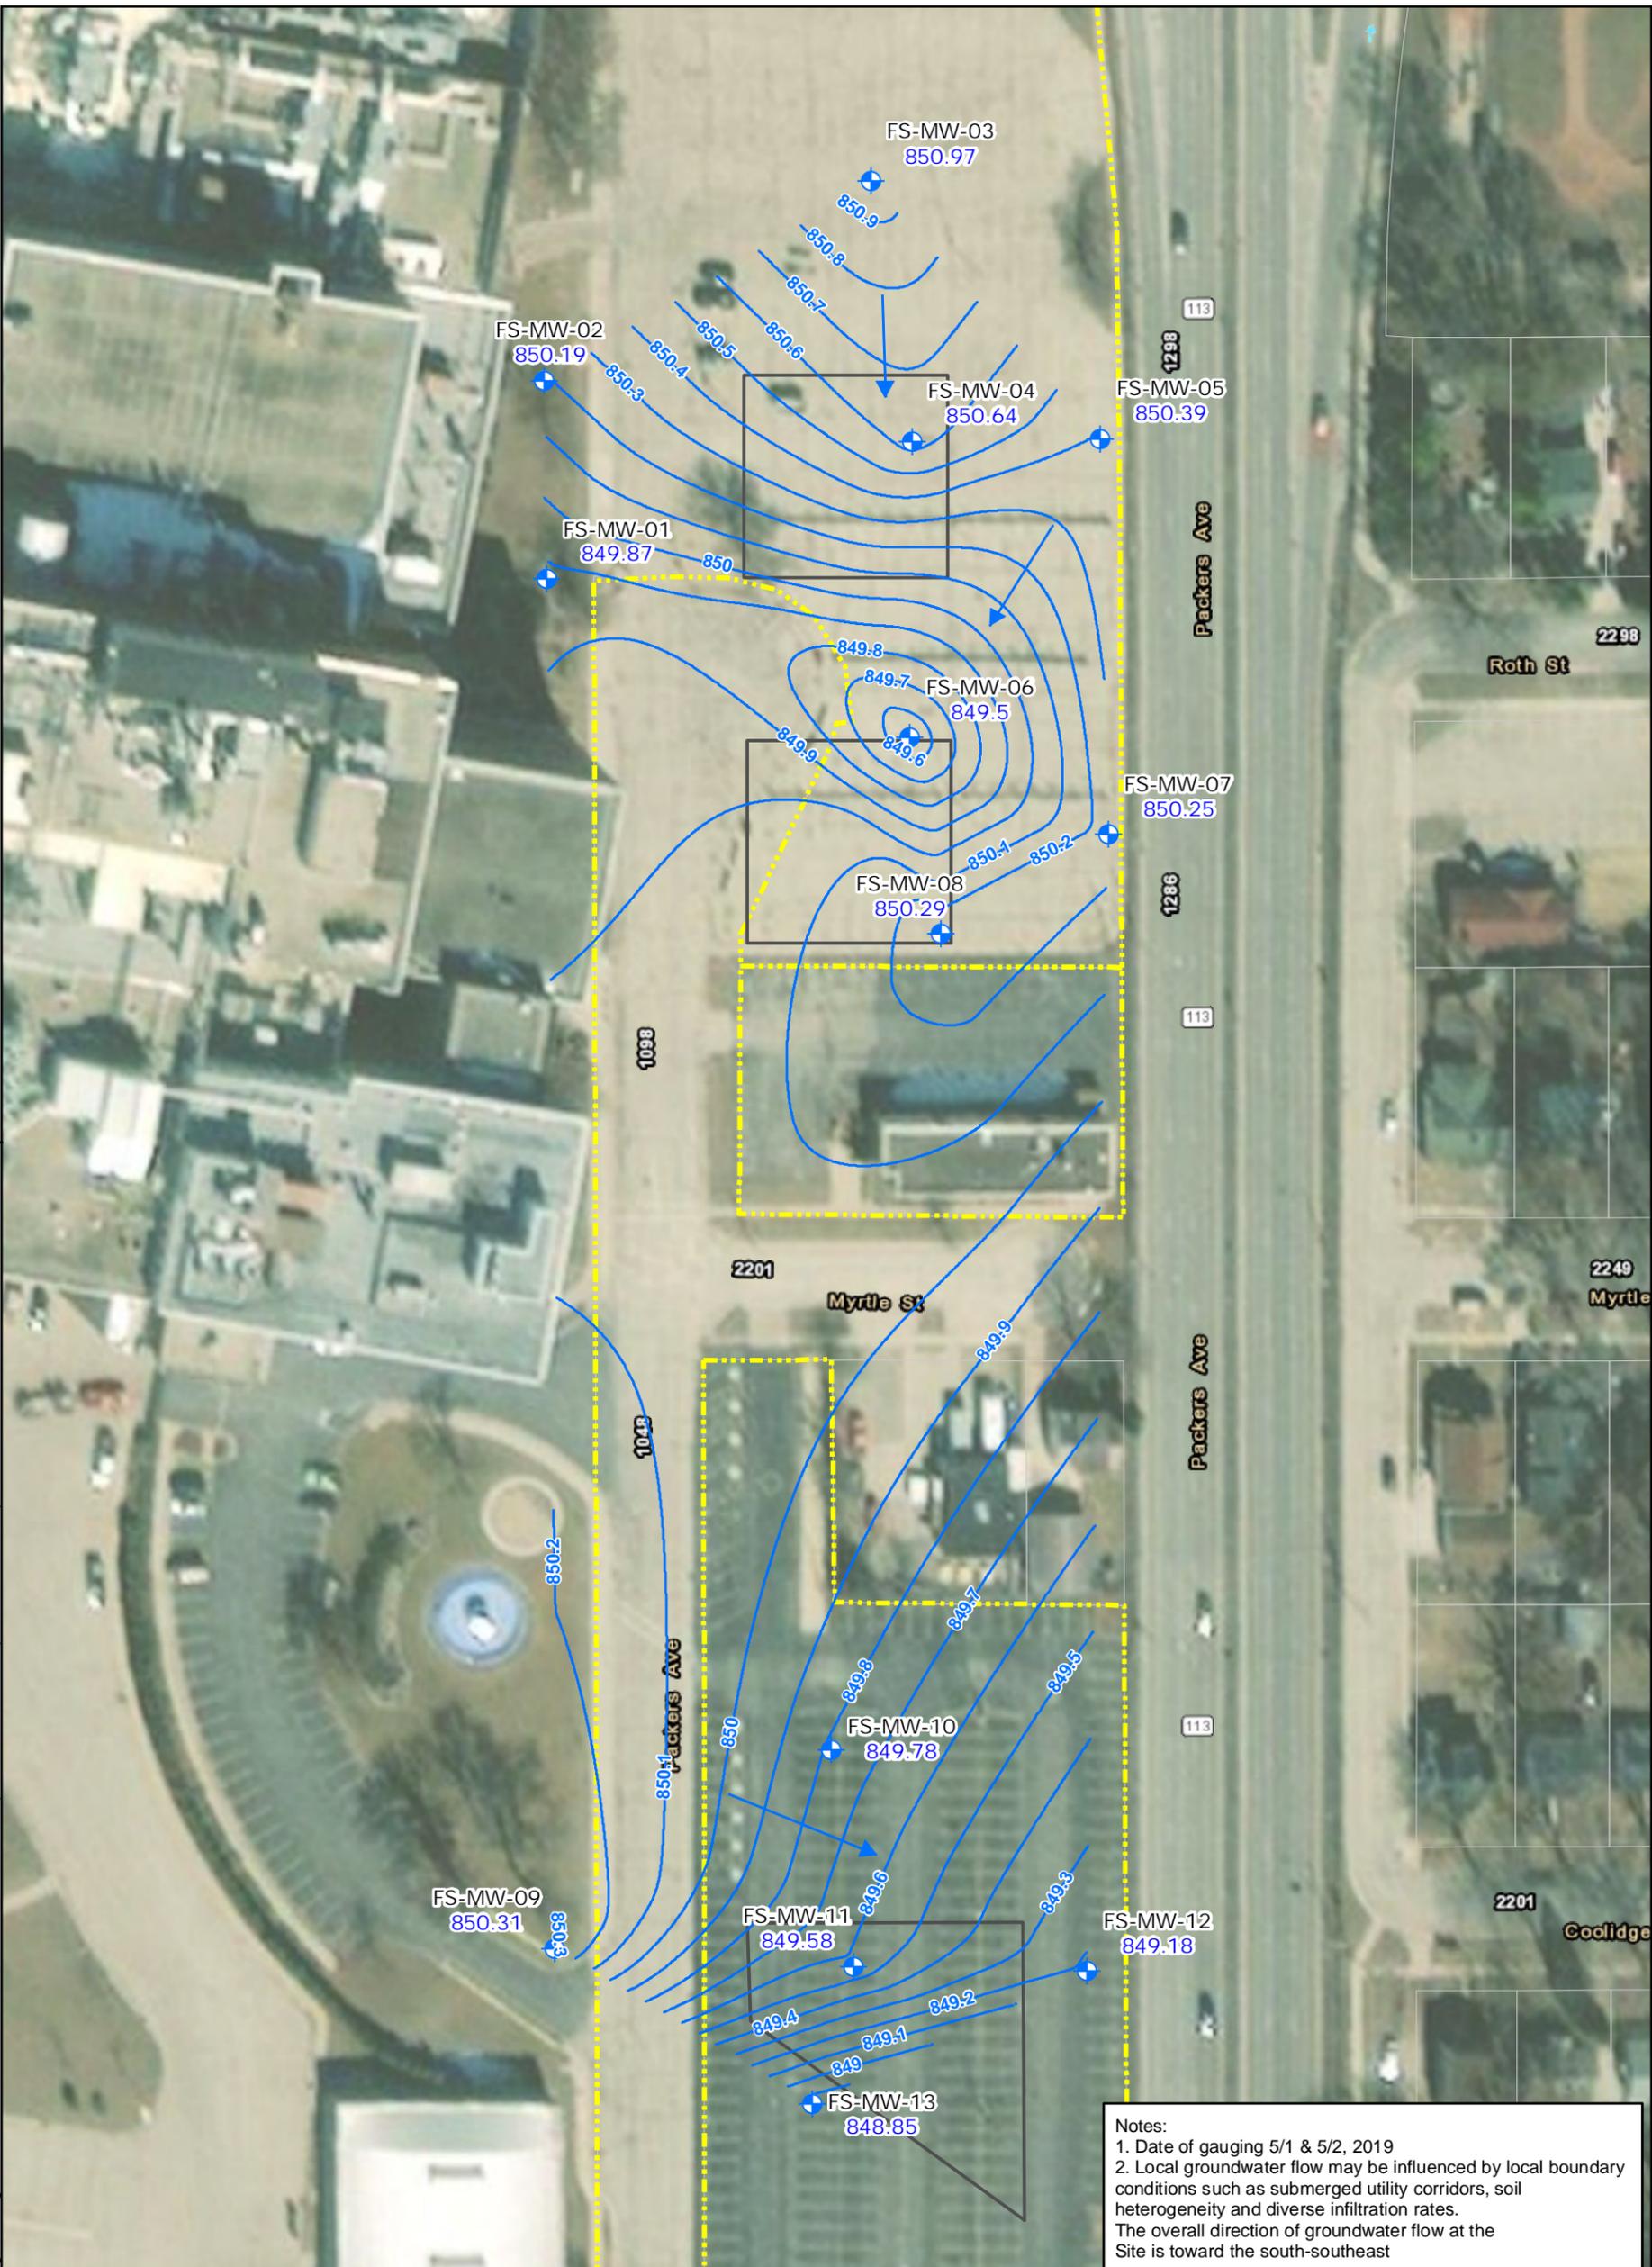
Figure B.3.c
Groundwater Flow Direction
May 2019
Filling Station Area
 910 Mayer LLC
 910 Oscar Avenue
 Madison, Wisconsin

Notes:
 1. Date of gauging 5/1 & 5/2, 2019
 2. Local groundwater flow may be influenced by local boundary conditions such as submerged utility corridors, soil heterogeneity and diverse infiltration rates.
 The overall direction of groundwater flow at the Site is toward the south-southeast

- ii. Discuss groundwater flow direction(s), shallow and deep. Describe and explain flow variations, including fracture flow if present.
 Groundwater flow direction in the uppermost saturated zone is generally to the south-southeast. Based upon the shallow nature of the uppermost zone of saturation, groundwater elevations may be influenced locally by buried utility corridors.

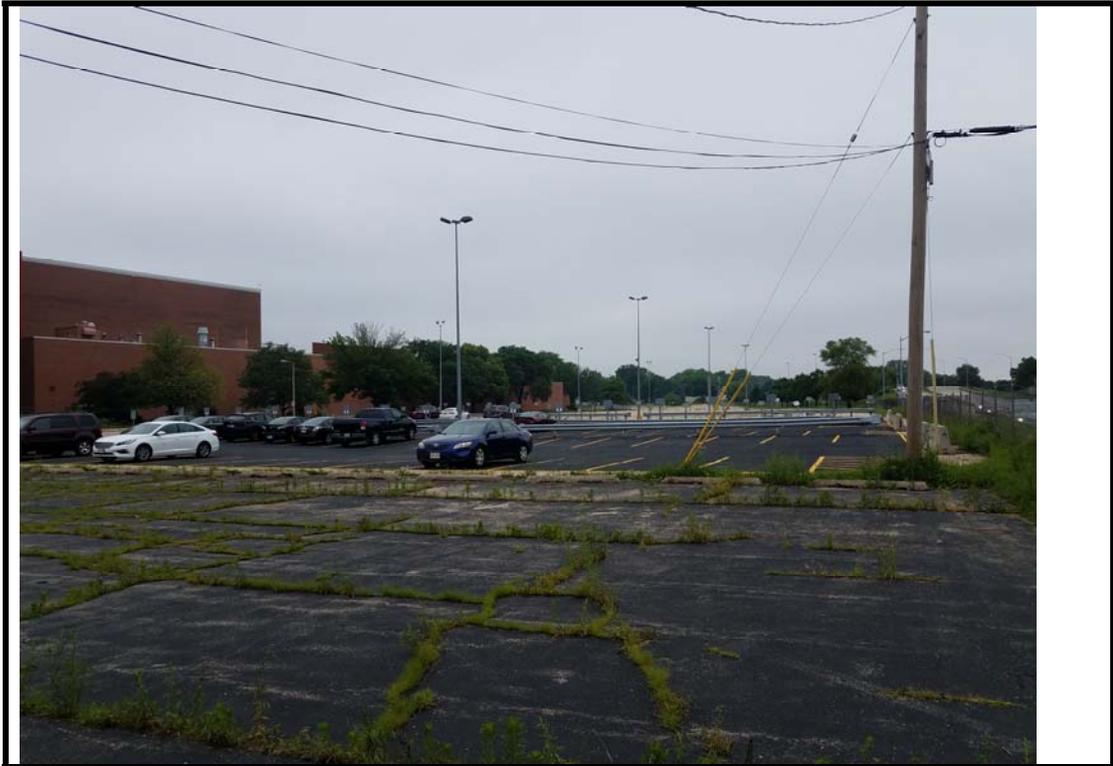
*Photo No. 1 Northern Cap 910 Mayer looking north to Asphalt Parking Lot
(newer asphalt where the cars are parked)*

On the Site the cover to be maintained consists of approximately three to six (3-6) inches of asphalt plus underlying sandy gravel or unpaved clean soils. The existing asphalt parking lot will serve as a cover to prevent direct human contact with residual contamination that might otherwise pose a threat to human health, as well as to prohibit groundwater infiltration. The location of the cover that requires maintenance and inspection is depicted in the figure included in Section D.2 below. Photographs showing the condition and extent of the cover are provided in Section D.3 below.

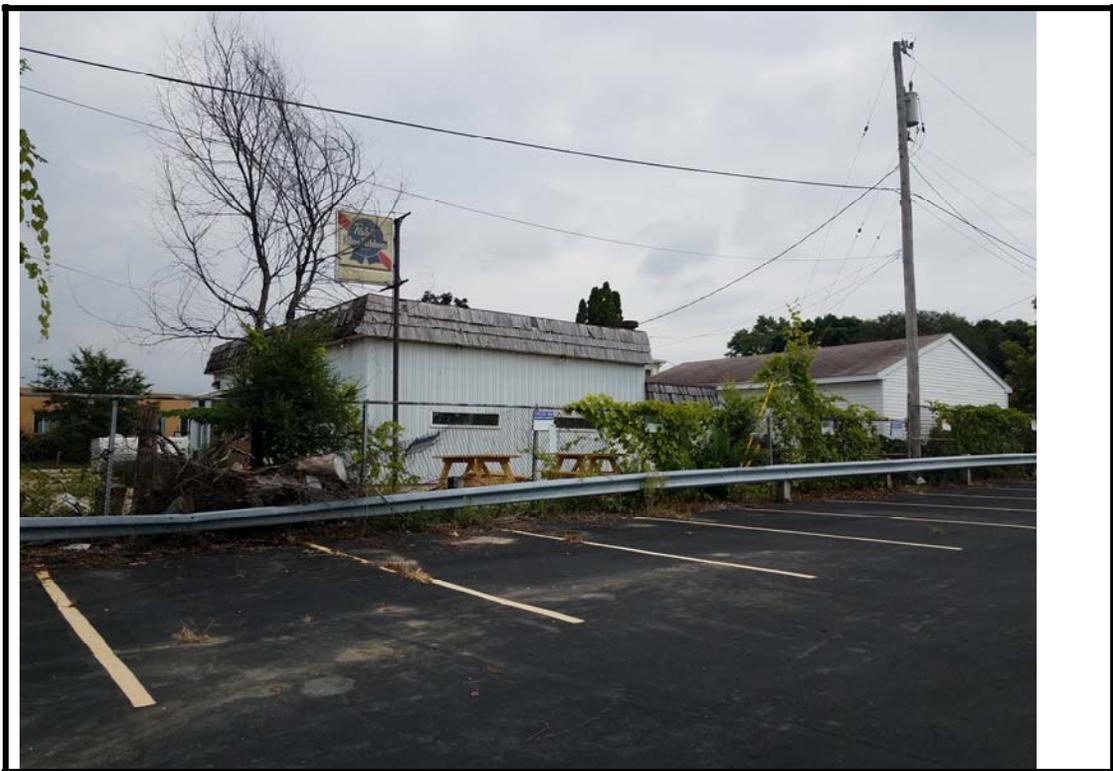
Photo No. 2 Southern Cap 910 Mayer looking north to adjacent property
