From: [DOLORES KESTER](#)
To: [Urban Design Comments](#)
Subject: Agenda item 3. Legistar 88916
Date: Wednesday, March 4, 2026 7:42:22 PM

An 800 foot long apartment building on the corner of Commercial Avenue facing Packers Ave. has been approved for the Oscar Mayer site. We neighbors of this project are requesting the Urban Design Commission to not approve this project until the following problems are addressed:

The Department of Natural Resources (DNR) considers the Oscar Mayer Former Filling Station East site closed, with continuing obligations. The Closure determination relates to petroleum contamination found to be present in the soil and groundwater during the site investigation. No further investigation or remediation is required at this time. However, you, future property owners, and occupants of the property must comply with the continuing obligations as explained in the conditions of closure in this letter. Read this letter closely to ensure that you comply with all conditions and other on-going requirements. Provide this letter and any attachments listed at the end of this letter to anyone who purchases, rents or leases this property from you.

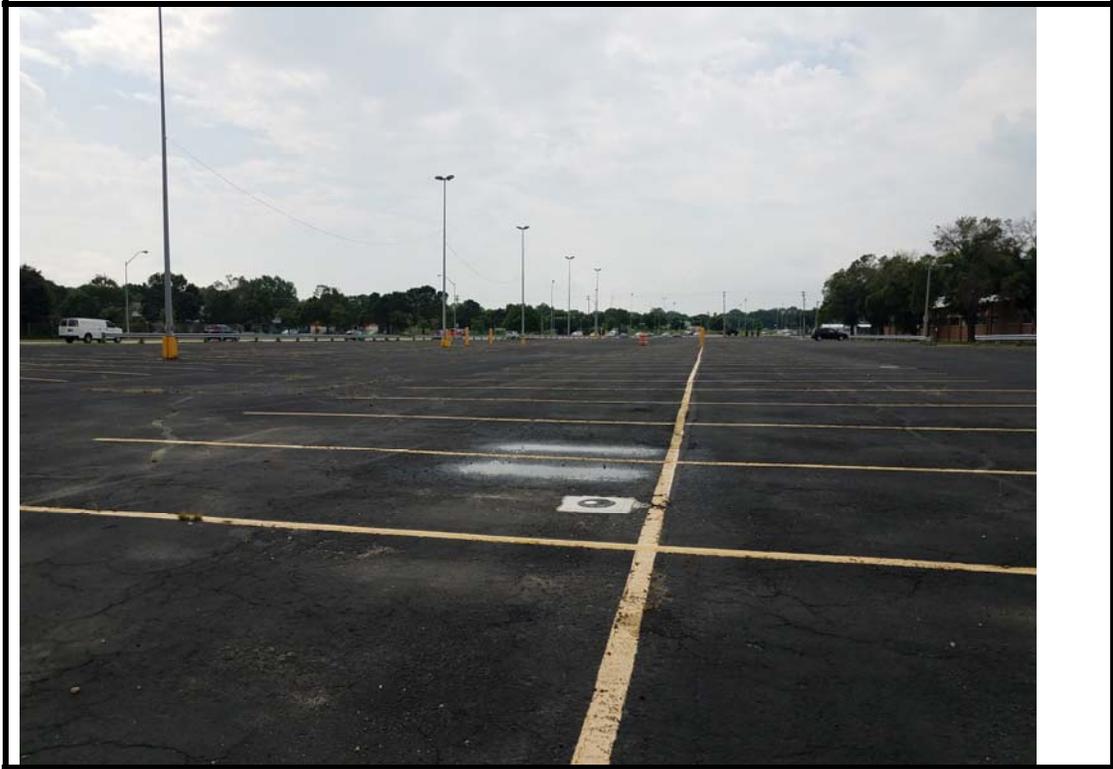
Photo No. 3 Southern Cap 910 Mayer looking South into Asphalt Parking Lot
