2121 Jefferson St

1007 Edgewood Ave

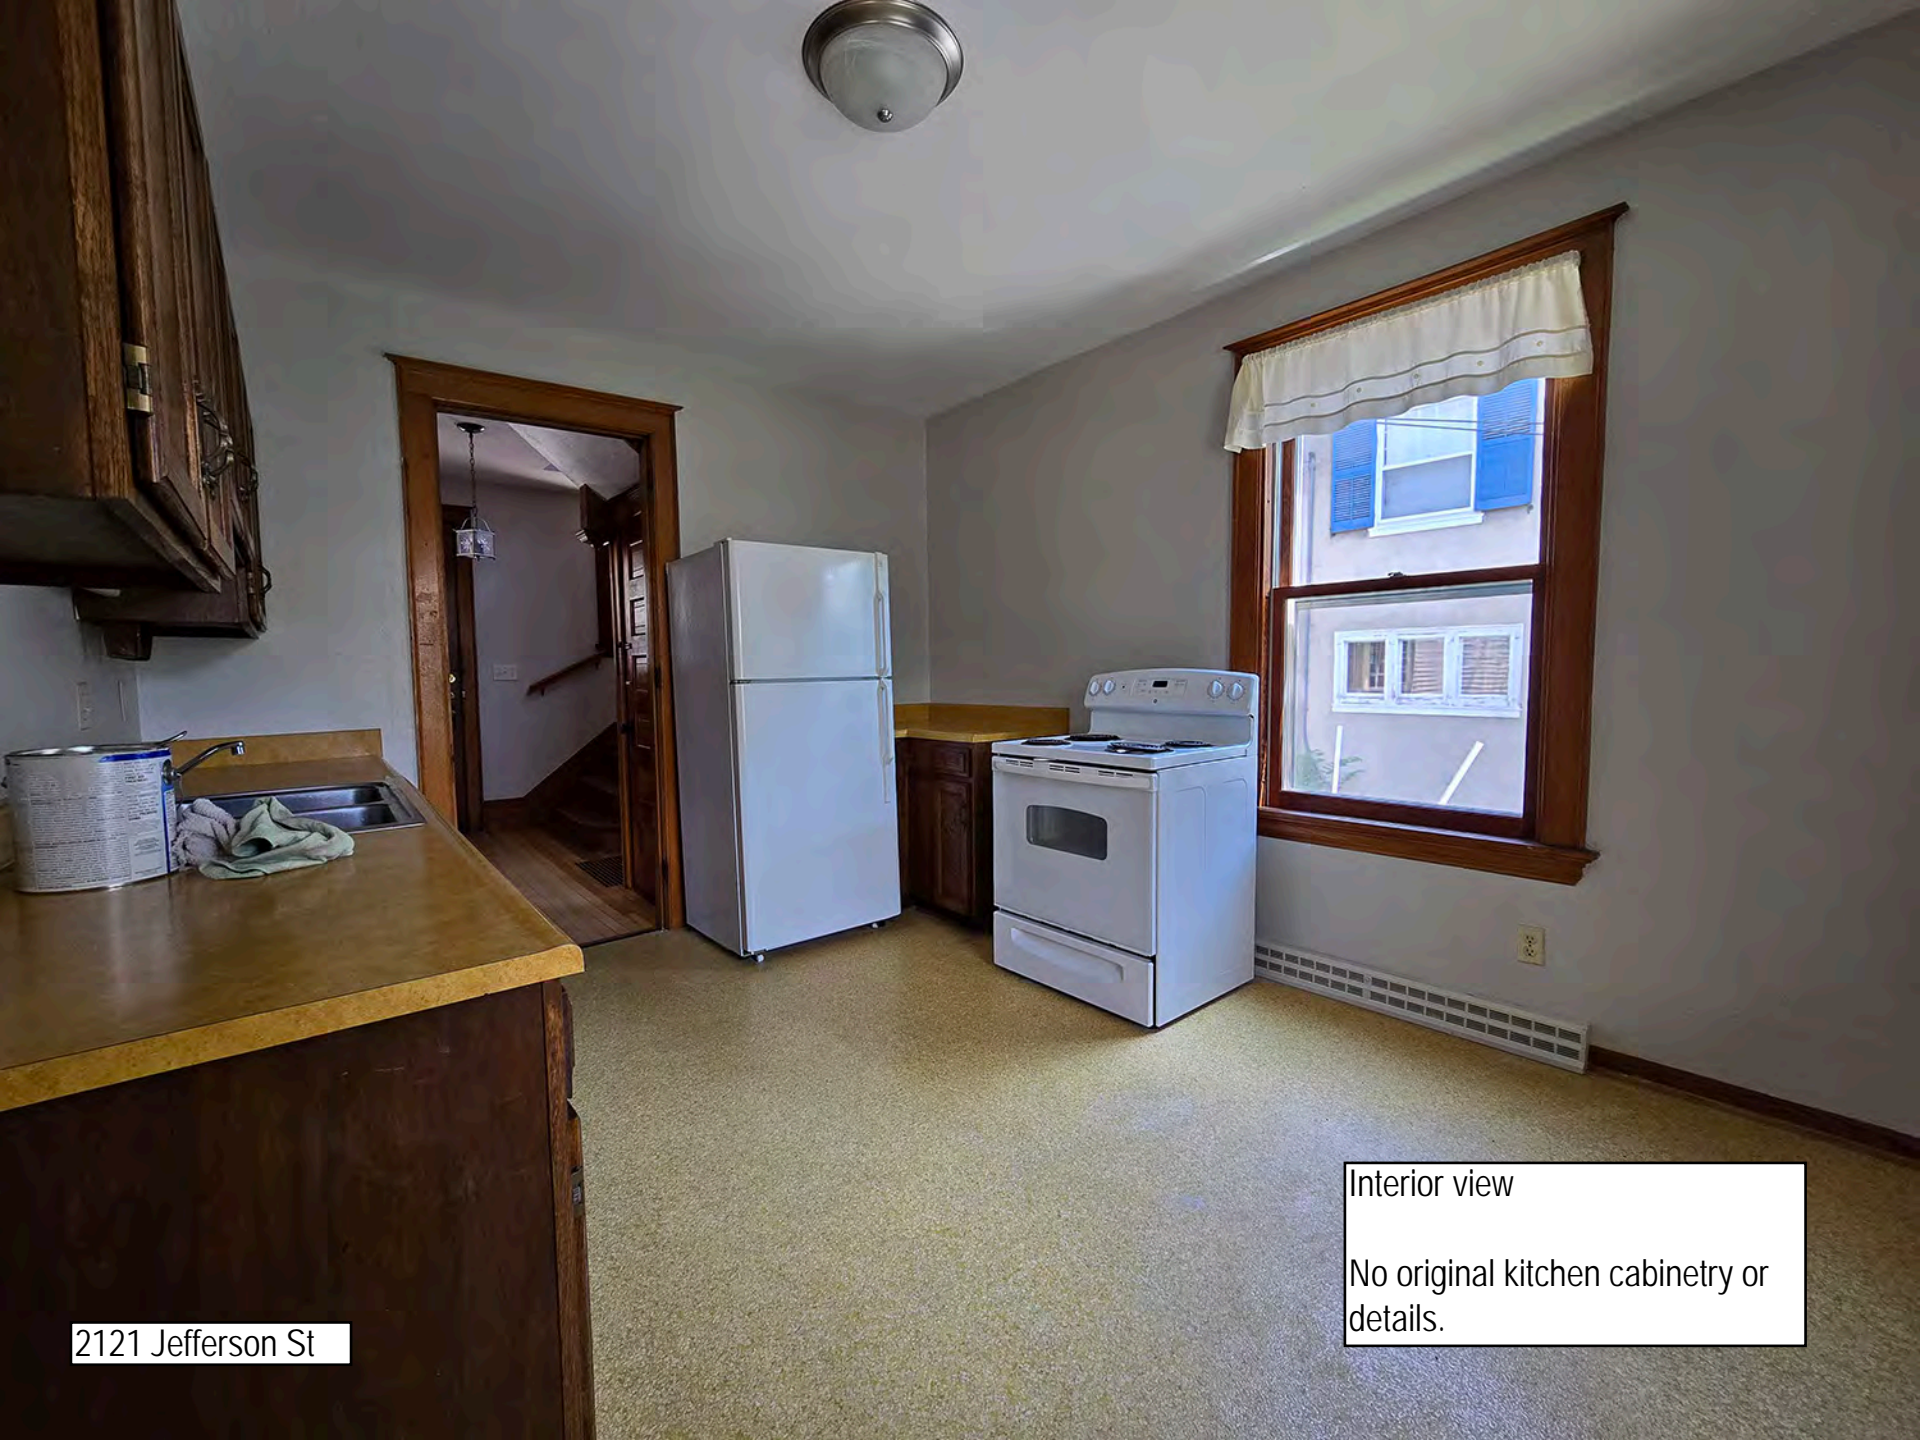
Interior view
No original kitchen cabinetry or details.

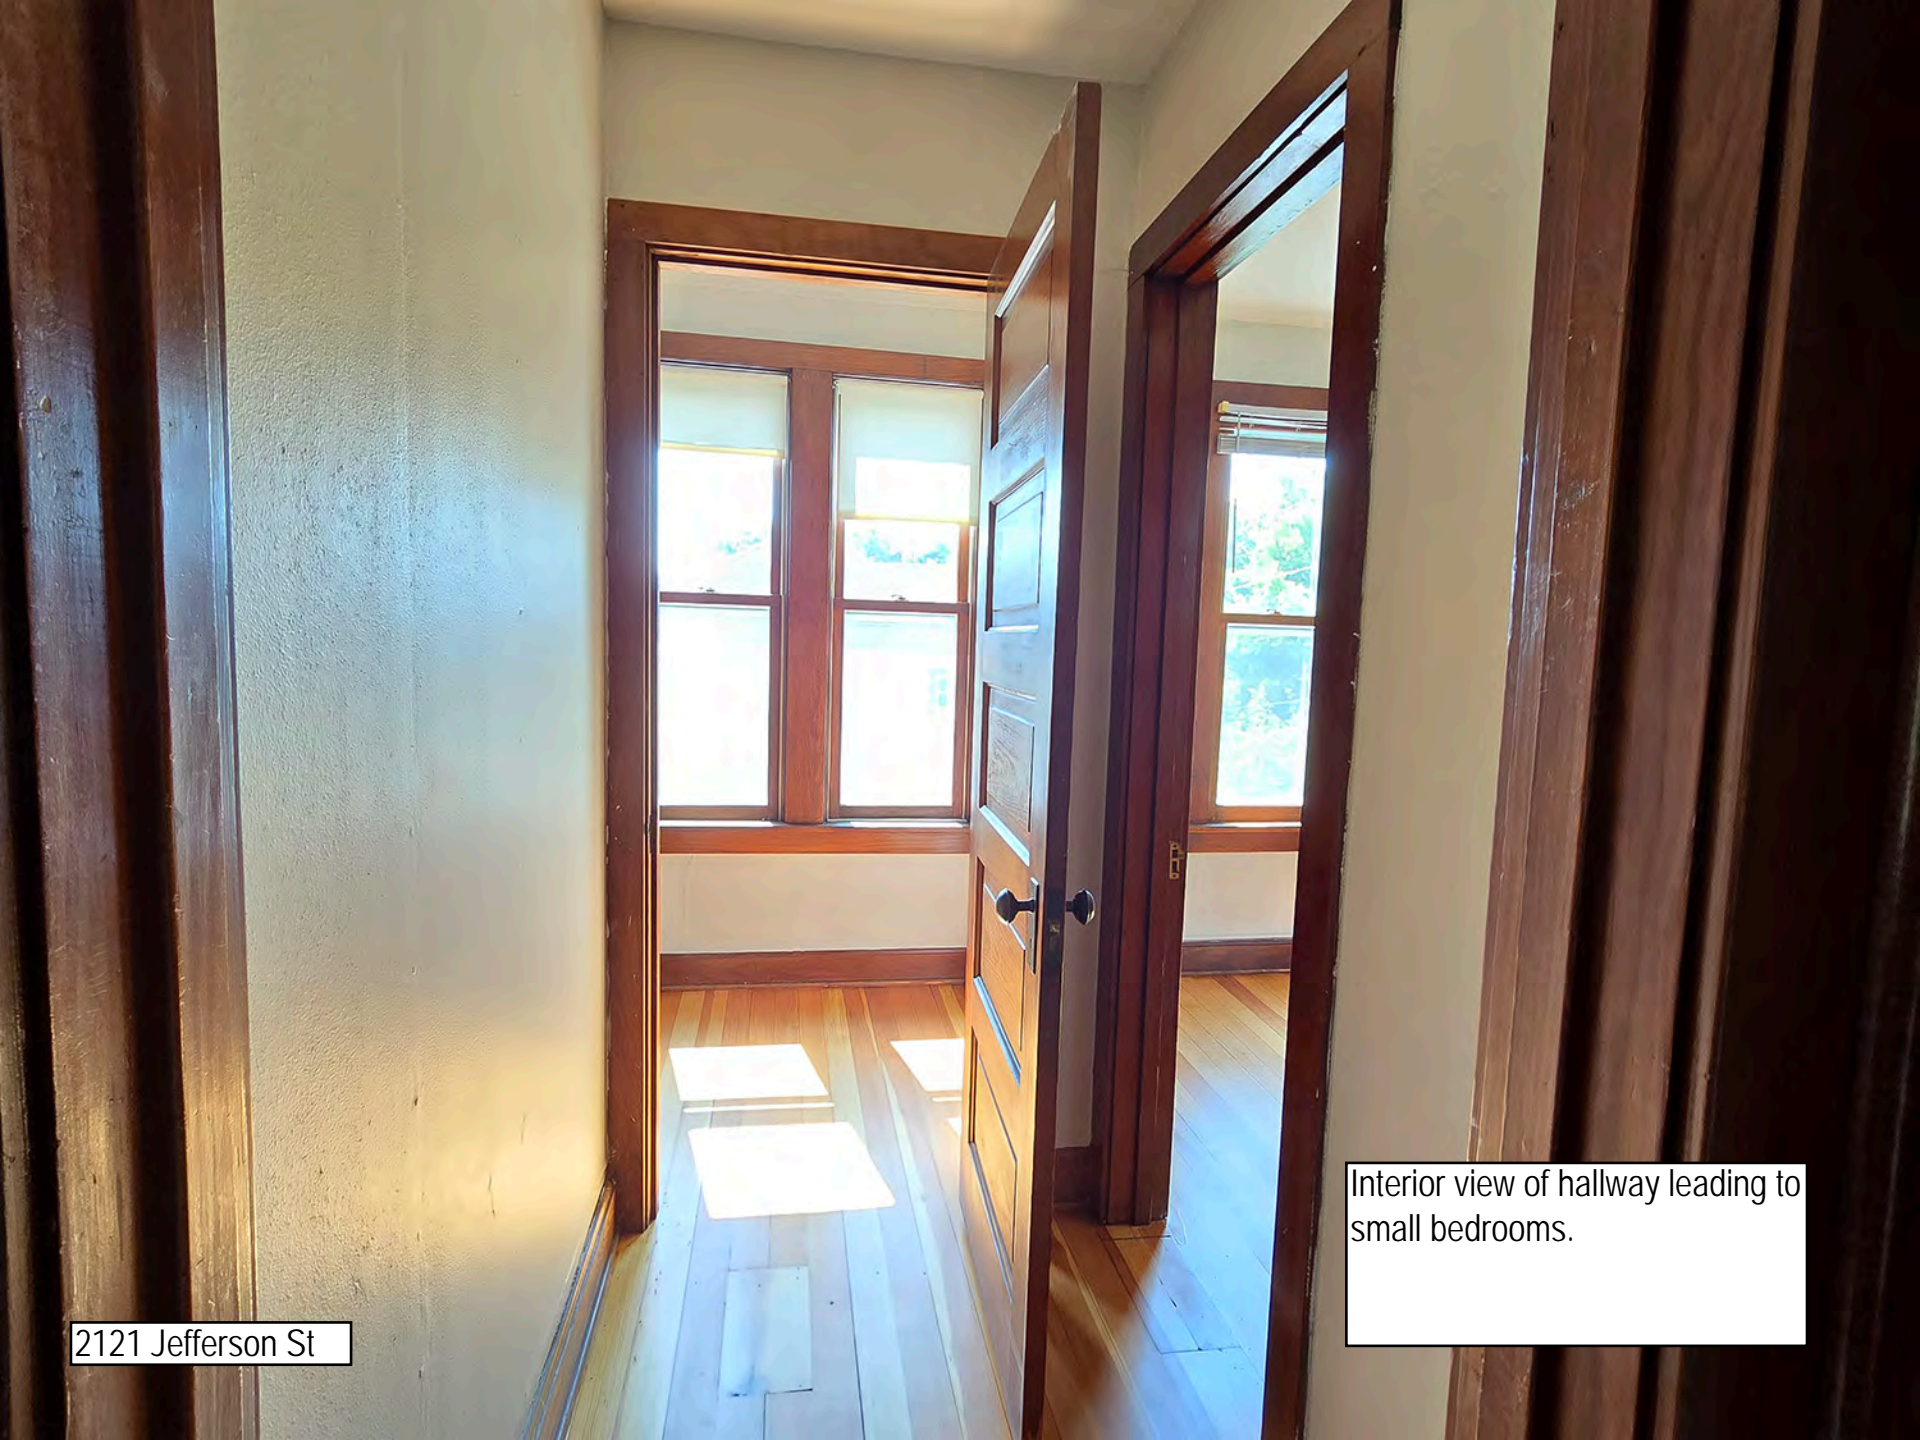
No built-ins remain.
