BLOCK 100 FOUNDATION

GENERAL PROJECT INFORMATION

Castle and Doyle Building | 125 State Street

Andrew Schubert Building | 120 West Mifflin Street

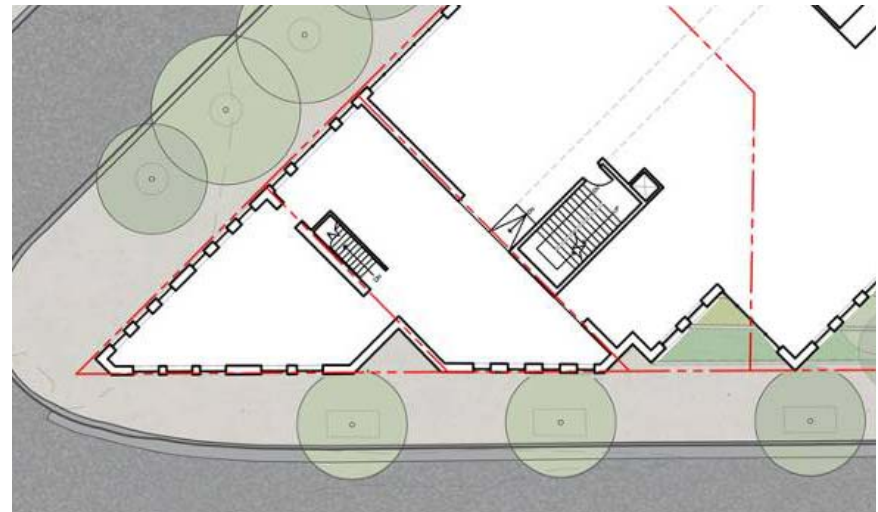
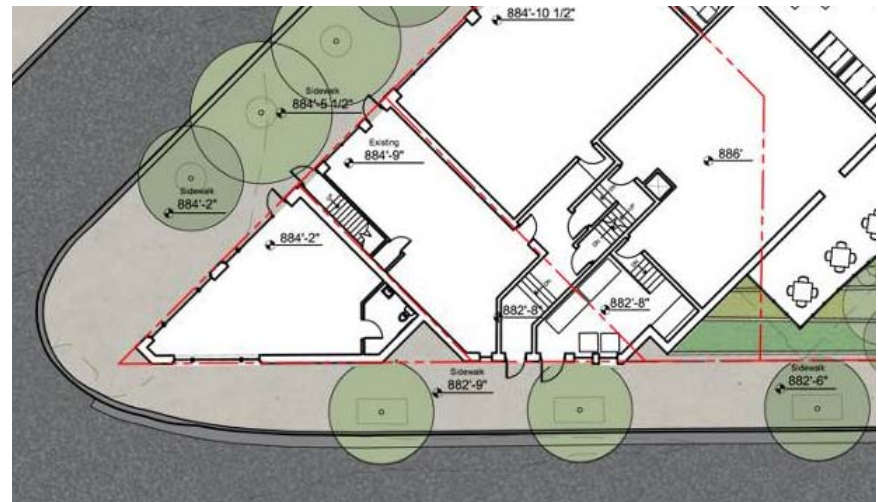
Proposed Floor Plans

PROPOSED IMPROVEMENTS (125 State Street, Castle & Doyle Building)

- Repair and re-set damaged terra cotta units and repointing of mortar joints
- Replace faux marble cast stone base with granite on State Street
- Restore and refinish historical wood windows
- Restore State Street first floor retail window to original single glazed window unit
- Replace the central second floor non-original window assembly
- Restore and refurbish original wood doors on State Street
- Repair masonry and mortar on Fairchild Street
- Install appropriate termination and flashing at the parapet wall along State Street
- Structural modifications, if required
- Upgrade mechanical and electrical systems to comply with current code requirements
- If required, other improvements necessary for code compliance will be completed

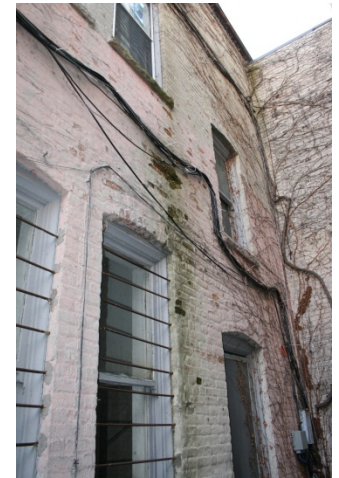
Alley and rear building facades

- Remove the existing coating and parge materials on the brick
- Extensive replacement of the majority of the brick on both facades – potential replacement of the masonry back-up system may also be required
- Remove and re clad the recessed area on the second floor currently covered in painted sheet metal
- Replace the gutter and downspout system and tie into a new storm water line to the street
- Repair the existing double-hung windows on the second floor
- Replace the first floor windows
- Re clad the roof access penthouse and replace the exterior door to the roof
- Replace the roof on the penthouse roof access structure

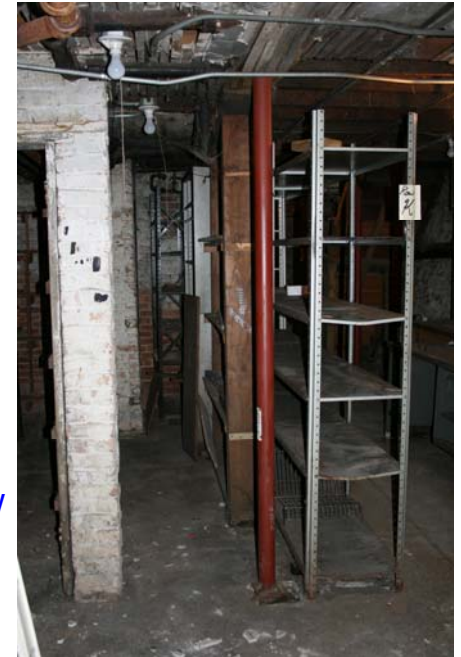
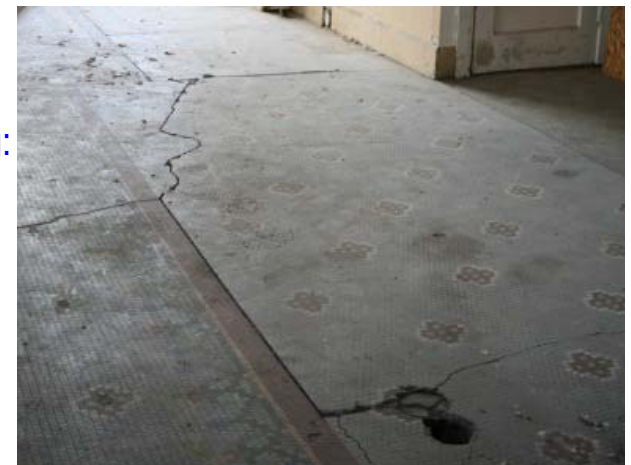
- Install new first floor finish
- Where required, repair the rubble foundation walls
- Replace the structure with fire resistive construction pursuant to the Capitol Fire District requirements

- Install a first floor toilet room
- Repair the plaster walls and ceilings on the first and second floors
- For the change in occupancy on the second floor, complete the following:

- Remove the existing second floor walls and re-support the roof structure
 - Remove the existing kitchens
 - Relocate and install a second floor toilet room

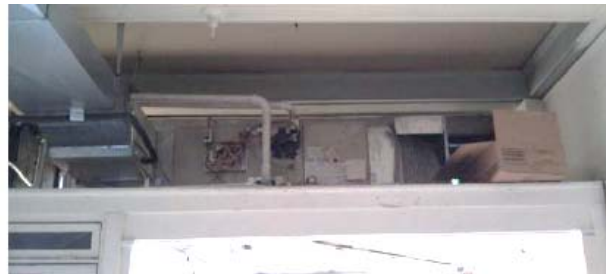
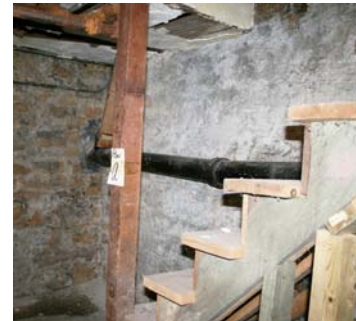
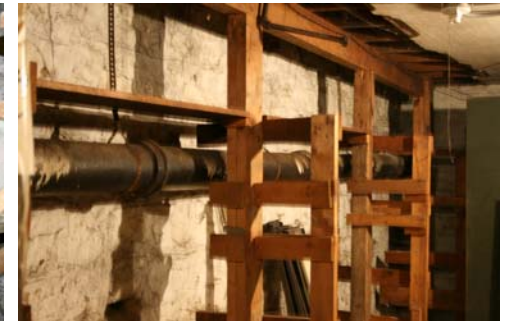
Mechanical, Electrical and Fire Protection

- Install a fire protection system
- Upgrade the HVAC system
- Remove the existing lead piping and patch floors, walls and ceilings
- Install a first floor toilet room
- Replace the electrical infrastructure
 - Install new branch circuit wiring and fuse panels
 - Install new lighting and electrical outlets
- For the change in second floor occupancy, complete the following:
 - Remove the kitchen fixtures and bathroom fixtures, patch floors, walls and ceilings
- Remove the storm water cistern in the rear of the building and the storm water piping running horizontally through the basement
 - Have adjacent building Owner(s) route storm water to W. Mifflin Street
- Construct a new storm water line to route storm water from the rear of the building to W. Mifflin Street
- Replace the gas piping in the basement

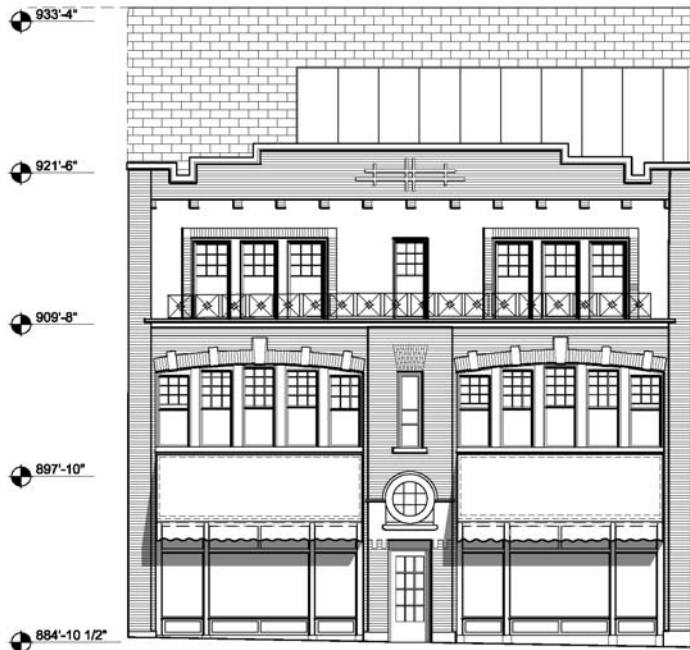
Proposed

[The existing three story brick façade on State Street will remain]

- Repoint masonry (open mortar joints and poorly installed previous repointing)
- Replace plywood infill at circular opening with historical assembly
- Repair and/or replace existing stucco cladding at the third floor
- Restore and refinish historical wood windows
- Replace non-orig. vinyl windows with a window assembly similar to historic windows
- Replace non-original first floor storefronts
- Provide accessible entry to first floor retail
- Install appropriate termination and flashing at the parapet wall

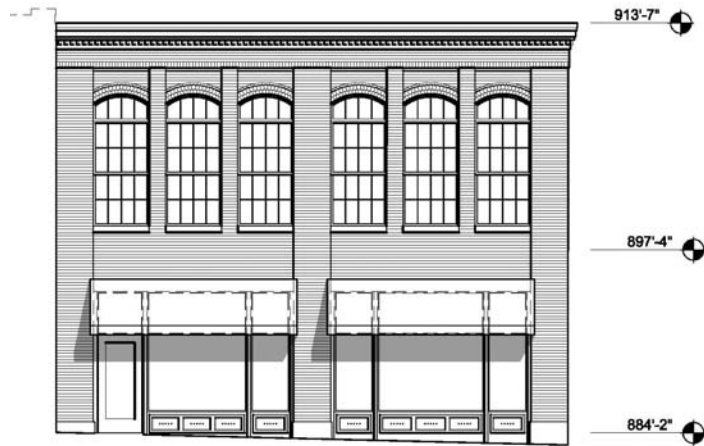
Proposed

PROPOSED IMPROVEMENTS

- New two-story brick building with same height and mass of the existing building State Street facade is designed to reflect the historic character of the original building.
- This façade wraps the flat-iron corner and the architectural character of the State Street façade is reflected in the design of the new Fairchild Street façade.

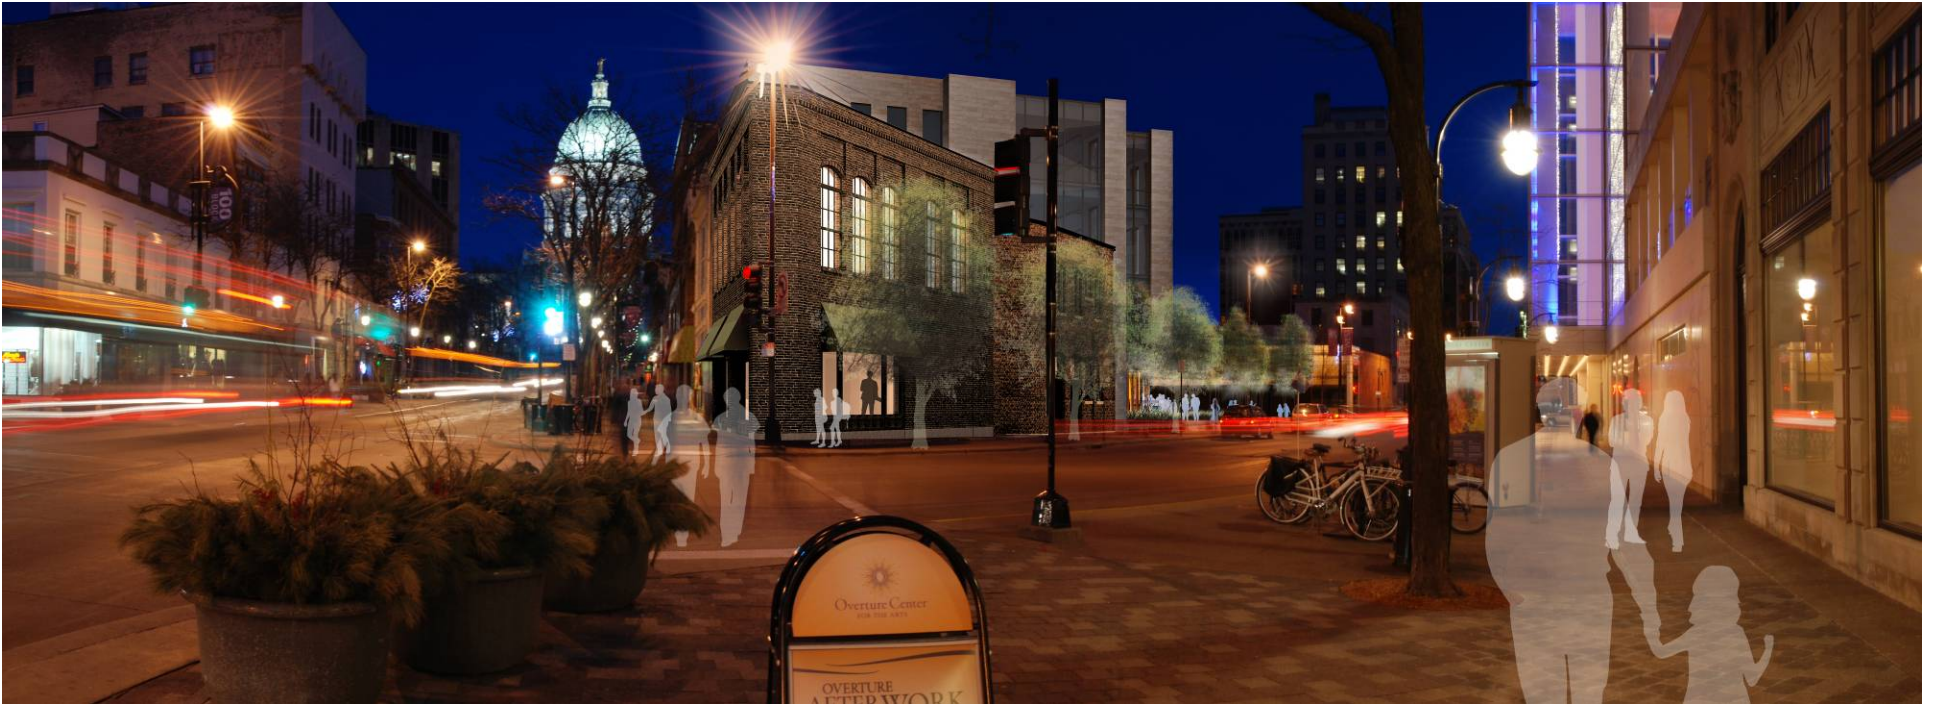
Corner of State St and N Fairchild St Perspective - Proposed

PROPOSED IMPROVEMENTS

- New two-story brick building with same height and mass of the existing building
- On the Fairchild Street sidewalk the existing stairway access to the basement of the existing building is eliminated and the gas meter is relocated out of the public right-of-way
- New architectural expressions similar to State Street
