Olbrich Garden Roof Detail 'As Built' Drawing

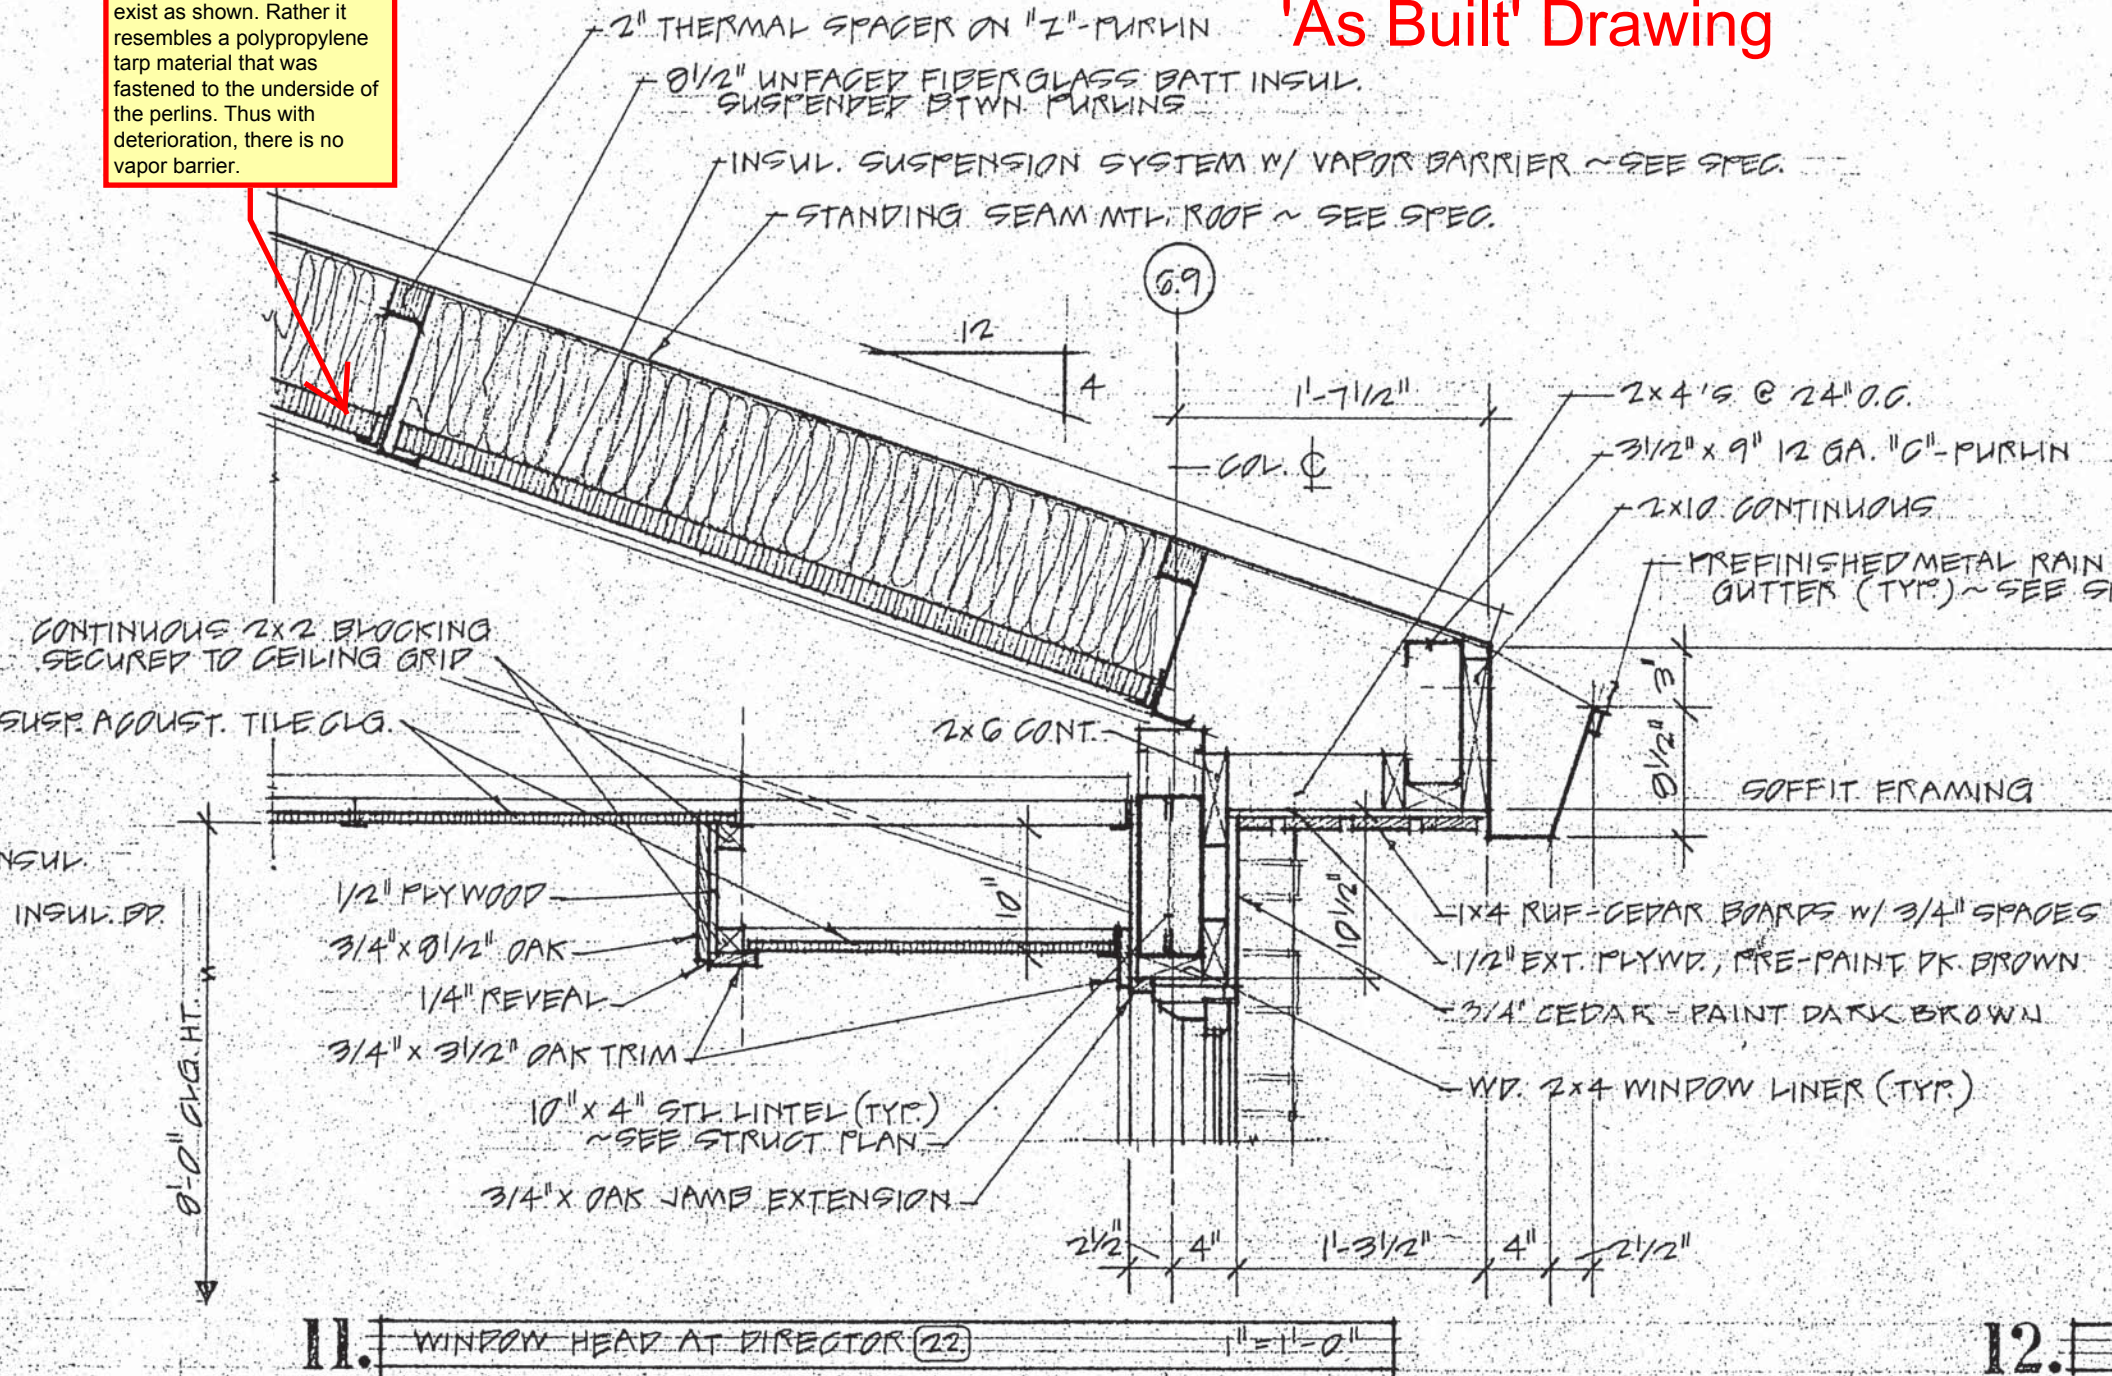
This vapor barrier does not exist as shown. Rather it resembles a polypropylene tarp material that was fastened to the underside of the perlin. Thus with deterioration, there is no vapor barrier.
