## Public Health Assessment

### Evaluation of soil, groundwater, and vapor intrusion contamination at open and closed investigations on the Hartmeyer and Oscar Mayer sites in Madison, WI

Hartmeyer & Oscar Mayer Sites  
2007 Roth St & 910 Mayer Ave  
Madison, Wisconsin

November 28, 2022

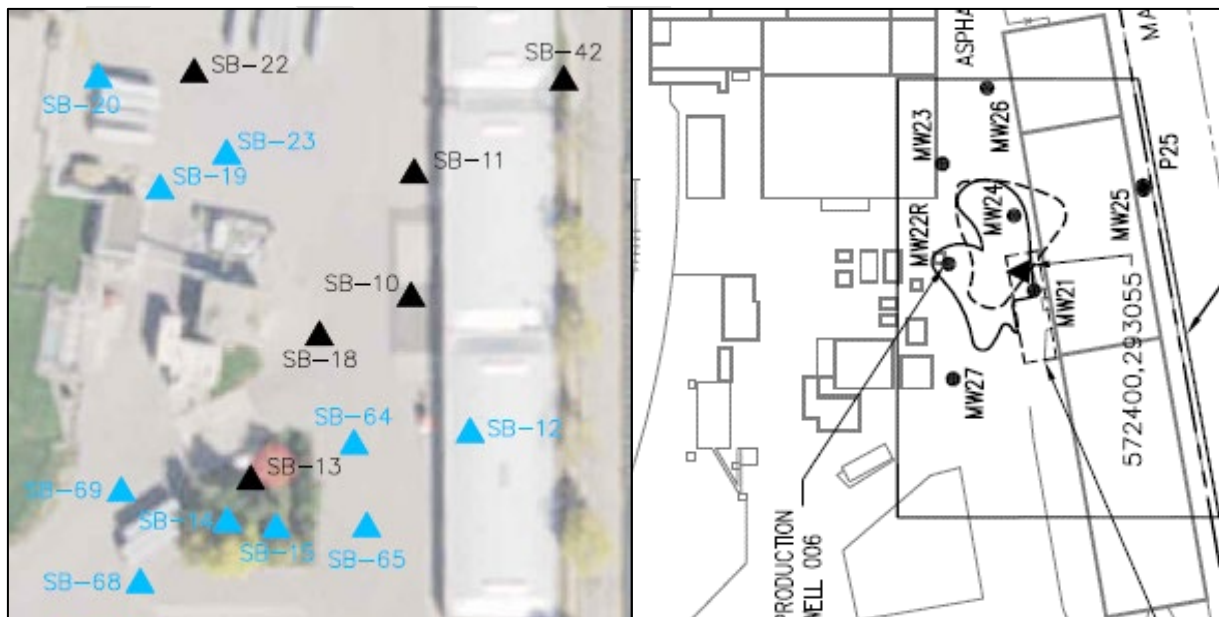
**Figure 4. Closed Site #3 with 2017 data near site (left) and 1996 (right) extent of contamination.**

Closed Site #3 (BRRTS 03-13-114831) is located just west of The Bodgery building on the South side of the Central portion of the Oscar Mayer Property (Figure 4). An underground storage tank (UST), former diesel dispensers, and several former gasoline dispensers were excavated for removal from the site. Following excavation, the site was backfilled with clean fill and a new diesel UST. The former UST excavation for gasoline was also backfilled. Following the original excavation,

soil and groundwater analytical results were taken in 1996 and 1997 from the excavation to determine soil and groundwater contamination at the site. The cap is required to be maintained and inspected annually to determine its integrity. Sampling was also performed on this site as part of the 2017 Oscar Mayer investigation. Additional soil samples and groundwater samples were taken throughout Oscar Mayer property in 2017. The samples were also taken on the former 1,2-DCA tank site and from the area near Closed Site #3 (Figure 4 and Figure 5). Soil samples in the top 5 feet of soil (SB-11, SB-12, SB-18, SB-19, SB-23, SB-42) where the soil is most accessible, and groundwater samples (SB-10, SB-12, SB-18, SB-19, SB-23, SB-42, SB-64) were also taken near the former UST site behind the Bodgery.

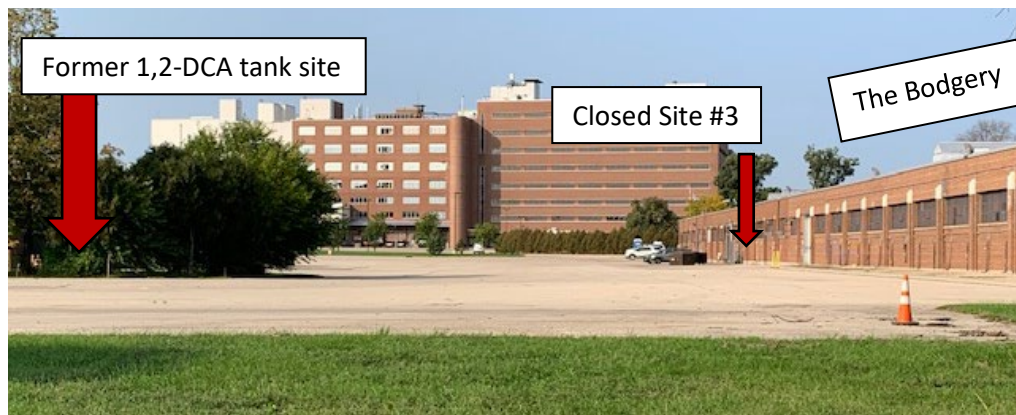
**Figure 6. The former 1,2-DCA Tank location behind the Bodgery, which is a community building used as a makerspace for artists and community members.**

To our knowledge and at the time of our site visit, there was no construction taking place in this area (In December 2020, an excavation to remove contaminated soil was carried out). It was also observed that access to this site appears to be limited due to a fence limiting access to a portion of the site. On the back of the

Bodgery, there is a “garage door” type entrance to the building and a side door. Both appeared to not be in use (Figure 6). The fencing right outside this area does have a “No Trespassing” sign (Figure 7). A building at the back of the lot did appear to be in use with cars parked in the parking lot but it appeared to be for the building labeled “Nine-Ten” which is being leased out by a third party company. Upon further

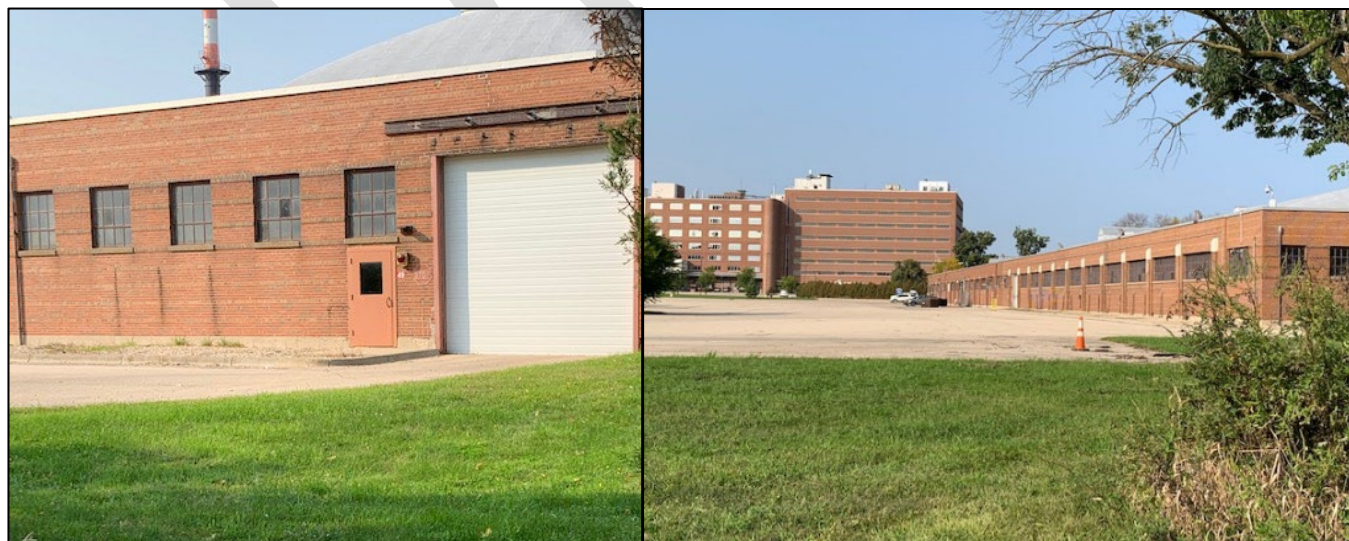
**Figure 8. The south side of the Bodgery building adjacent to the former 1,2-DCA tank site**

- 1) Deed restrictions that require a surface barrier over the remaining soil contamination in order to prevent contamination from impacting human health through direct contact and to prevent contamination from impacting groundwater due to the infiltration of precipitation. The deed restriction also requires the property owner to investigate the degree and extent of residual contamination that is currently inaccessible if and when structural impediments that currently exist on the property are removed.
- 2) If contamination remains, all current and future owners and occupants of the property need to be aware that excavation of the contaminated soil may pose an inhalation or other direct contact

hazard at the time of excavation. Special precautions may need to be taken during excavation activities to prevent a direct contact health threat to humans.

As part of the deed restriction, the pavement barrier is required to be inspected annually and documentation kept noting said annual inspection. **Therefore, these sites have no apparent public health hazard at this time.** Future changes that impact or remove the existing barriers would require DNR approval, which would include an evaluation of potential health hazards by DHS.

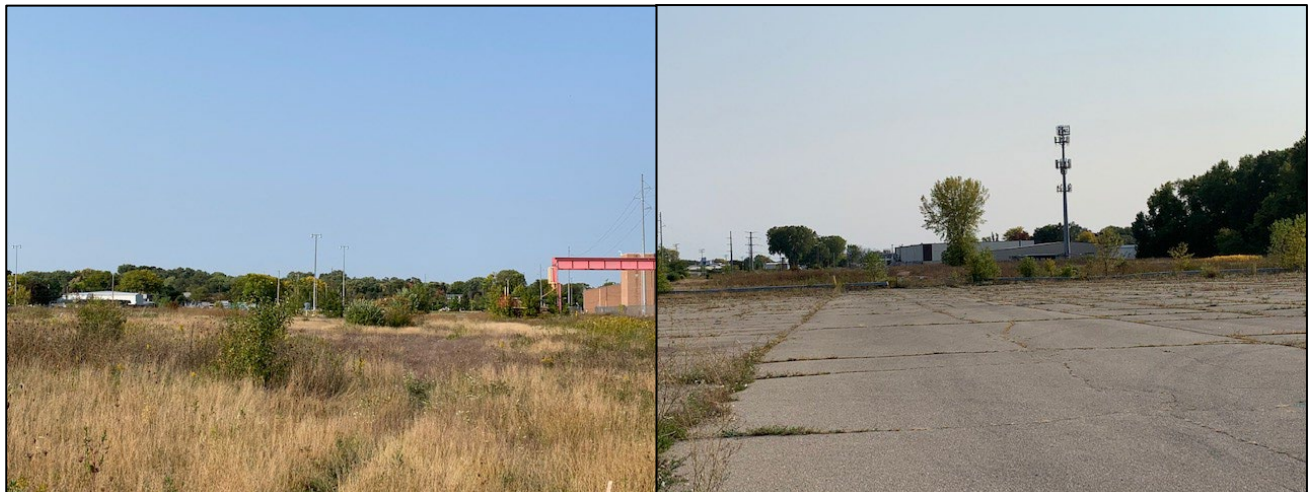
**Figure 10. Hartmeyer site looking South to North (left photo) and looking north to South (right photo).**

Closed site #2, located within the Hartmeyer property, had residual fuel oil petroleum contamination originating from the distribution lines associated with the aboveground storage tank area located on the Hartmeyer property. These tanks have been removed and no indication of them can be seen on the Hartmeyer Site (Figures 10 and 11). The Wisconsin & Southern Railroad at the time was considered an adjoining property that was impacted by the contamination and they were notified. In 2006, the extent of the plume on the site was well defined and limited to the general area as defined by Figure 14. Because Closed Site #2 is part of the Hartmeyer property, we considered information from the 2019 investigation as well as the data from Closed Site #2 investigation when evaluating exposure pathways and health risks. For soil concentrations, we used the 2019 values as they were more up to date and distinguished individual compounds (e.g., benzo[a]pyrene). Some past samples were analyzed for “diesel range organic compounds” which is no longer tested for in site investigations since it measures the concentration of a mixture of compounds.

Currently, this site is easily accessible to the general public, is not enclosed by a fence, and there is no signage on the property. It also sits adjacent to businesses with parking lots. The northwestern portion of the site is partially capped with pavement. The site is also covered with dense vegetation (Figure 10 and 11) and there are railroad tracks to the east of the site that would limit access in that direction. As long as these features ensure sub-surface soils remain inaccessible, ingestion or dermal exposure to contaminated soil is unlikely and the exposure pathway for contaminated soil at the site is considered to be incomplete
