Robin Greenway & Orchard Drive Culvert

Habitat Stewardship Subcommittee
City of Madison Engineering Division
May 9, 2023

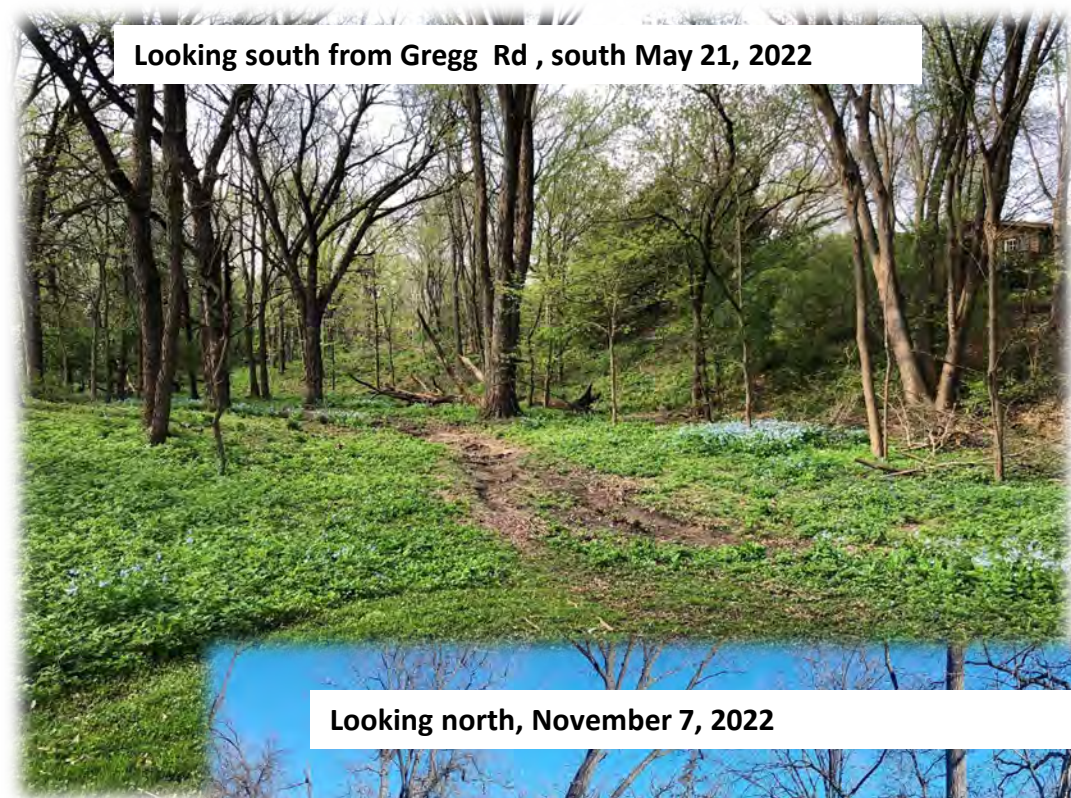
Looking south from Gregg Rd , south May 21, 2022

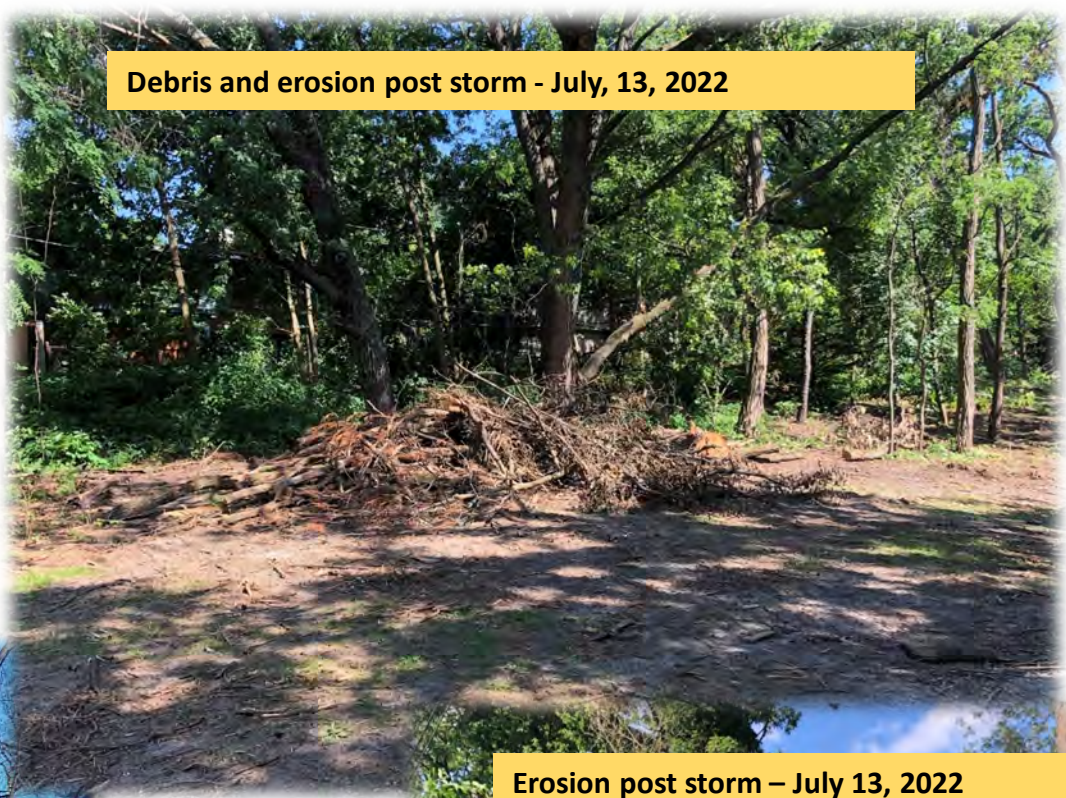
Debris and erosion post storm - July, 13, 2022

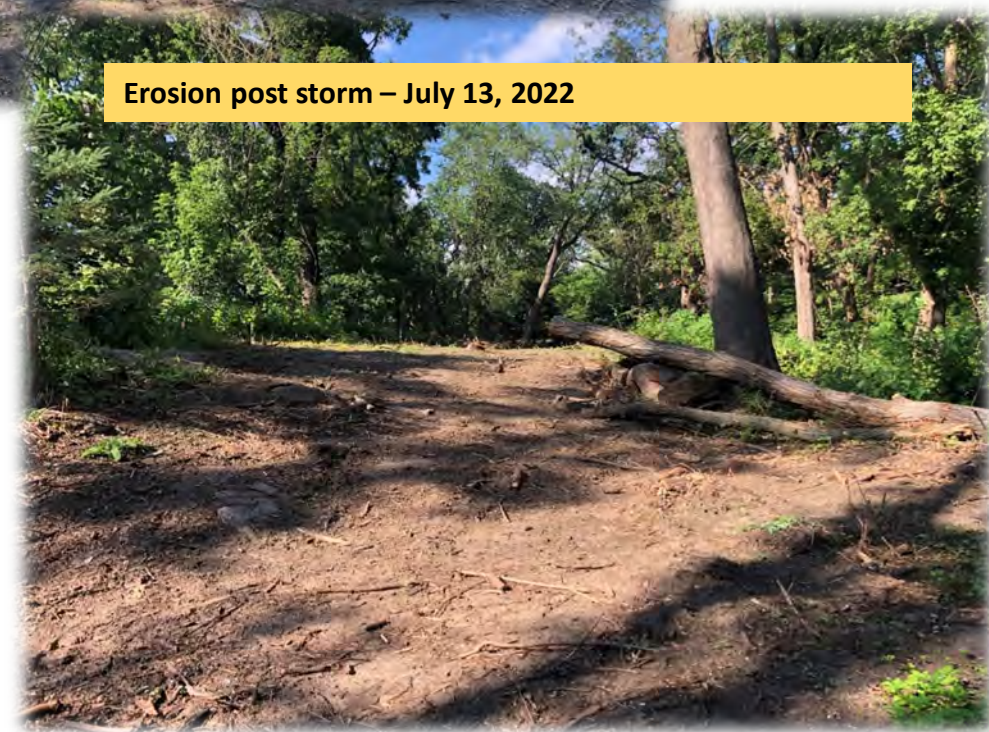
Erosion post storm – July 13, 2022

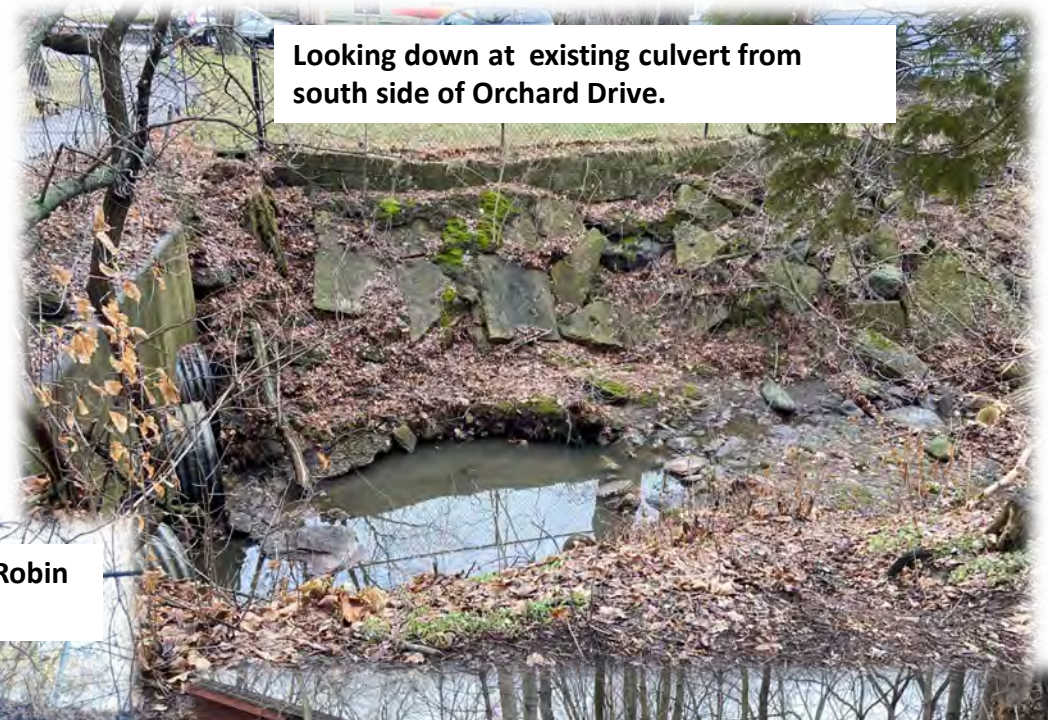
Looking down at existing culvert from south side of Orchard Drive.

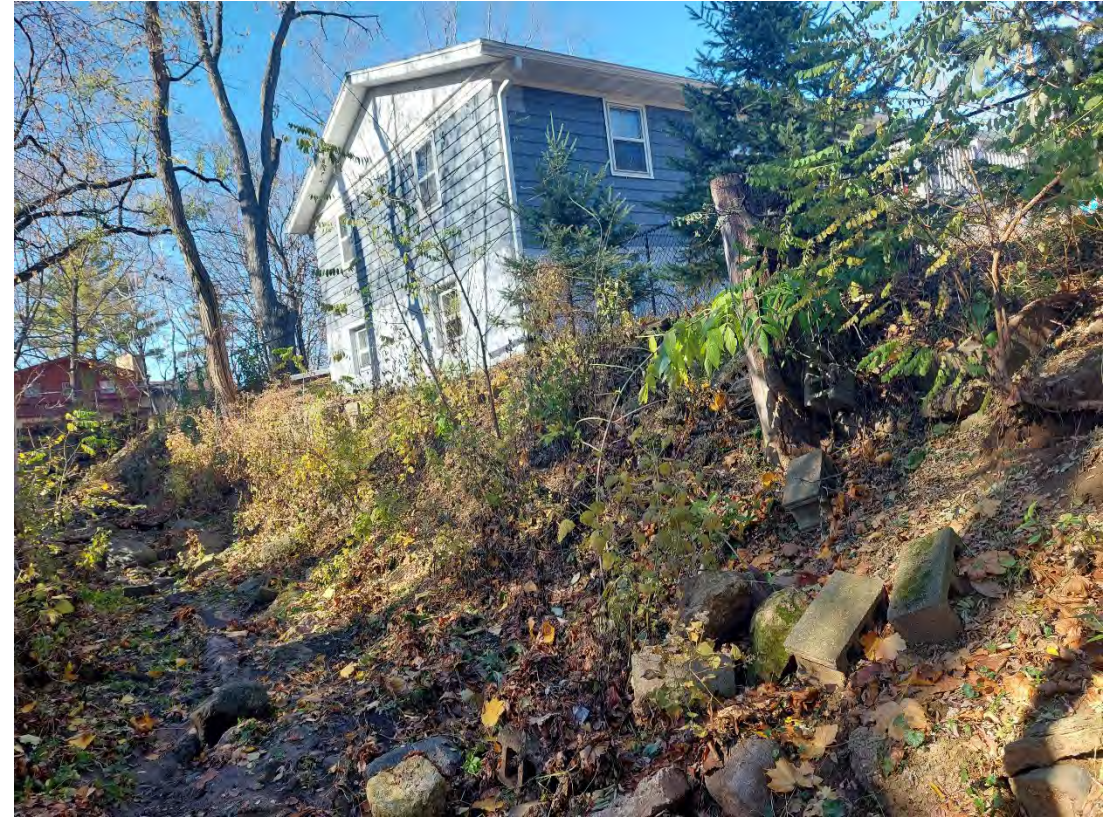
Eroded slope in channel

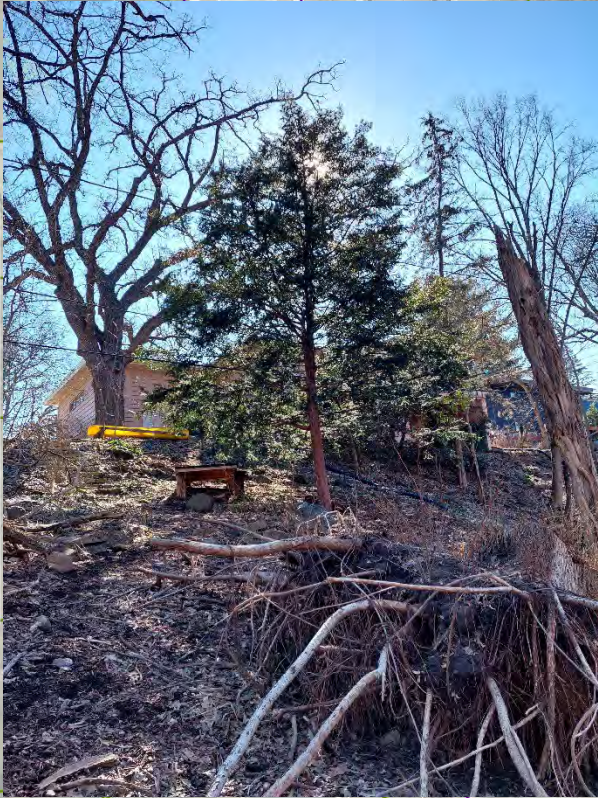
Tree Removals – Power Line Conflicts

Private Property: Will not Remove 8" Diameter Black Locust in Good Condition

Remove: Determined through site visit on 3/24, verified by certified arborist on 3/31 Black Locust in Very Poor Condition

Will not remove: Upright yew 9.5" in Good Condition Touching power lines, upright habit
