Pumpkin Hollow- North

Professionally Assured Wetland Delineation Report

Project Number: DAN21-011-01

Property Address: 4404 Hoepker Road, City of Madison, Dane County, Wisconsin

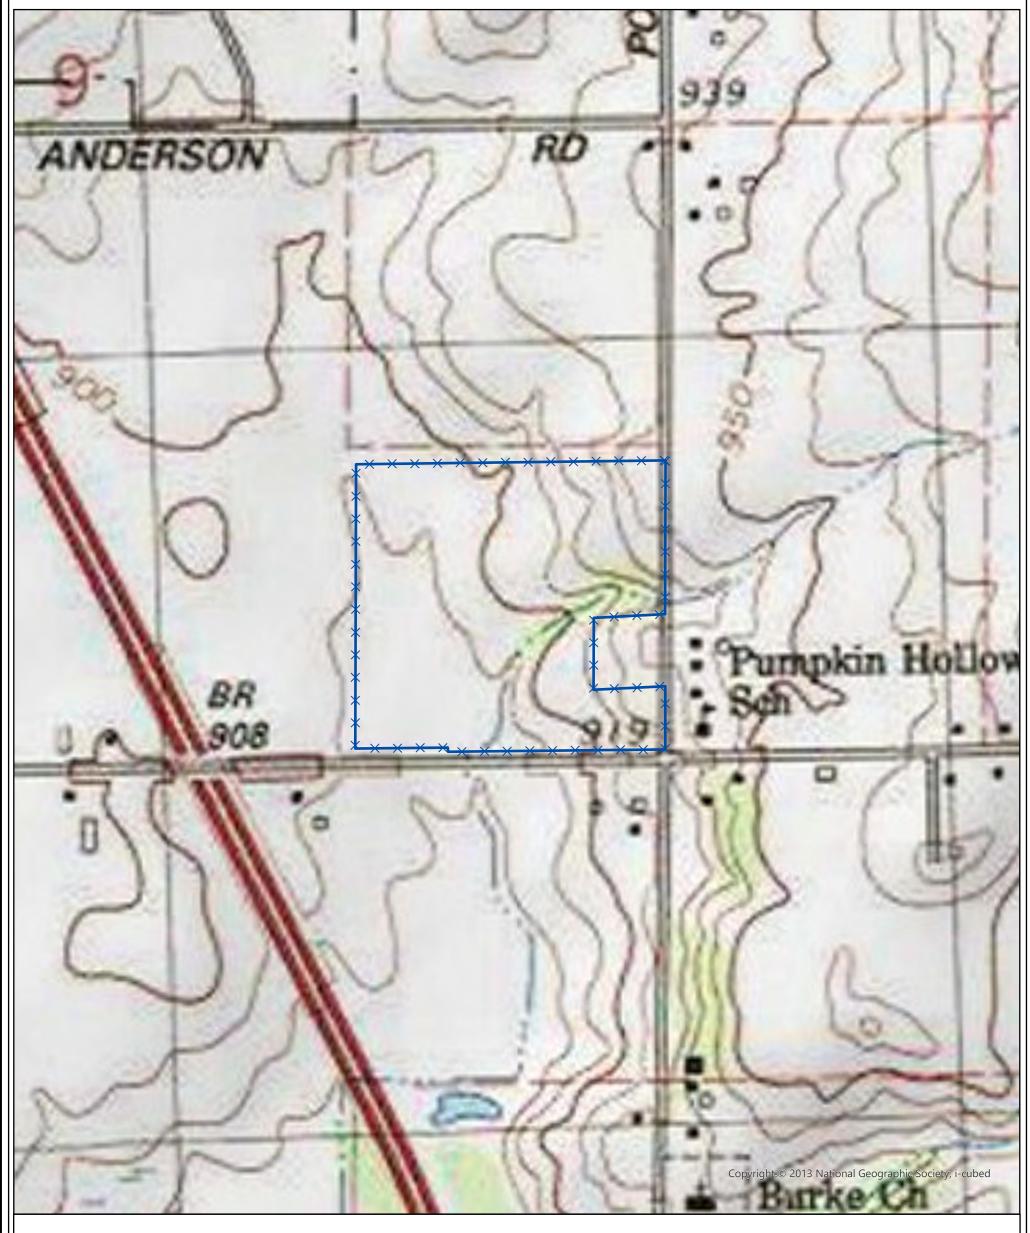
Pumpkin Hollow Properties
Quadrangle Map
4404 Hoepker Road
City of Madison
Dane County, WI

The topography at the Site ranges from an elevation of 941 feet down to 882 feet. The topography of the Site slopes towards the ditch in the southeast corner of the study area. The Topographic Map is in Appendix A.

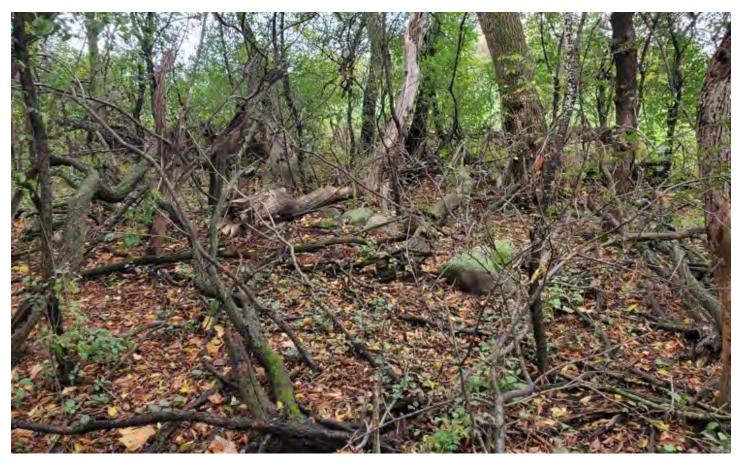
T1A was placed on a rocky forested hillslope. The soil was observed to a depth of 24 inches. Wetland hydrology and hydric soils were not present at this sample point; therefore, this sample point does not meet wetland criteria.

Dominant vegetation observed in T1A included boxelder maple (*Acer negundo*, FAC), common buckthorn (*Rhamnus cathartica*, FAC), and riverbank grape (*Vitis riparia*, FAC).

1- Standing near T1A.

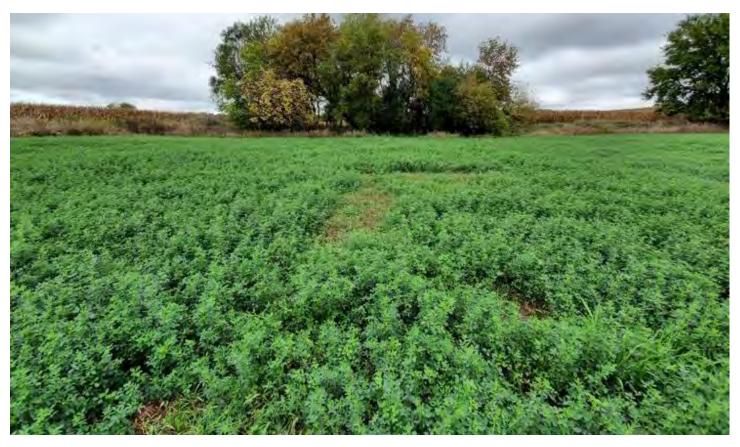
T2A was placed on a shallow hillslope within an alfalfa field. This area has been a historic grassed swale constructed for erosion control. The soil was observed to a depth of 24 inches. Wetland hydrology, hydrophytic vegetation, and hydric soils were not present at this sample point, therefore this sample point does not meet wetland criteria.

Dominant vegetation observed in T2A included common crabgrass (*Digitaria sanguinalis*, FACU) and barnyard grass (*Echinochloa crus-galli, FAC*). The adjacent vegetation at the field edge just off-site upslope is brome grass and boxelder. Due to lack of hydric soil and hydrology indicators, one would expect upland vegetation to dominate under normal circumstances.

2- Standing near T2A facing north.

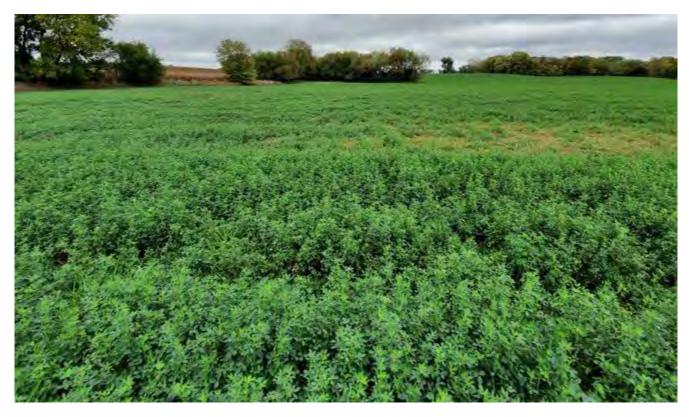
3- Standing near T2A.

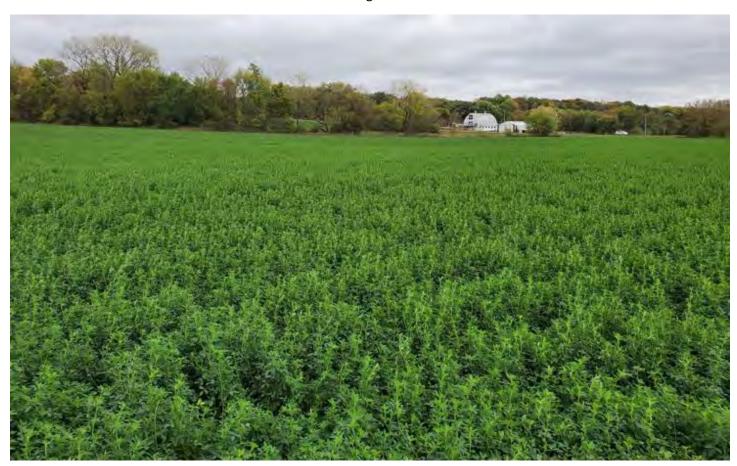
T3A was placed on a hillslope within an alfalfa field. The soil was observed to a depth of 24 inches. Wetland hydrology, hydrophytic vegetation, and hydric soils were not present at this sample point, therefore this sample point does not meet wetland criteria.

4- Standing near T3A facing southeast.

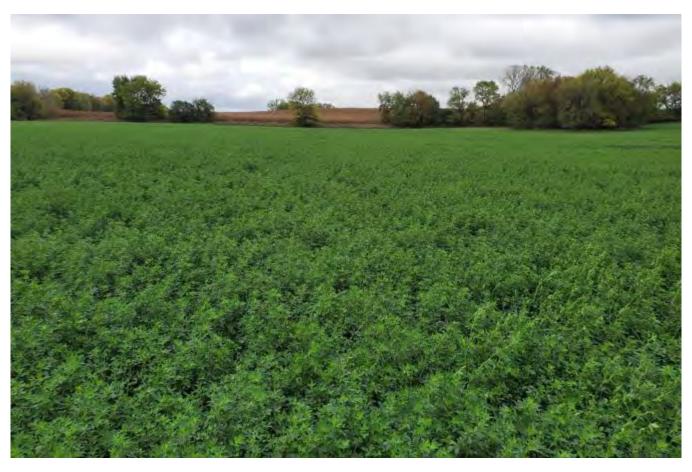
5- Standing near T3A.

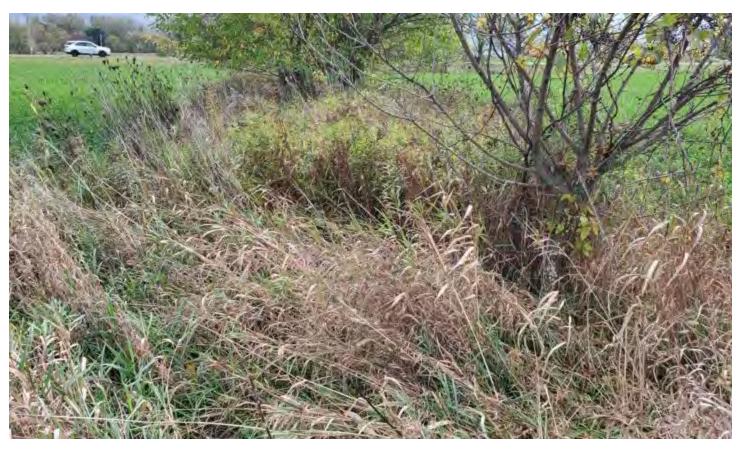
T4A was placed in a wide grassed swale within a hillslope that is flanked by an alfalfa field. The soil was observed to a depth of 24 inches. Wetland hydrology, hydrophytic vegetation, and hydric soils were not present at this sample point, therefore this sample point does not meet wetland criteria.

Dominant vegetation observed in T4A included boxelder maple (*Acer negundo*, FAC) and smooth brome grass (*Bromus inermis*, FAC).

6- Standing near T4A facing south.

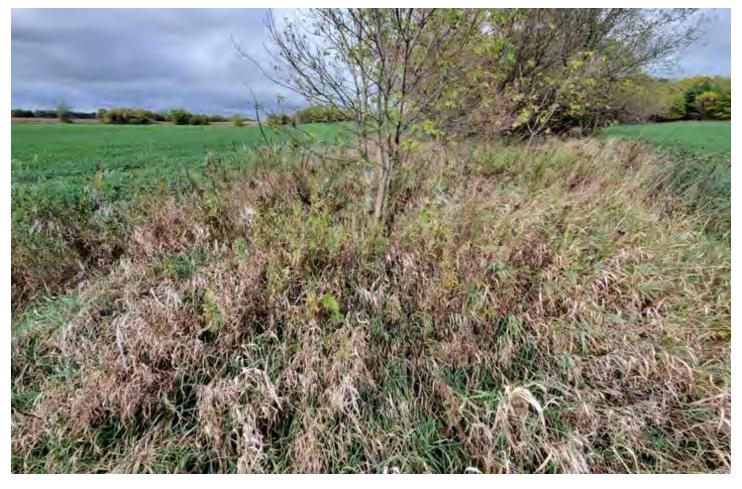
7- Standing near T4A facing north.

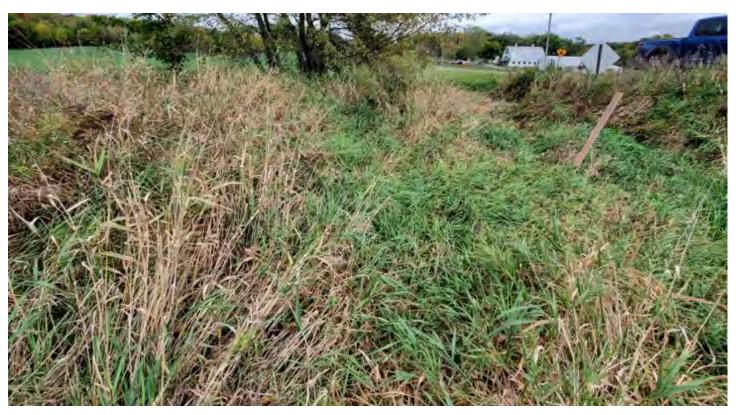
8- Standing near T4A facing east.

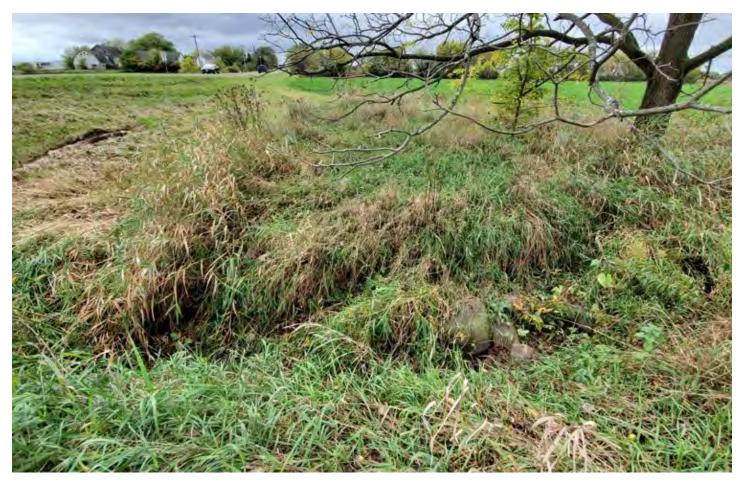
T5A was placed in a depression adjacent to the road and a narrow ditch that runs throughout the study area. The soil was observed to a depth of 24 inches. The area is drained by the adjacent narrow ditch, the ditch started a few feet away from the test point, dry and rocky. Wetland hydrology, hydrophytic vegetation, and hydric soils were not present at this sample point, therefore this sample point does not meet wetland criteria.

Dominant vegetation observed in T5A included boxelder maple (*Acer negundo*, FAC) and smooth brome grass (*Bromus inermis*, FAC), black walnut (*Juglans nigra*, FACU), and reed canary grass (*Phalaris arundinacea*, FACW).

9- Standing near T5A facing west.

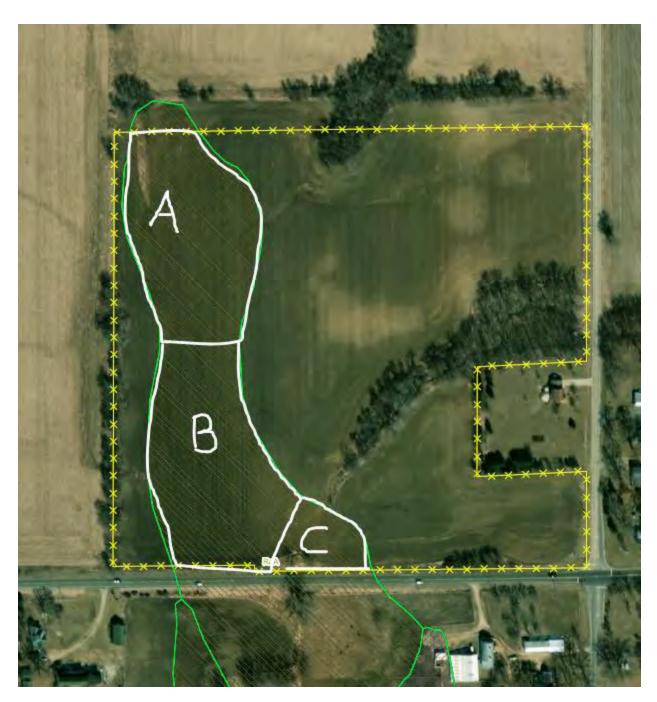
Review Areas

A hydrology assessment was completed as the Site has been cropland historically. Three areas were reviewed for wet signature based on soils and topography. Area A was the only area that required a review in the field. All the signature in Area A was related to a grassed swale, that was avoided during planting for erosion control purposes. There was no hydric soil or other indicators observed, therefore Area A was determined to not have any wetlands present. The complete review of the Historic Aerial Photographs and Hydrology Assessment is in Appendix D.

roject Nam	e: Pumpkin Hollow	North	Date:	Date: Oct 2021 County: DANE						
nvestigator	: Chad Fradette		Legal Description (Sec, T, R): Sec 9, T8N, R10E							
Year Image Source	Image	Climate Condition (wet, dry,			ydrology indicato		e.g. crop stres	s, drowned ou	ut, standing wa	iter, etc.)
		normal)	А	В	С	D	Е	F	G	Н
1979	FSA	D	AV**	NV	NV	**Avoidance	in area is likely	a planted gra	assed swale.	
1981	FSA	N	AV**	NV	NV					
1982	FSA	N	NV	NV	AV					
1983	FSA	N	AV**	NV	NSS					
1984	FSA	W	AV**	NV	DISTURBANCE					
1985	FSA	D	AV**	NV	NV					
1986	FSA	N	NV	NV	NV					
1987	FSA	N	NV	NV	NV					
1988	FSA	D	NV	NV	NV					
1989	FSA	D	NV	NV	NV					
1990	FSA	N	AV**	NV	NV					
1991	FSA	N	NV	NV	NV					
1992	FSA	D	NV	NV	NV					
1993	FSA	W	AV**	NV	NV					
1994	FSA	N	AV**	NV	NV					
1995	FSA	N	AV**	NV	NV					
1996	FSA	W	AV**	NV	NV					
1998	FSA	N	AV**	NV	NV					
1999	FSA	W	AV**	NSS	NSS/NV					
2000	FSA	W	AV**	NV	DISTURBANCE					
2001	FSA	W	AV**	NV	NV
