### **RE: Sesquicentennial Markers Replacement**

# Sesquicentennial Markers Condition Review

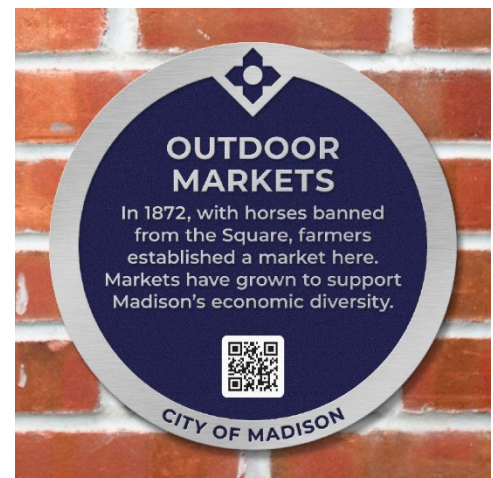
#### Draft Design Example of new Historic Marker

(Wording subject to change after consultation with Stakeholders)

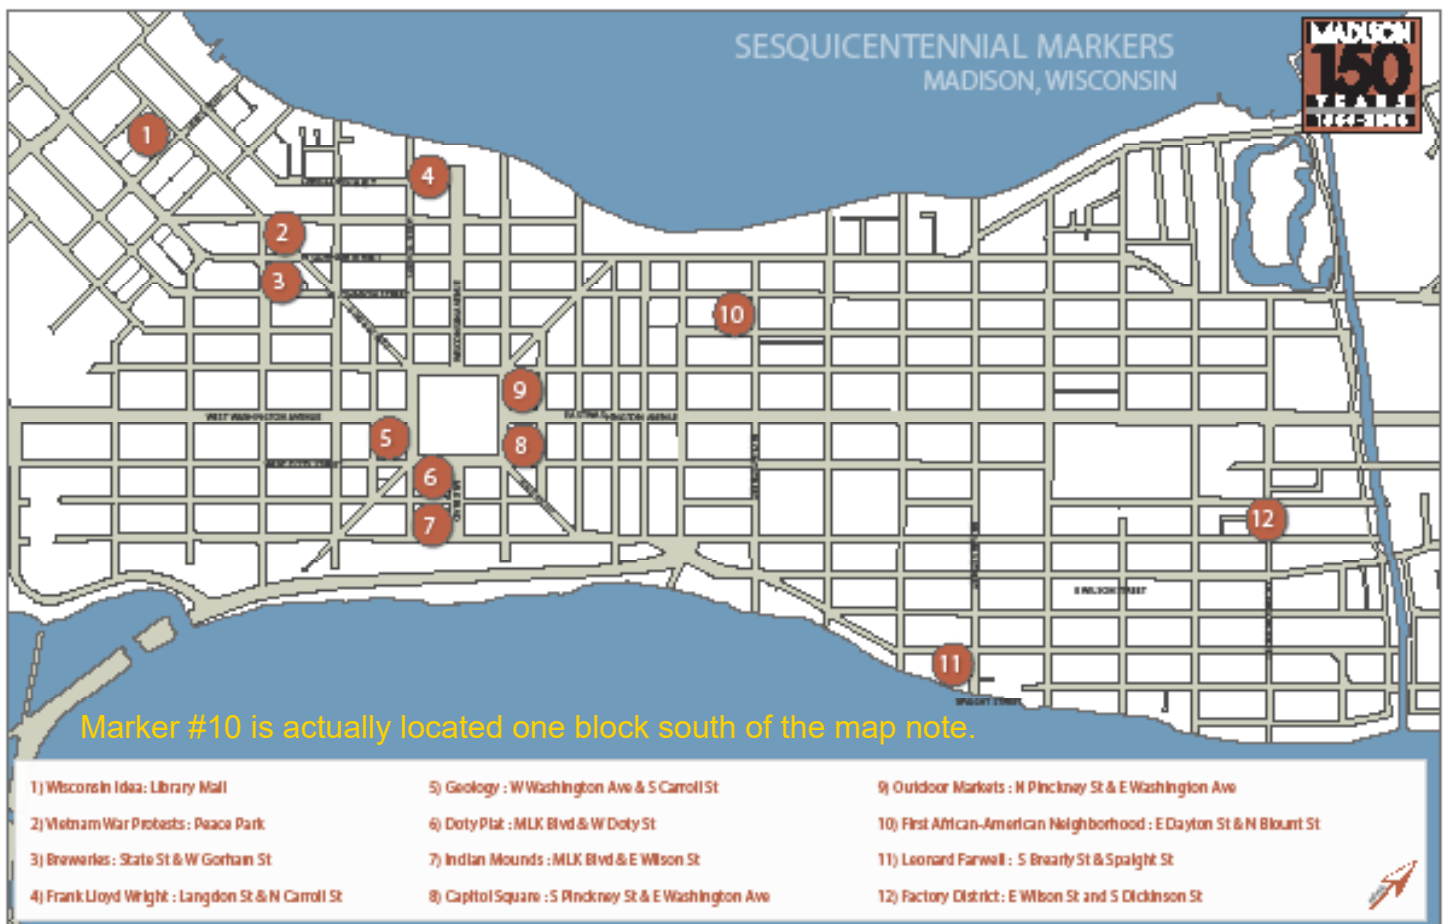
As part of the celebration of the Sesquicentennial of the City of Madison, 12 historical markers were placed around the downtown and near Eastside giving passersby a glimpse of Madison's past. See map below for locations.

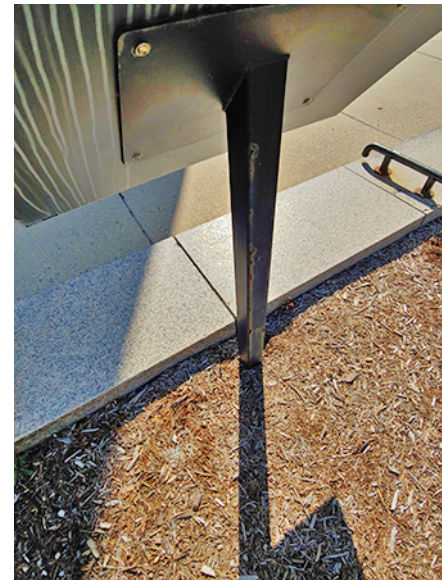
## 1) Wisconsin Idea: Library Mall

The plaque shows minor signs of fading and is wearing around all sides with the top being the most damaged. There is minor chipping across the plaque. It seems like some of the material used in making the plaques has run down the back side. The post has rust on it, but none of it seems severe and the structure of the post seems solid.

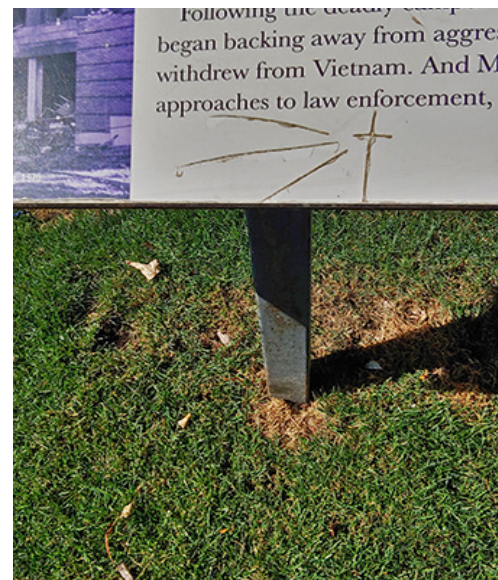
## 2) Vietnam War Protests : Peace Park

The plaque shows minor signs of fading and is wearing around all sides with the the top having the most damaged. There was intentional damage done to the plaque along with other chipping. The post has some rust on it but mostly seems solid.

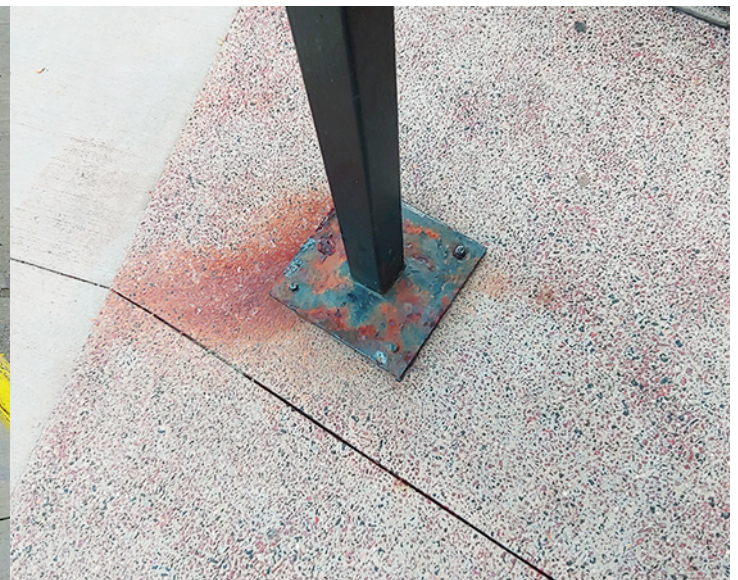
### 3) Breweries : State St & W Gorham St

The plaque shows minor signs of fading and is showing some wear around all sides

The post has a small amount of rust that is mainly one the base. The rust has been leaching onto the sidewalk. The post seems solid.

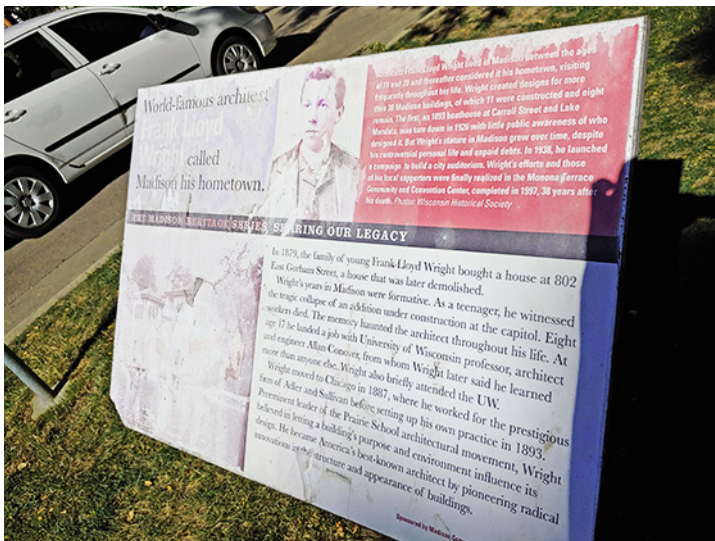
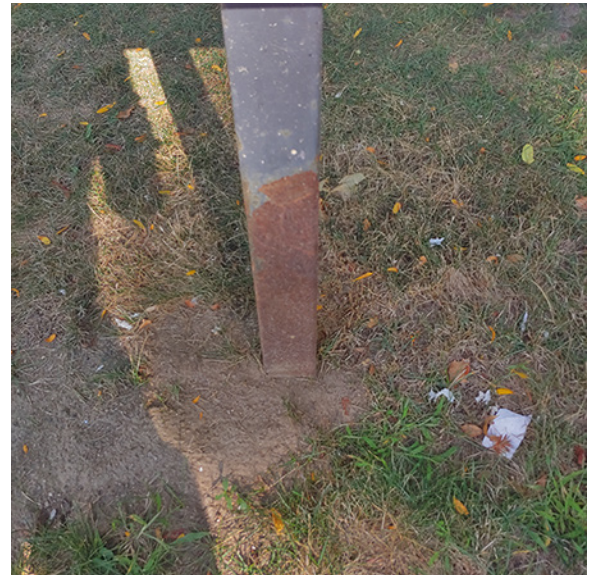
### 4) Frank Lloyd Wright : Langdon St & N Carroll St

The plaque is fading badly and is wearing around all sides with the top showing the most weathering. There is substantial damage across the face of the plaque, including the lower left corner missing, and is generally in poor shape. The post has a large amount of surface rust, but still seems solid.

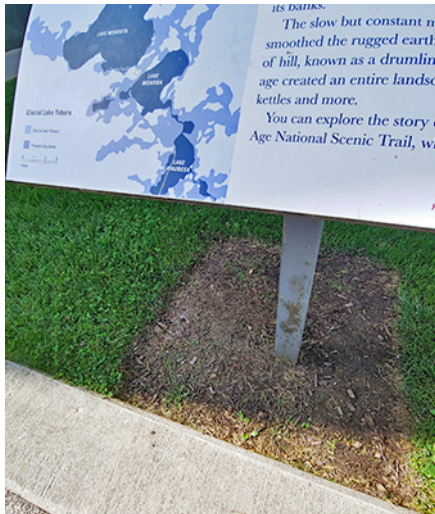
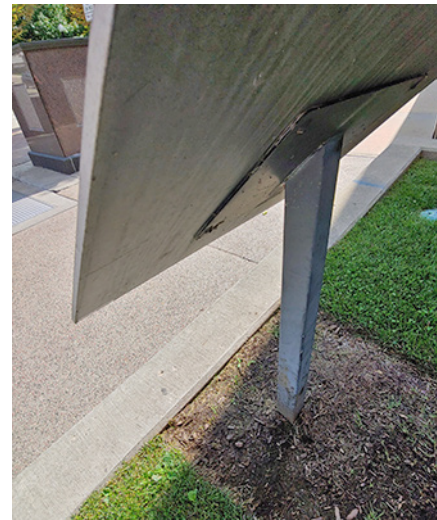
## 5) Geology : W Washington Ave & S Carroll St

The plaque shows minor signs of fading and is wearing around all sides  
The post has a small amount of rust on it but mostly seems solid.

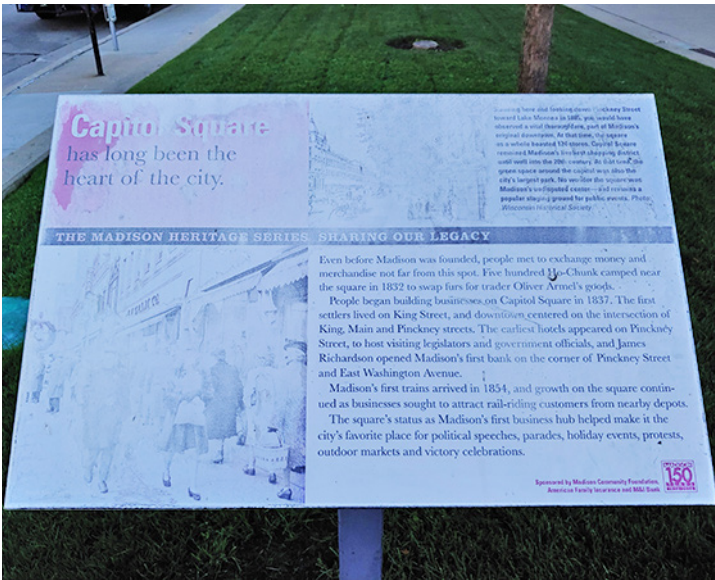
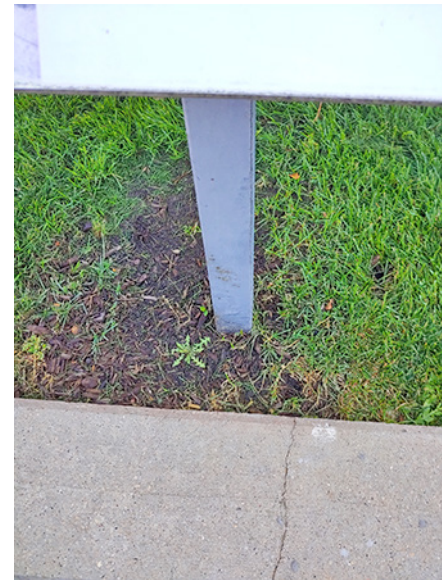
8) Capitol Square : S Pinckney St & E Washington Ave

**Observations**  
 The plaque is fading badly and some wear around all sides. There is some damage across the face of the plaque. The post has a small amount of surface rust, but still seems solid.

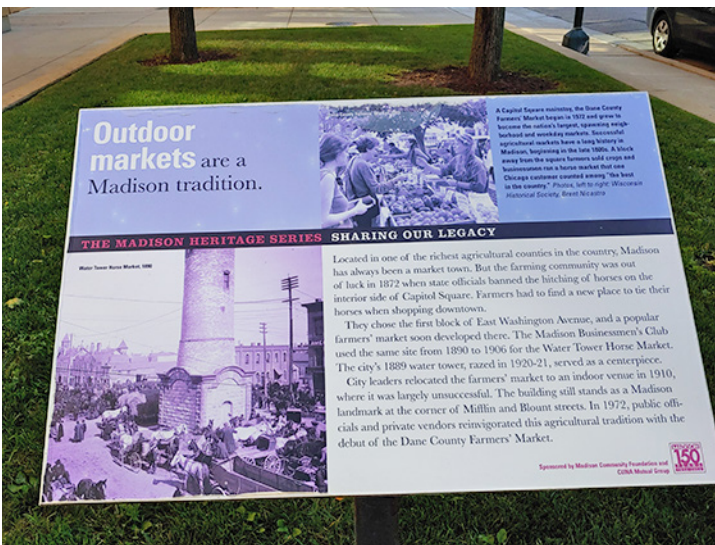
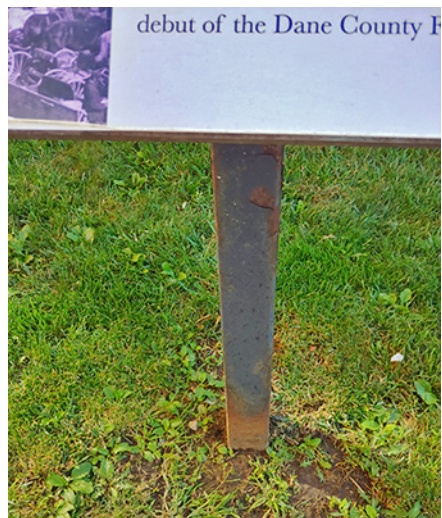
9) Outdoor Markets : N Pinckney St & E Washington Ave

**Observations**  
 The plaque shows minor signs of fading and is wearing around all sides  
 The post has a fair amount of rust on it but mostly seems solid.

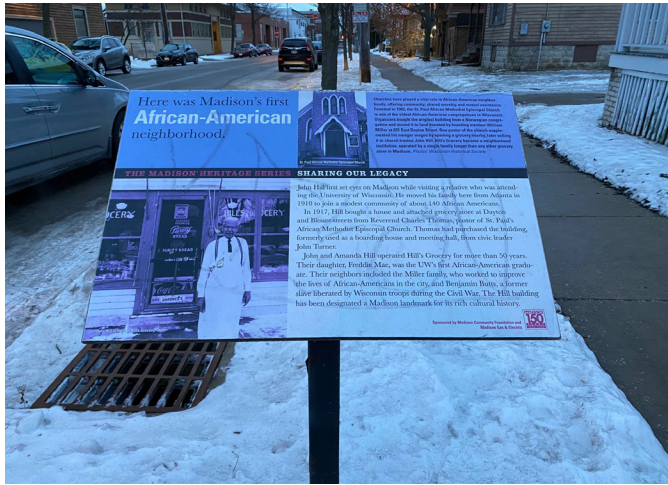
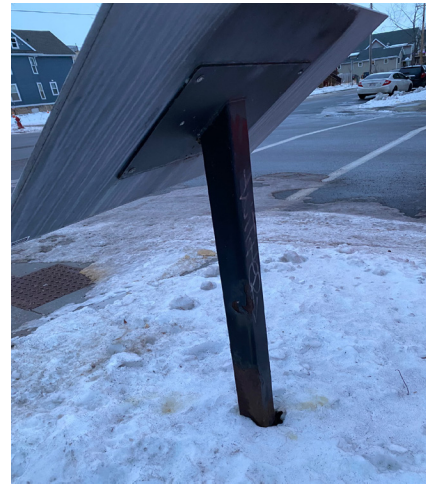
## 10) First African-American Neighborhood : E Mifflin St & N Blount St

Plaque has graffiti, post in similar condition to others.

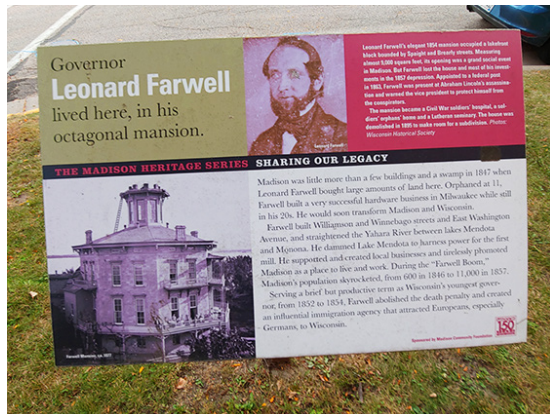
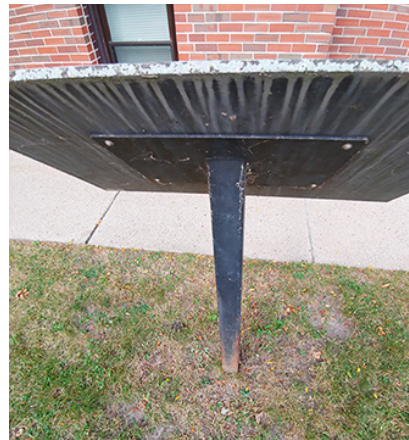
## 11) Leonard Farwell : S Brearly St & Spaight St

The plaques has some fading and is generally in good shape, but seems like some of the material used in making the plaques has run down the back side. The post has some rust, but mostly seems solid.

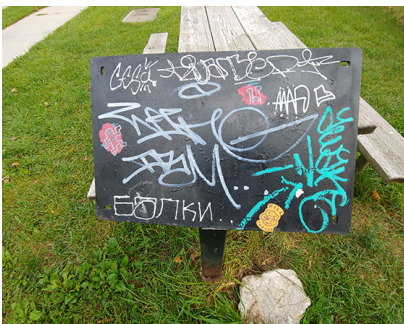
## 12) Factory District : E Wilson St and S Dickinson St

The plaque is gone, the smaller mounting area on the post remains, and has graffiti. The post has some rust, but is generally solid.
