2121 Jefferson St

1007 Edgewood Ave

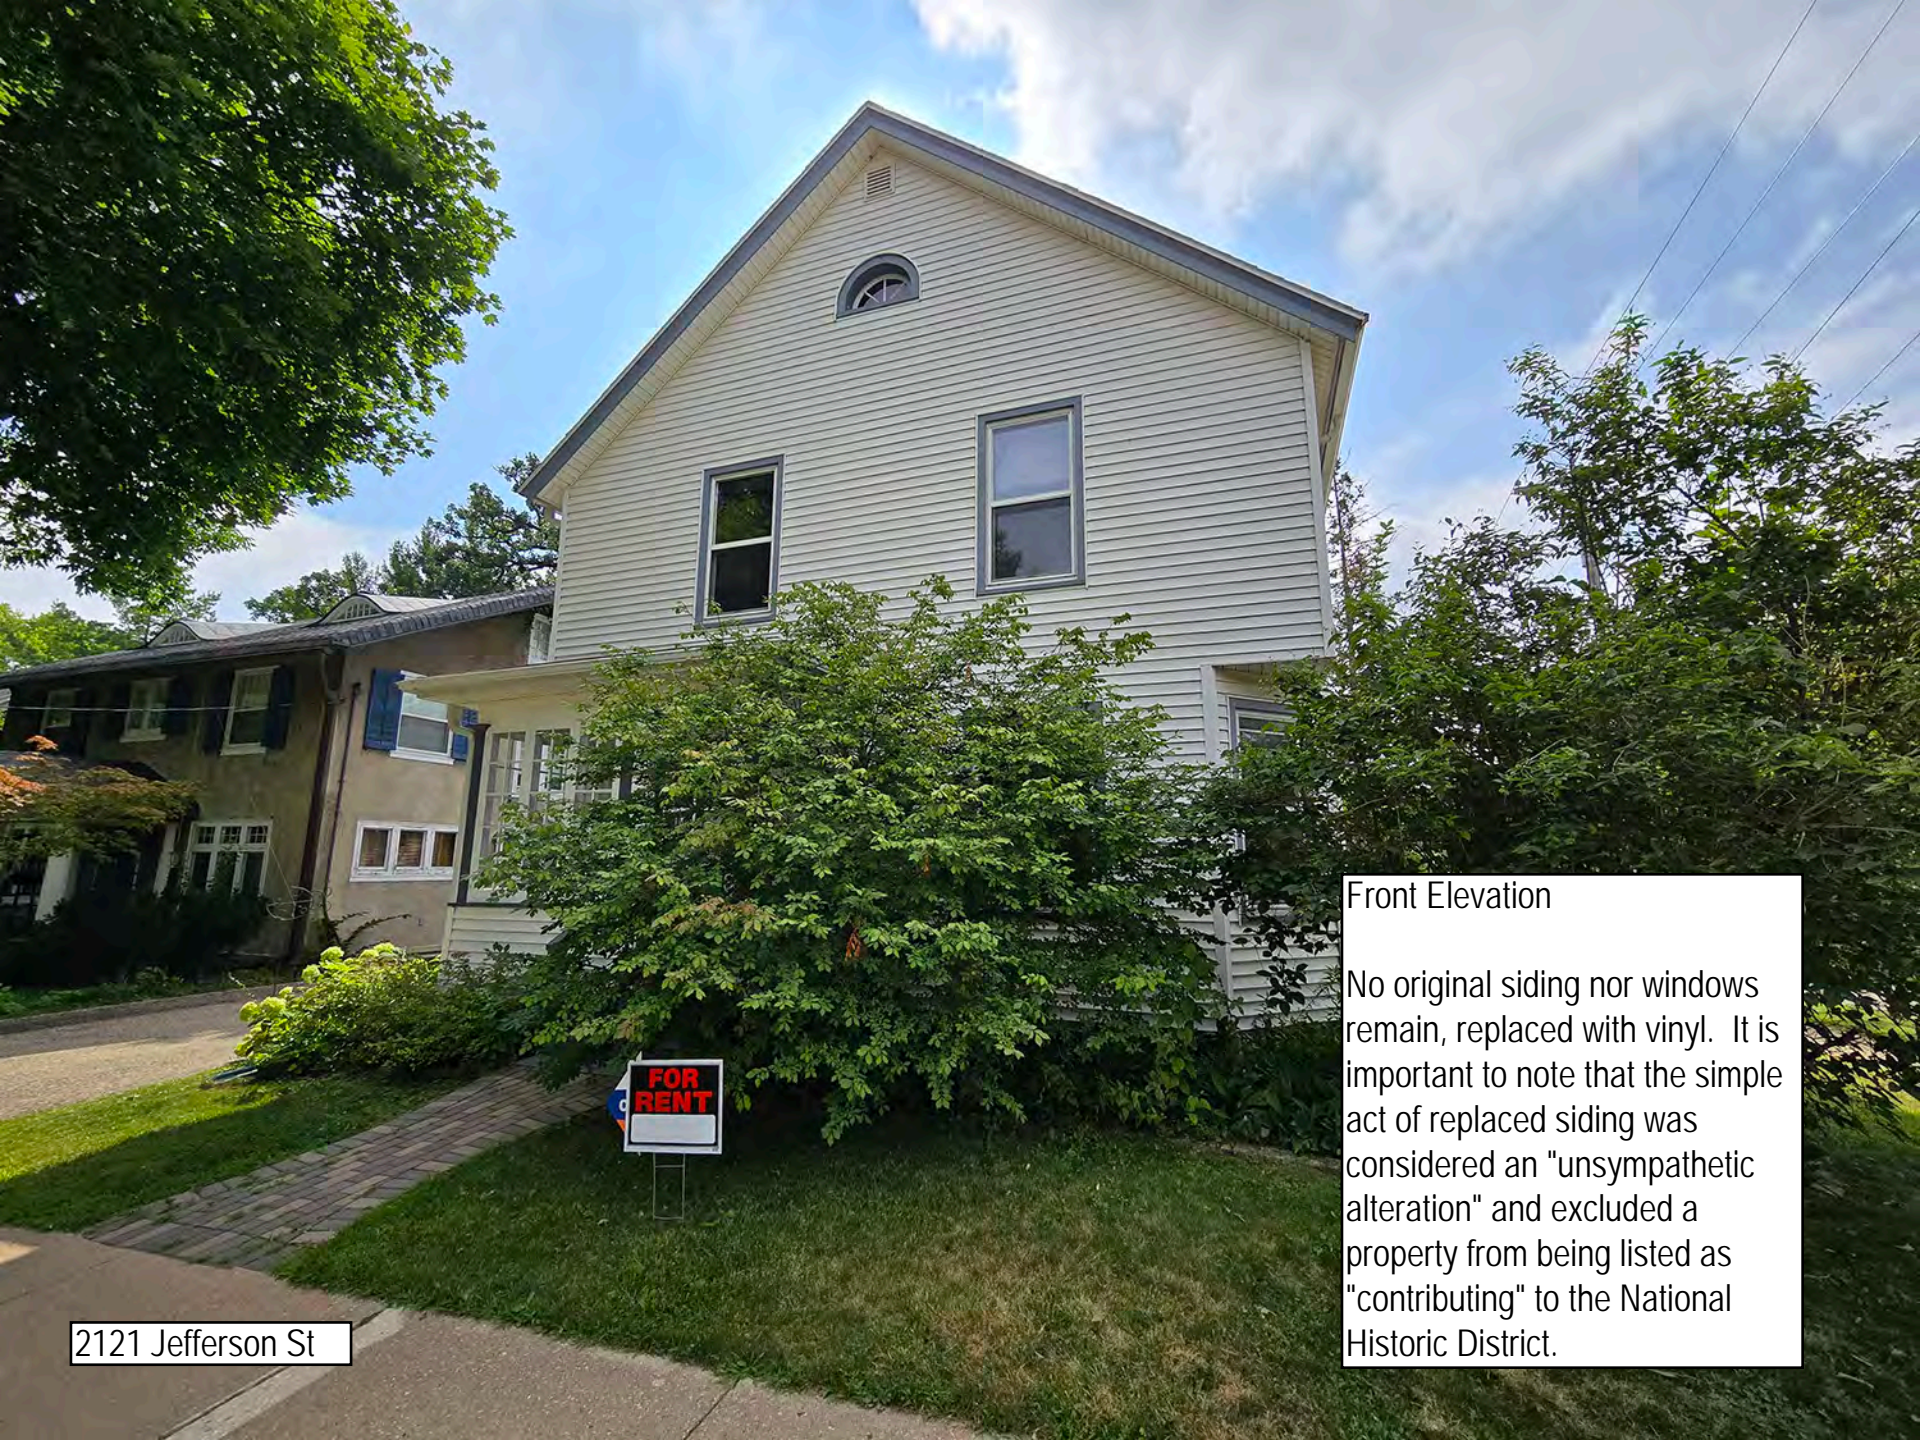
Front Elevation

No original siding nor windows remain, replaced with vinyl. It is important to note that the simple act of replaced siding was considered an "unsympathetic alteration" and excluded a property from being listed as "contributing" to the National Historic District.

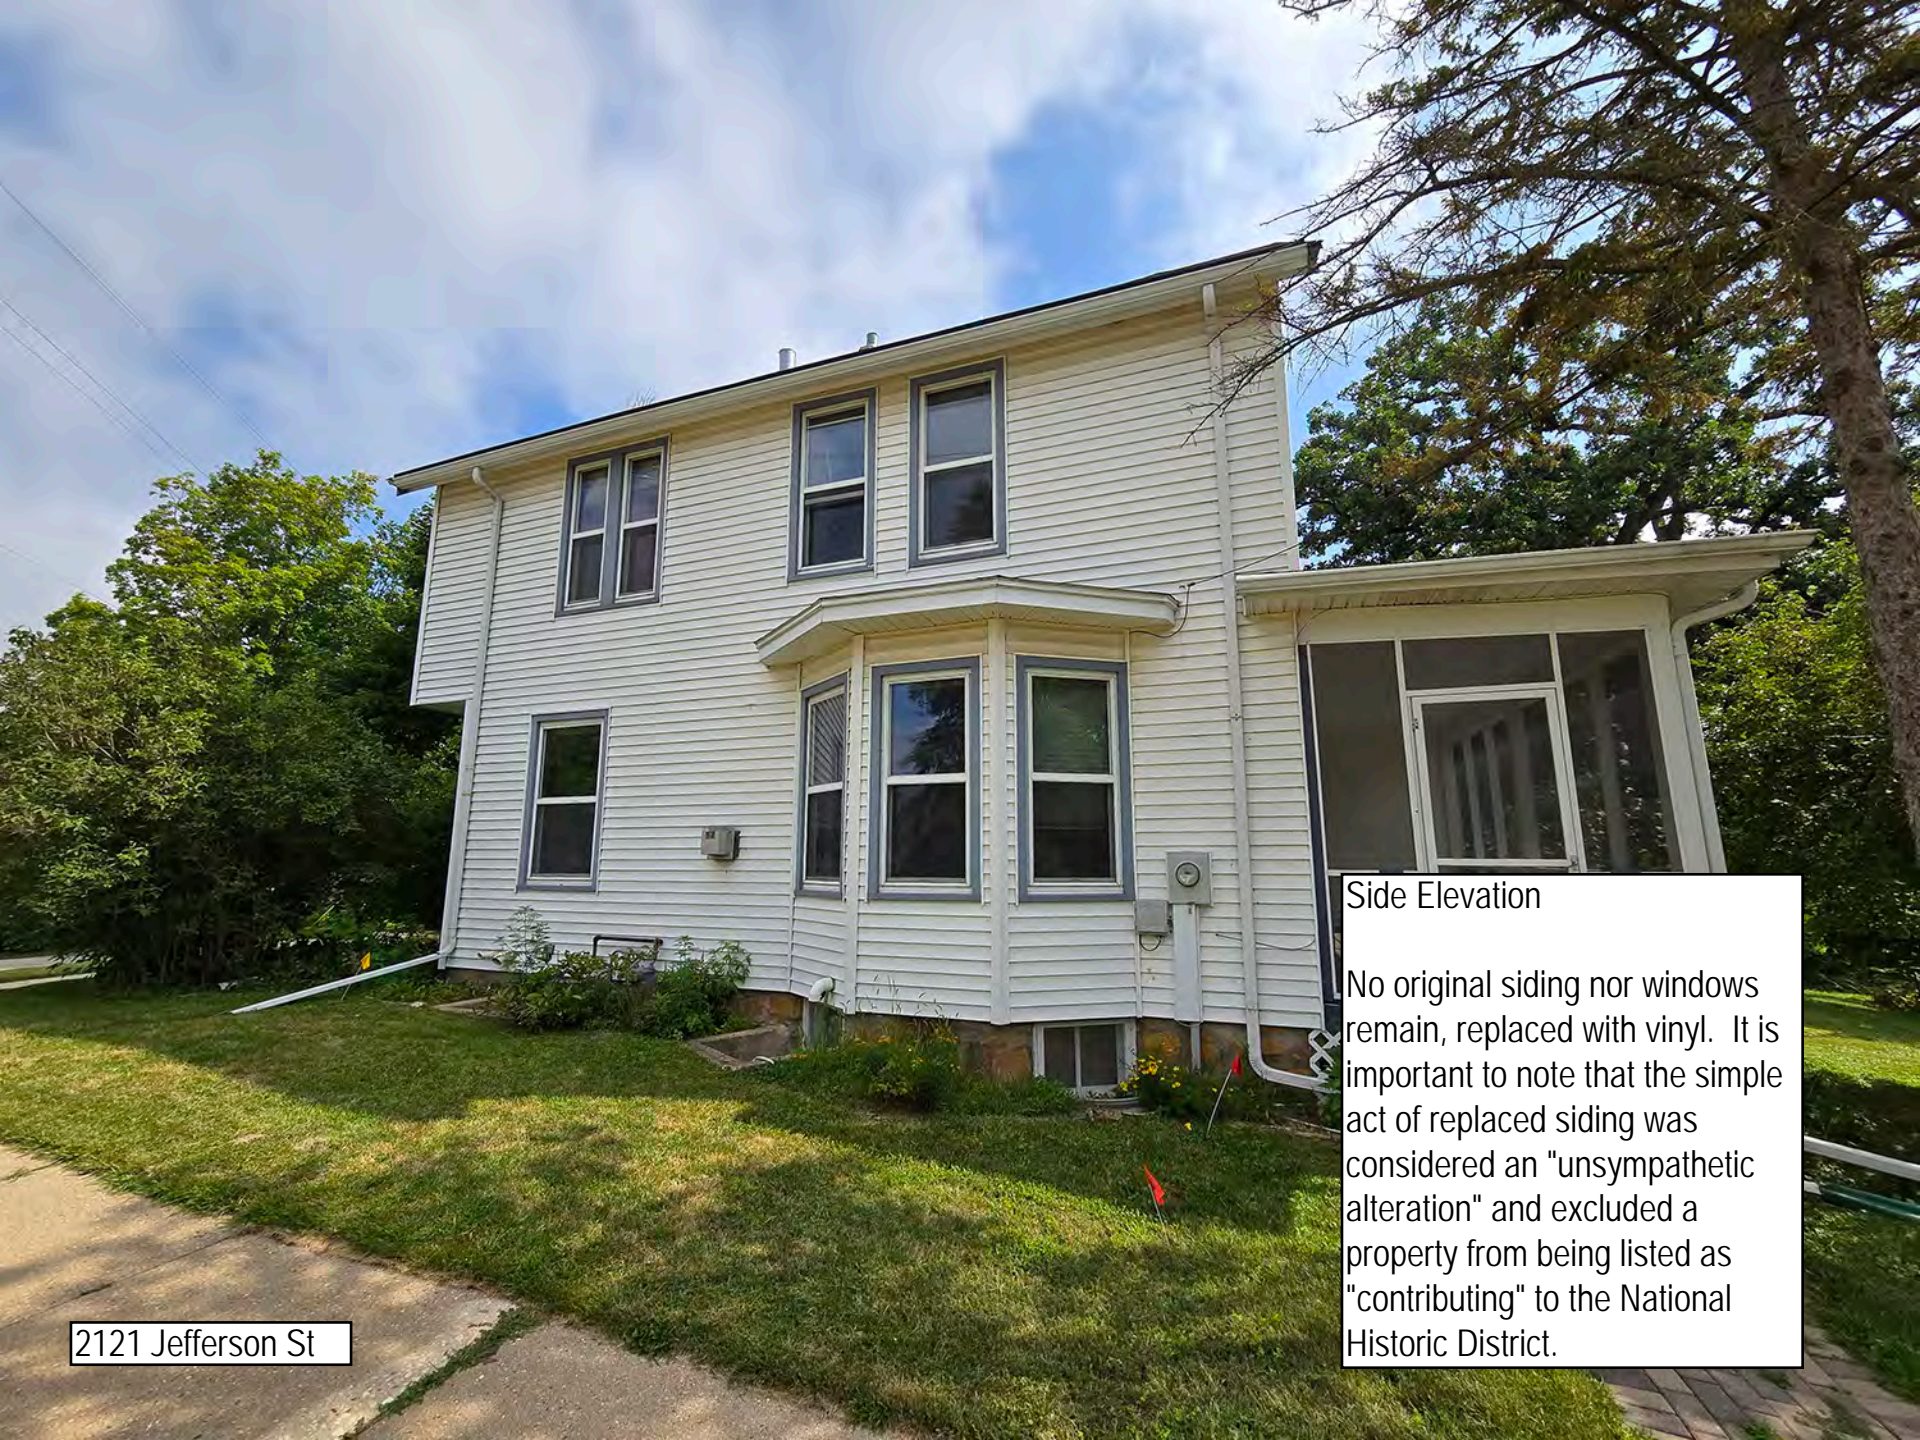
Side Elevation

No original siding nor windows remain, replaced with vinyl. It is important to note that the simple act of replaced siding was considered an "unsympathetic alteration" and excluded a property from being listed as "contributing" to the National Historic District.

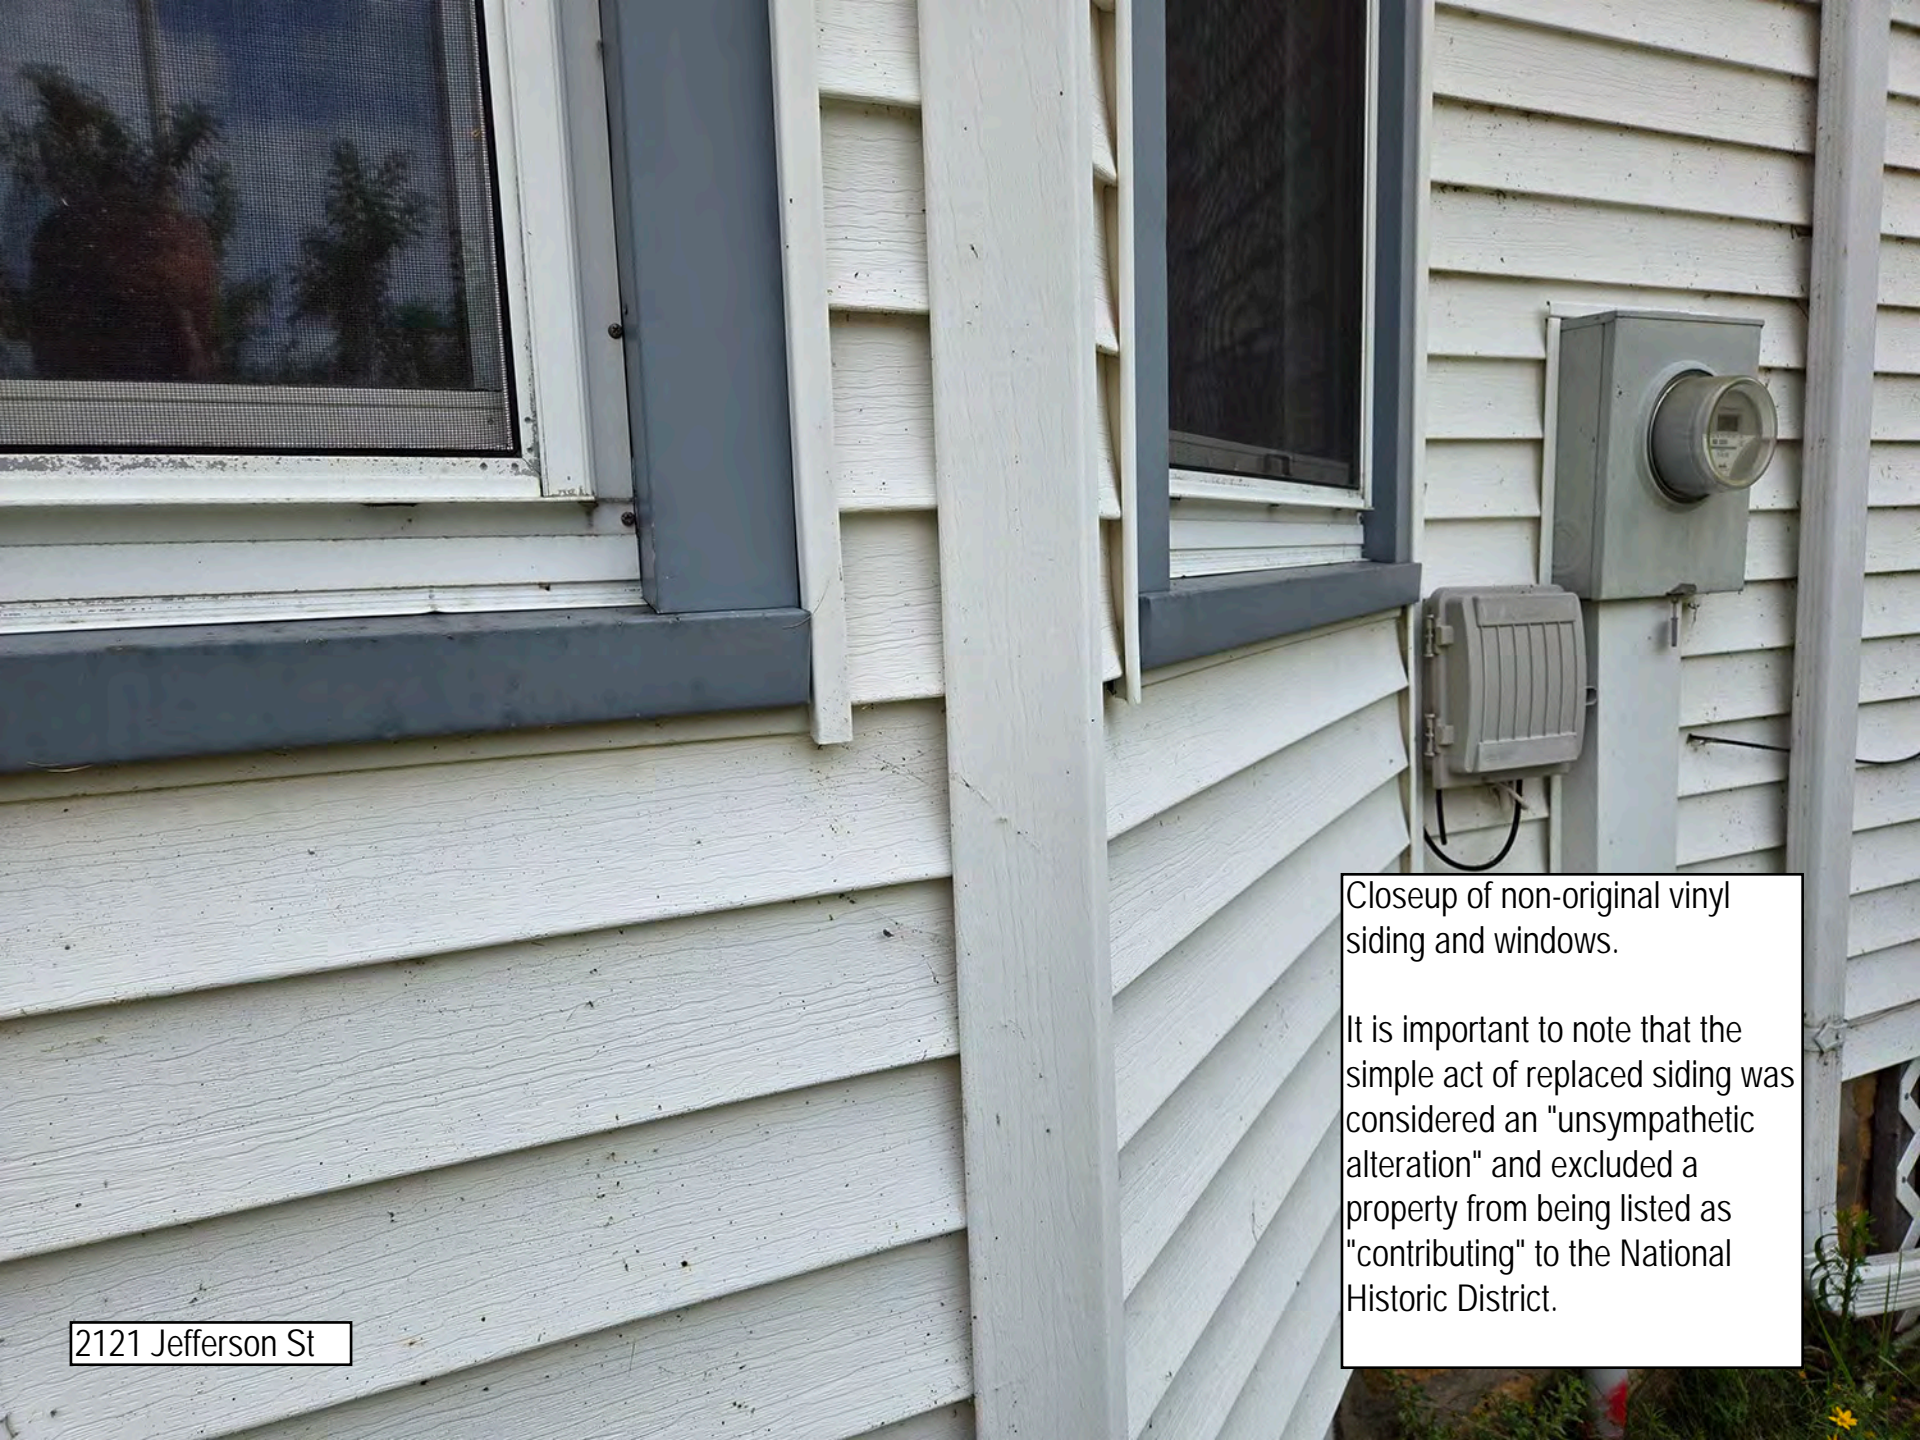
Closeup of non-original vinyl siding and windows.

It is important to note that the simple act of replaced siding was considered an "unsympathetic alteration" and excluded a property from being listed as "contributing" to the National Historic District.

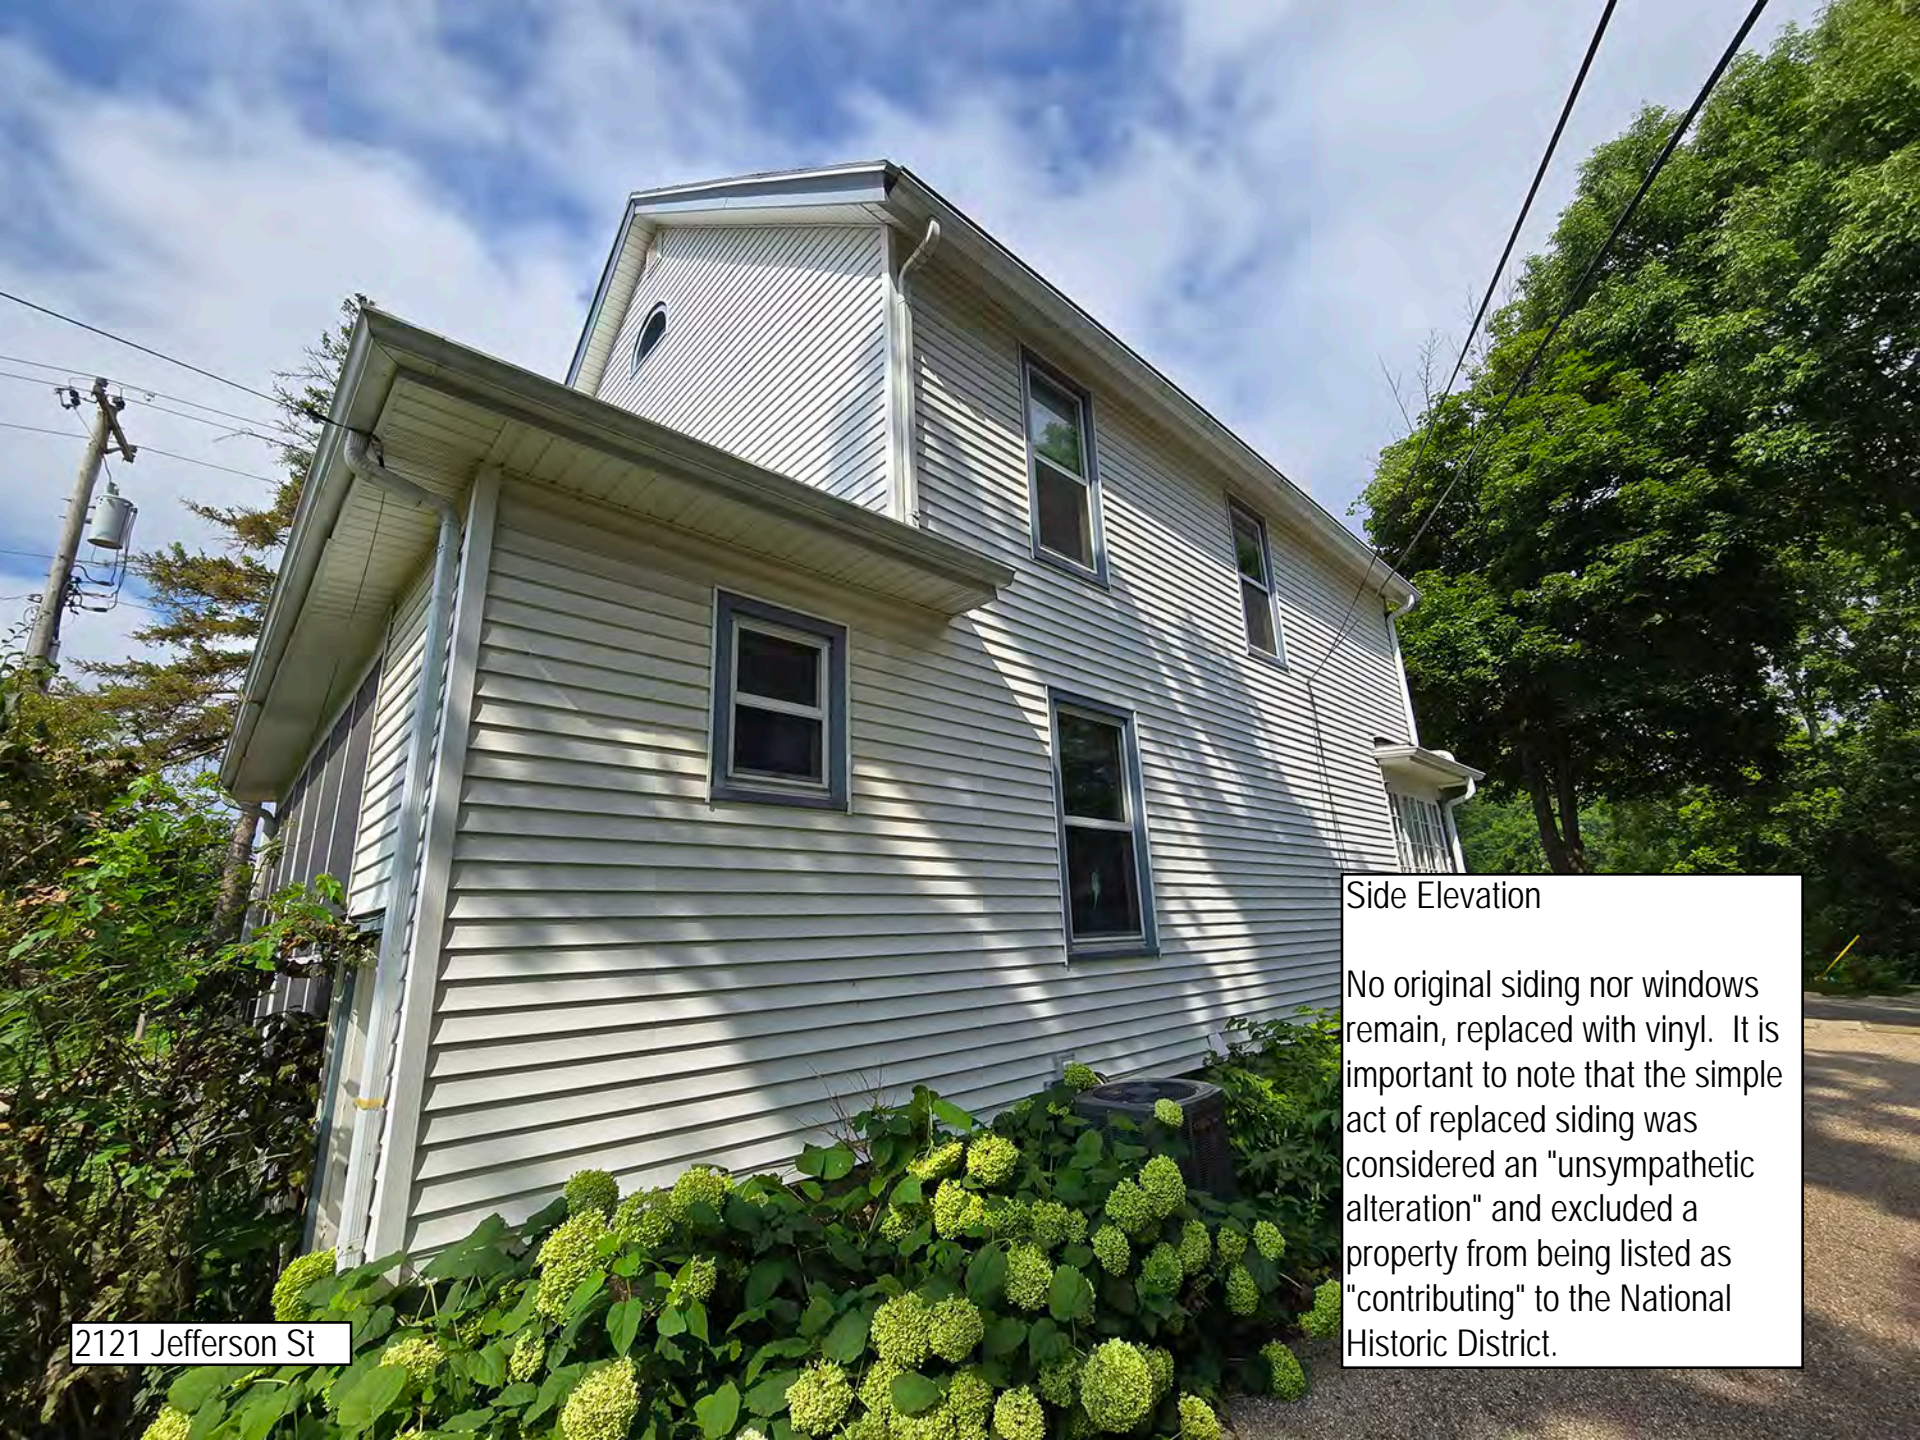
Side Elevation

No original siding nor windows remain, replaced with vinyl. It is important to note that the simple act of replaced siding was considered an "unsympathetic alteration" and excluded a property from being listed as "contributing" to the National Historic District.

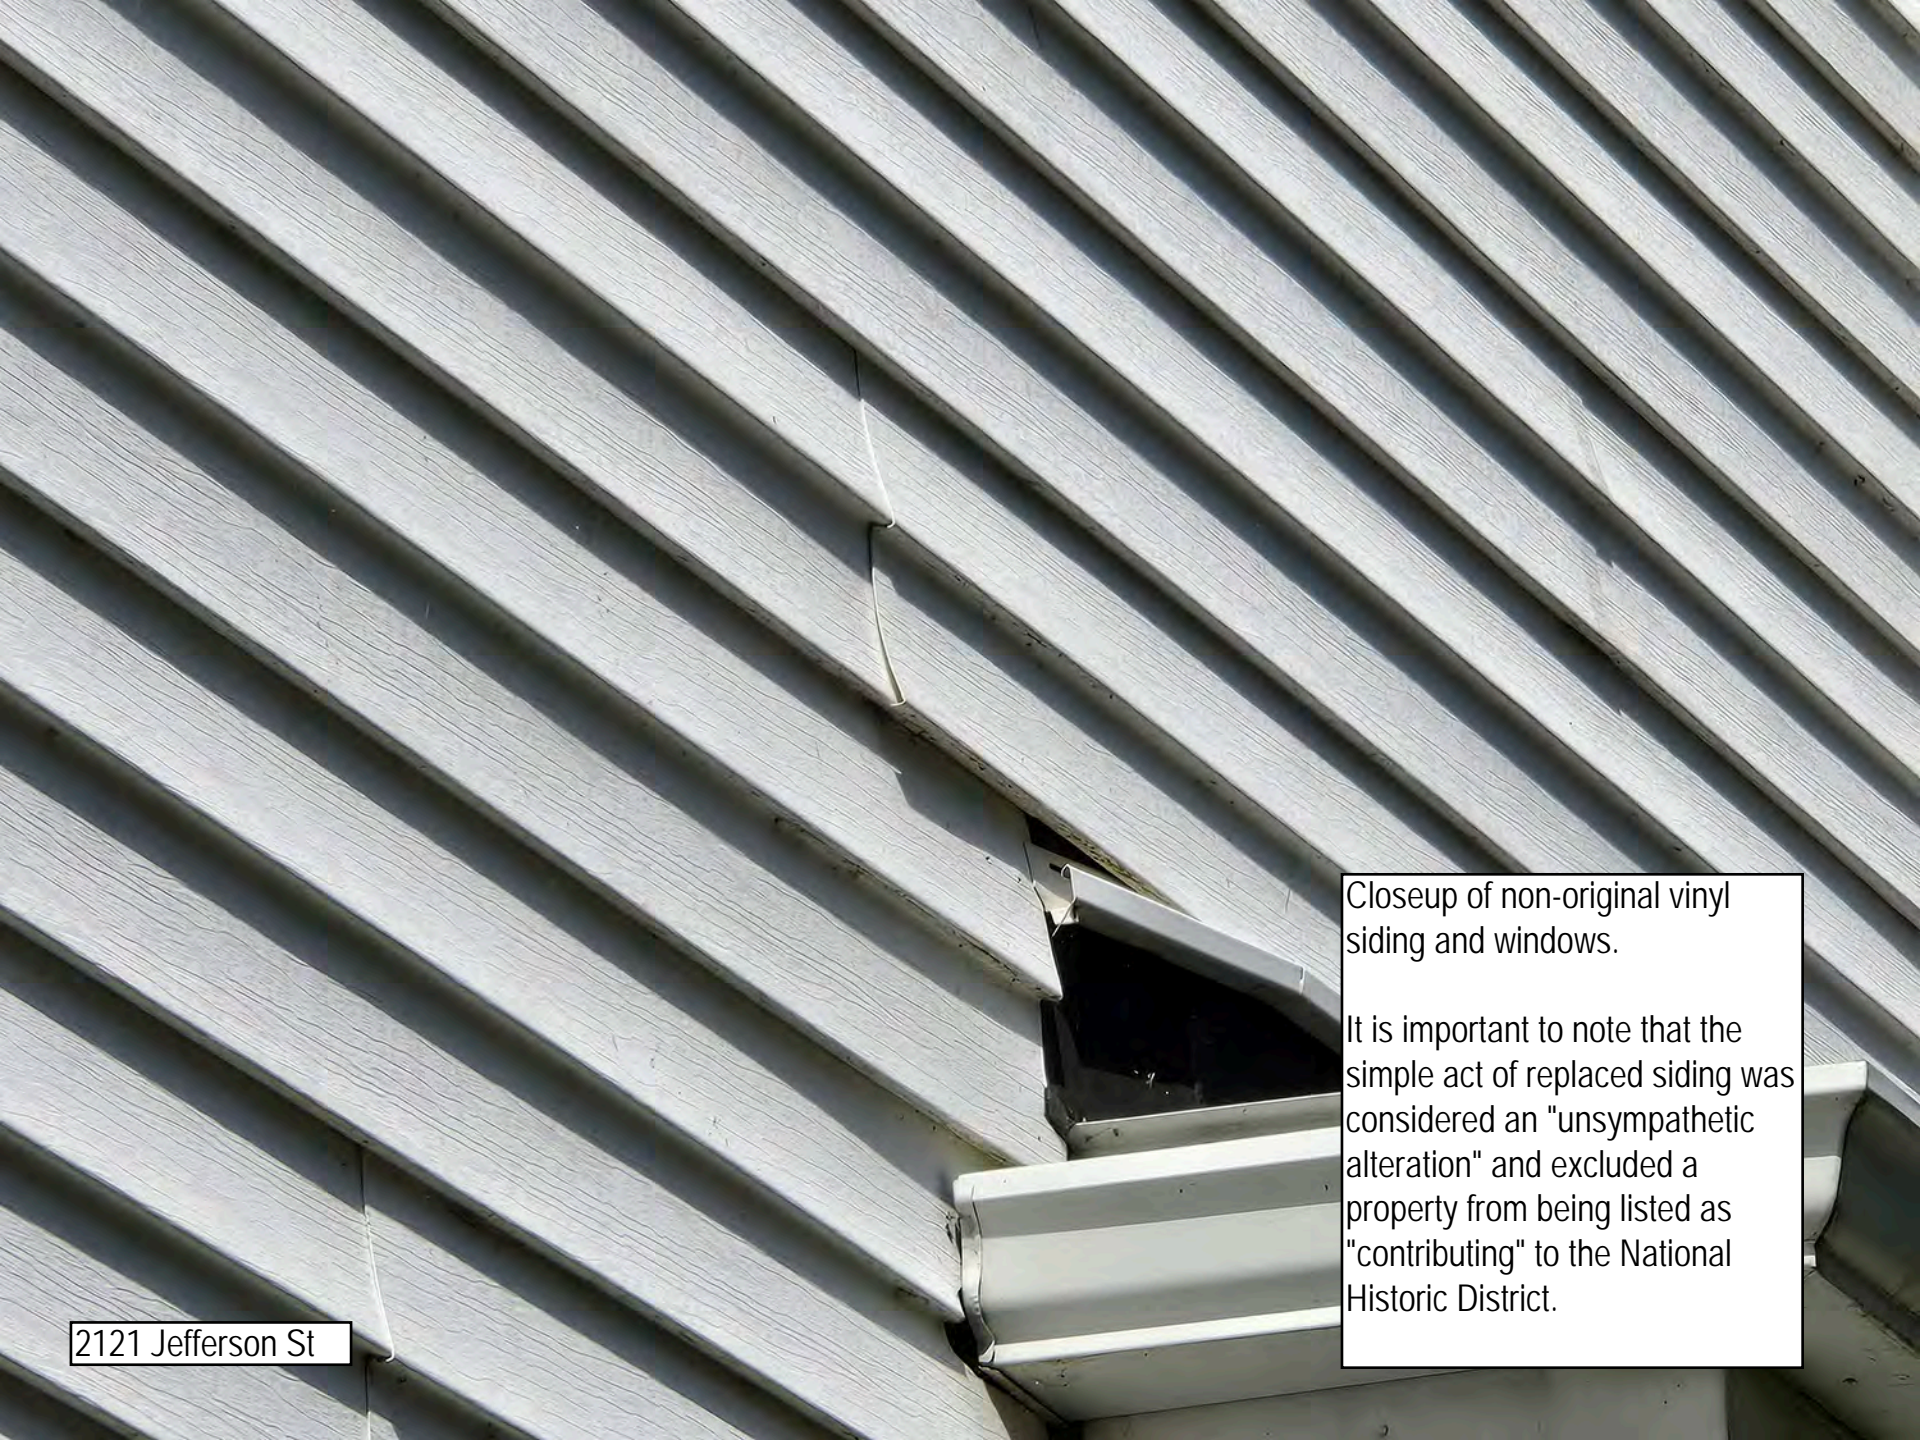
Closeup of non-original vinyl siding and windows.

It is important to note that the simple act of replaced siding was considered an "unsympathetic alteration" and excluded a property from being listed as "contributing" to the National Historic District.

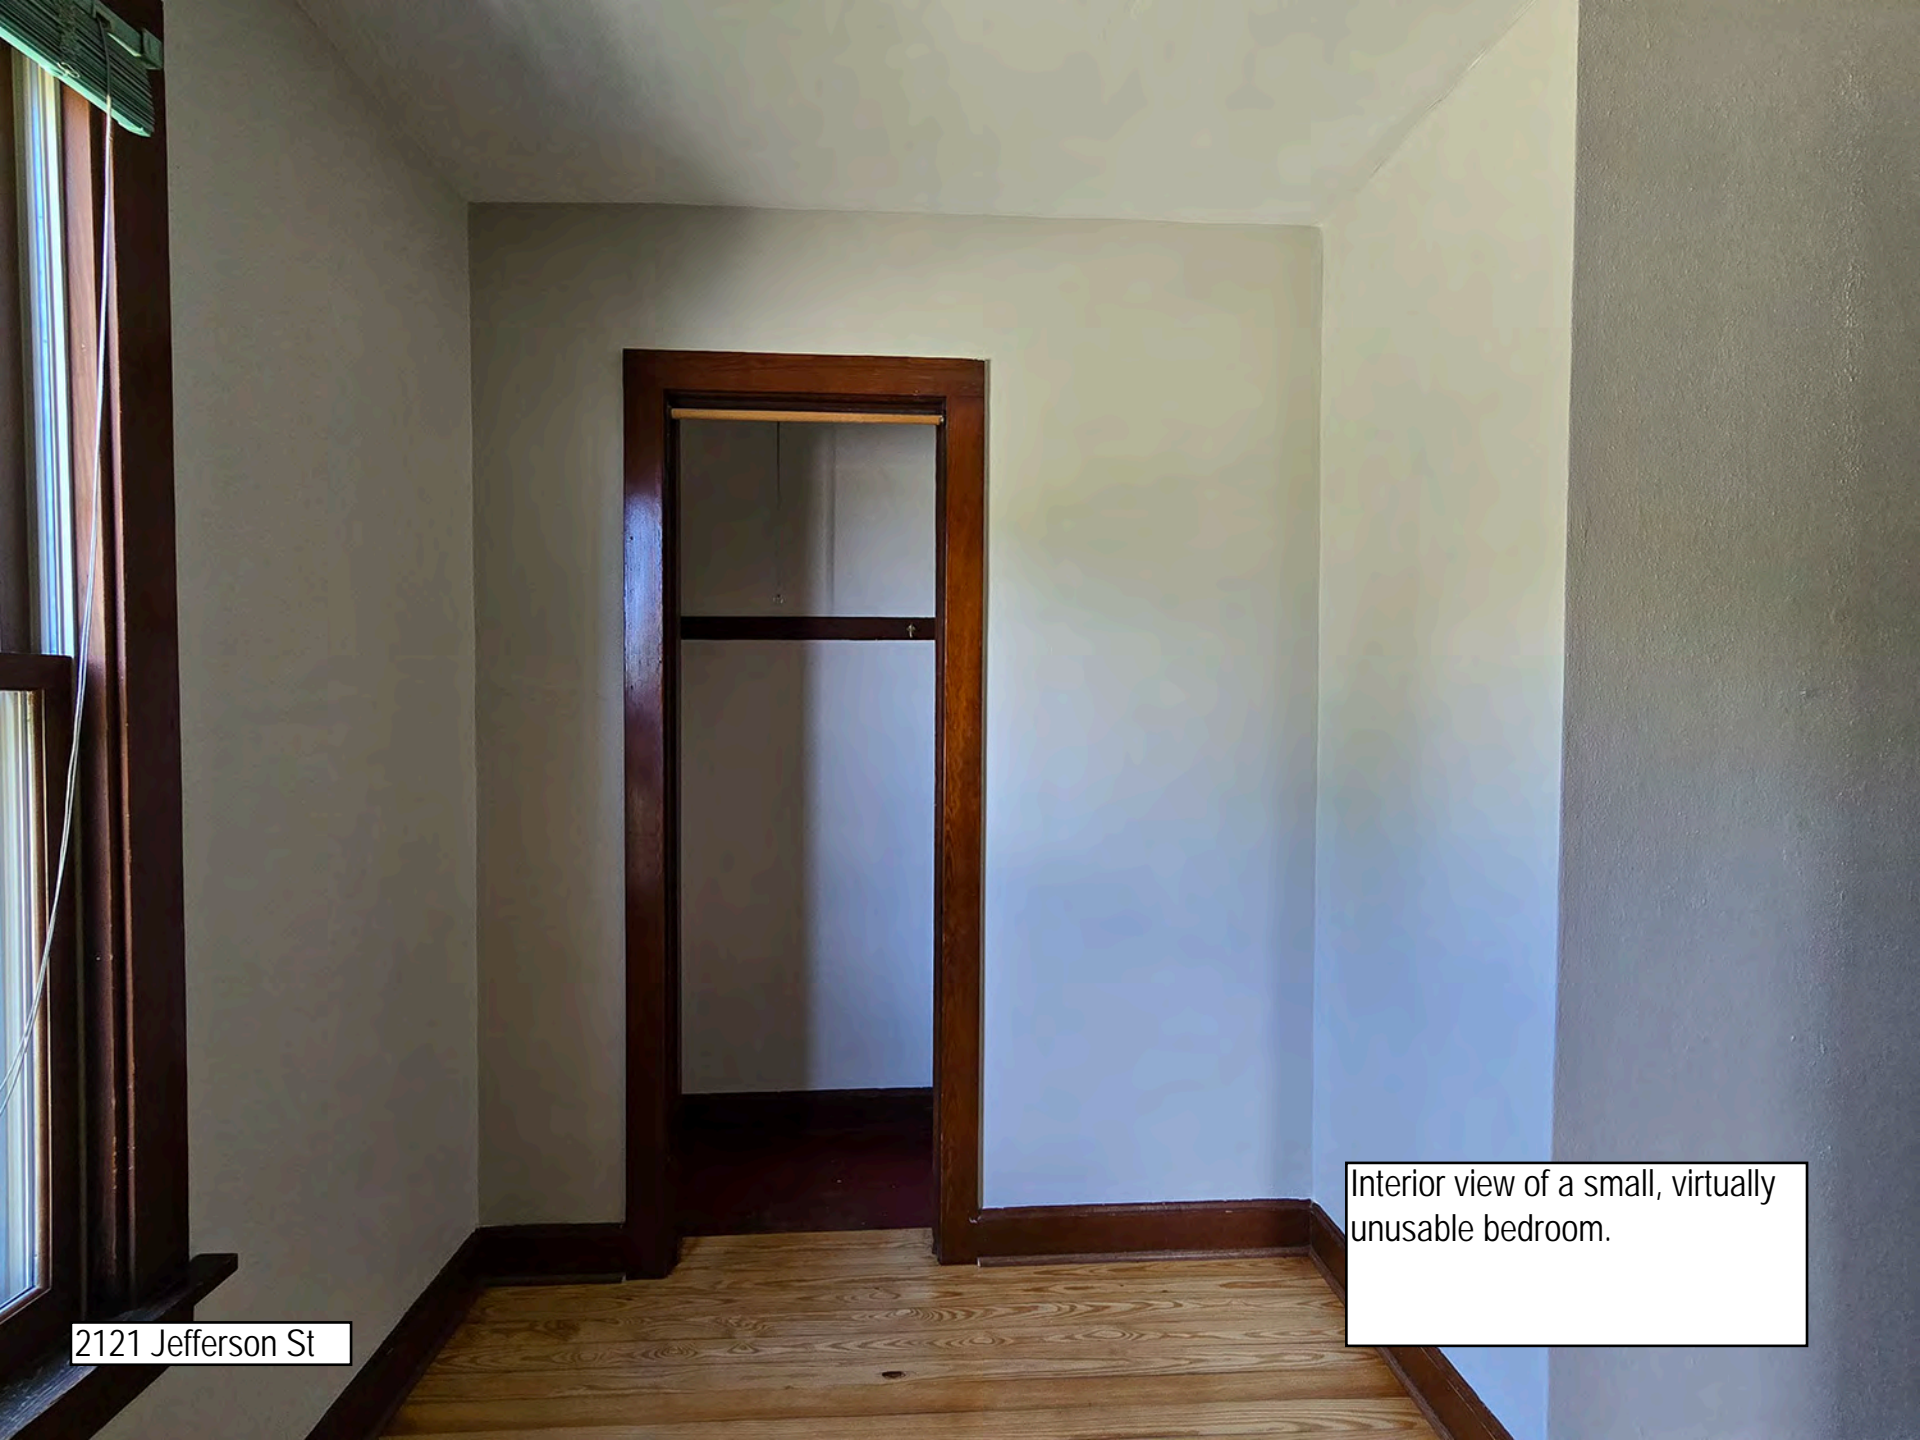
Interior view of a small, virtually unusable bedroom.

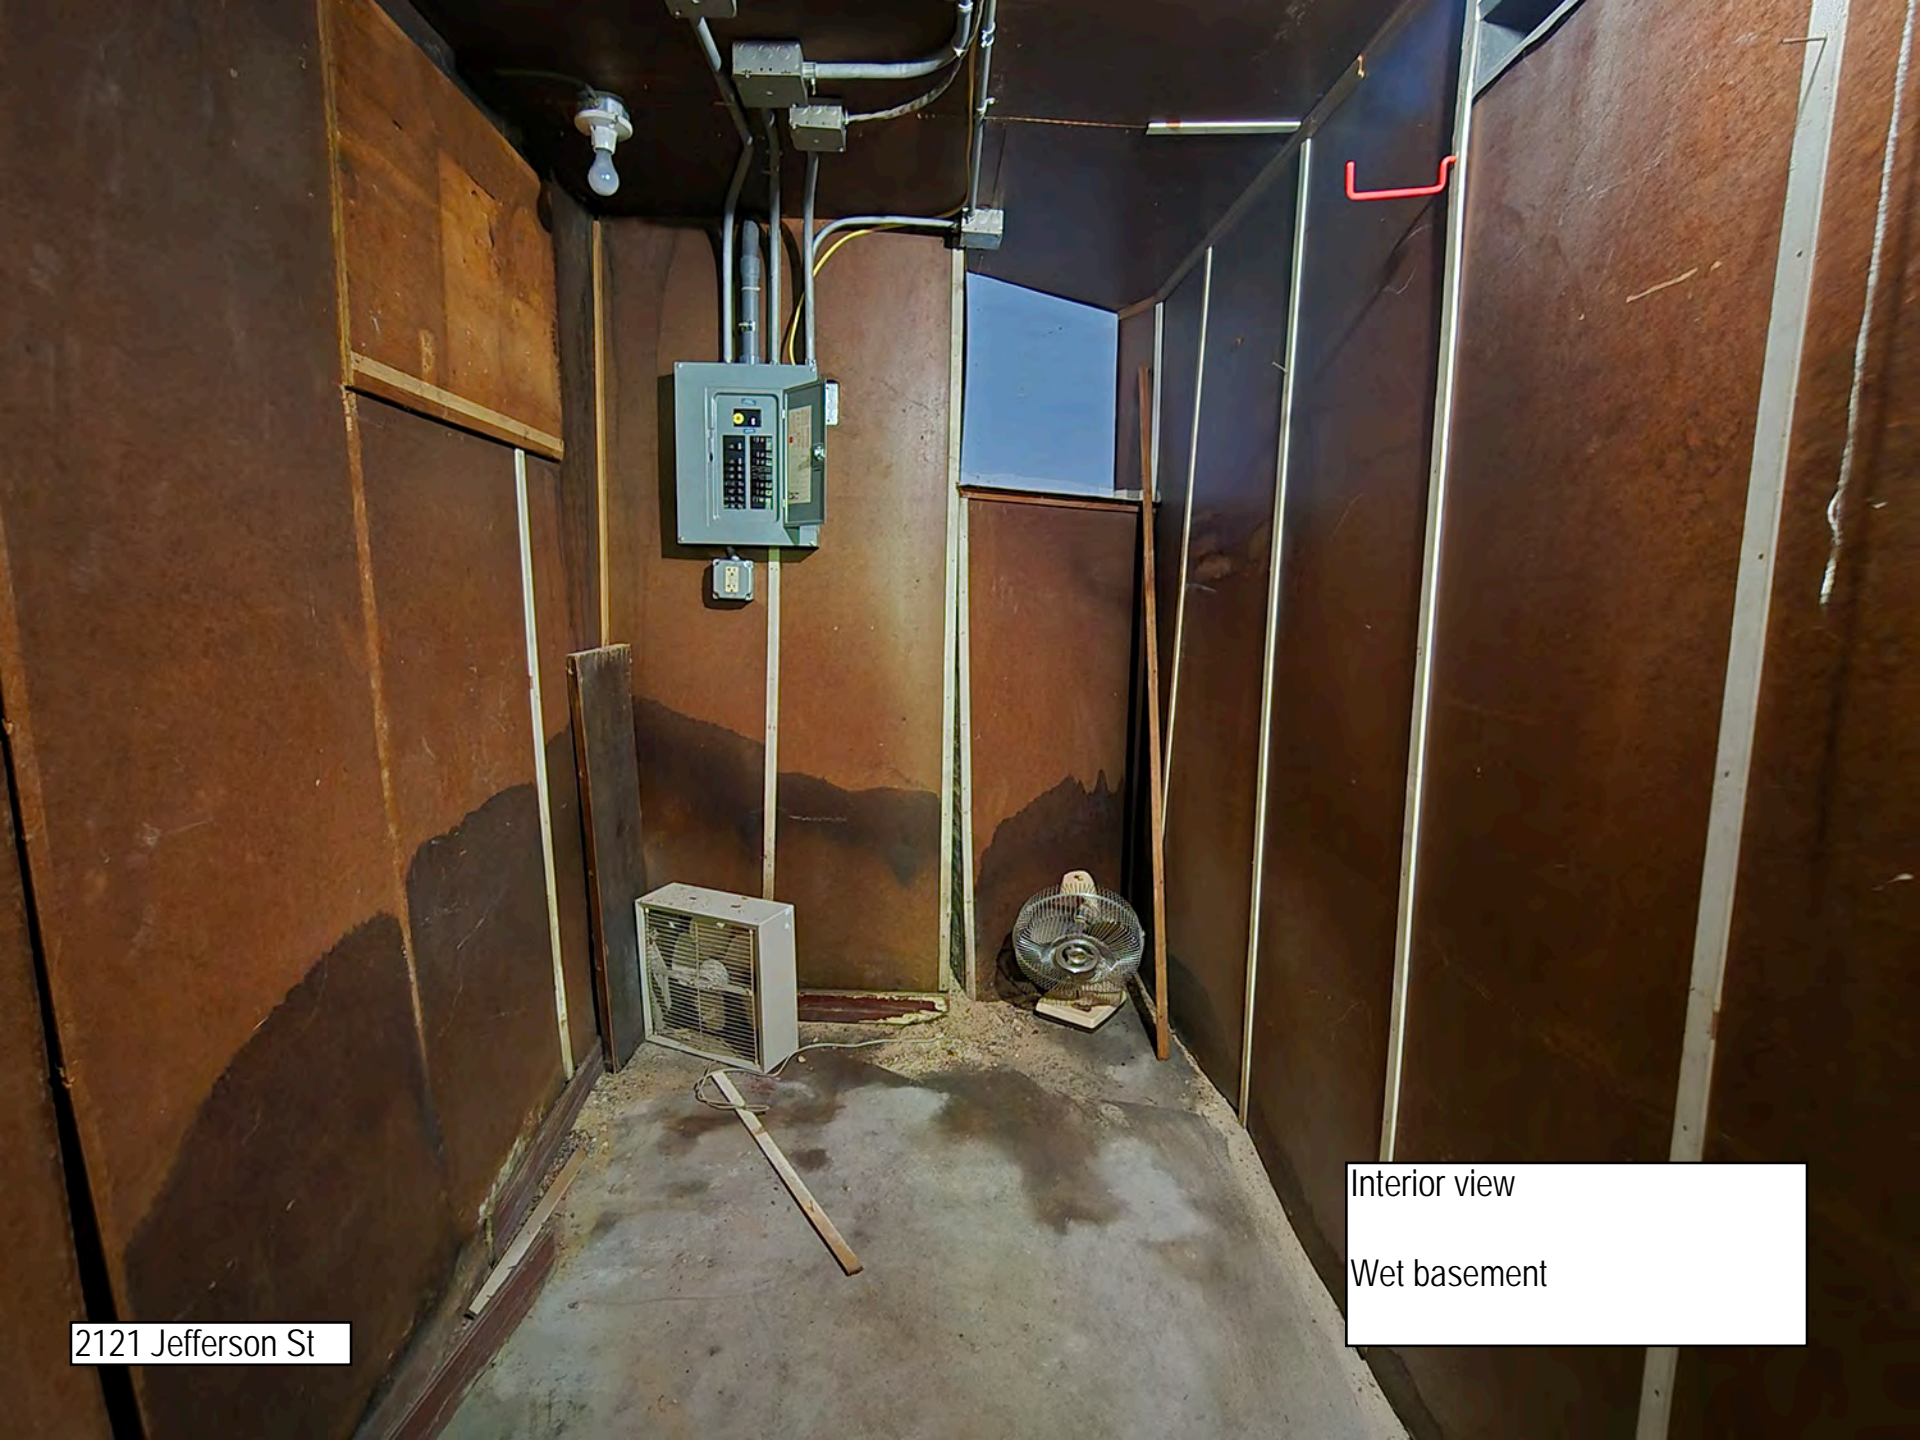
Interior view
Wet basement

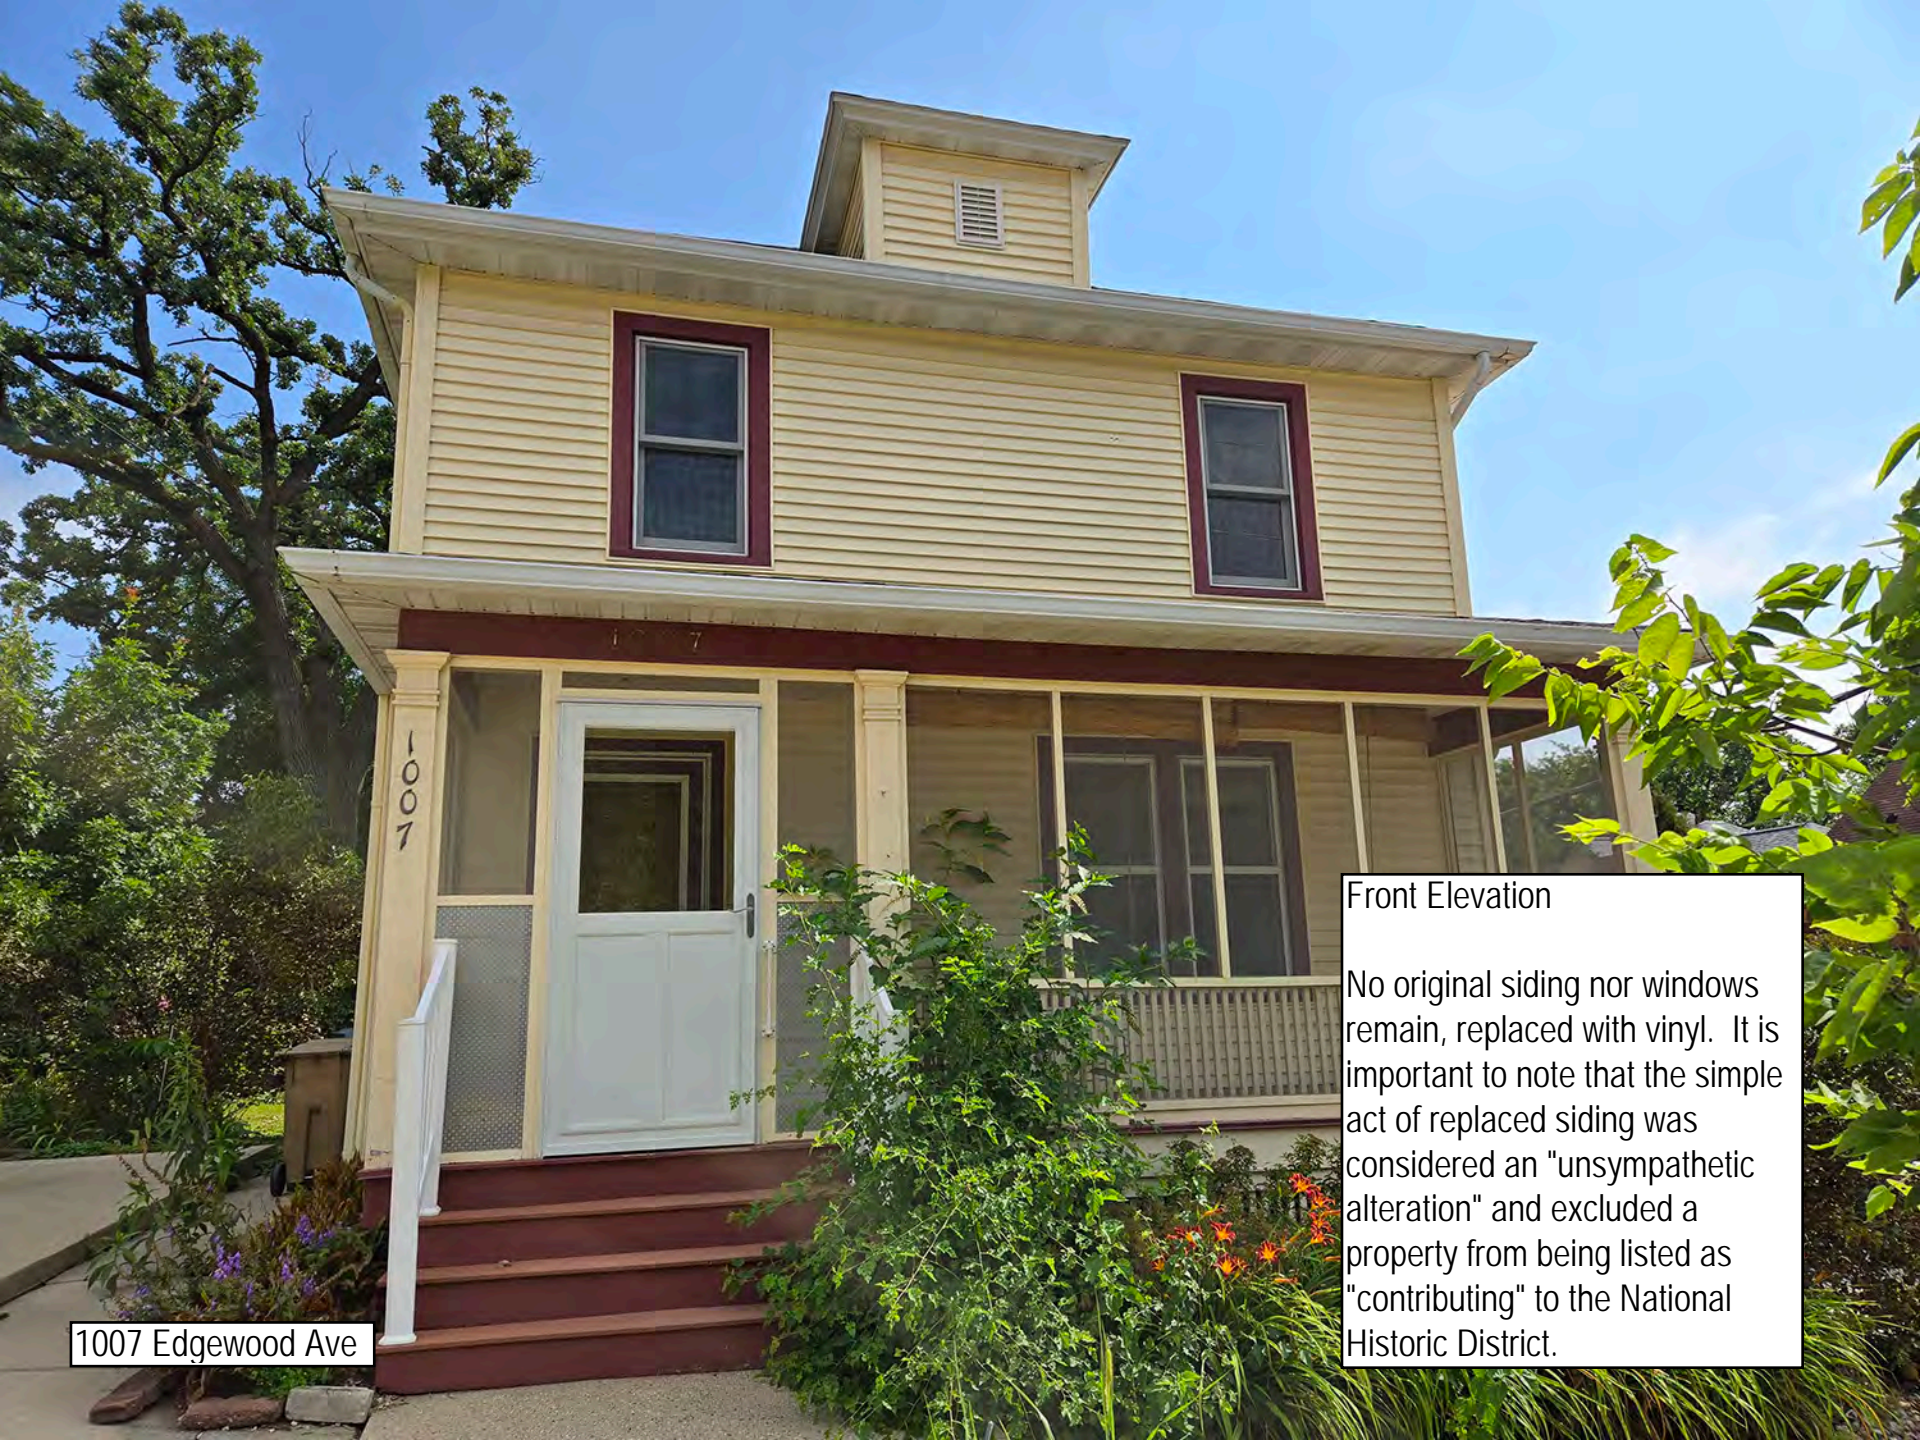
Front Elevation

No original siding nor windows remain, replaced with vinyl. It is important to note that the simple act of replaced siding was considered an "unsympathetic alteration" and excluded a property from being listed as "contributing" to the National Historic District.
