2121 Jefferson St

1007 Edgewood Ave

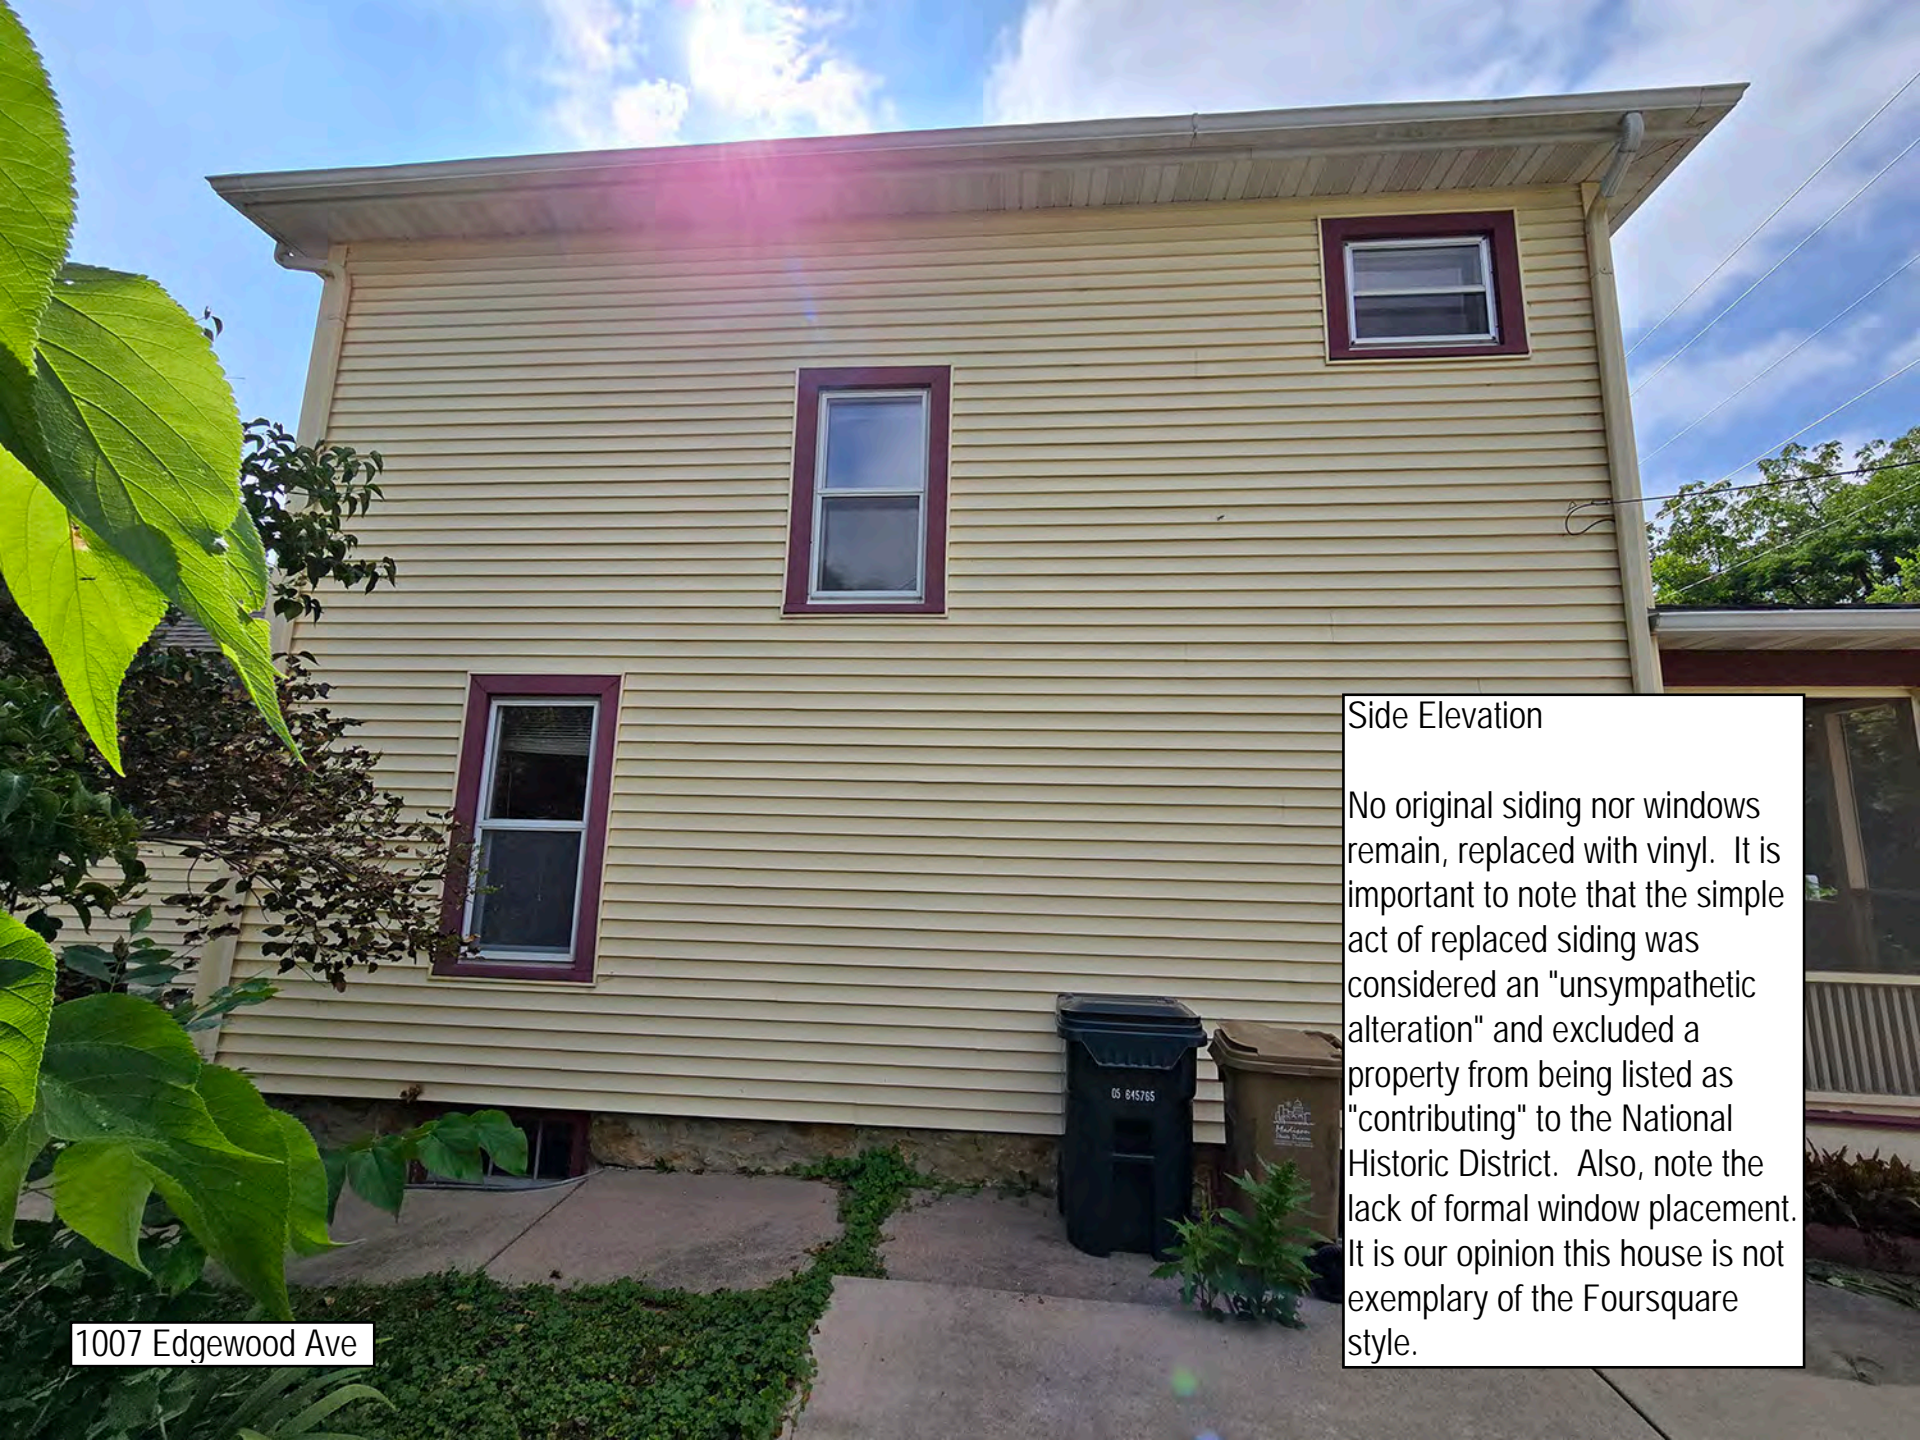
Side Elevation

No original siding nor windows remain, replaced with vinyl. It is important to note that the simple act of replaced siding was considered an "unsympathetic alteration" and excluded a property from being listed as "contributing" to the National Historic District. Also, note the lack of formal window placement. It is our opinion this house is not exemplary of the Foursquare style.

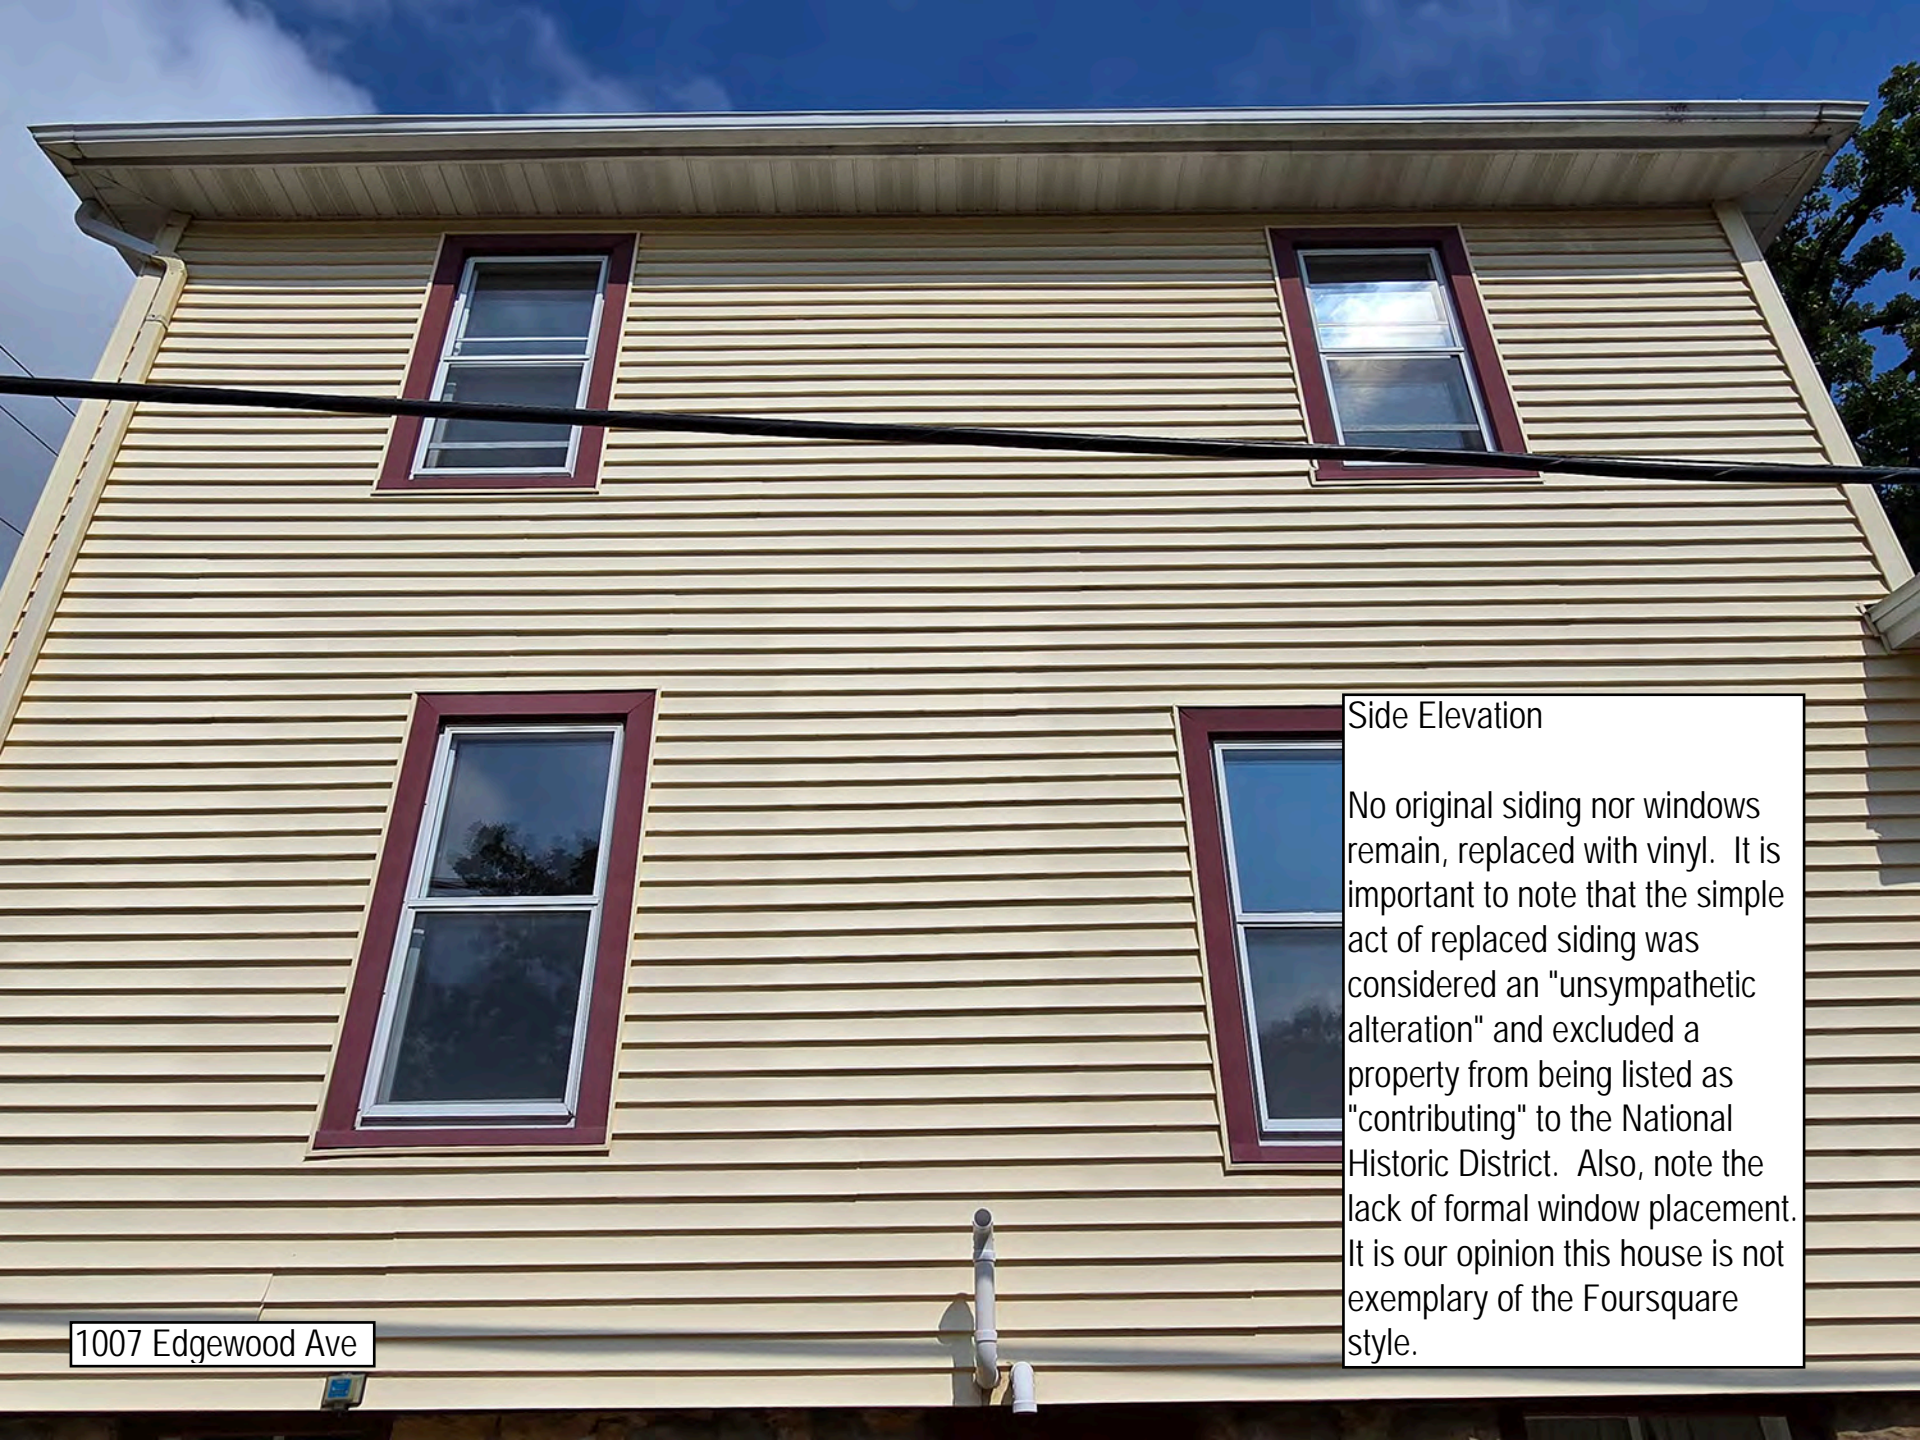
Side Elevation

No original siding nor windows remain, replaced with vinyl. It is important to note that the simple act of replaced siding was considered an "unsympathetic alteration" and excluded a property from being listed as "contributing" to the National Historic District. Also, note the lack of formal window placement. It is our opinion this house is not exemplary of the Foursquare style.

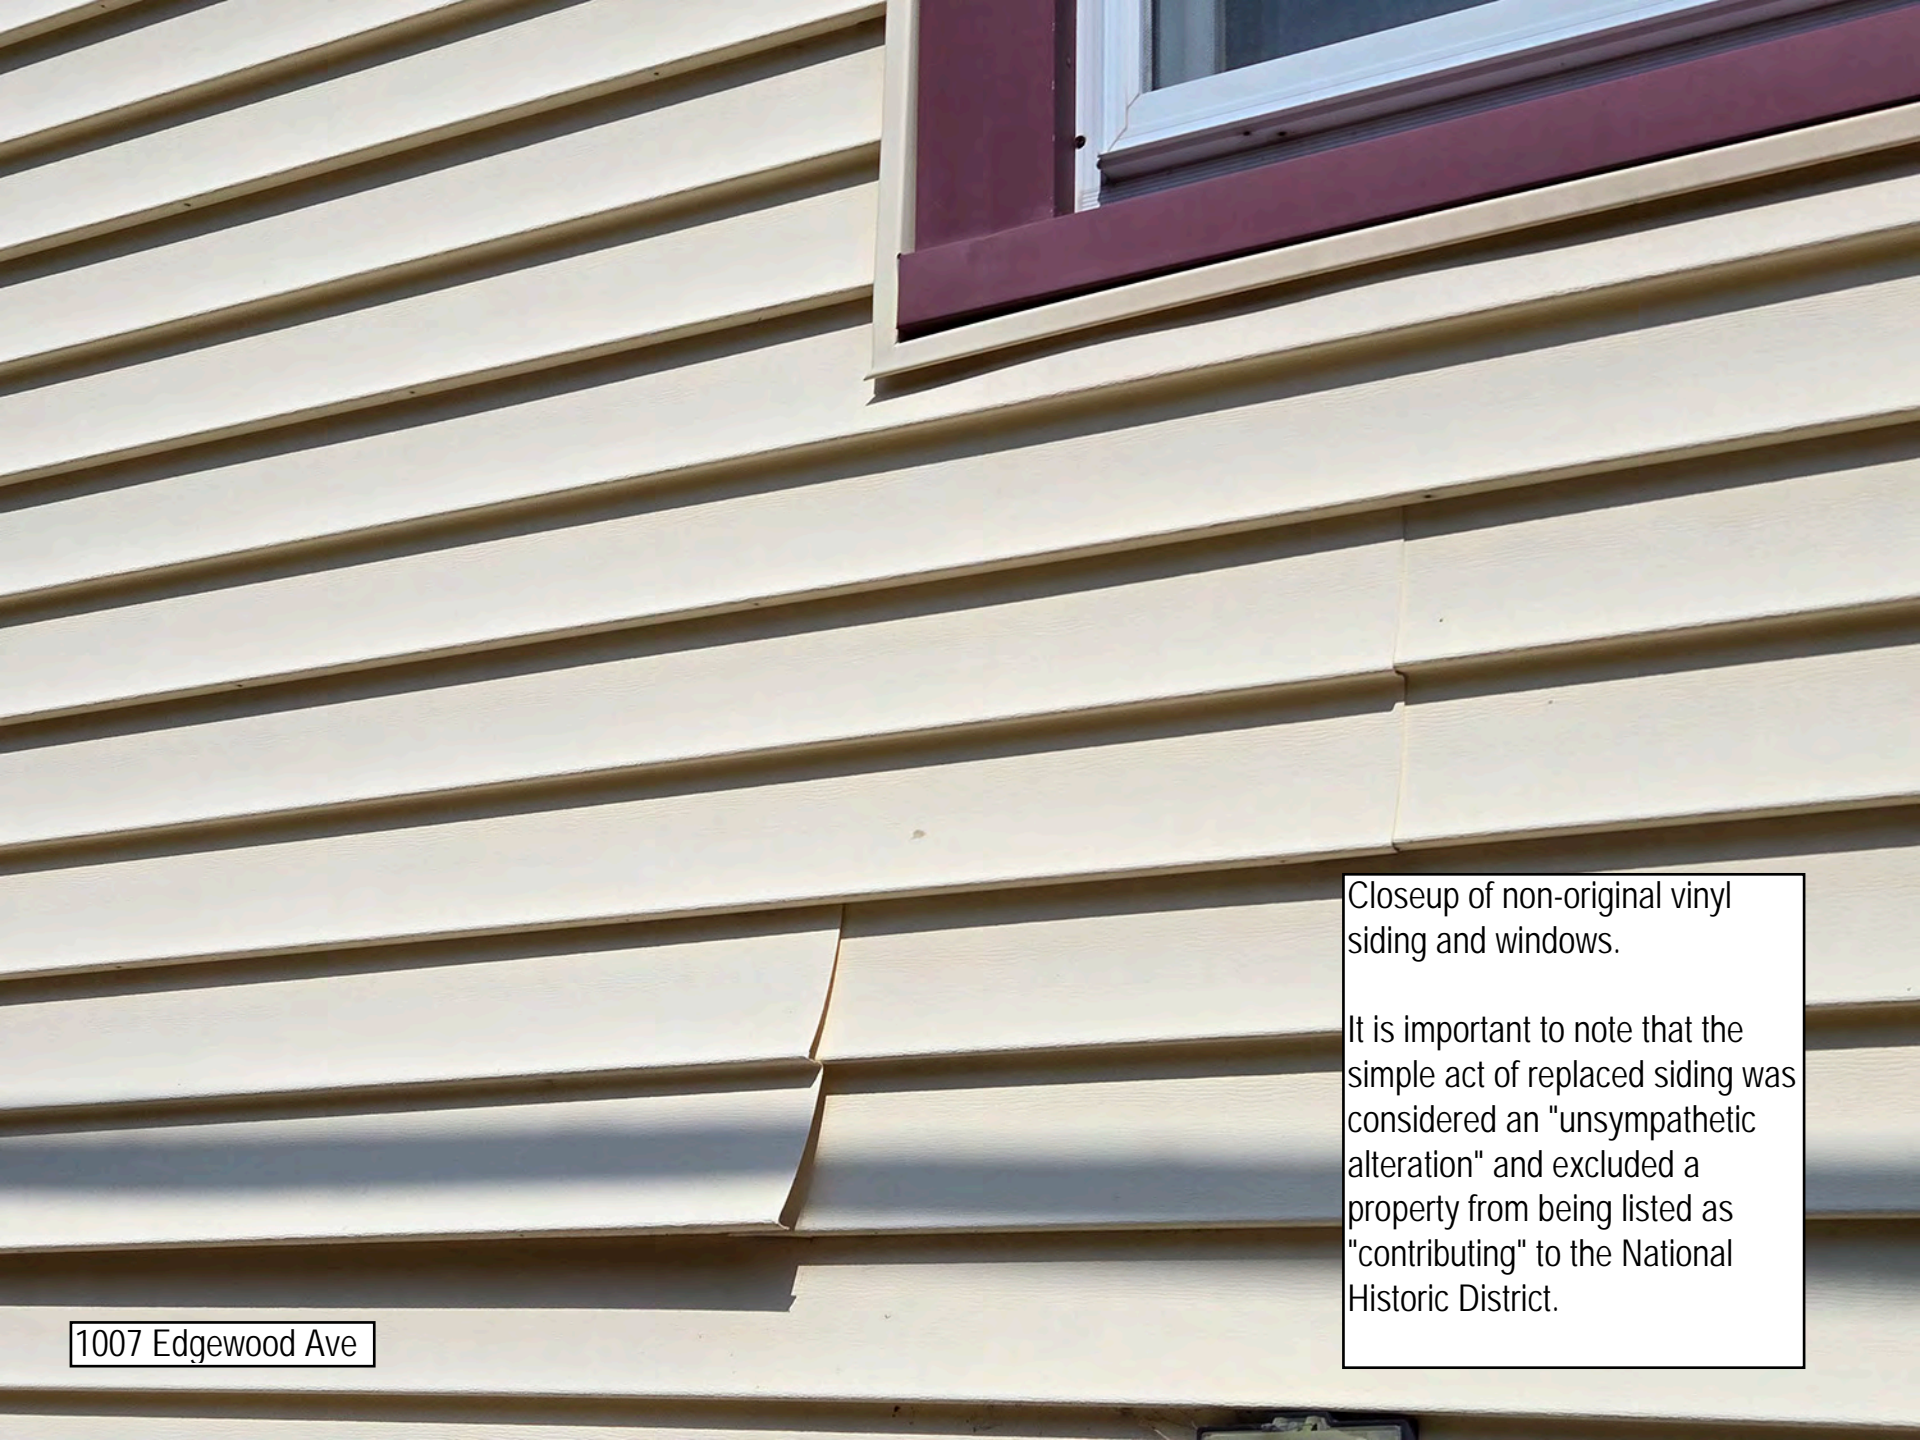
Closeup of non-original vinyl siding and windows.

It is important to note that the simple act of replaced siding was considered an "unsympathetic alteration" and excluded a property from being listed as "contributing" to the National Historic District.

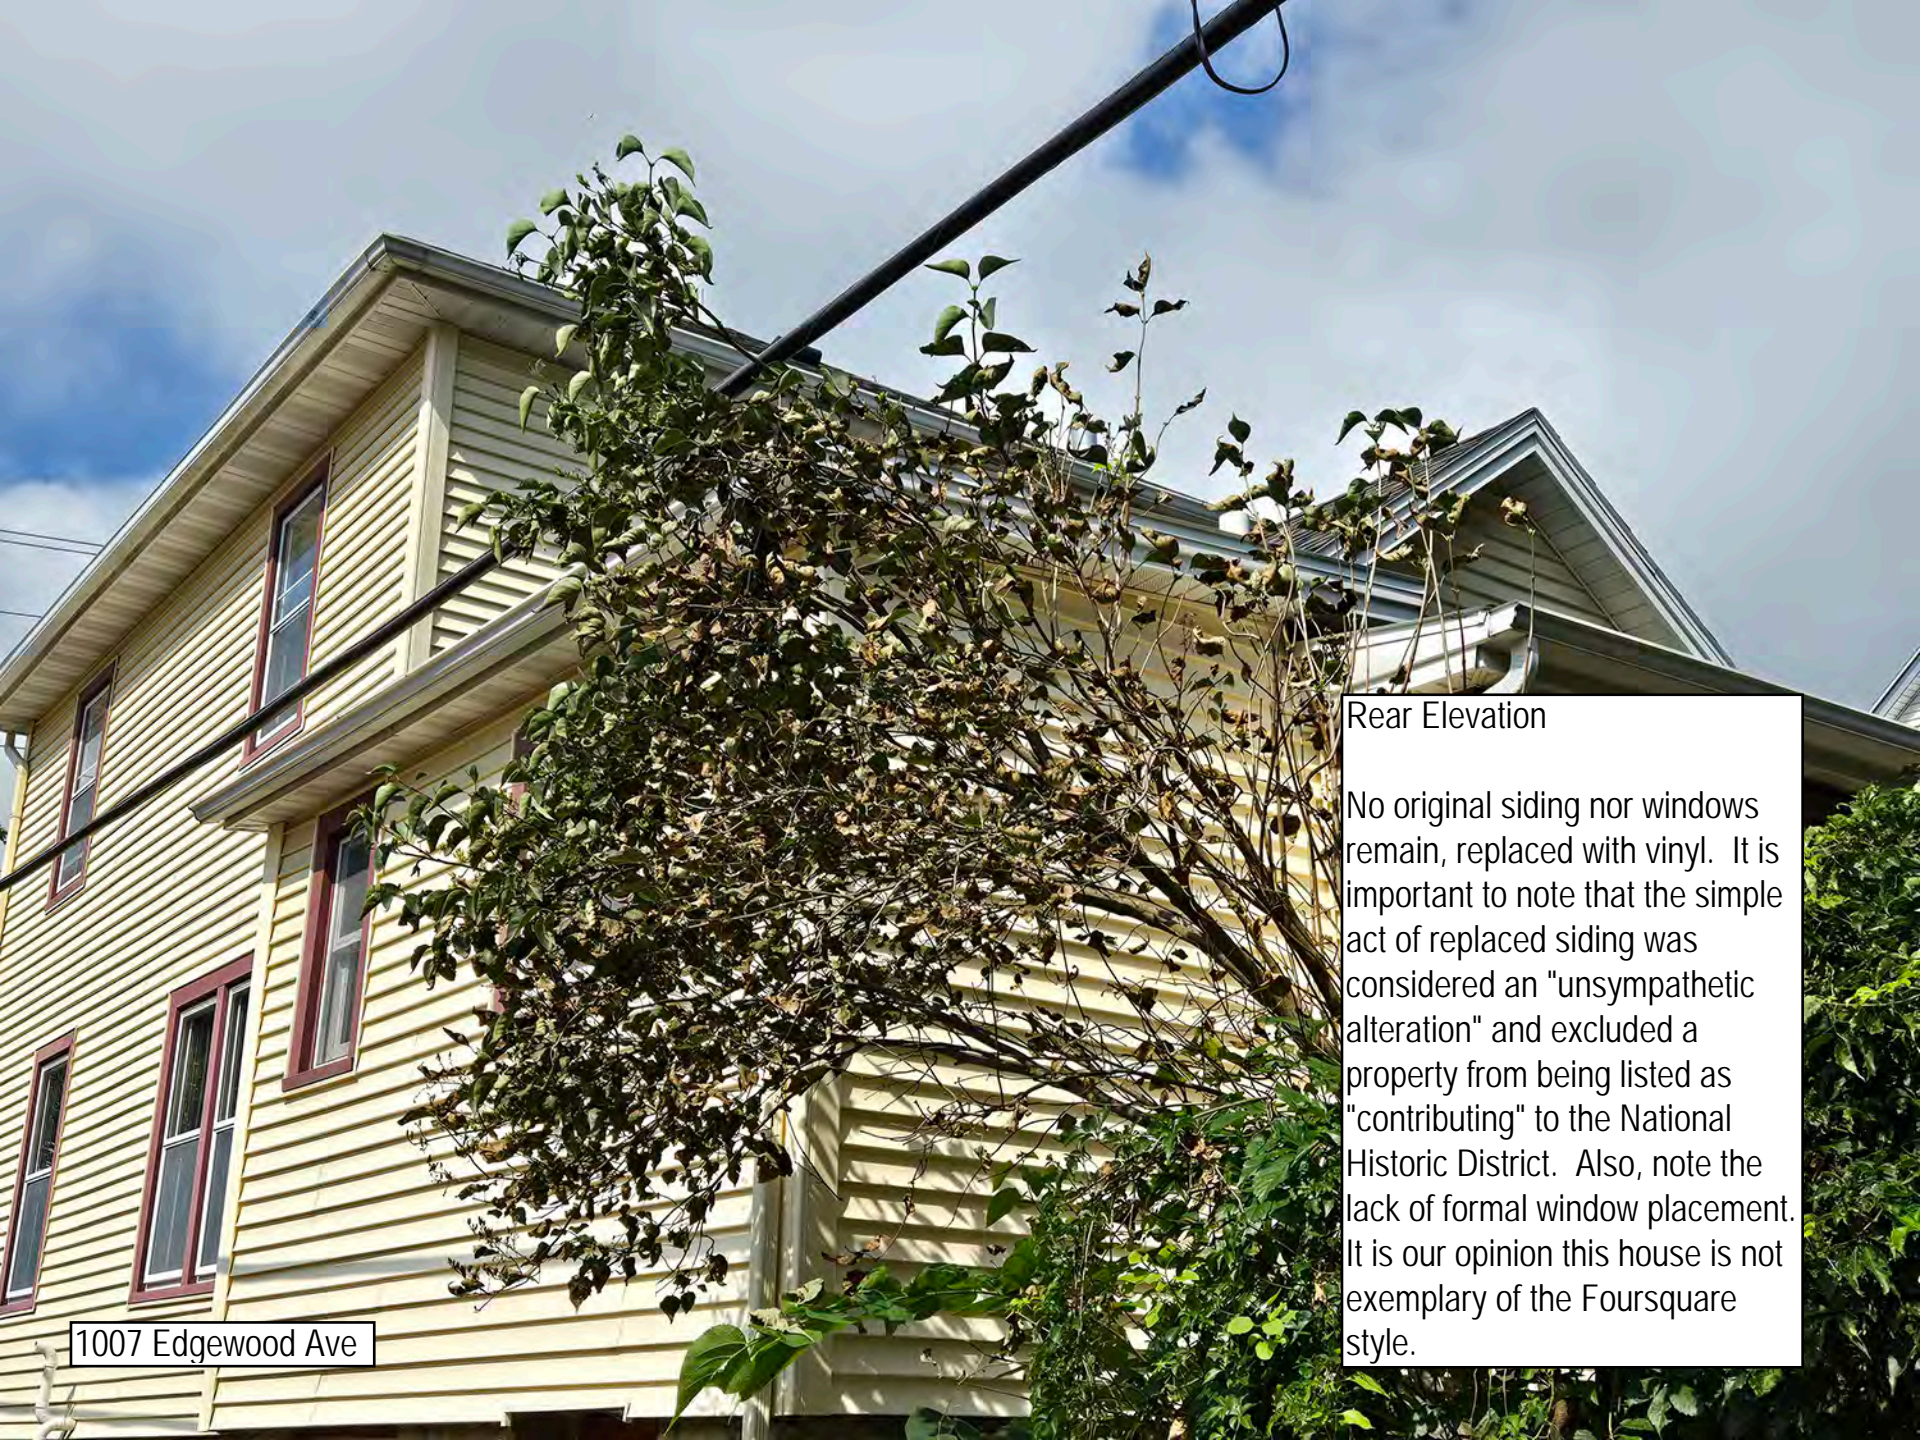
Rear Elevation

No original siding nor windows remain, replaced with vinyl. It is important to note that the simple act of replaced siding was considered an "unsympathetic alteration" and excluded a property from being listed as "contributing" to the National Historic District. Also, note the lack of formal window placement. It is our opinion this house is not exemplary of the Foursquare style.

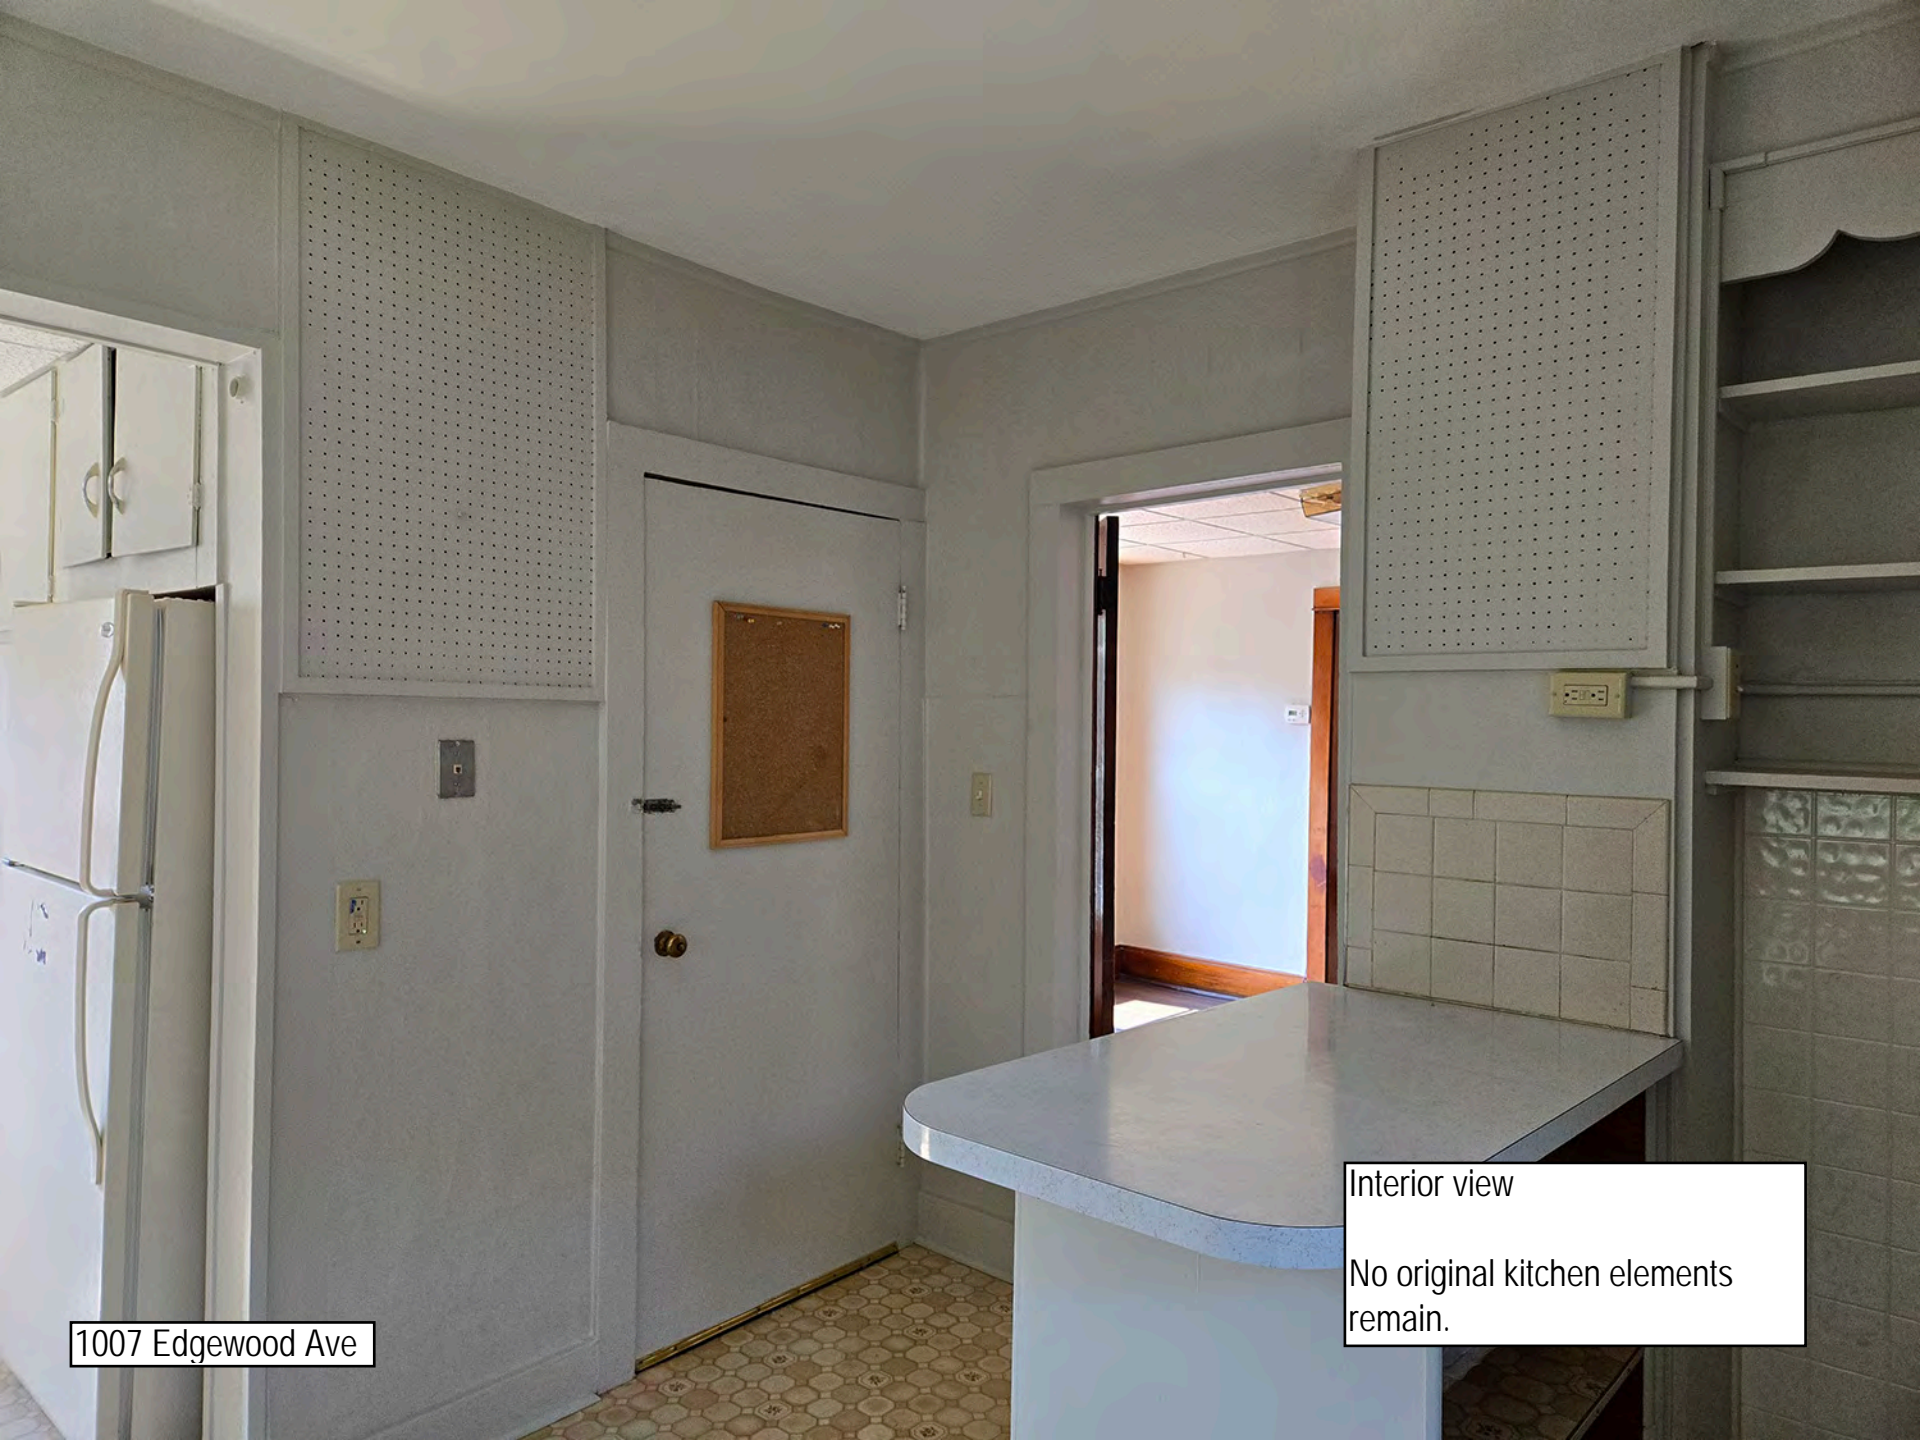
Interior view

No built-ins remain. Also, note the drop ceiling and "vinyl plank" flooring.

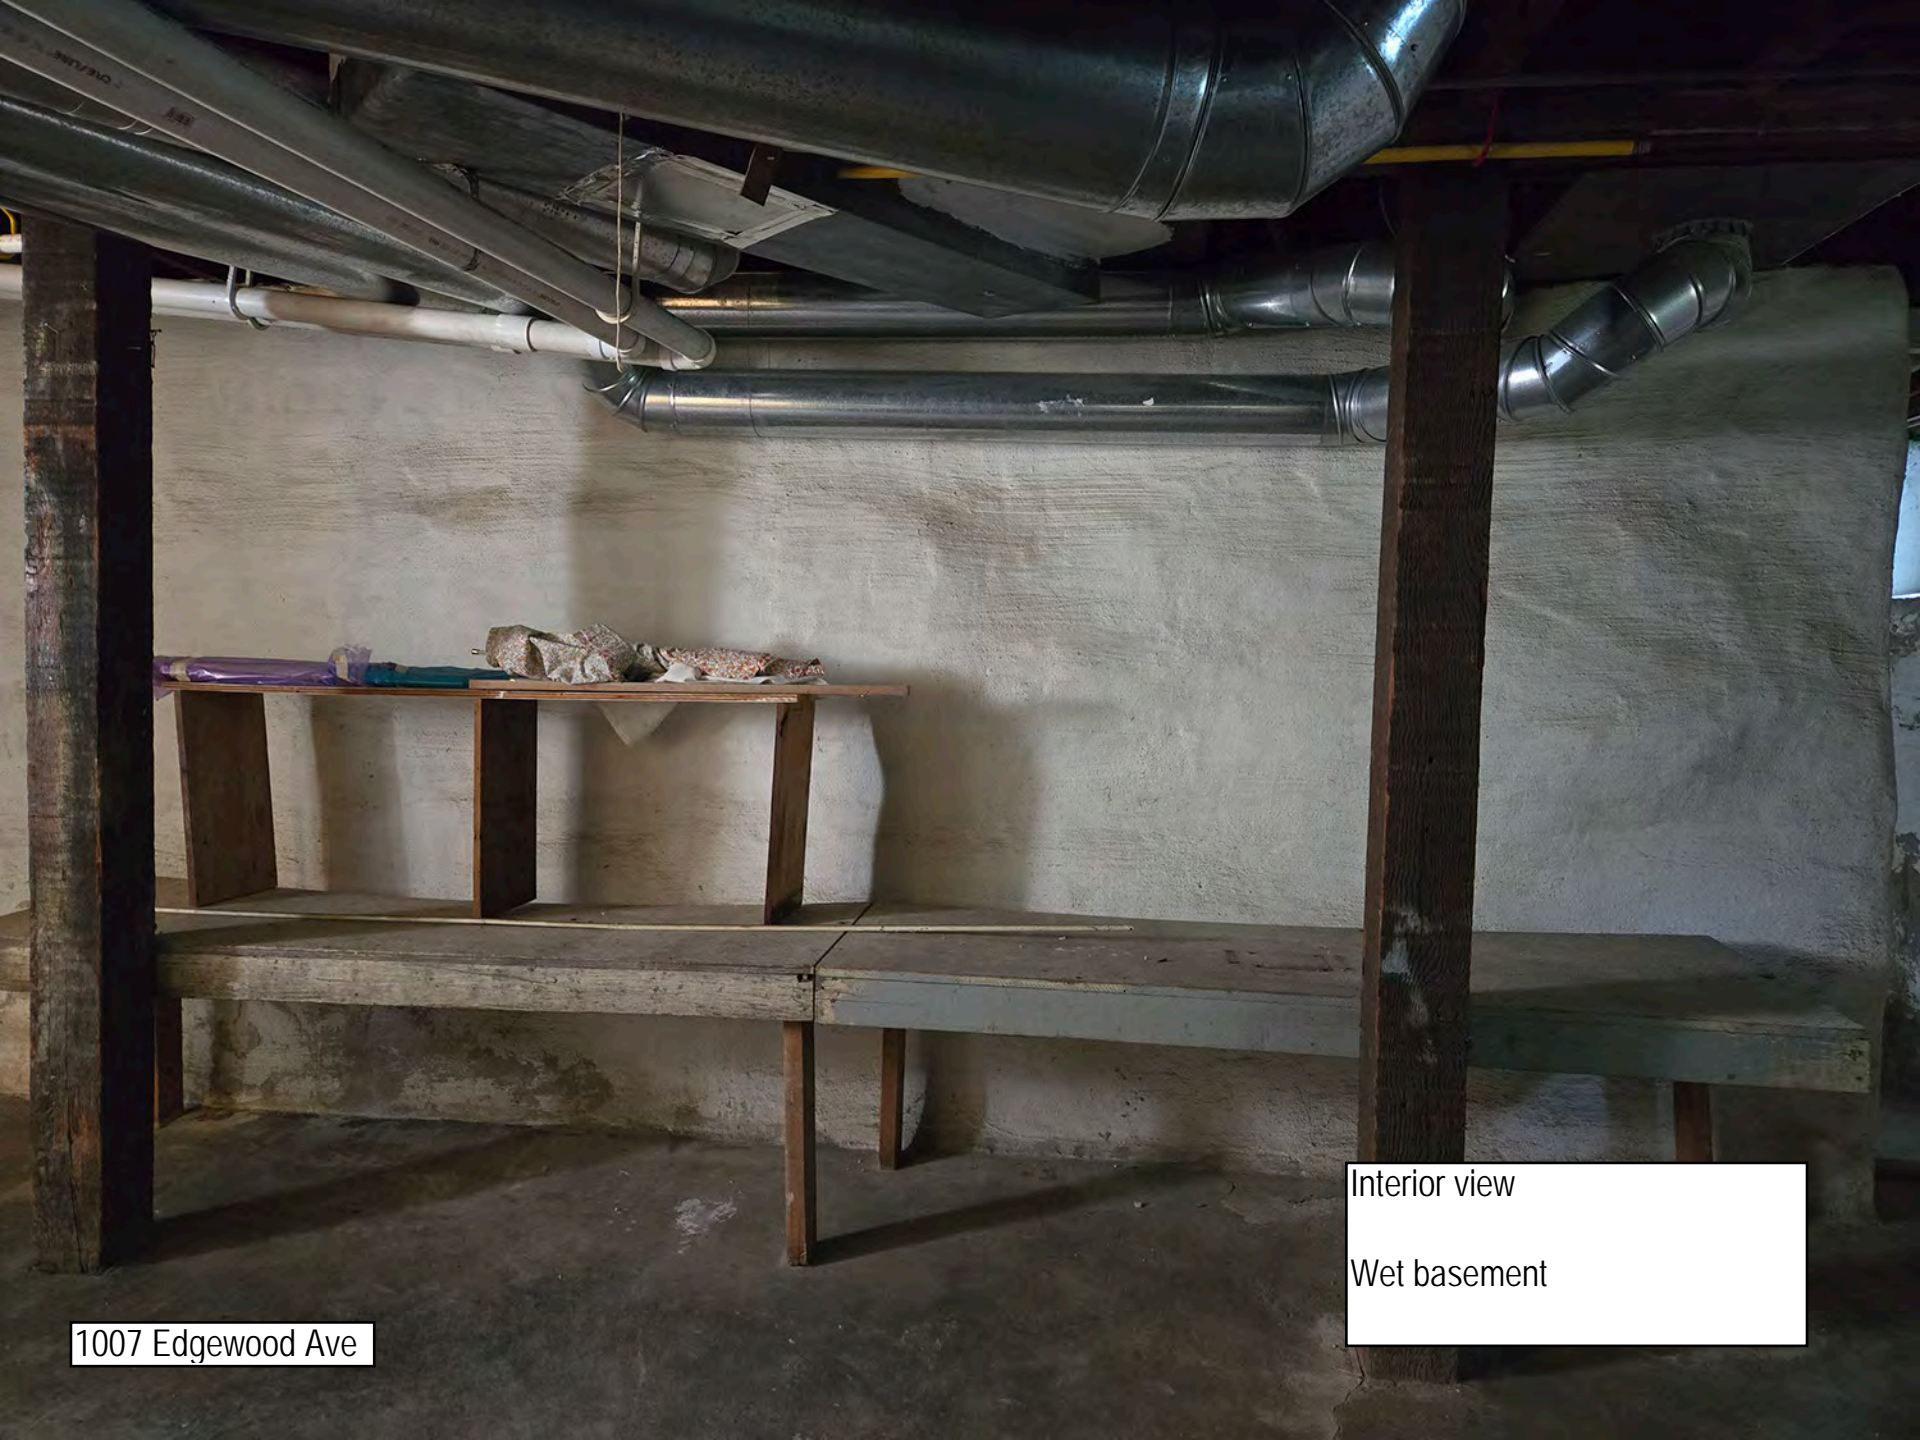
Interior view
Wet basement
