East Washington Proposed Redevelopment District Blight Study

December 14, 2011
Madison, WI

PREPARED BY MSA PROFESSIONAL SERVICES, INC.

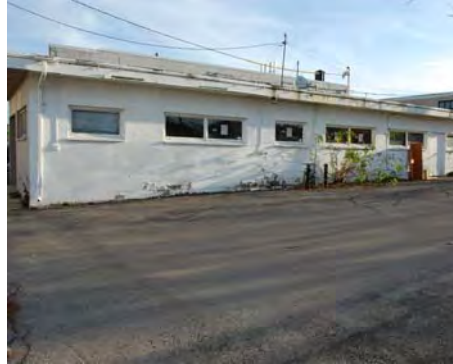
Score: 22.4

Paint peeling from walls and cladding, window and door frames, and fascia; elements of roof rusted, broken, bent; garage doors dented; sign face missing; paint peeling from existing sign and poles; parking lot cracked and overgrown; walk heaving; litter; landscaping not maintained; junk behind building

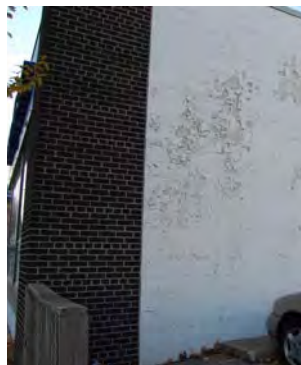
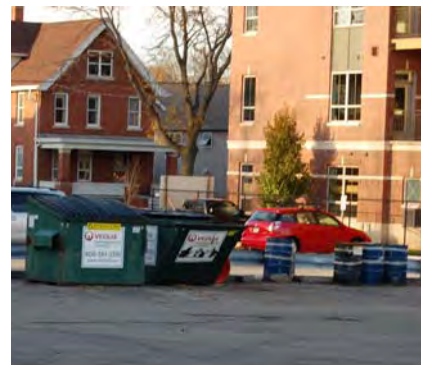
Parcel 5

Score: 59.8

Paint peeling from walls, stair railings, foundation and overhang; foundation cracked; window sills cracked; garage doors dented and rusted; rear door heavily rusted; dumpster and fluid drums not screened; asphalt lot cracked and pitted; litter

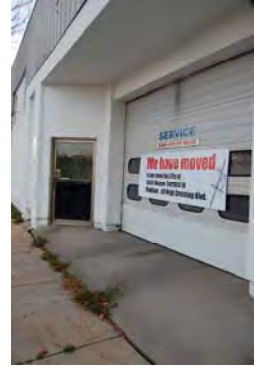
Score: 31.1

Cracks and holes in cladding; windows graffitied, broken, boarded, dirty and scratched; paint peeling from frames; vents rusted; garage doors dented/rusted; screening rusted and leaning; signage missing; parking lot cracked, overgrown; sidewalk cracked, aggregate beginning to show; litter; overgrown/dead vegetation in lot; vacant

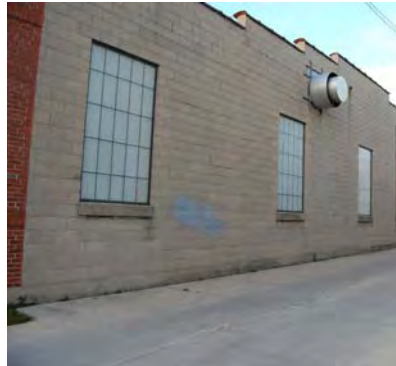
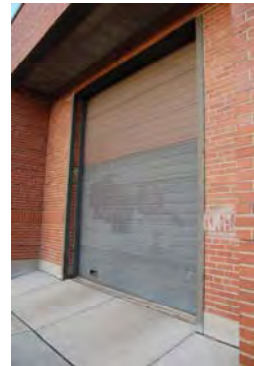
Parcel 9

Score: 46.4

Paint mismatched/peeling; walls on interior buildings heavily cracked; graffiti; gutters rusted; window sills crumbling; concrete wear on garage overhangs; chain-link not providing adequate screening; cracked and worn asphalt drives; litter; some water pooling in drive

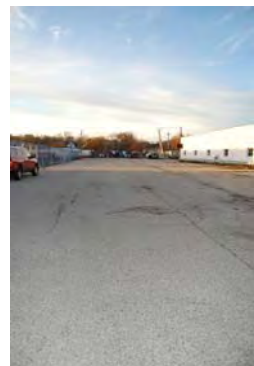
Parcel 10

Score: 50

Signage missing; lot in poor condition-cracks, pot holes, weeds, gravel; debris and water pooling in lot

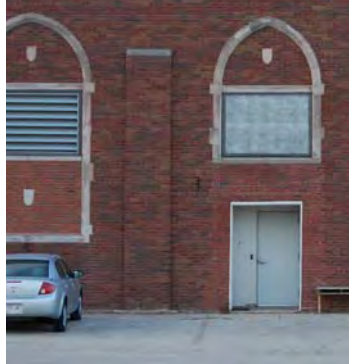
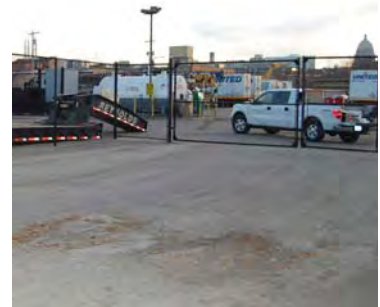
Some brick discoloration and mortar wear on structure; minor rust staining on doors; chain-link not providing adequate screening; drives and lot cracked and pitted; sidewalk cracked, aggregate starting to show; not compatible with adjacent HDR; low lot utilization compared to preferred future land use

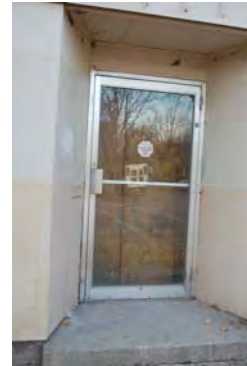
Parcel 12

Score: 41.2

Foundation is crumbling/discolored; walls heavily graffitied; mismatched paint; metal siding curling-sharp pieces; rust stains; gutters full of debris, rusted, sections missing; overhang dirty, paint peeling; door dirty, boarded from the inside; junk on side of building not screened by chain-link fence

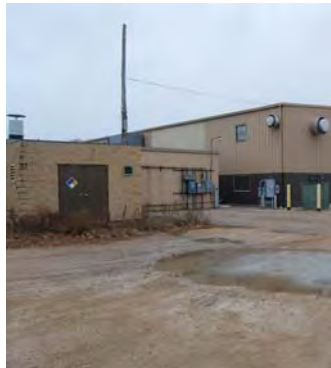
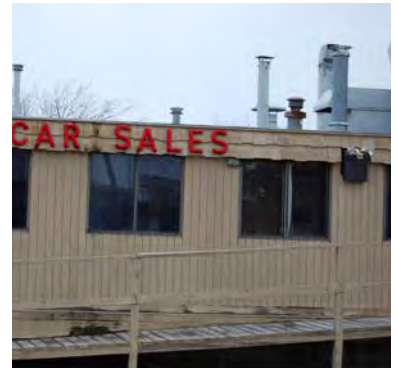
Parcel 14 (1)

Score: 53.3

Wood siding deteriorating at base; metal siding bent and rusted; minor rust on vents; minor discoloration on doors; accessory structures in poor conditions; fencing bent and rusted; no screening around dumpsters; pole sign rusted; asphalt parking worn; pooling in unpaved areas

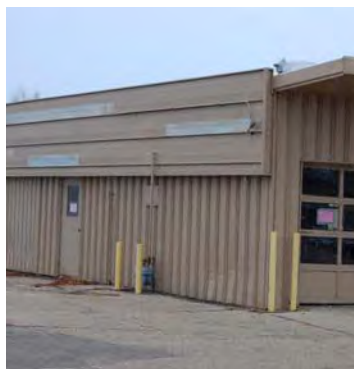
Parcel 14 (2)

Score: 28.9

Metal siding bent and patched; paint wearing; brick discolored; major cracks in concrete blocks; shed buildings very rusted; broken windows; graffiti; no screening around dumpsters; major cracks and weathering in paved areas; piles of trash; graffiti; open wires; some pooling and washed out gravel

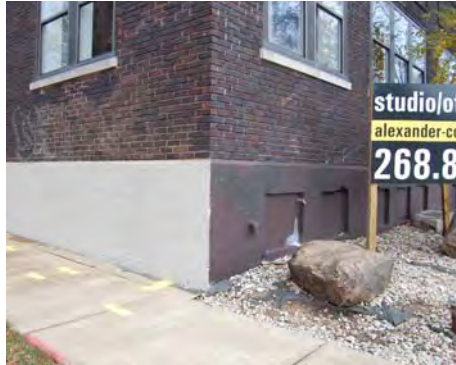
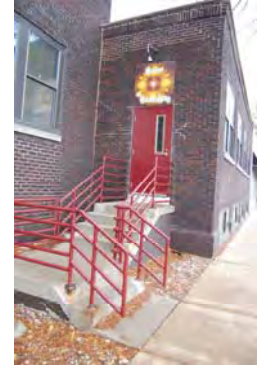
Foundation cracked; some brick discoloration; graffiti; concrete damage, rust on roof; window sills stained, paint peeling from frames; porch screens damaged, paint peeling; vents rusted; railings rusted; handicap ramp rusted, crumbling; some units vacant

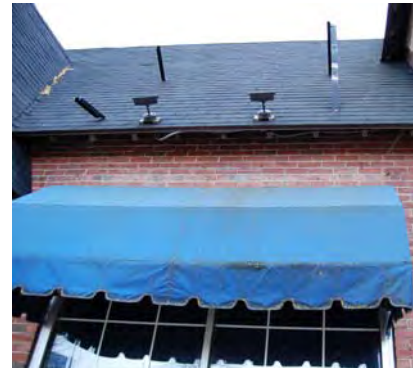
Parcel 26

Score: 56.1

Brick discolored; minor graffiti; paint peeling from fascia and decorative elements of roof; some shingles curling; canopies dirty; gate rusted; signage missing; sidewalk-minor heaving; minor graffiti; for sale, partial occupancy

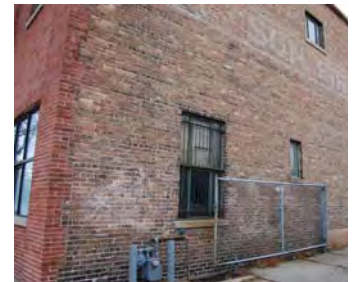
Parcel 27

Score: 59.3

Bricks discolored; poorly covered graffiti; window frames rusted, paint peeling; crack in door frame; sign dirty, faded; asphalt drive cracked, pooling water;

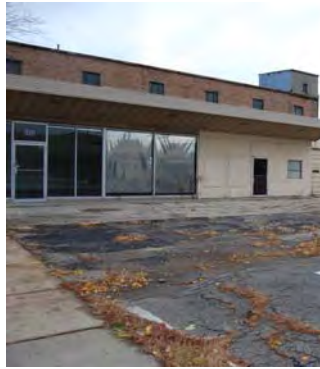
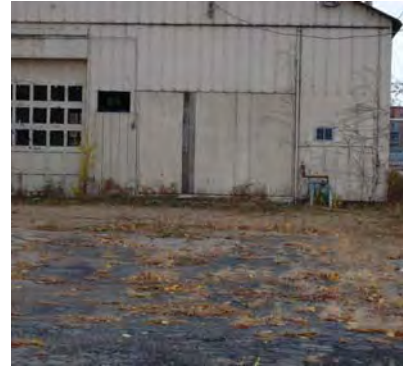
Parcel 28

Score: 34.5

Paint peeling, mismatched; some siding missing; windows covered with plastic on outside; paint peeling from window frames; overhang faded, rusted, warped; garage door and frame sagging; parts of address missing; Drive cracked, potholes, gravel, debris; overgrown; minor stormwater issues; vacant

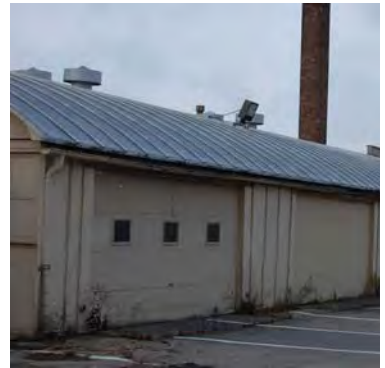
Parcel 29

Score: 33.7

Foundation cracked; siding dirty, rust stained and dented; some windows boarded up; stoop discolored; paint peeling from garage doors; side door in poor shape; overall condition of garage poor; dirty parking light fixtures; weeds overgrown; asphalt cracked and weathered; major heaving; vacant

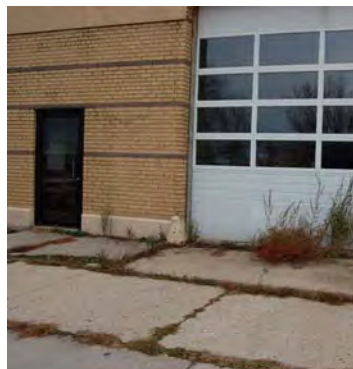
Parcel 31

Score: 31.3

Cracks in foundation; holes and discolored brick and mortar; graffiti; window frames rusted; rusted railings; concrete cracked and aggregate showing; weeds in joints of public sidewalks; vacant

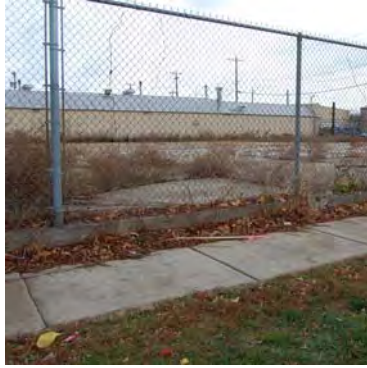
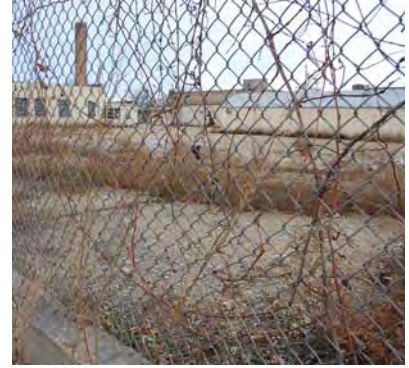
Parcel 32

Score: 39.7

Fence rusted; asphalt lot deteriorating; loose gravel; concrete base along fence line discolored; weeds throughout; debris; vacant

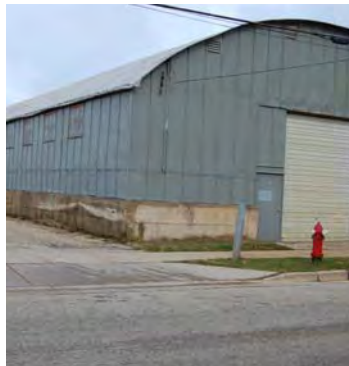
Parcel 34

Score: 43.7

Cracks in foundation; cladding dented; roof warped, rusted, edges sagging; windows painted over; garage door paint mismatched; drive cracked, pot holes; vents rusted;

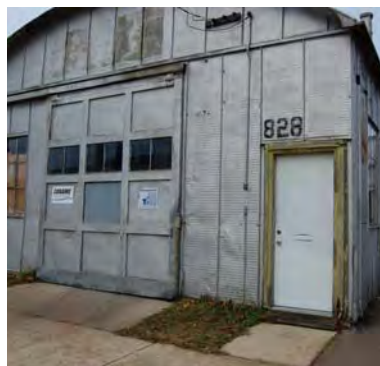
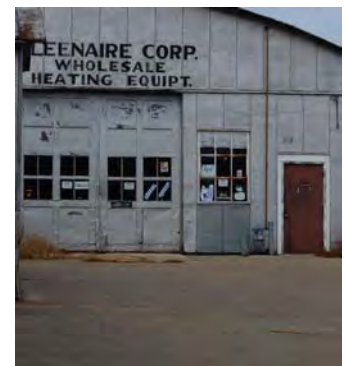
Parcel 35

Score: 43.5

Cladding rusted, dented, curling; roof rusted, metal missing; window frames rusted; some windows painted over/covered with cardboard from the inside; drive cracked, overgrown; vacant

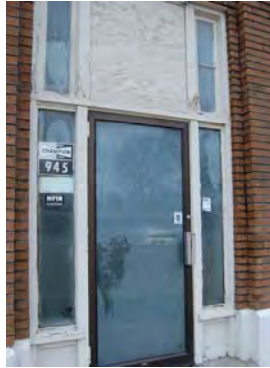
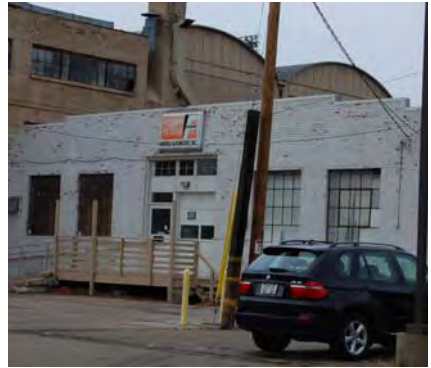
Paint peeling from walls; some windows boarded; paint peeling from window frames and doors; signage missing; cracks in asphalt lot; vacant

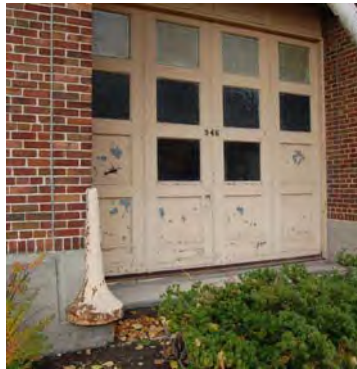
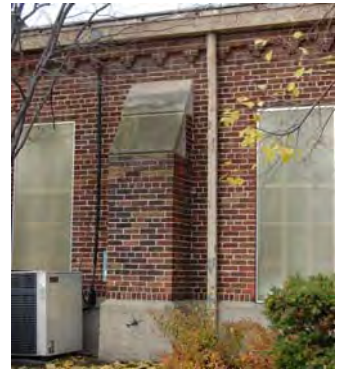
Parcel 17

Score: 35.3

Graffiti; walls-concrete stained, bricks discolored; cracks in foundation; gutter rusted, debris-filled; windows dirty and rusted, covered from inside; door frame rusted, paint peeling; graffiti on drive; vacant

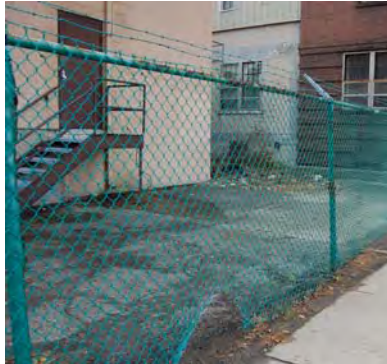
Parcel 19(1)

Score: 33.2

Foundation of main building worn, discolored, cracked and crumbling; graffiti; discolored and mismatched brick; metal siding graffitied; paint wearing; broken window panes; rusted framing; dock doors dirty; minor cracks and cosmetic damage to 910 building; chainlink rusted and bent; access drive in poor shape; many buildings vacant/unused

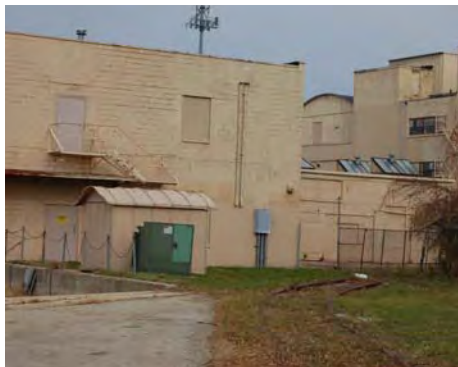
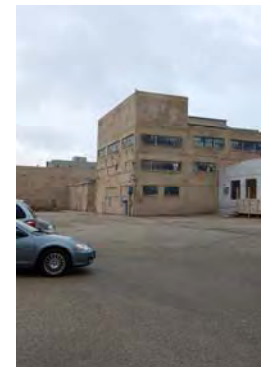
Parcel 19(2)

Score: 33.5

Mortar issues on side and brick; broken windows; paint peeling; rusted mullions; exterior doors worn, dirty; loading dock in poor shape; signage rusted; asphalt cracked/potholes; lawn and landscaping not maintained in back; graffiti; many buildings appear vacant/unused

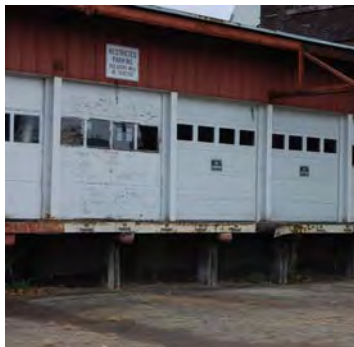
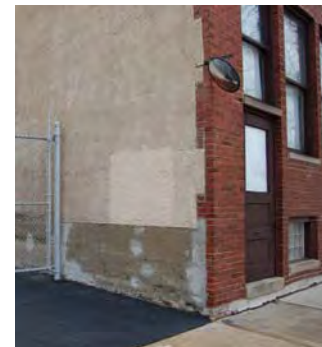
Parcel 20

Score: 40.1

Foundation cracked, crumbling; wood siding broken; mismatched wall paint; some windows broken; dock doors curling; dock rusted; screening missing; parking lot cracked; graffiti; litter/debris; partially vacant

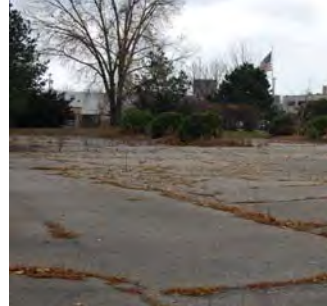
Fence rusted, bent; lot overgrown; pavement significantly deteriorated; graffiti; litter; vacant

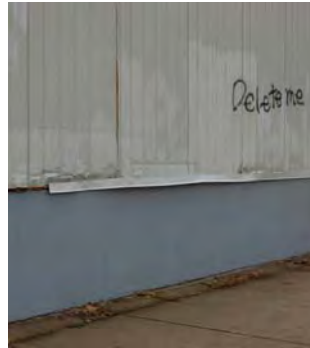
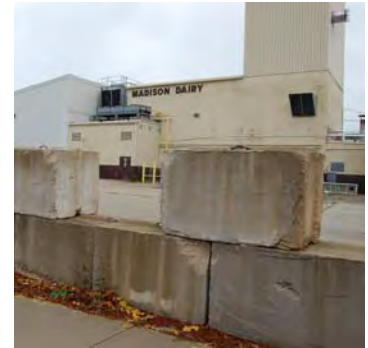
Parcel 24

Score: 55.2

Paint peeling from walls, cracks in concrete; siding missing; graffiti; vents and dock doors rusted; slats missing from fence; asphalt lot cracked, pot holes; rusted and crumbling concrete blocks blocking drive; weeds around base of building

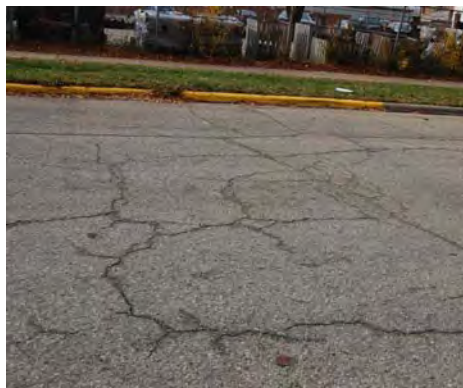
Paterson St at Main St (Fair condition)

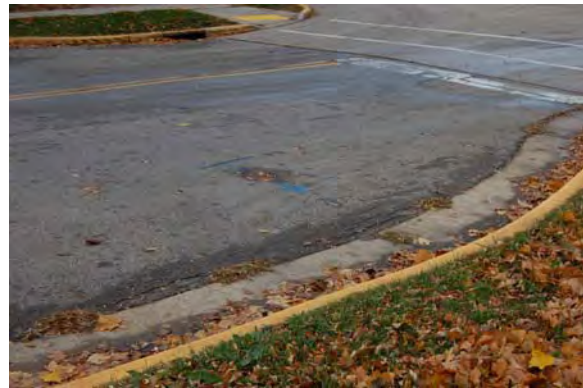
Brearly at E Washington (Good condition)

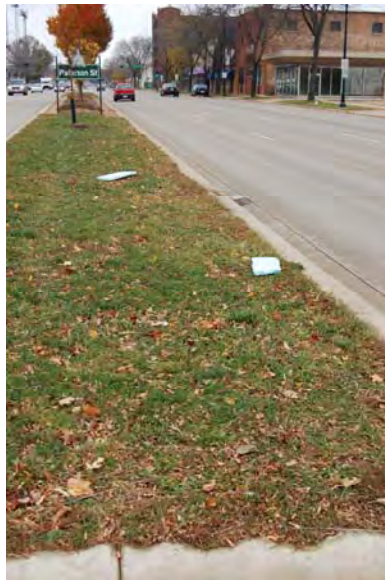
E Washington looking NE (litter)
