Deller Conservation

Annie C. Stewart Memorial Fountain

Condition Assessment and Treatment Proposal

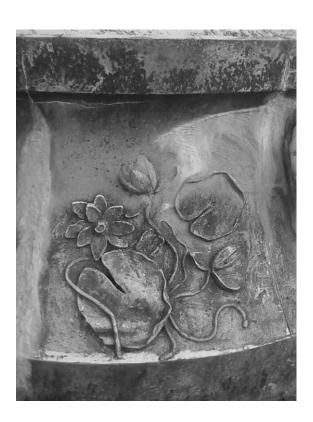
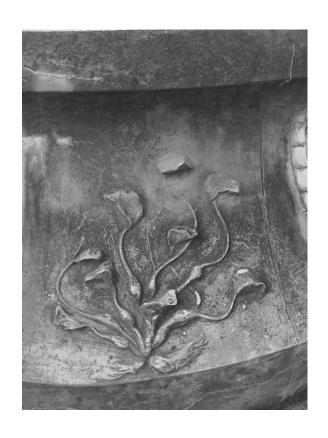
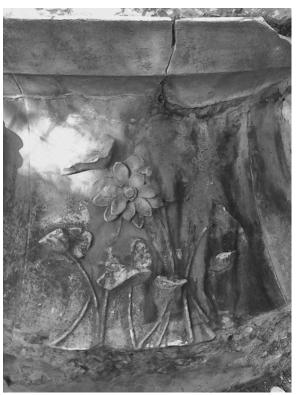
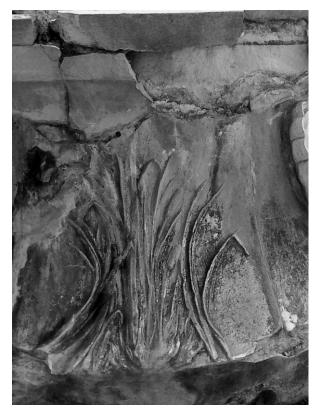
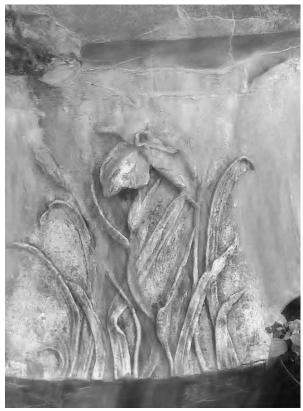
Bas-Relief Photos:

- The decorative bas-relief carvings of various flora are to be molded for later casting. There are 6 (six) carvings which are all different. (see attached photos). Therefore 6 (six) separate molds will be made, one of each. Due to the poor execution of the cement rendering, the detail of the bas-relief carvings are muted. Once the molds are made, an initial cast of plaster will be created so they may be re-carved to enhance the details and then re-molded and cast in fiber-reinforced concrete. (see note on concrete recommendations)

- The condition of the existing concrete base has been determined to be unsound and of no significant historical context with the exception of the bas-relief flora and protruding shells. Therefore, the existing concrete will be removed and replaced including the newly cast shells and bas-relief flora. With the removal of the existing concrete base, there is no need to analyze the existing by previously proposed X-Ray Diffraction (XRD).
