Certificate of Appropriateness for 128 W Johnson St.

Proposed Work

Holy Redeemer Church

128 W. Johnson Street

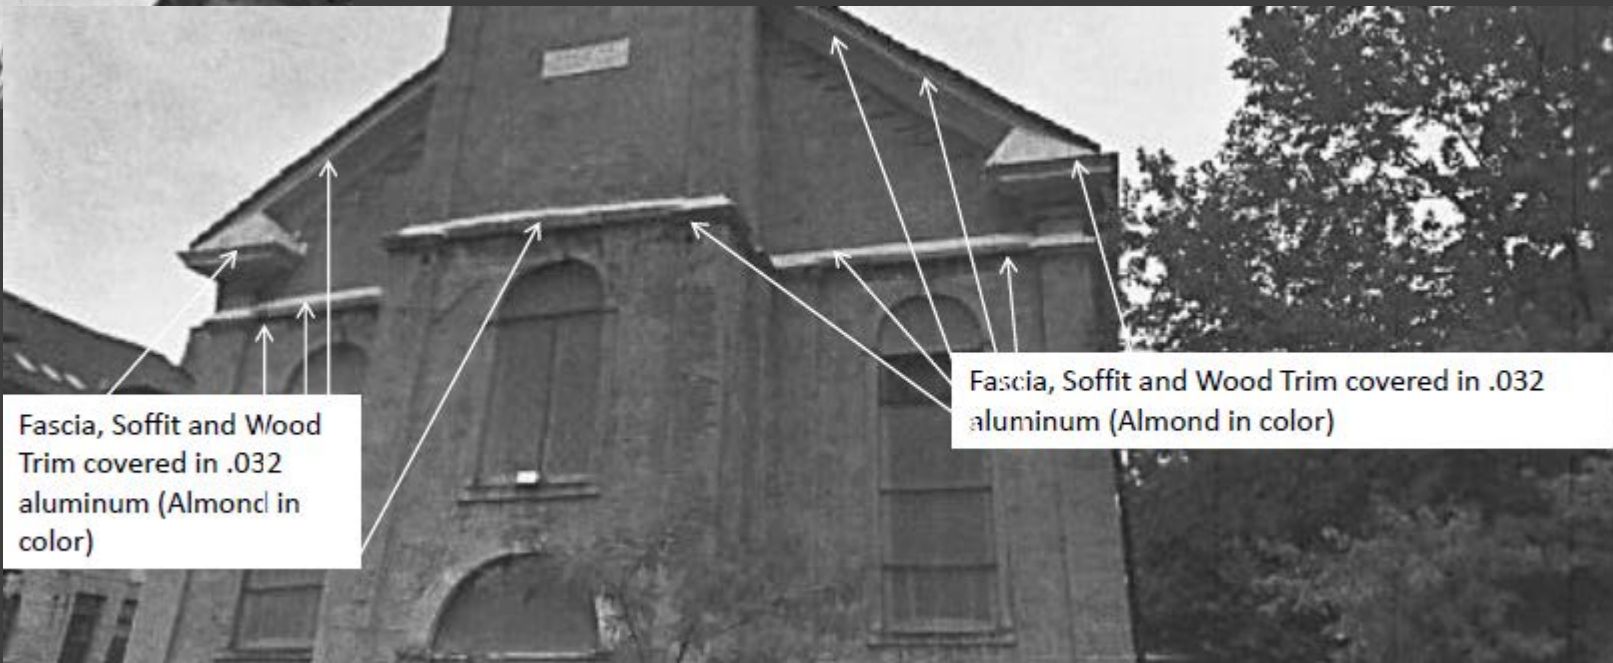
Fascia, Soffit and Wood Trim covered in .032 aluminum (Almond in color)
