# 216 S. HAMILTON ST. MADISON, WI

**ANALYSIS & SUMMARY**

## 216 S Hamilton St., Condition Report

## 216 S. Hamilton St. Gabriel Bjornson House Supplemental Research

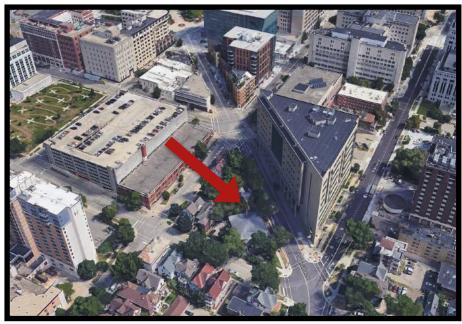
The gabled ell has a distinctive "L" shape, which creates a front gable and a side gable. The Gabled Ell was a common house style from about 1870 to 1910. They could be quite simple or very decorative, which created houses with various stylistic elements such as bracketing, fishscale shingling, aingerbread, and Queen Anne style windows with stained glass.

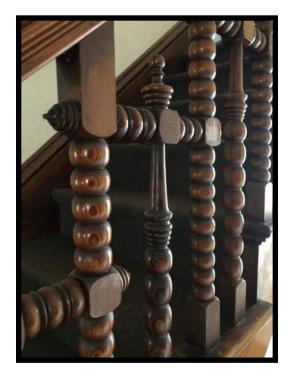
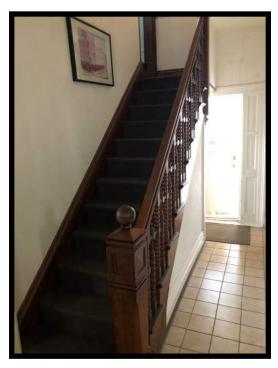
Stair Balustrade

Stained Glass at top of stairs

Stained alass facina S. Hamilton St.

We recommend salvage and reusing the 3 character defining features of the existing structure (2 windows and balustrade) for other houses of a similar type in Madison, the demolition of the existing structure and replacement with a Live/Work building that reflects the changing uses of the Downtown and S. Hamilton block, improves the pedestrian experience, and provides ancillary support spaces for the Courthouse.

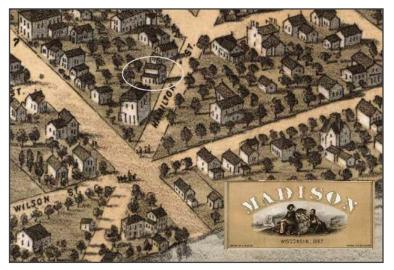
Bird's eye drawing of Madison, 1867

The 1867 bird's-eye drawing that Rankin and Miller refer to (excerpted here) shows a house at that location that is a two-story front-gabled house with a side porch, but without the ell that exists today. It should be noted that bird's-eye drawings from this period are not noted for their accuracy at the level of the common residential building.

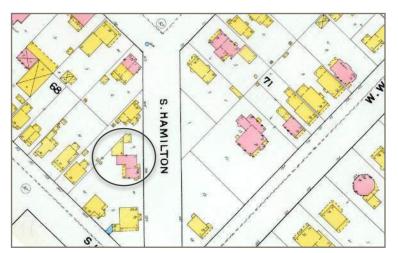
Sanborn Fire Insurance map - 1892 Pink is masonry. Yellow is wood frame

It is certain that by 1892 both masonry sections of the house that exist today were in place. The Sanborn Fire Insurance map of the area published that year show a masonry structure with the same footprint occupied by the house today. It also shows a wood frame section attached to the northwestern elevation of the one-story section. That frame section is not extant.

an ell elongated to the rear. The house represents the Gabled Ell form well with its upright, two-story, front-gabled section, one-story wing extending from one side, and the entry porch located at the intersection of the two.

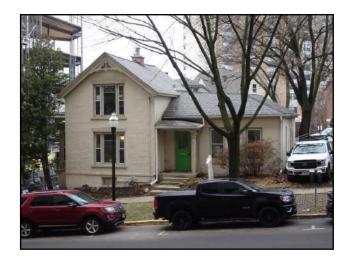
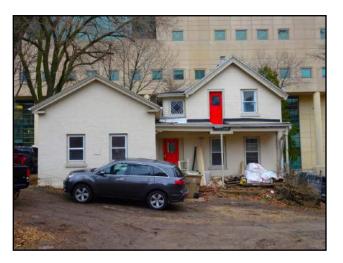
The form typically consists of two masses, of similar or different heights, set at a perpendicular angle to each other, with the main entrance under a porch or portico at the intersection of the two masses. The dominant mass, usually built with a gable end facing the front, typically contained formal and private spaces. The deferential mass (the ell) typically contained the kitchen and informal or private spaces. Stylistic treatments were commonly applied to the exterior, and reflected what was popular at the time and in the region. Given the temporal range of the form's occurrence in Wisconsin, style often exhibits the influence of the Greek Revival, Gothic Revival, or Queen Anne.

The Gabled Ell, as a vernacular form of construction, was ubiquitous throughout the United States, especially in rural areas and small towns as settlement spread from east to west. The form reached the height of popularity from 1870 through about 1920. The temporal prevalence of the form in Madison corresponds with this trend.
