REVISED 01.04.2021

**216 S. HAMILTON ST.
MADISON, WI**

ANALYSIS & SUMMARY

Prepared for:
Courtside Development, llc

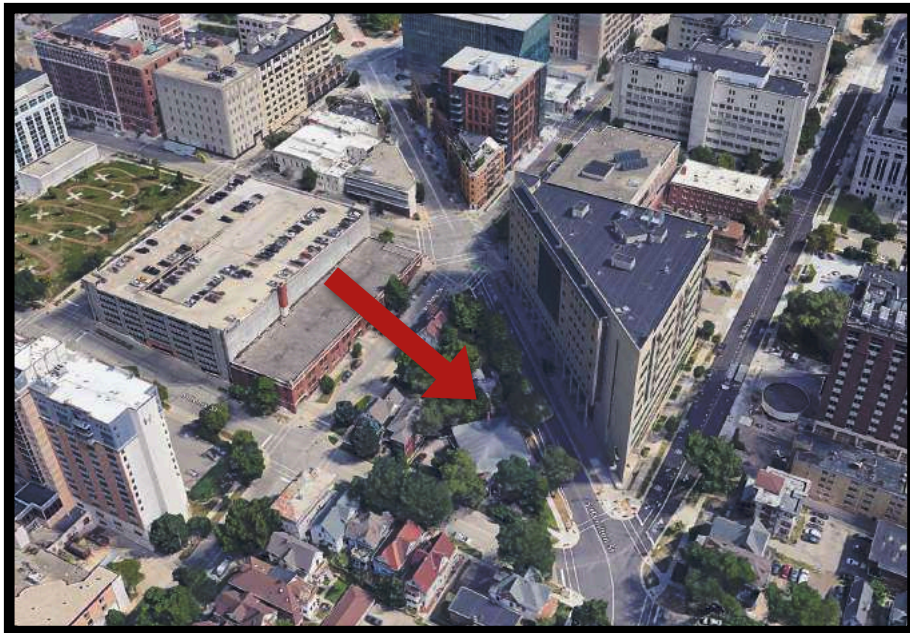
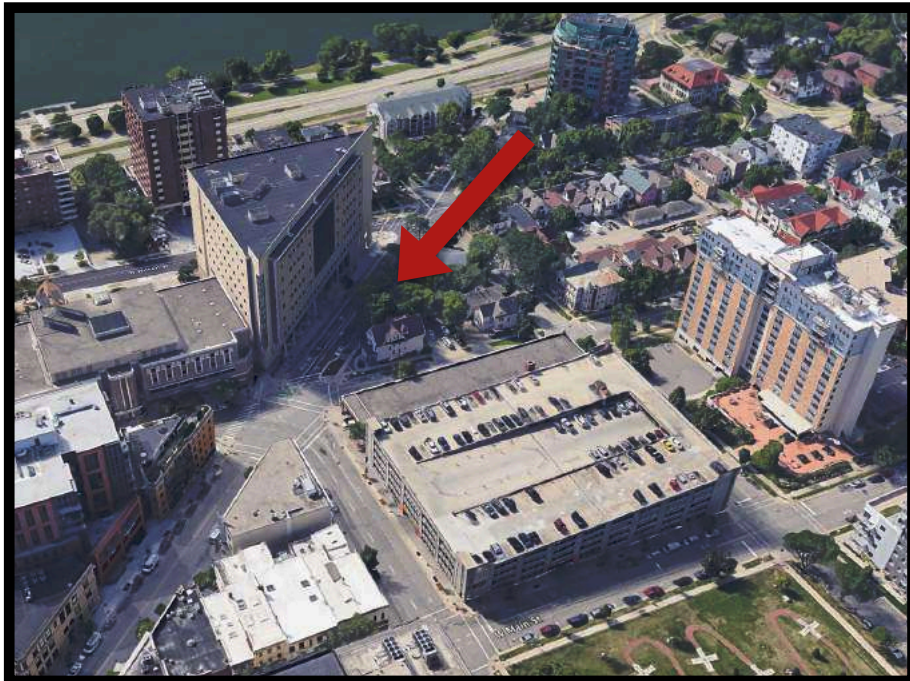
The Gabled ell has a distinctive "L" shape, which creates a front gable and a side gable. The Gabled Ell was a common house style from about 1870 to 1910. They could be quite simple or very decorative, which created houses with various stylistic elements such as bracketing, fishscale shingling, gingerbread, and Queen Anne style windows with stained glass.

- "L" shaped with a front and side gable.
- (3) Windows with stained glass.
- Vernacular Wood Stair Balustrade

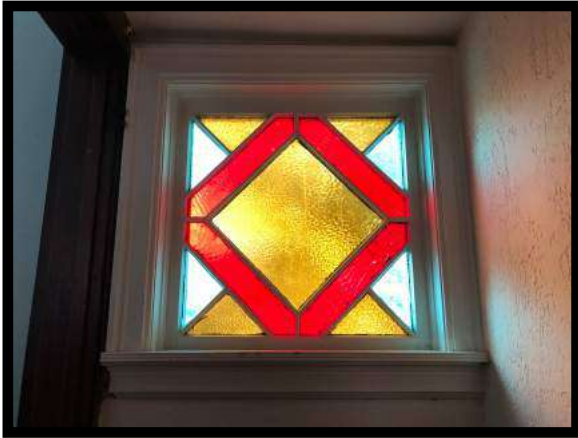
Stained Glass at top of stairs

We recommend salvage and reusing the 3 character defining features of the existing structure (2 windows and balustrade) for other houses of a similar type in Madison, the demolition of the existing structure and replacement with a Live/Work building that reflects the changing uses of the Downtown and S. Hamilton block, improves the pedestrian experience, and provides ancillary support spaces for the Courthouse.

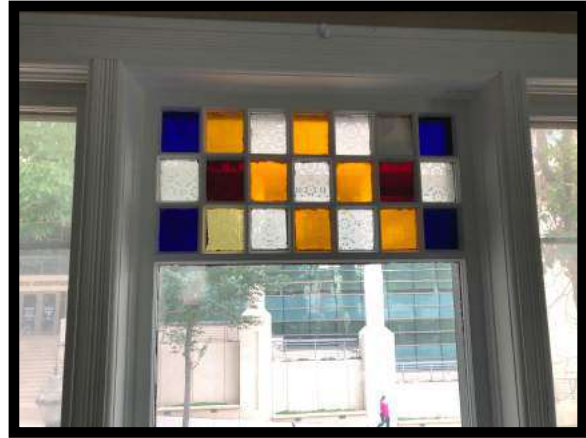
Stained glass facade S. Hamilton St.

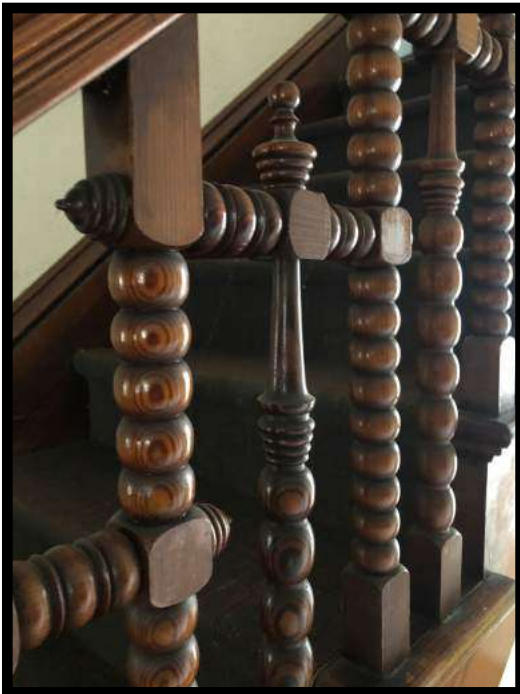
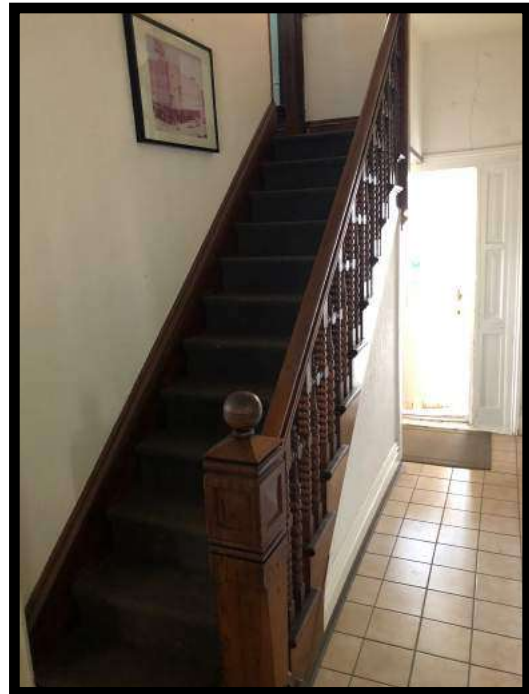
Stair Balustrade

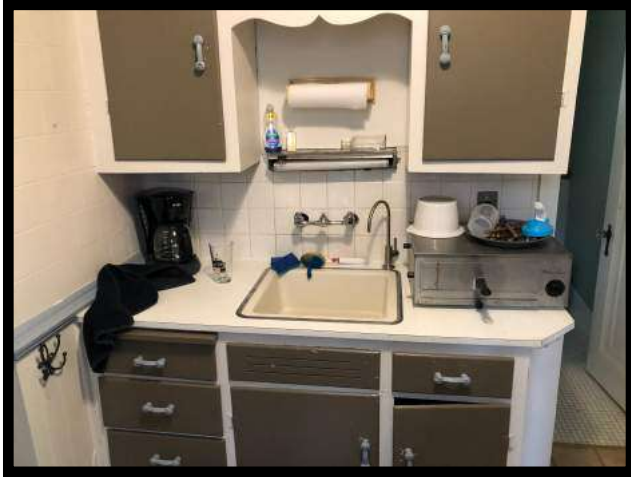
Existing Kitchen

- New code compliant Kitchen (currently only has a sink)
- New code compliant Shower/tub(s)
- Window replacement (approx. 60% of windows)
- Electrical upgrades
- Exterior work-brick pointing and roof/fascia repair
- Foundation repair

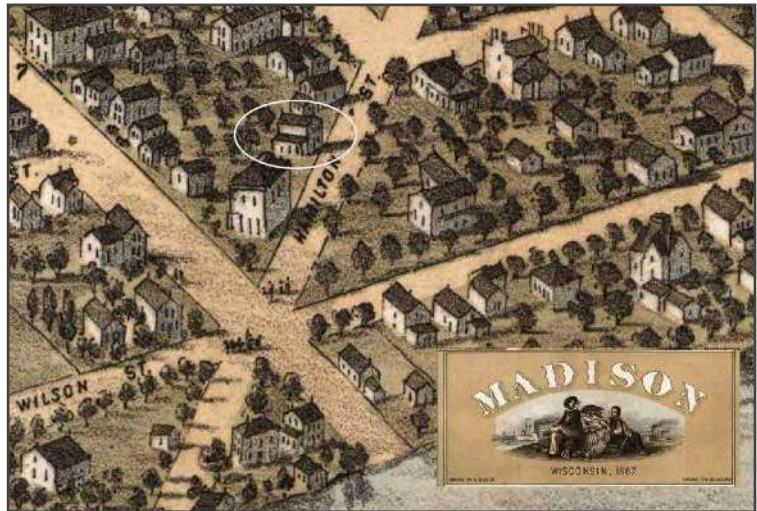
Bird's eye drawing of Madison, 1867

The 1867 bird's-eye drawing that Rankin and Miller refer to (excerpted here) shows a house at that location that is a two-story front-gabled house with a side porch, but without the ell that exists today. It should be noted that bird's-eye drawings from this period are not noted for their accuracy at the level of the common residential building.

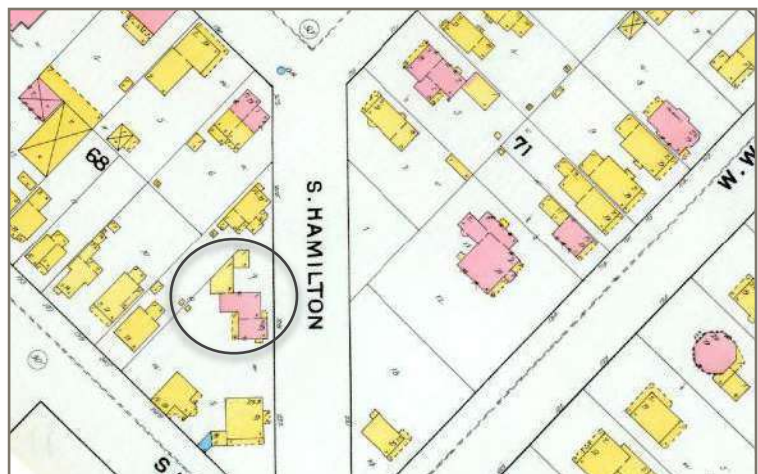
It is certain that by 1892 both masonry sections of the house that exist today were in place. The Sanborn Fire Insurance map of the area published that year show a masonry structure with the same footprint occupied by the house today. It also shows a wood frame section attached to the northwestern elevation of the one-story section. That frame section is not extant.

*Sanborn Fire Insurance map - 1892
Pink is masonry. Yellow is wood frame*

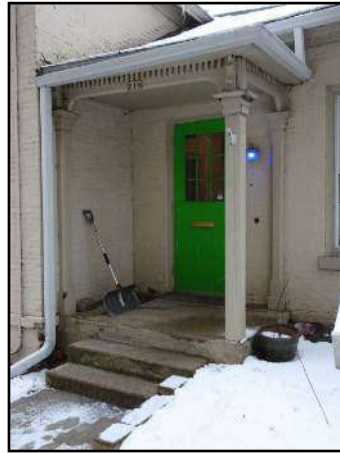
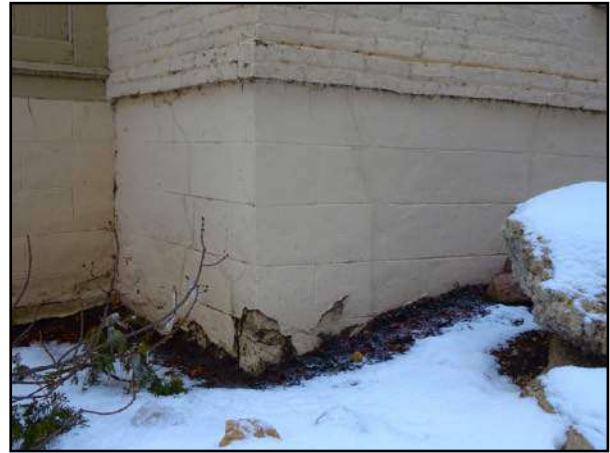
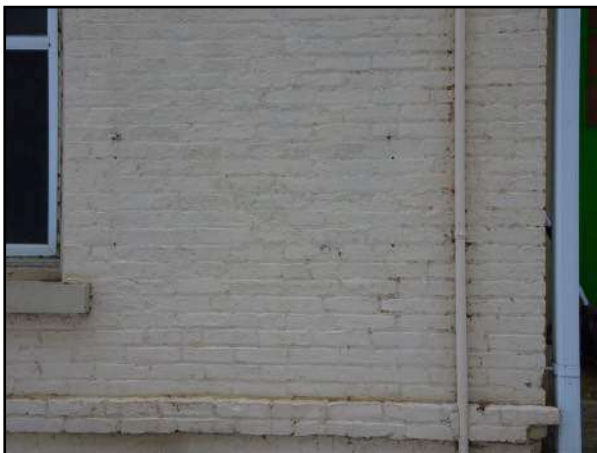
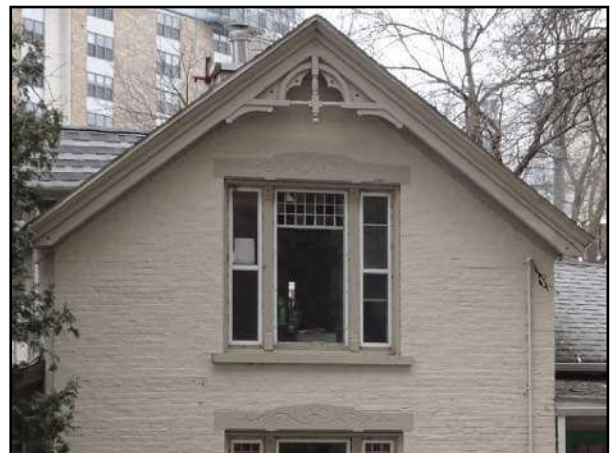
- Materials:* The house does not retain integrity of materials. Most exterior materials from the period of construction and early decades are extant, but much of it has been obscured by the application of other materials. Brick cladding has been painted, but still shows the its course pattern and orientation. Irregular limestone foundation materials, once exposed on the facade, have been covered with a skim coat, incised to mimic dimensioned masonry units. Some extant exterior materials appear to date to the period of construction or the early decades of the

house's life: decorative concrete window headers, decorative barge board and fascia boards, a bay window (obscured by foliage), and window mullions. We did not have access to the interior of the house, so our evaluation of interior materials is dependent on photos included in the *Populance* report. Interior materials that might be associated with an early period of significance are largely gone. There are some windows with decorative colored glass, and a decorative stairway balustrade that likely date to the time of construction. The wood entrance portico is difficult to date without close examination of its materials. Stylistically, it could date to the first 40 years of the house's existence. It could also be a later construction designed to match the style of the house.
