**216 S. HAMILTON ST.  
MADISON, WI**

**ANALYSIS & SUMMARY**

Prepared for:  
**Courtside Development, llc**

# 216 S Hamilton St., Condition Report

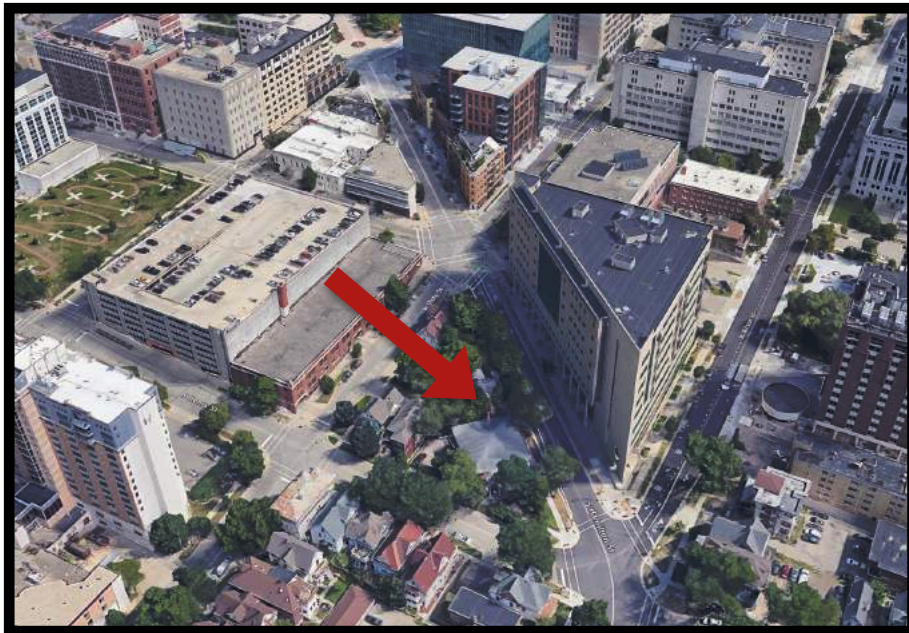
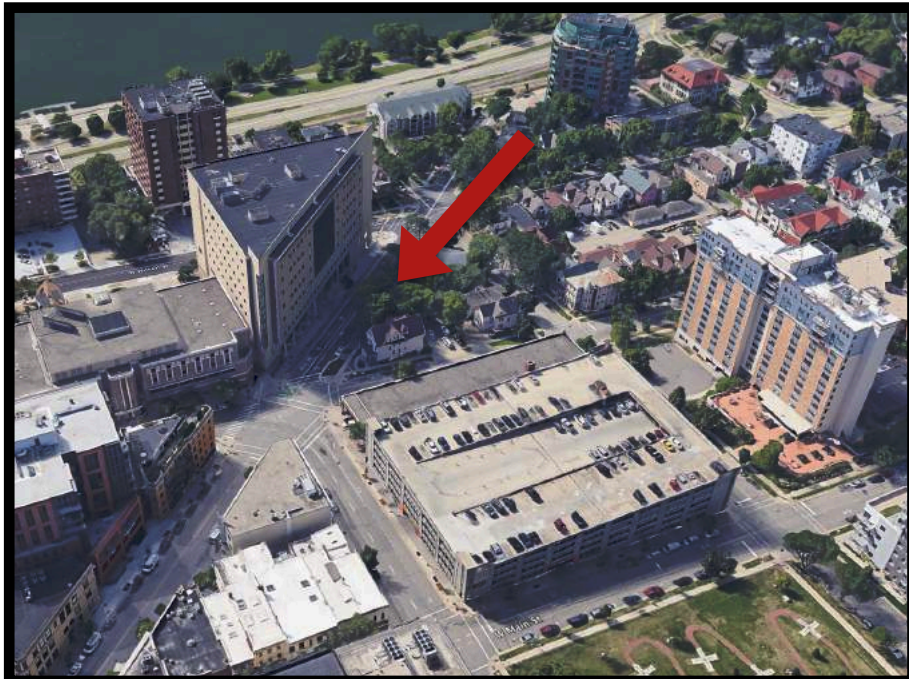
The Gabled ell has a distinctive "L" shape, which creates a front gable and a side gable. The Gabled Ell was a common house style from about 1870 to 1910. They could be quite simple or very decorative, which created houses with various stylistic elements such as bracketing, fishscale shingling, gingerbread, and Queen Anne style windows with stained glass.

- "L" shaped with a front and side gable.
- (3) Windows with stained glass.
- Vernacular Wood Stair Balustrade

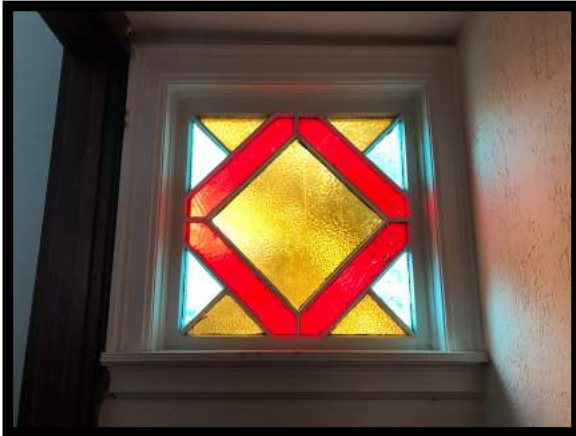
Stained Glass at top of stairs

We recommend salvage and reusing the 3 character defining features of the existing structure (2 windows and balustrade) for other houses of a similar type in Madison, the demolition of the existing structure and replacement with a Live/Work building that reflects the changing uses of the Downtown and S. Hamilton block, improves the pedestrian experience, and provides ancillary support spaces for the Courthouse.

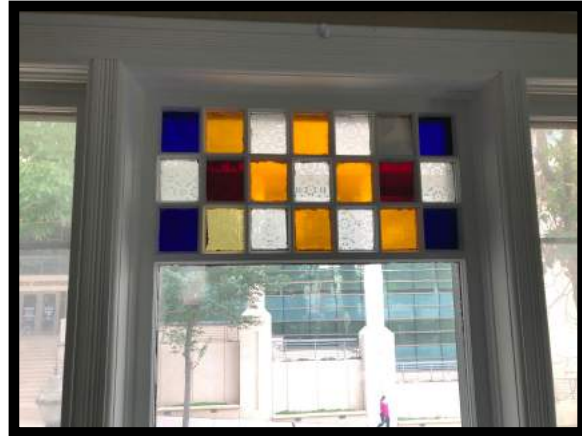
Stained glass facade S. Hamilton St.

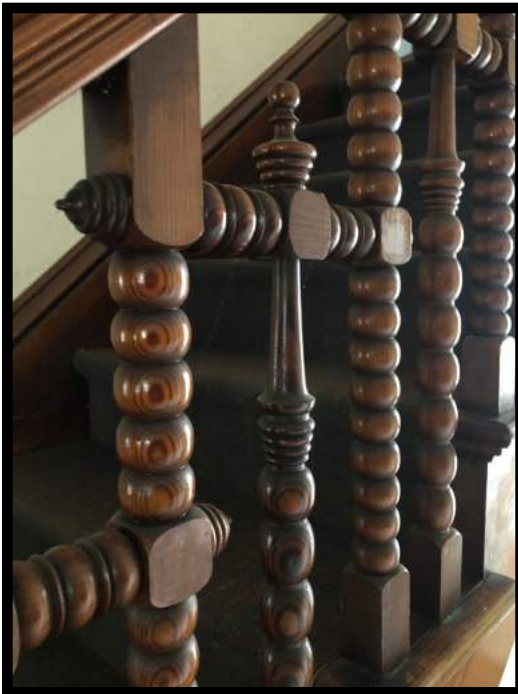
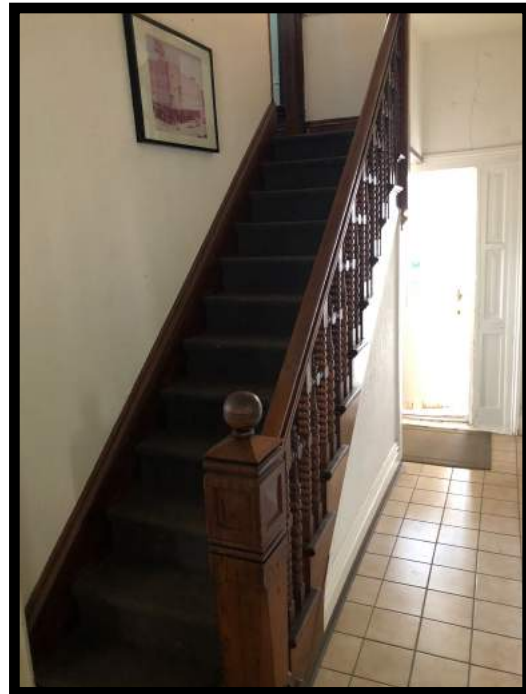
Stair Balustrade

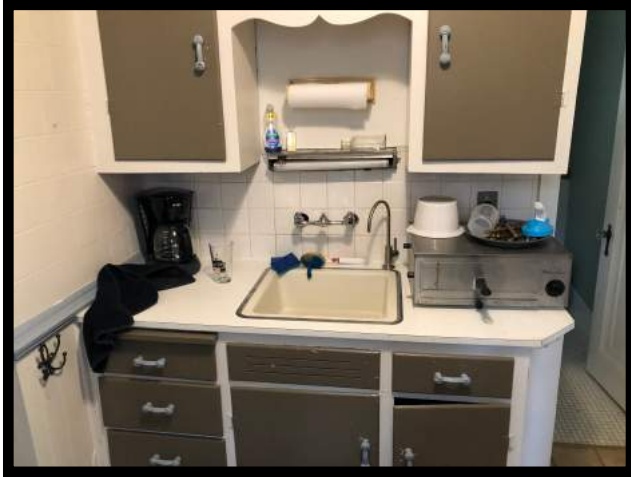
Existing Kitchen

- New code compliant Kitchen (currently only has a sink)
- New code compliant Shower/tub(s)
- Window replacement (approx. 60% of windows)
- Electrical upgrades
- Exterior work-brick pointing and roof/fascia repair
- Foundation repair

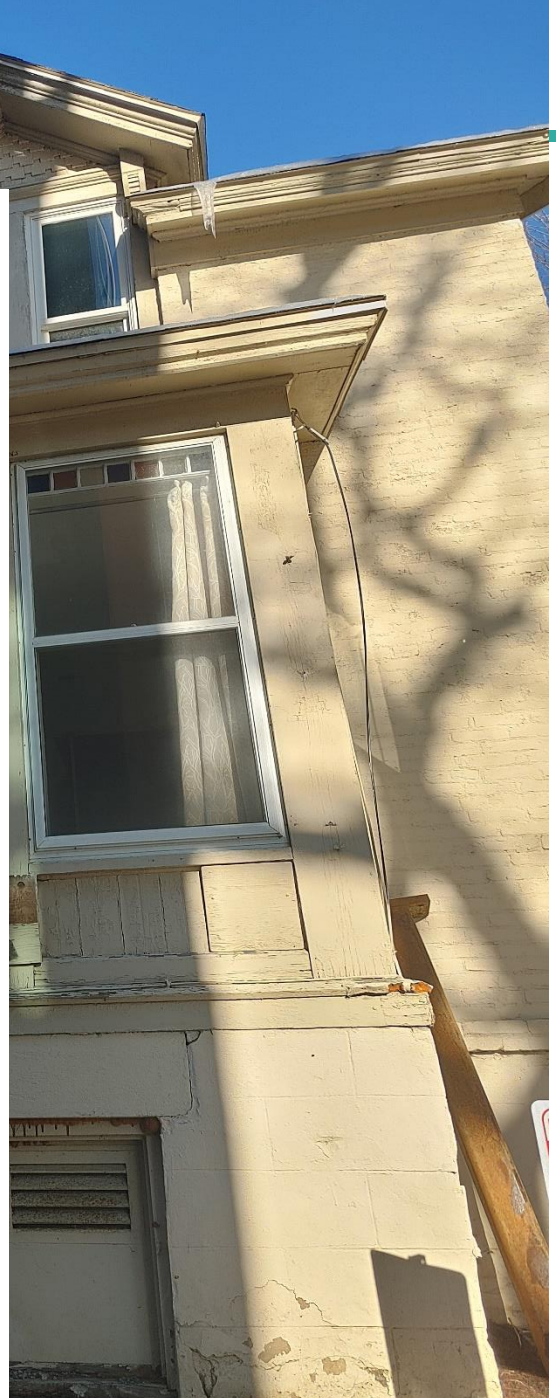
## Structural issues (all present in 2016)

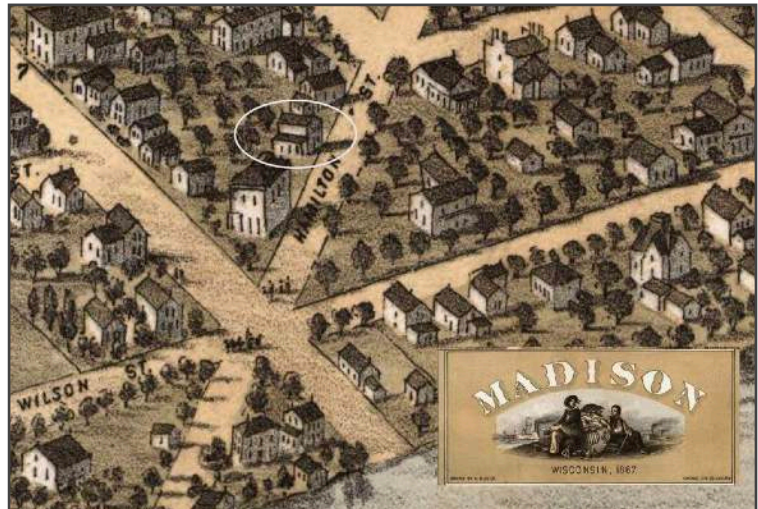
*Bird's eye drawing of Madison, 1867*

The 1867 bird's-eye drawing that Rankin and Miller refer to (excerpted here) shows a house at that location that is a two-story front-gabled house with a side porch, but without the ell that exists today. It should be noted that bird's-eye drawings from this period are not noted for their accuracy at the level of the common residential building.

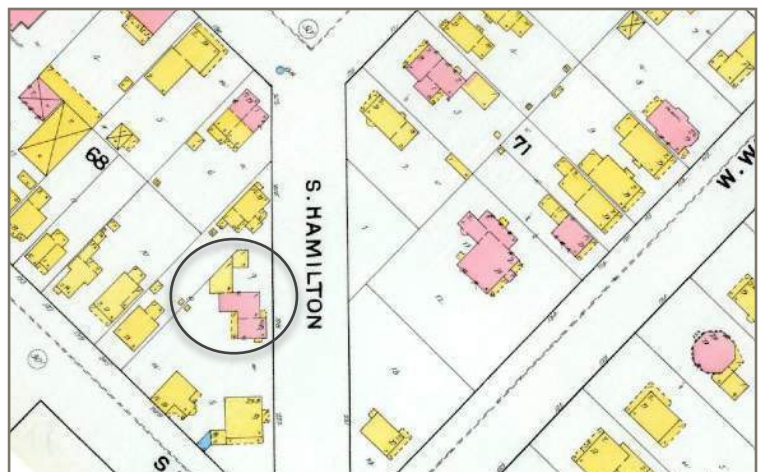
It is certain that by 1892 both masonry sections of the house that exist today were in place. The Sanborn Fire Insurance map of the area published that year show a masonry structure with the same footprint occupied by the house today. It also shows a wood frame section attached to the northwestern elevation of the one-story section. That frame section is not extant.

*Sanborn Fire Insurance map - 1892  
Pink is masonry. Yellow is wood frame*

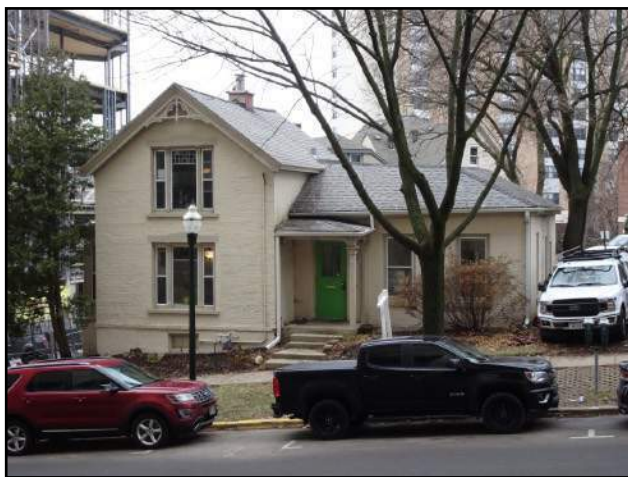
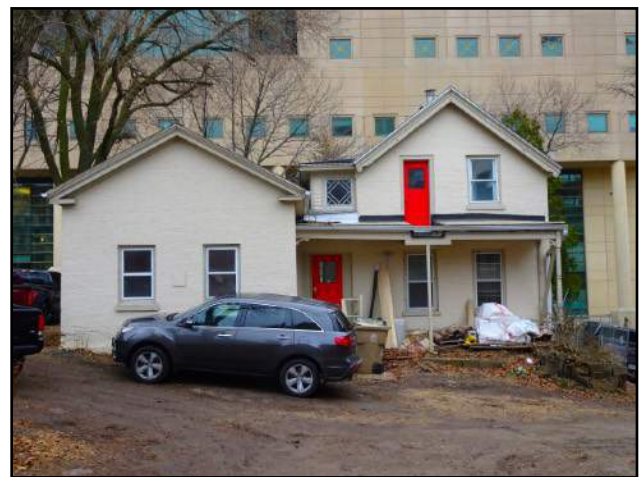
The form typically consists of two masses, of similar or different heights, set at a perpendicular angle to each other, with the main entrance under a porch or portico at the intersection of the two masses. The dominant mass, usually built with a gable end facing the front, typically contained formal and private spaces. The deferential mass (the ell) typically contained the kitchen and informal or private spaces.<sup>26</sup> Stylistic treatments were commonly applied to the exterior, and reflected what was popular at the time and in the region. Given the temporal range of the form's occurrence in Wisconsin, style often exhibits the influence of the Greek Revival, Gothic Revival, or Queen Anne.

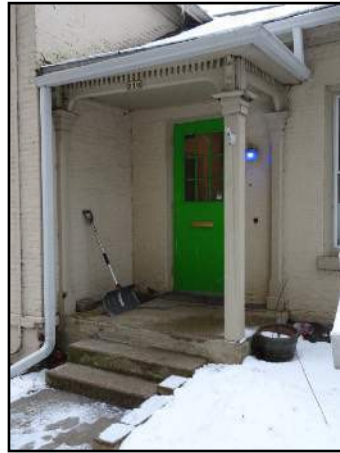
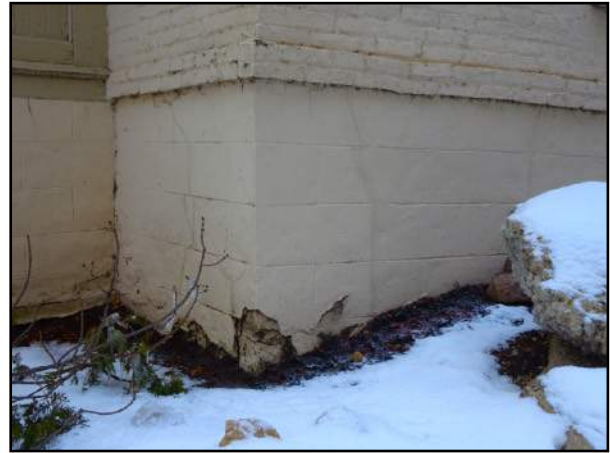
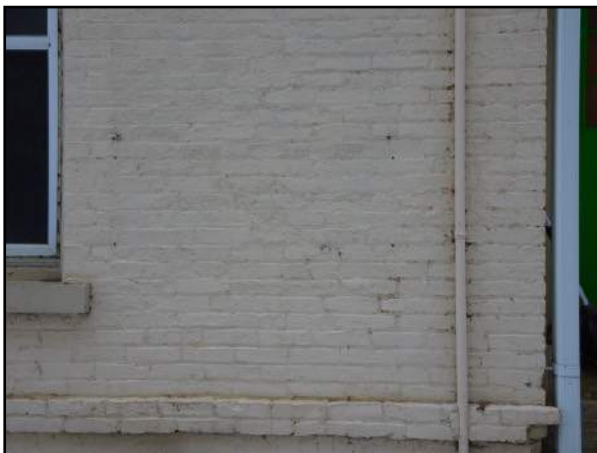
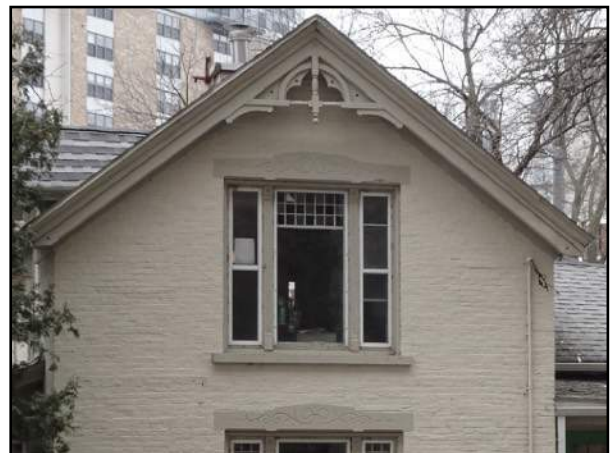
- Materials:* The house does not retain integrity of materials. Most exterior materials from the period of construction and early decades are extant, but much of it has been obscured by the application of other materials. Brick cladding has been painted, but still shows the its course pattern and orientation. Irregular limestone foundation materials, once exposed on the facade, have been covered with a skim coat, incised to mimic dimensioned masonry units. Some extant exterior materials appear to date to the period of construction or the early decades of the

house's life: decorative concrete window headers, decorative barge board and fascia boards, a bay window (obscured by foliage), and window mullions. We did not have access to the interior of the house, so our evaluation of interior materials is dependent on photos included in the *Populance* report. Interior materials that might be associated with an early period of significance are largely gone. There are some windows with decorative colored glass, and a decorative stairway balustrade that likely date to the time of construction. The wood entrance portico is difficult to date without close examination of its materials. Stylistically, it could date to the first 40 years of the house's existence. It could also be a later construction designed to match the style of the house.
