**Historic Preservation Assessment**  
of  
**7 North Franklin Street**  
and  
**502 & 506 East Washington Avenue**  
Madison, WI

November 2017

Re: Assessment of 502 and 506 East Washington Avenue & 7 North Franklin Street  
Madison, WI

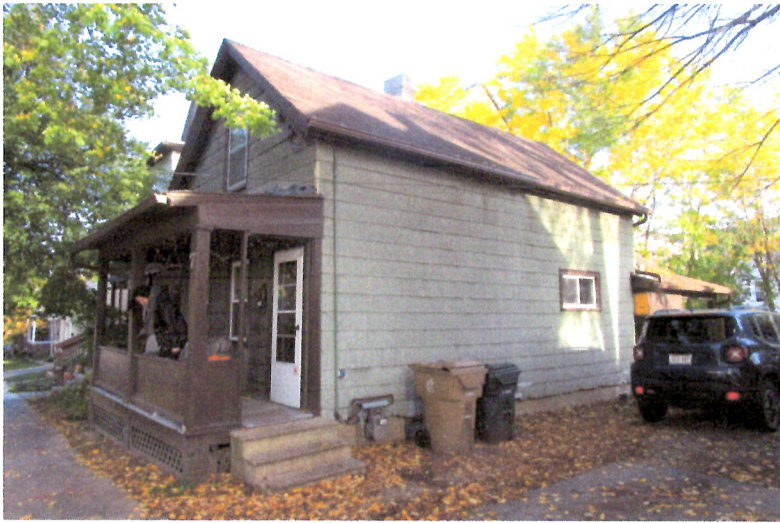
*View of the front of 7 North Franklin Street*

The exteriors of the house retains its primary form but has lost portions of the defining elements, details and finishes as they are covered by an asphalt fiber board siding. The front and side porches appear to be original to the house, but need structural repairs. Windows are non-original vinyl units.

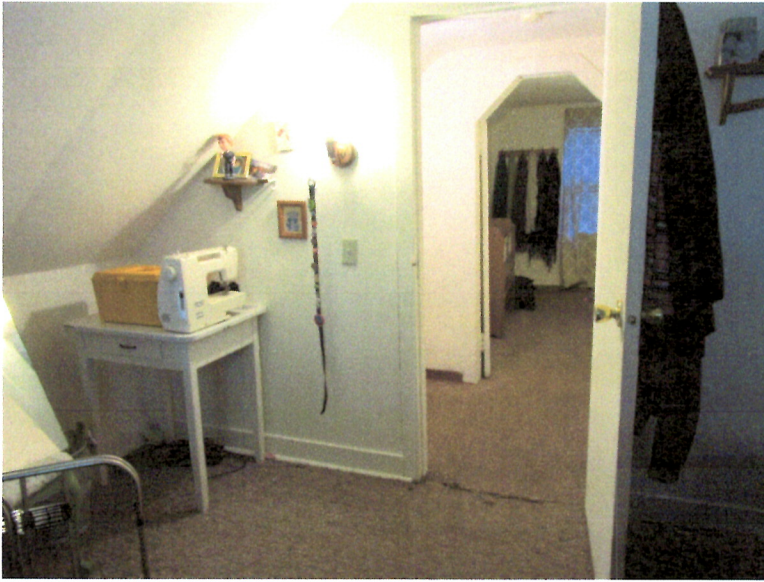
*View of second floor level. Note the low ceilings and half height side walls.*

The second floor features low ceilings and half height side walls. There two bedrooms and no baths on this level.
