City of Madison

**Madison Municipal
Building
Conceptual
Schematic
Design Study**

November 2013

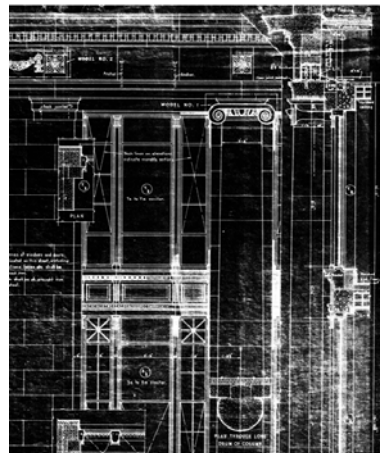
Figure 6 – Original Drawing of Front Window and Wall Section

“The integrity of the building has been affected by the 1979-1982 remodeling. On the exterior, the dark, fixed replacement windows are incompatible with the building as shown in Figure 6. The first floor and basement have been gutted, losing all integrity. However, the second and third floors are intact. While the alterations detract from the building’s architectural character, enough of the original appearance has been retained to lend the building as a fine local example of Neo-Classical Revival design applied to a civic building.”¹

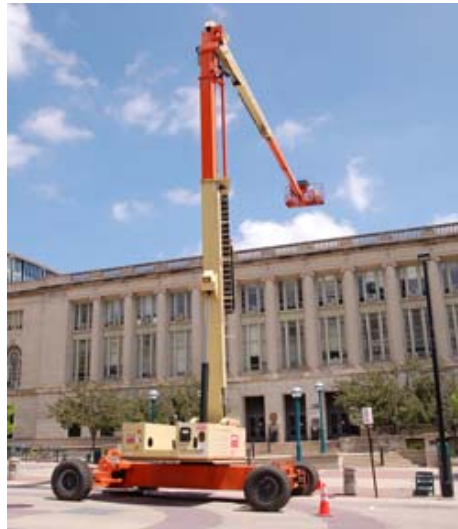
Figure 18 – Boom Lift used for Onsite Survey

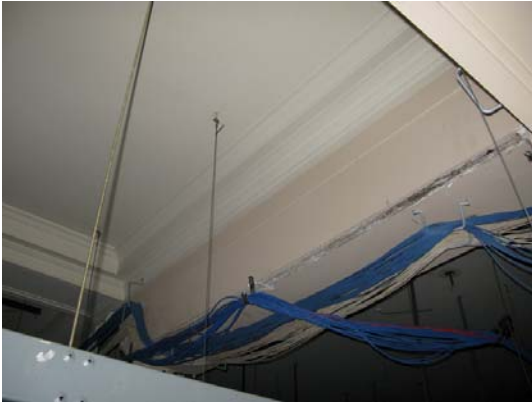
Figure 25 – Original Plaster Ceilings and Decorative Crown Moldings remain above the Suspended Ceilings on the First Floor

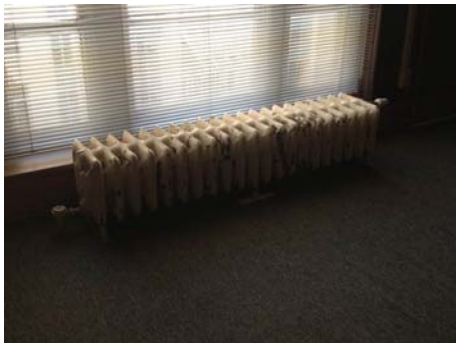
Figure 35 – Steam Radiator

The only temperature controls on second and third floor during heating season is through manually opening or closing the control valve located at each radiator. These radiators and associated steam and condensate piping are approximately eighty-seven years old and are at the end of their expected life. Moisture damage was noted in multiple locations due to radiator leaks, and the radiators have been painted multiple times with paint peeling on all radiators.

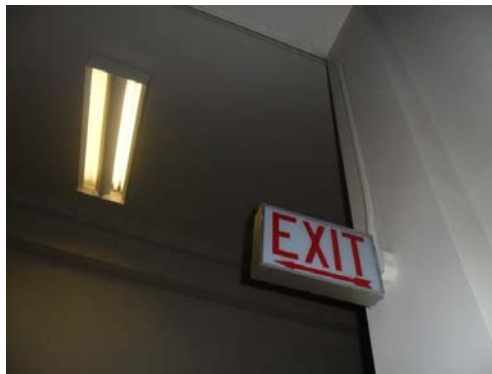
Figure 47 – Exit Sign

The existing electrical system is a 4000 Amp, 120/208V 3-phase, 4-wire service, which is adequate for the facilities current functions and use. This electrical system is most likely more than capable of handling modifications and minor expansions to the existing building, as the majority of new systems are very efficient compared to what is currently installed. The existing lighting is largely outdated, and very inefficient to modern fluorescent and LED fixtures. Fire alarm is dated and may require updates in the near future. All three electrical systems have a fair amount of exposed conduit and junction boxes, especially on second and third floor due to the original block walls and additional system items being added over the years.

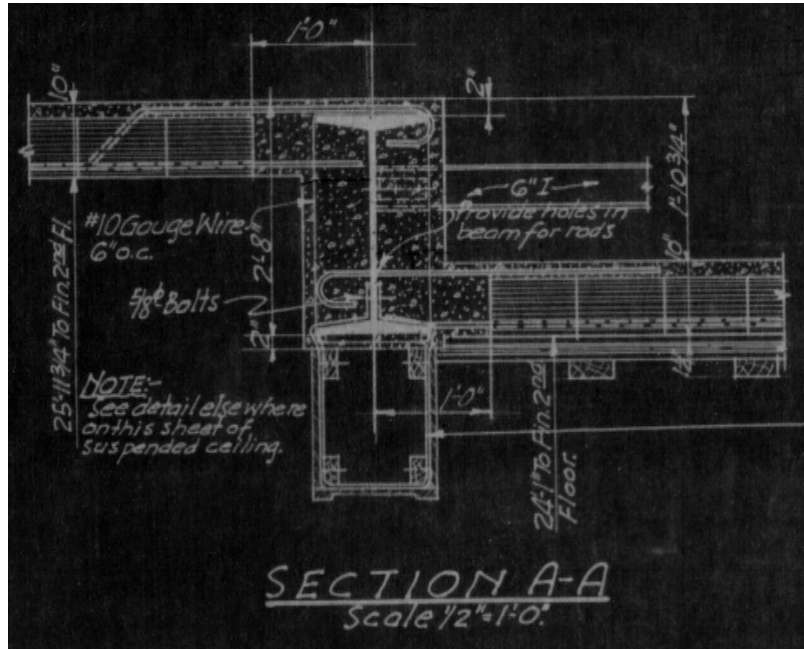
Figure 56 – Recessed Roof Slab at Court Room from Existing Drawings

The old court room on second floor is a two story space. There is an opening in the third floor slab for this space and the existing drawings indicate the roof slab is recessed 1'-10 3/4".

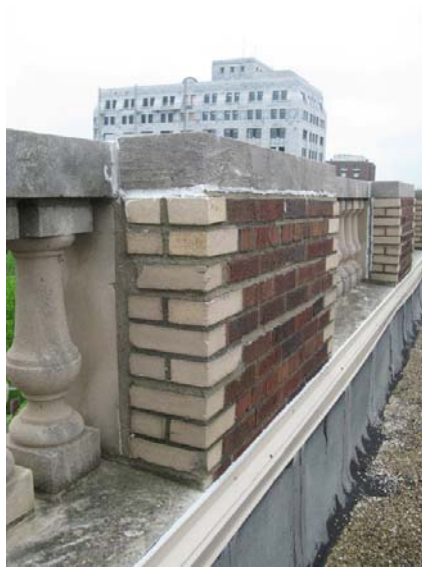
Figure 62 – Brick and Stone Parapet

The brick and stone parapet sits on top of the massive, through-wall stone cornice.

Drawings have not been found to determine how these elements are connected together but standard practice at the time of construction does suggest that some sort of mechanical means was used. It is also not known whether steel anchors were used to tie the stone to the brick inside the parapet. The amount of movement seen in the parapet increases the possibility that rust jacking of steel is occurring; that freeze/thaw of the brick and mortar are not enough to warrant this movement. We recommend a portion of a parapet wall be deconstructed down to the top of a cornice block in order to study and fully understand the dynamics occurring in the wall. From this evaluation we will be able to determine the cause of the movement and what the best methods are to resolve the issues. Adjustment to the shifted portions of the stone cornice is not required since it is very slight and further movement can be arrested. At this time, we do not suggest installing metal on top of the stone coping or cornice as long as the joints are maintained on a regular basis.

Replacement mortar for both re-building and/or re-pointing shall be based on test results taken from mortar samples within the wall. Achieving the correct ratio between sand, lime, Portland cement and water is crucial to getting the correct color and absorptive qualities that will be compatible with the stone. Replacement stone shall also be as close a match to the original as possible so the restored wall works as one unit.

Roof replacement will resolve the water issues at the back wall parapet. Cap flashing replacement at the side and back wall parapet will resolve the balance of the water issues. Reconstruction of the parapet walls in the “U” shape is not required; however, the brick as well as the stone should be completed re-pointed.

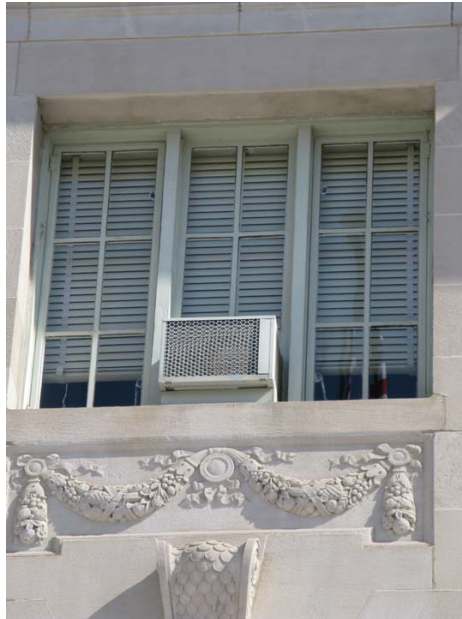
Figure 63 – Steel Window with Stone Carving Decorations

There are no products available today that can replicate the intricacies of these steel windows. Their design and contribution to the overall aesthetics and historic nature of the building is the same as the two-story stone columns on the front elevation. Removal of them would irrevocably harm the character of the building.

A thorough condition survey should be conducted at the Design Development stage to create a comprehensive scope of work for each window. Removal for any reason, including refurbishment, of the cast iron framing members is not recommended as they are imbedded in the stone rough opening and their removal could result in undue damage to the opening. The cast iron should be stripped in place of any existing coatings and re-coated with high quality advance engineered coating products. The steel sashes should be removed, tagged with their individual window opening number and restored off site. All of the hardware should be removed and completely reconditioned including the removal of all paint. The sliding tube hold-opens will properly function after a rigorous clean-up and re-lubing.
