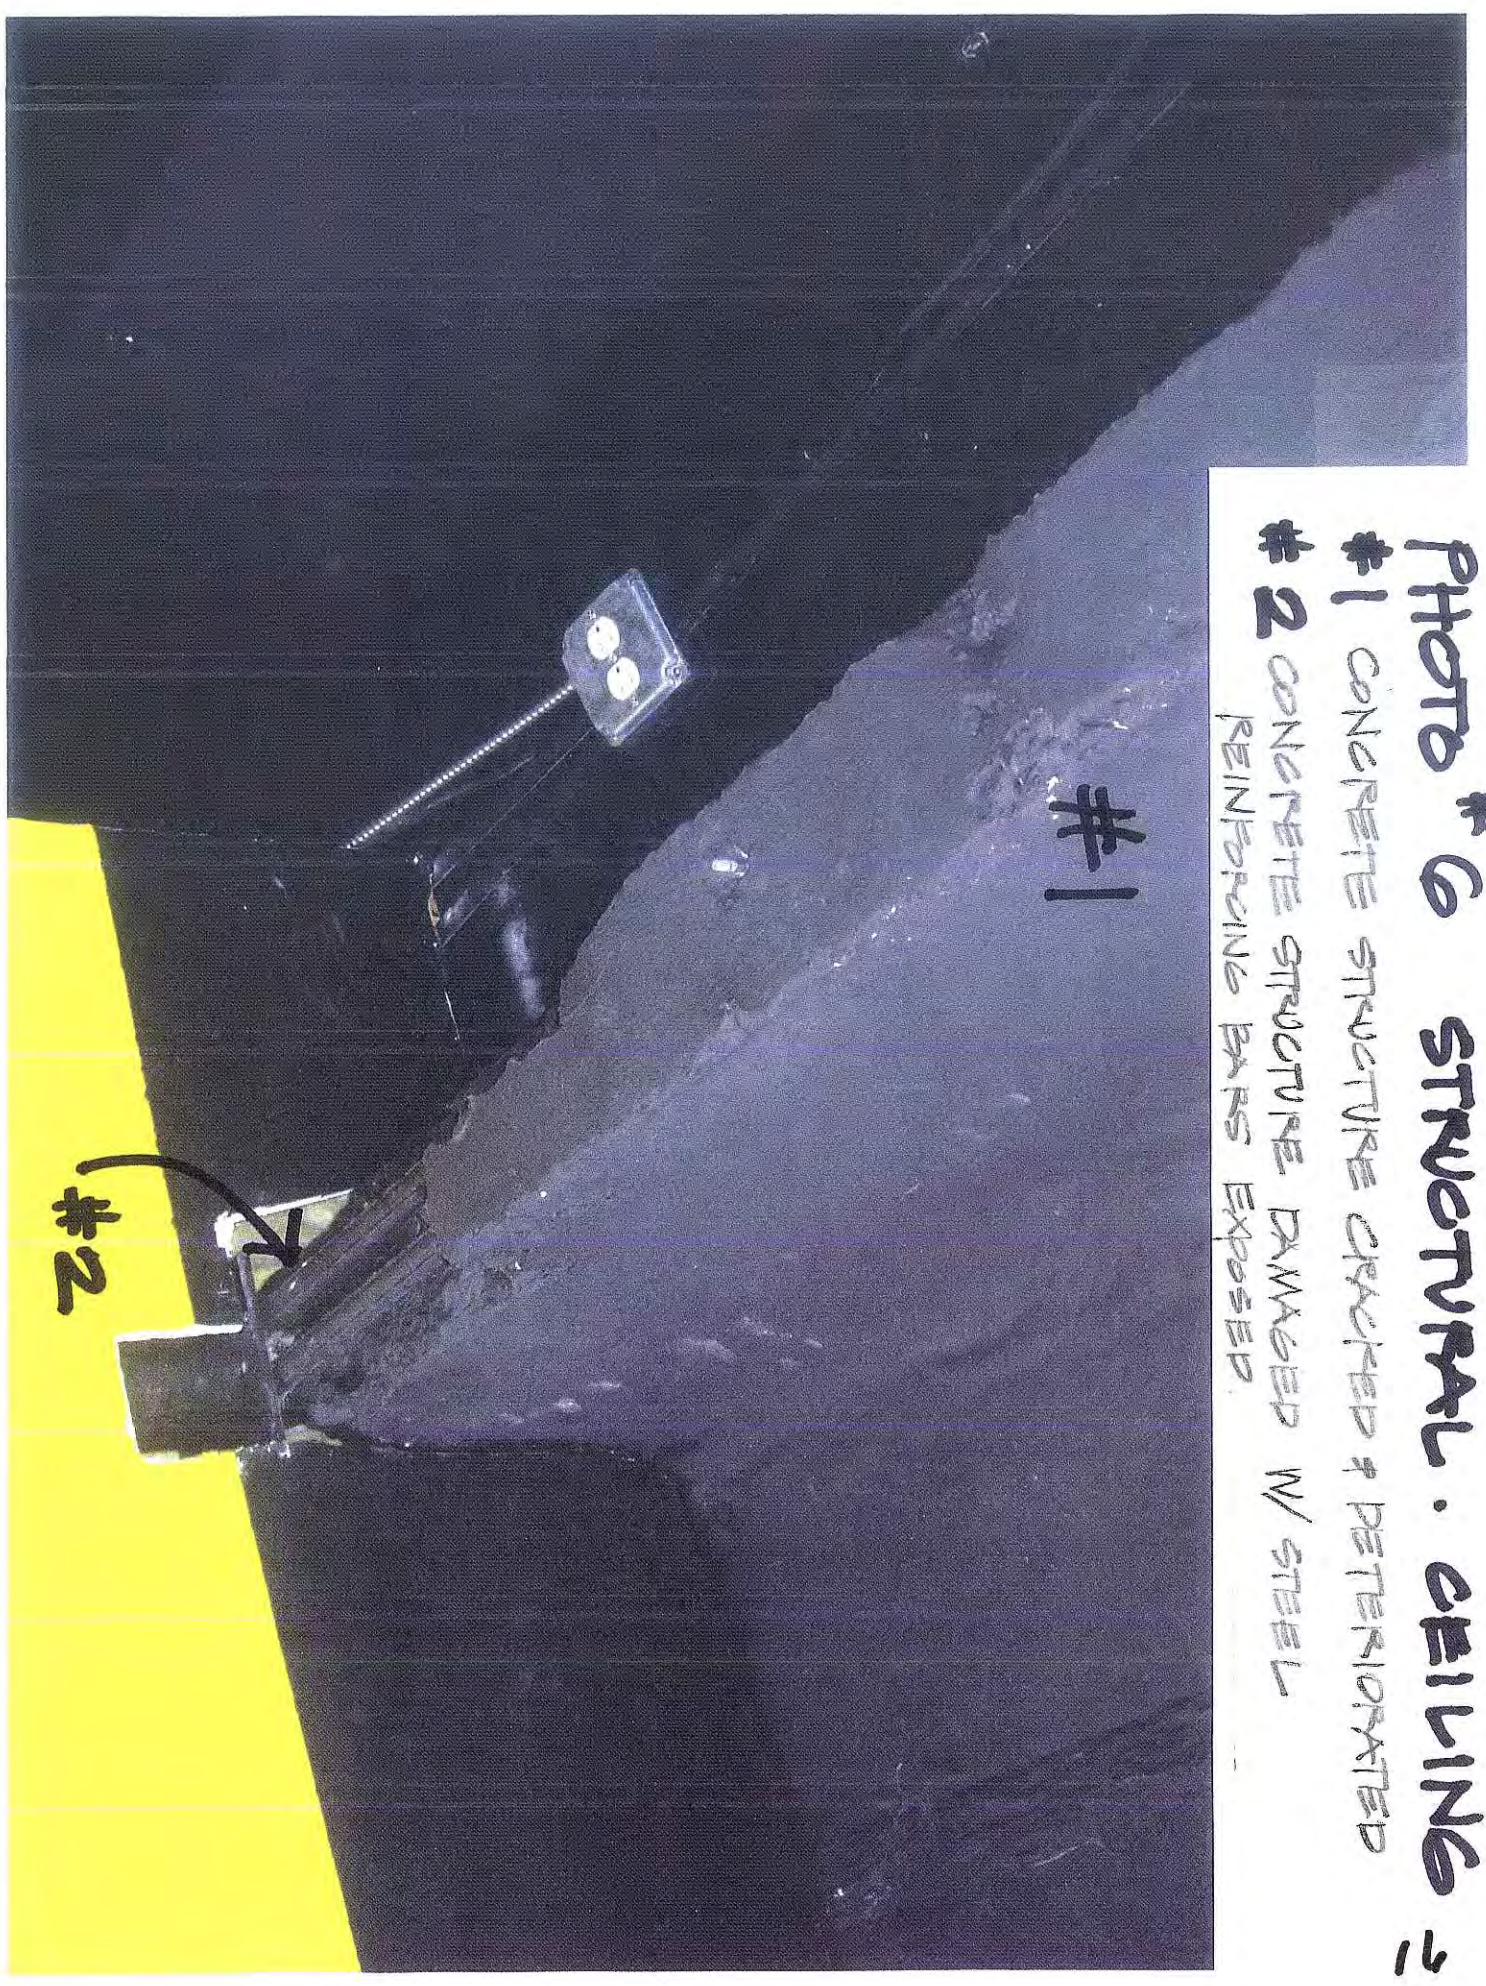
PHOTO # 6 STRUCTURAL: CEILING =
#1 CONCRETE STRUCTURE CRACKED & DEGENERATED
#2 CONCRETE STRUCTURE DAMAGED W/ STEEL
REINFORCING BARS EXPOSED.
