## **EXISTING BUILDING REVIEW**

### **127-129 State Street**

## **127–129 State Street – Architectural Review**

Walk thru Evaluation of 127-129 State Street  
Madison, WI  
Date of Walk thru 11/18 and 12/3/2011. Date of report 12/7/2011  
PE Job #11272

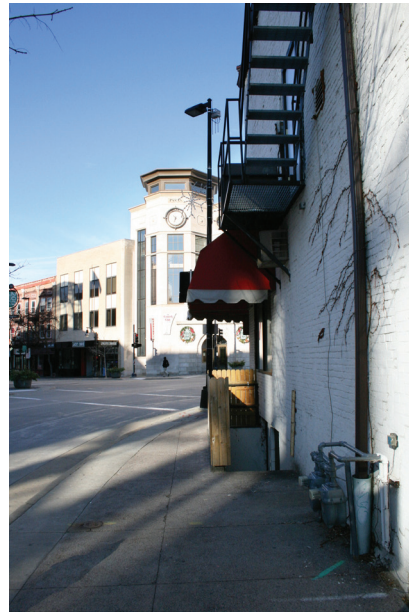
Exterior: View of basement access, gas meter and fire escape within the public right-of-way

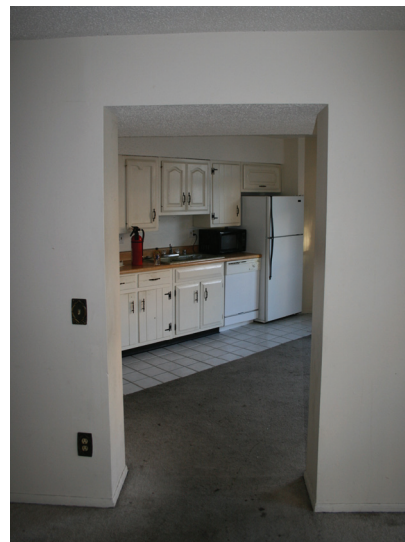
Second Floor: Structural bearing wall between living room and kitchen

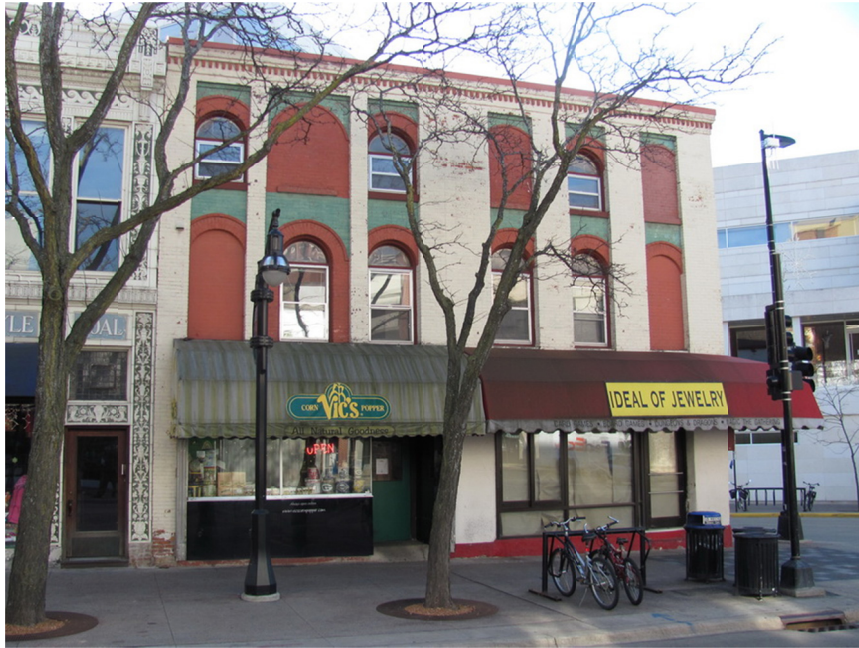
All of the exterior walls are load-bearing common brick masonry. Stone is used for window sills. All of the masonry is painted. The State Street facade has two storefronts at the first floor and an unevenly spaced arrangement of six bays with round-arch headed window openings at the second and third floors (Figure 1). The Fairchild Street facade has a more irregular appearance; the location of window and door openings appears to have been significantly altered in the past (Figure 2).

*Figure 1. Overall view of the State Street facade.*

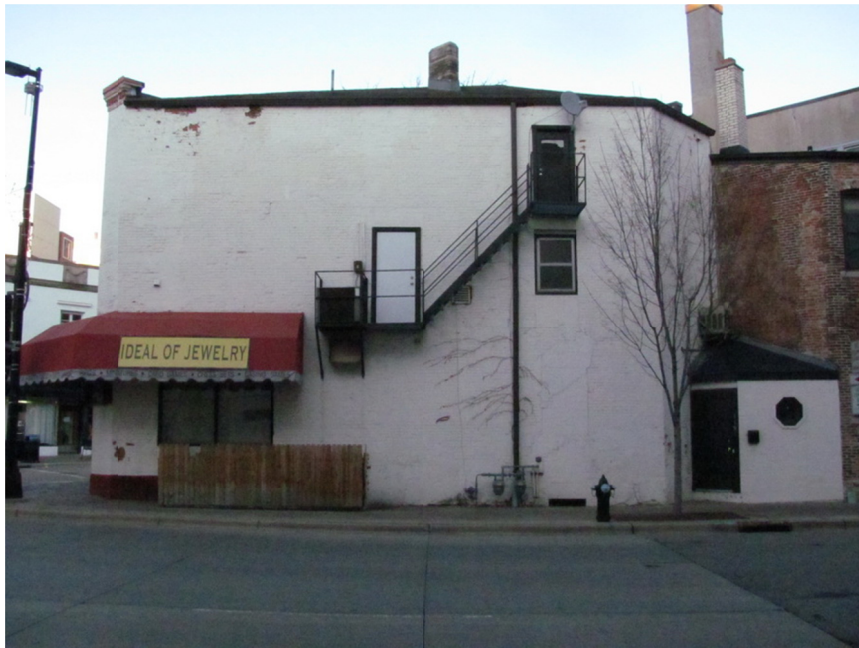
*Figure 2. Overall view of the Fairchild Street facade.*

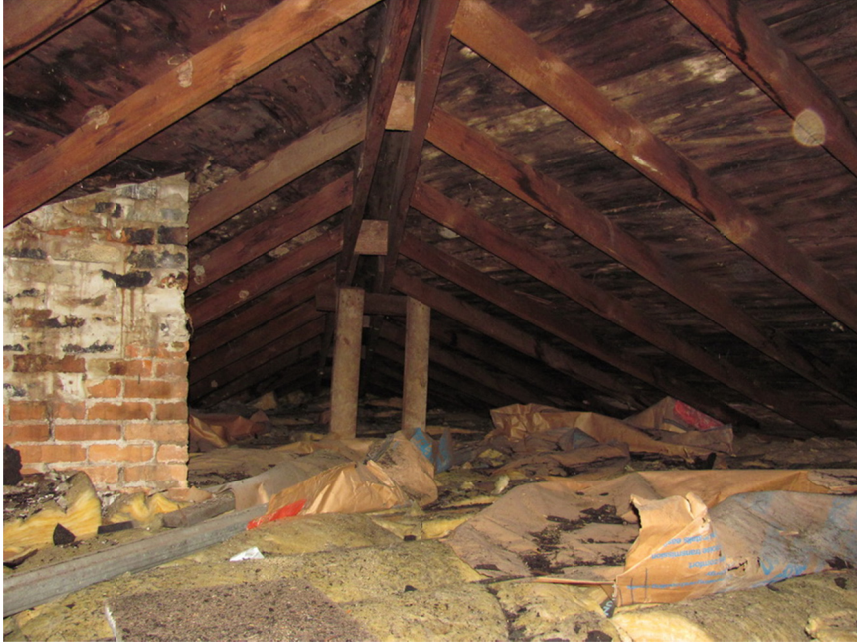
*Figure 9. View of the roof framing from the attic.*

The roof framing is wood joists overlain with spaced wood 1 x decking overlain with modern day wood sheathing. The roof rafters measure full size 2x6 at 22" oc. Their calculated live load capacity is 21 psf. There is no noted snow drift to this roof. There are separate 2x4 ceiling joists. The shingles are in need of replacement. The chimney is in need of repair or rebuild.

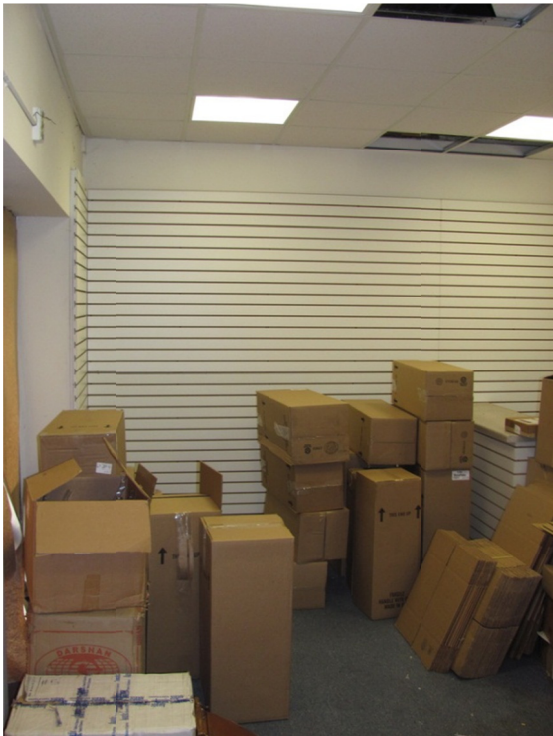
The first floor interior is divided into two retail small retail spaces. The retail interiors have non-historic finishes including sheet vinyl flooring and carpeting, wood and gypsum board walls, and suspended acoustic tile ceilings (Figure 10). Where the contemporary finishes had been previously removed by others for inspection of the structure, no evidence of underlying historic finishes was observed.

*Figure 10. View of the retail interior at the first floor.*

None of the existing interior finishes or features is historically significant, and many of the existing materials are in poor condition. Substantial renovation of the interior would be required for reuse.

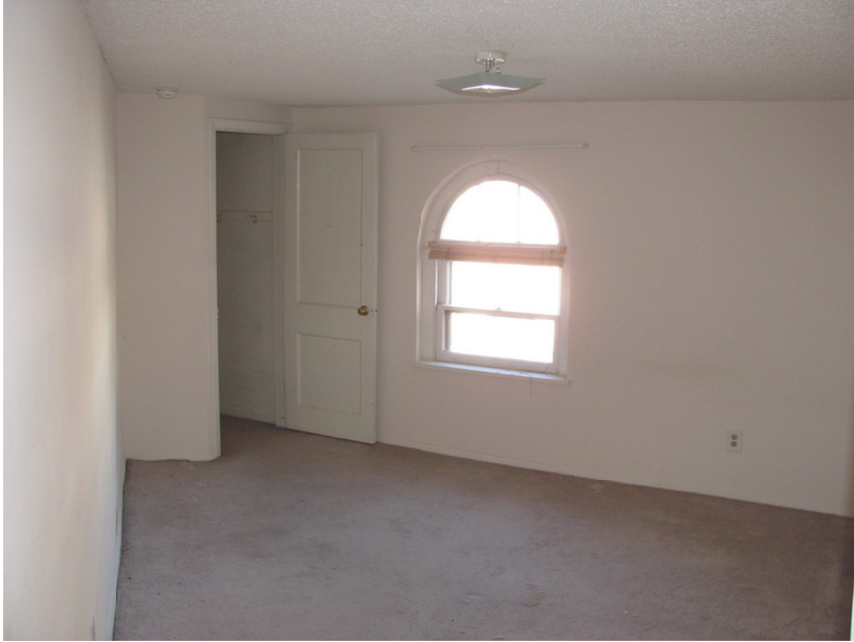
The second and third floors together constitute one three-bedroom rental apartment. The apartment is accessed via a separate entrance vestibule and stair from the south corner of the building on Fairchild Street. The apartment interior finishes include carpeting, sheet vinyl flooring, wood paneling, and gypsum board walls and ceilings (Figure 11). Several inspection openings were made during the site inspection at the exterior walls of the third floor. From interior to exterior, the exterior construction consists of gypsum board supported on 2x4 studs with batt insulation between the studs, installed inside the original brick masonry wall. Previous plaster finishes were observed directly applied to the inside face of the brick masonry. Staining and evidence of moisture penetration was observed on the batt insulation and plaster (Figure 12).

*Figure 11. Typical view of the interior of the rental apartment.*

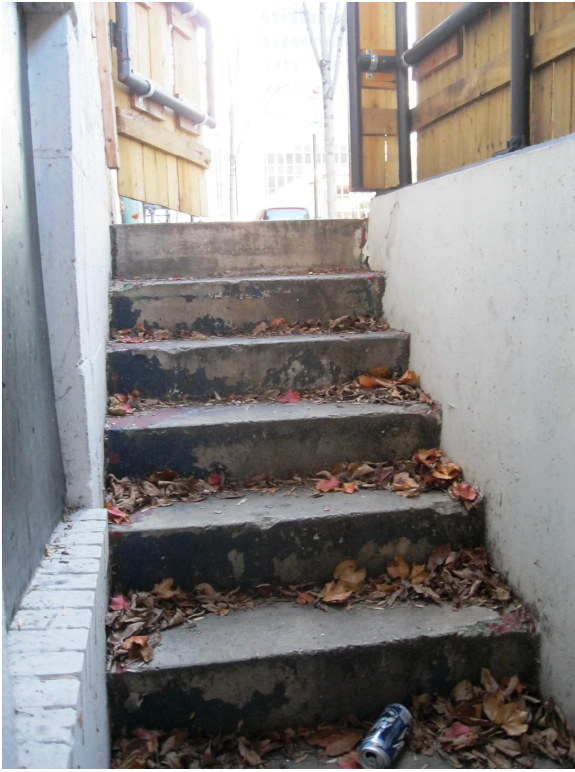
**Photo 5** – Fairchild Street access to basement

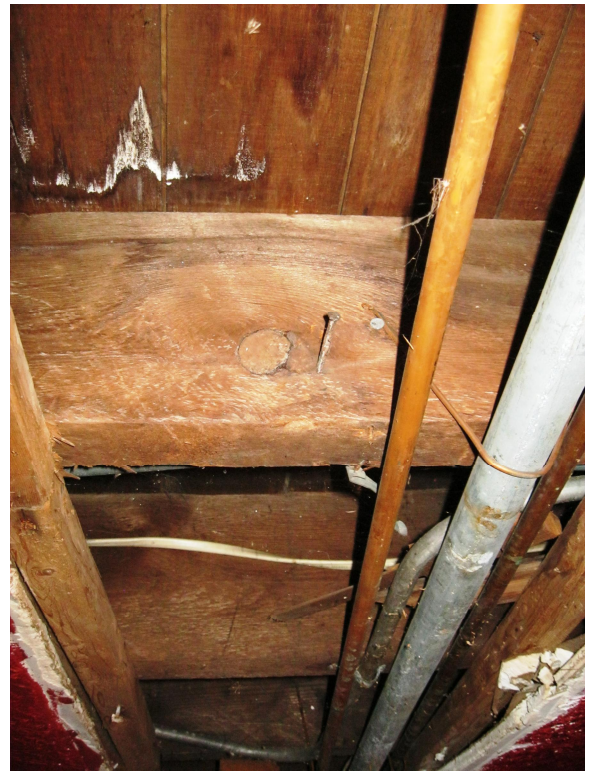
**Photo 6** – 1<sup>st</sup> floor joist framing

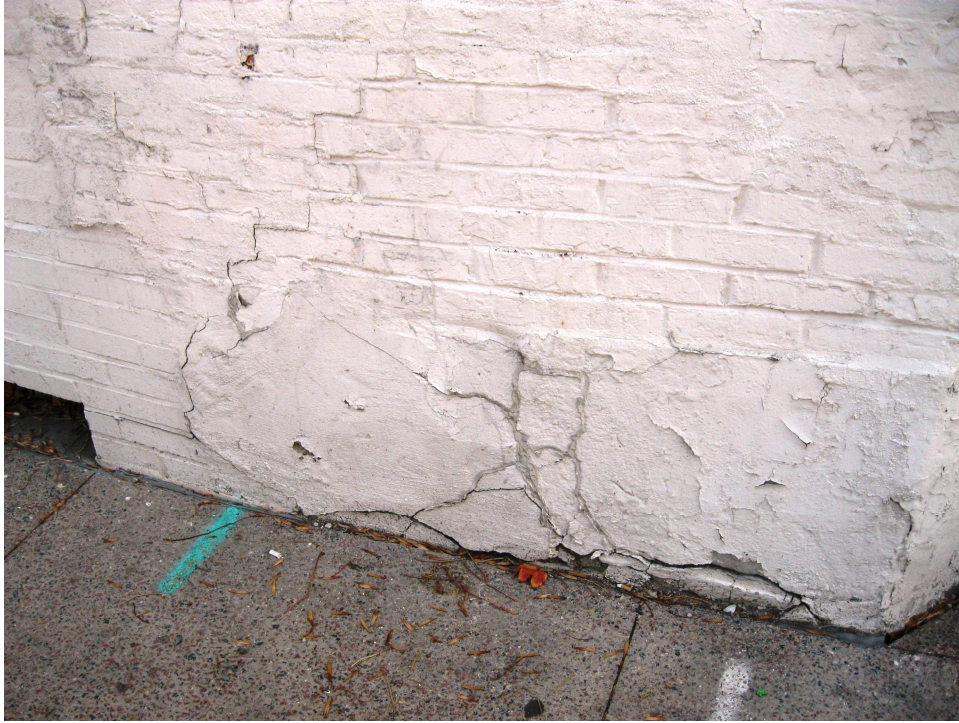
The exterior walls are thru the wall brick. In the basement, the exposed face shell of the brick basement wall have spalled and windrowed on the floor. This indicates significant water entry to this wall and makes one suspicious as the condition of the unobservable inner wythe of the wall. The inside surface of the gable end wall exposed in the attic was observed have been damaged by moisture entry. The wall is exposed above the adjacent roof. The wall has been parged presumably to resist water entry. The brick faces have been eroded away on the inner surface in the attic and are windrowed on the ceiling.

**Photo 11** – Exterior wall base at Fairchild Street sidewalk

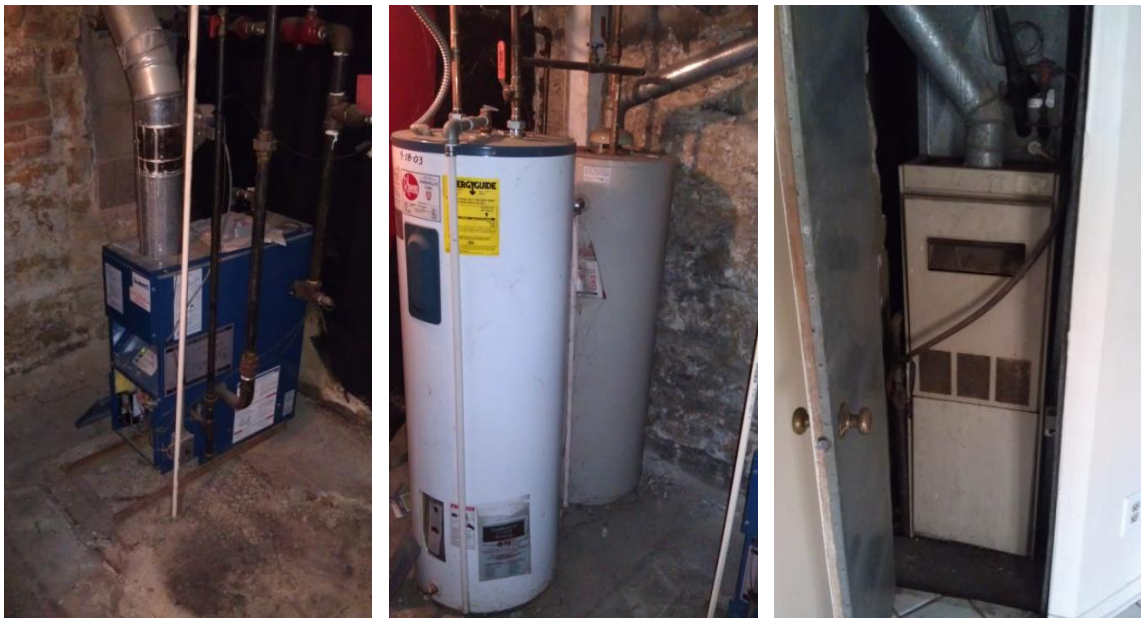
The heating system consists of an atmospheric hot water boiler in the basement, which provides heat for the first floor retail spaces. Three functional domestic water heaters are also contained in the basement that serves the retail spaces and the apartment. Two are electric and one is natural gas-fired. The apartment is heated and cooled by a gas-fired furnace within the apartment. The condensing unit is supported on the side of the building along Fairchild Street adjacent to the second floor fire escape. The corner (vacant) retail space is heated with a hot water unit heater and cooled with a window air conditioner. A second retail space (Vic's Popcorn) is heated and cooled with a furnace and the condensing unit is wall hung above the N. Fairchild apartment entrance.

Boilers, water heaters, and furnace

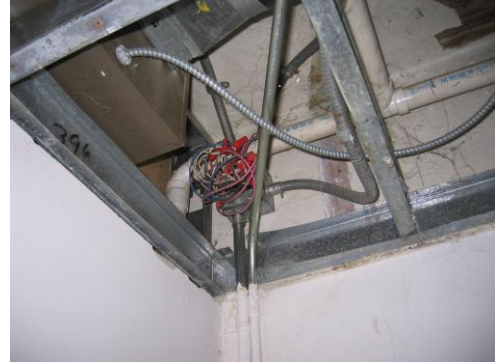
Wiring in 129 State Street.
