Facility Name	Unit Well 11	Facility Description
Well ID	BF511	Drilled in 1956, Unit Well 11 has a pumping capacity of 2,300 gallons per minute. It operates year-round and serves Madison's East side including the Emerson East, Eken Park, Marquette, Schenk-Atwood, Hawthorne, and Worthington Park neighborhoods as well as homes in Burke Heights, Hiestand, Rolling Meadows, and Eastmorland. In 2017, the well pumped 625 million gallons of water compared to its 5-year average of 526 million gallons annually.
Service Zone	6E	
Capacity	2.88 MGD	
Reservoir Capacity	0.150 MG	
Number of Assets	31	
Current Replacement Cost	\$3.2M

Asset Condition Profile

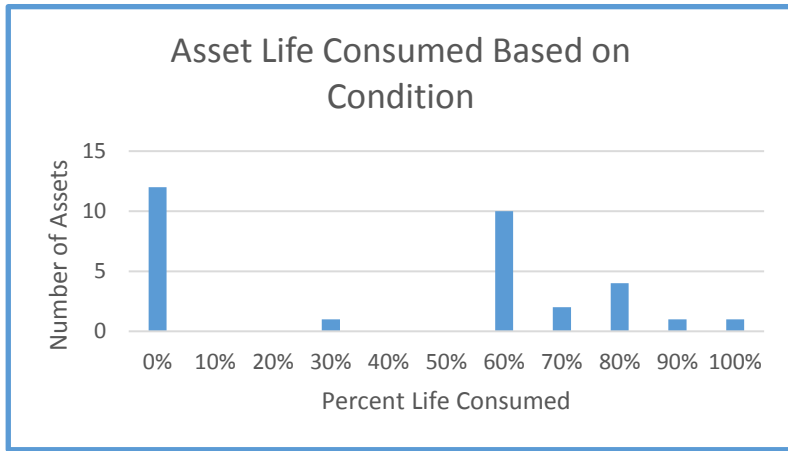
Figure 1. Life Consumed

Overall Condition Assessment: The assets at Unit Well 11 are in good to excellent condition with over 90% scoring 3 or better.

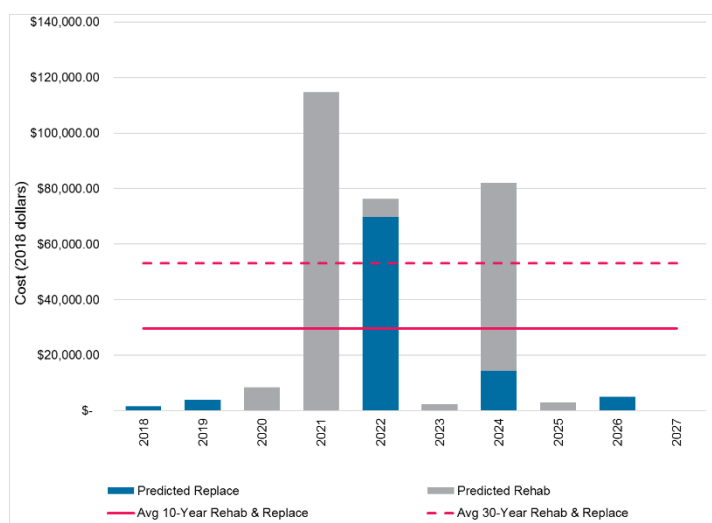
Figure 4. Base Scenario 10-Year Investment Requirements

The Base Scenario runs all assets to failure (condition 5) regardless of risk management zone. This scenario results in a baseline, lowest possible investment requirements, without regard to risk. The Base Scenario 10-year investment requirement for Unit Well 11 is shown in Figure 4. Although the investment requirement is relatively low with this scenario, it results in a much higher level of residual risk.

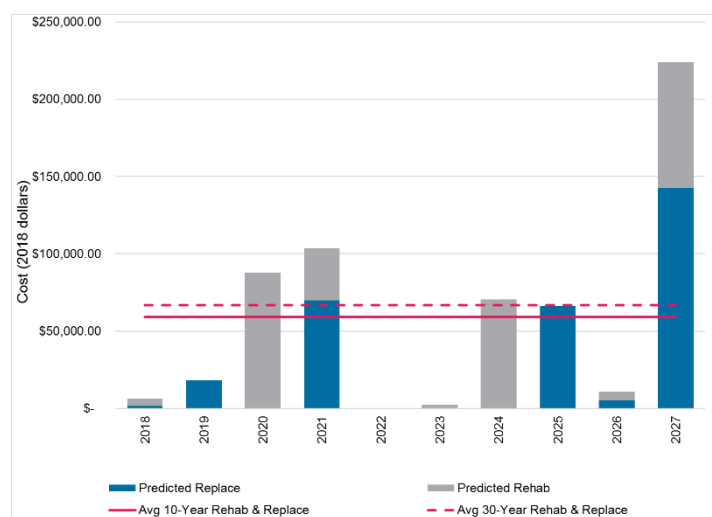
Figure 5. Significant Risk Scenario 10-Year Investment Requirements

The Significant Risk Scenario establishes a trigger for asset replacement or rehabilitation for assets that reach the tolerable core risk limit of 16. In this scenario, intervention occurs for assets in risk management zones 3 and 4 before they reach the significant risk zone. Action is taken to move assets that are already in zone 5. Assets in zones 2 and 3 are run to failure (condition 5). The Significant Risk Scenario 10-year investment requirement for Unit Well 11 is shown in Figure 5.
