**Tree Evaluation Report**

Old Sauk Managing Member LLC  
1010 East Washington Ave  
Madison, WI 53703

April 3. 2024

## **RE: 6706 Old Sauk Rd. Tree Survey (Heartland Project #20231124)**

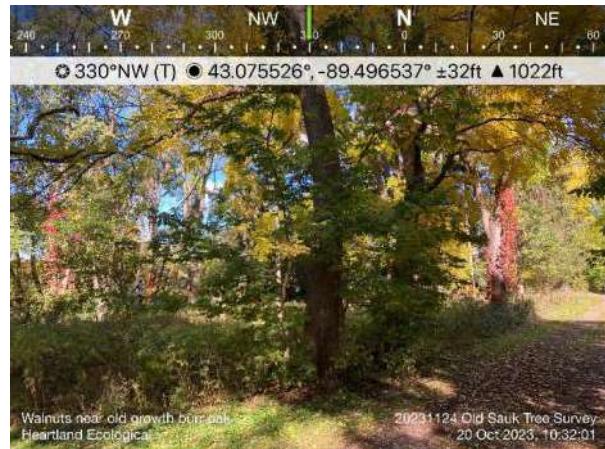
**Photo #1** Photo point PP1: Open area on north Study Area boundary

Walnuts near old growth oak  
Heartland Ecological
