**INSPECTION REPORT
FOR
SARA INVESTMENT REAL ESTATE
FLOOR INSPECTION – 6409 ODANA ROAD**

GEC No. 2-0519-243

INSPECTION REPORT
For
SARA INVESTMENT REAL ESTATE
MAY 2019

**INSPECTION REPORT
FOR
SARA INVESTMENT REAL ESTATE
FLOOR INSPECTION – CLOCK TOWER OFFICE
PARK**

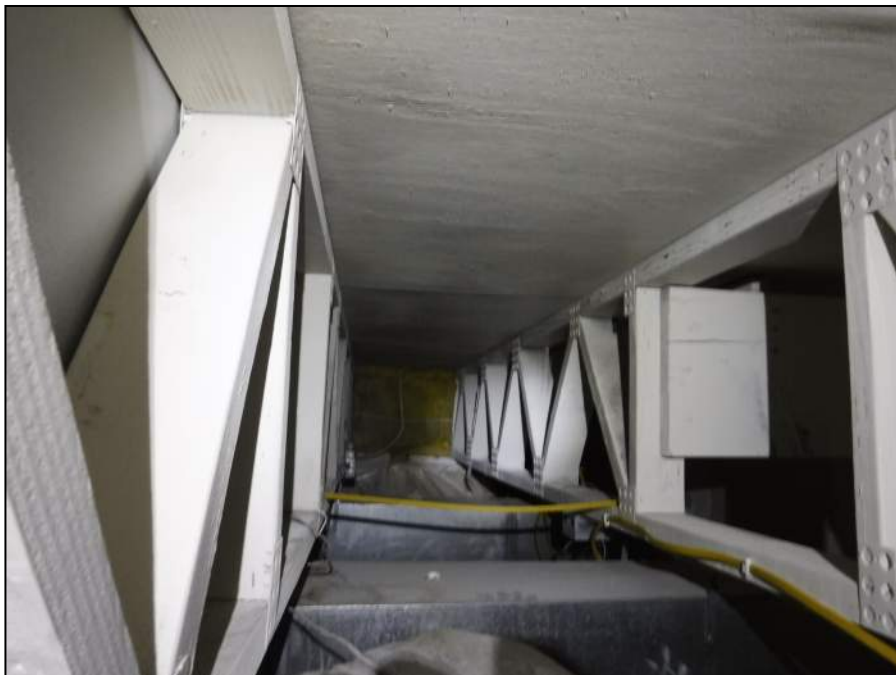
The floor system of this building has two beam lines and three truss spans. The trusses bear on the front wall, then a first intermediate beam, then a second intermediate beam, and then the back wall. The trusses are 18" deep floor trusses that span approximately 20'. The trusses are a top chord bearing truss.
