**FREIBURGER CONSTRUCTION CONSULTING, Inc.**  
**5438 County Highway M**  
**Fitchburg, WI 53575**  
**(608) 835-0001**

Woodland Montessori School  
1124 Colby St.  
Madison, WI 53715

## 114 Van Deusen

**Photo Log: 114 Van Deusen Street**

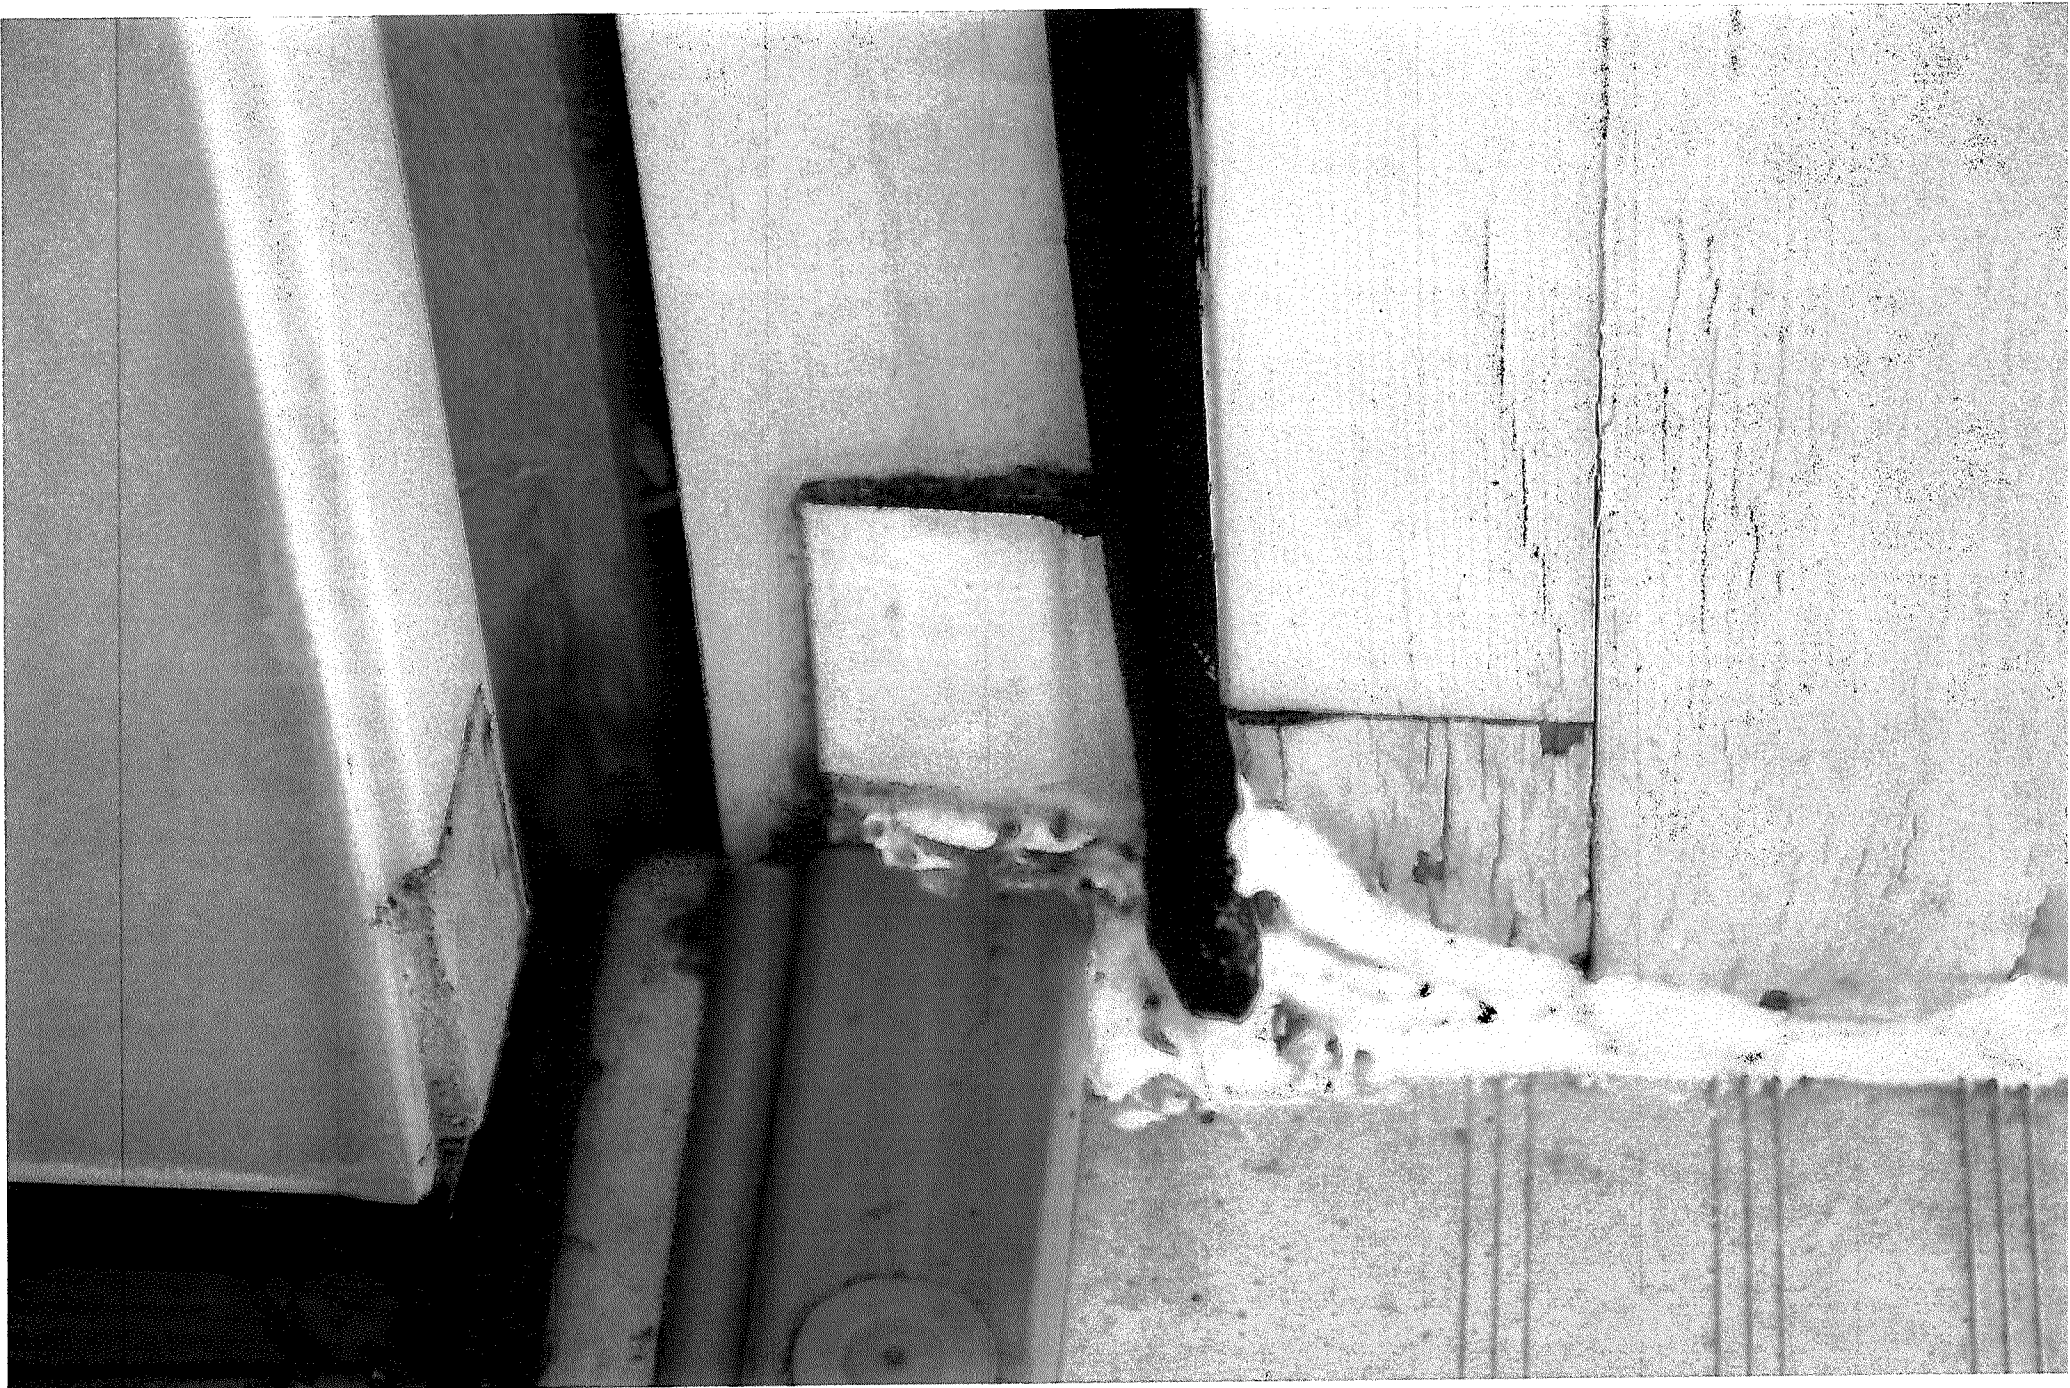
40

- Photo 39:** West side of Toddler House. Note rescue platform.
- Photo 40:** Closer look at rusty platform and paint peeling from siding that may contain lead.

put in new good door
