**Breese Stevens Field
Facility Plan**

April 2017

PART II- EXISTING CONDITIONS

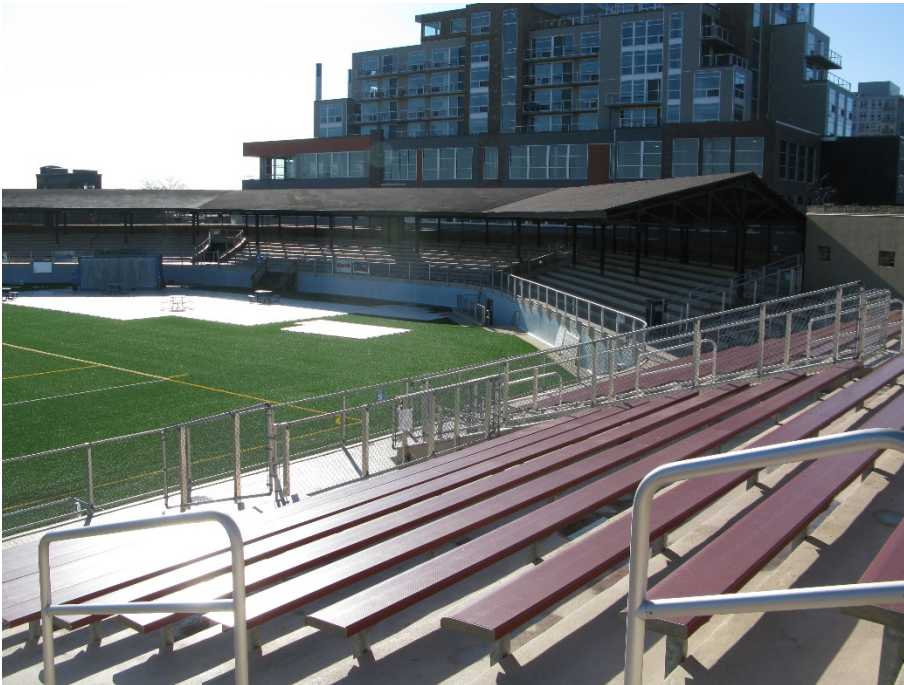
The seating deck of both the 1925 and 1934 grandstands is in fair condition. The absorption of moisture after rainfall on the topside of the deck contributes to deterioration of the concrete. The coating applied to the seating deck is failing, particularly at expansion joints, allowing moisture to enter the underside of the grandstands into occupied spaces. On the bottom side of the deck, concrete has spalled off at the edges and left exposed reinforcing bars in various locations.

In 2009, a liquid applied elastomeric waterproof membrane was applied to the deck and stands surface, and the face of the field wall. That installation did not provide for repair and improvement of the movement joints. Also, the detailing or installation of the membrane allowed for large portions of it to release itself from the concrete. Primarily along the 1925 stands and fieldwall, portions of the membrane have buckled and damaged upper levels of concrete that spalled off with the membrane. Further water penetration is noted on the underside regions. It is recommended that the seating deck be covered with an updated waterproof membrane and improvements to the expansion joints. Properly detailed movement joints are recommended for installation in conjunction with the membrane. Concrete repairs to the underside of the deck are recommended.
