Roof Inspection and Condition Report for:

**Madison Department of Public Works
Motor Equipment Division
200 North First Street
Madison, WI 53704**

Re: Transportation Garage—200 N. 1st Street—Madison, WI

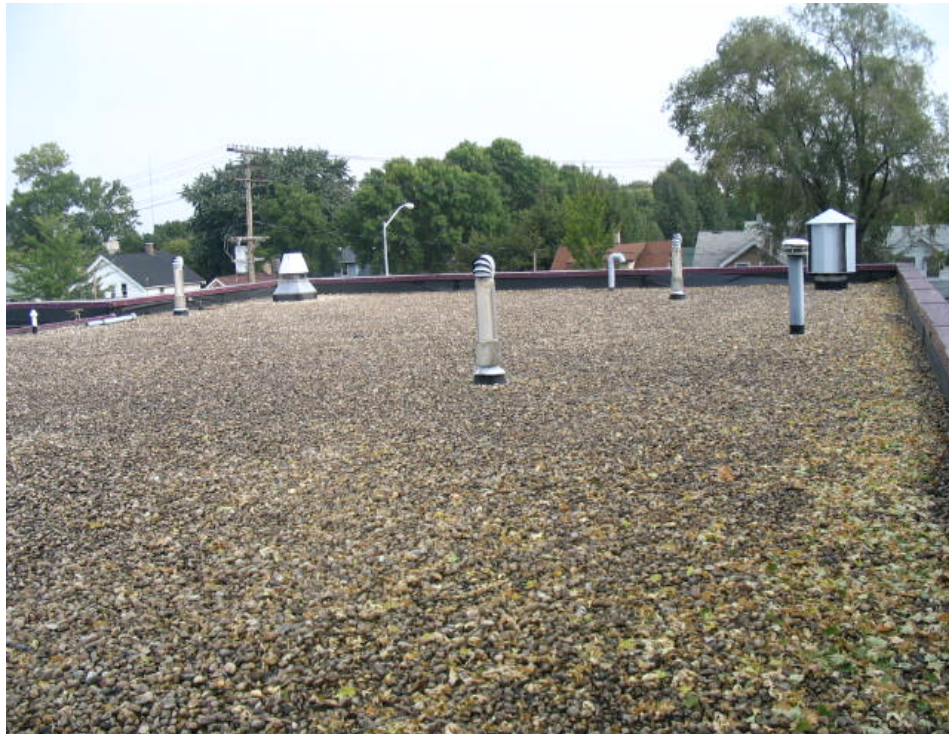
This roof area covers approximately 10,800 square feet and is composed of a structural steel framework with a metal roof deck. Covering the roof deck is an EPDM ballasted roof system. This roof system is approximately 14 years of age and is fair condition.

There are a few deficiencies in this roof system that should be taken care of before the problems worsen. The wall flashings around this roof section have become un-adhered from the wall, and are starting to tent. When wall flashings tent they will pull out from under the termination which in turn will cause water to enter the facility at the perimeters. There is an area where a contractor was looking for a leak and did not redistribute the ballast stone. The ballast serves a couple of purposes: **1)** It holds the roof membrane in place, **2)** It keeps the insulation from shifting, and **3)** acts as a protector to the membrane against UV rays. There is also a lot of debris on this roof system caused by the over hanging tree limbs. This will restrict the water flow to the drains and allows for excess weight to the structure of this facility.

With proper maintenance this roof system should to provide water tightness for an additional 5—7 years.

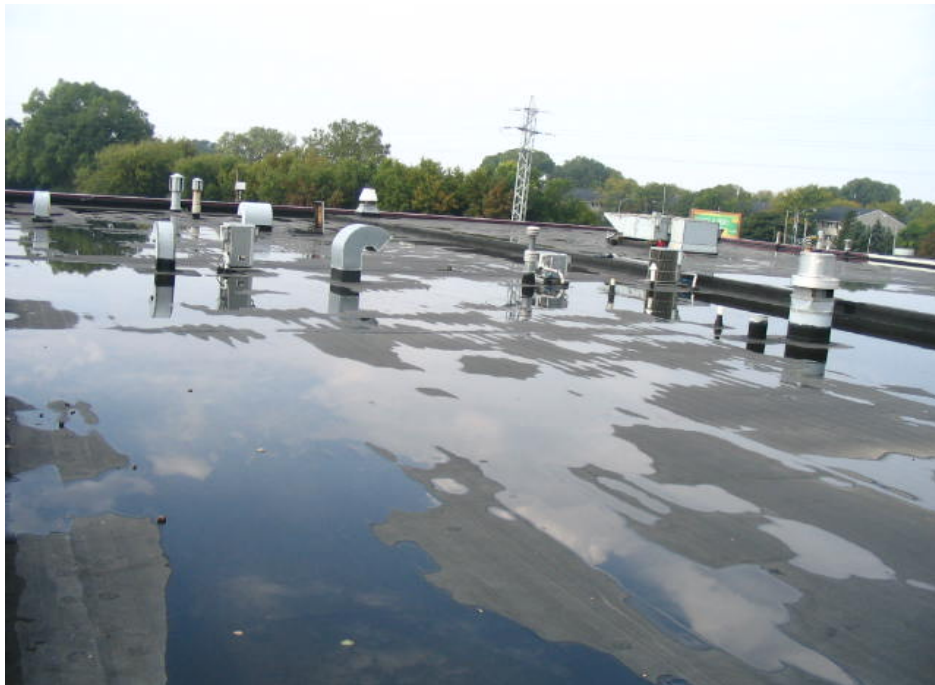
This roof area covers approximately 7,650 square feet and is composed of a structural steel framework with a metal roof deck. Covering the roof deck is fully adhered roof system with the membrane being .060 mils in thickness. This roof system is approximately 14 years of age and is fair condition.

There are a few deficiencies that need to be corrected. As you will see in the photographs, there are several holes in the wall flashing between the two adhered roof areas. There is also a dead roof penetration that is covered with a bag that should be removed. There is some ponding water along the west side of this roof area but it is not causing any problems at this time. We will need to keep an eye on this in the future, if the ponding starts to cause problems, we can install tapered insulation to eliminate the water.

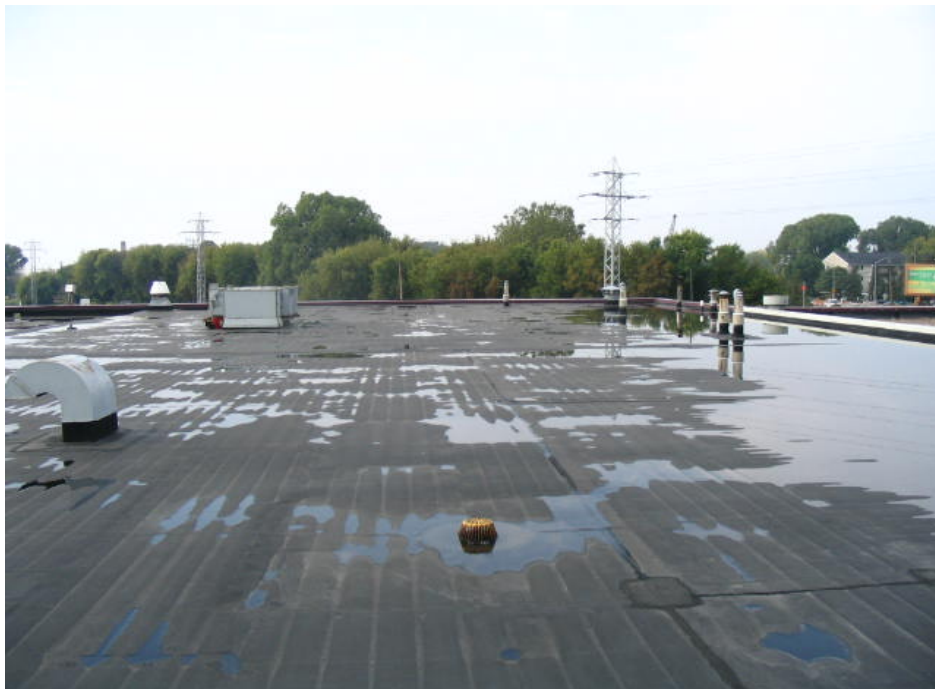
This roof area covers approximately 12,720 square feet and is composed of a structural steel framework with a metal roof deck. Covering the roof deck is fully adhered roof system with the membrane being .060 mils in thickness. This roof system is approximately 14 years of age and is fair condition.

There are a few deficiencies that need to be corrected. As you will see in the photographs there is a hole in the wall flashing. There is some ponding water (water was 2" deep in some spots) along the west side of this roof area and I feel is the cause of the roof problems during the freeze thaw in the Spring. We feel that we can eliminate this by removing the metal coping and installing tapered insulation out far enough so the water makes it to the roof drains.

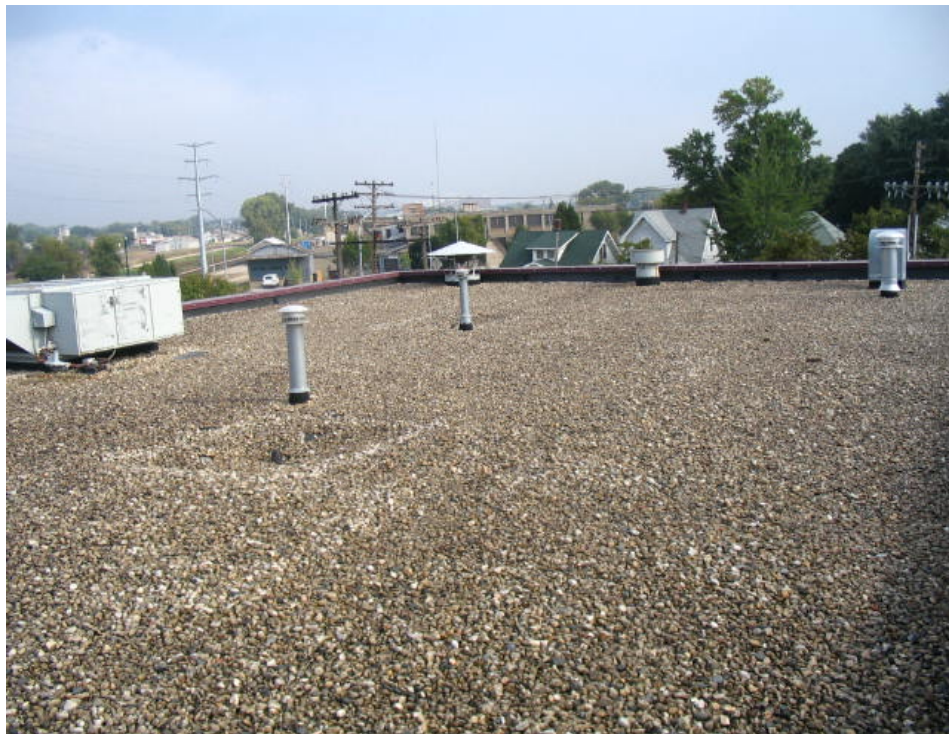
This roof area covers approximately 5,400 square feet and is composed of a structural steel framework with a metal roof deck. Covering the roof deck is an EPDM ballasted roof system. This roof system is approximately 14 years of age and is fair condition.

There are a few deficiencies in this roof system that should be taken care of before the problems worsen. The wall flashings around this roof section have become un-adhered from the wall, and are starting to tent. When wall flashings tent they will pull out from under the termination which in turn will cause water to enter the facility at the perimeters.

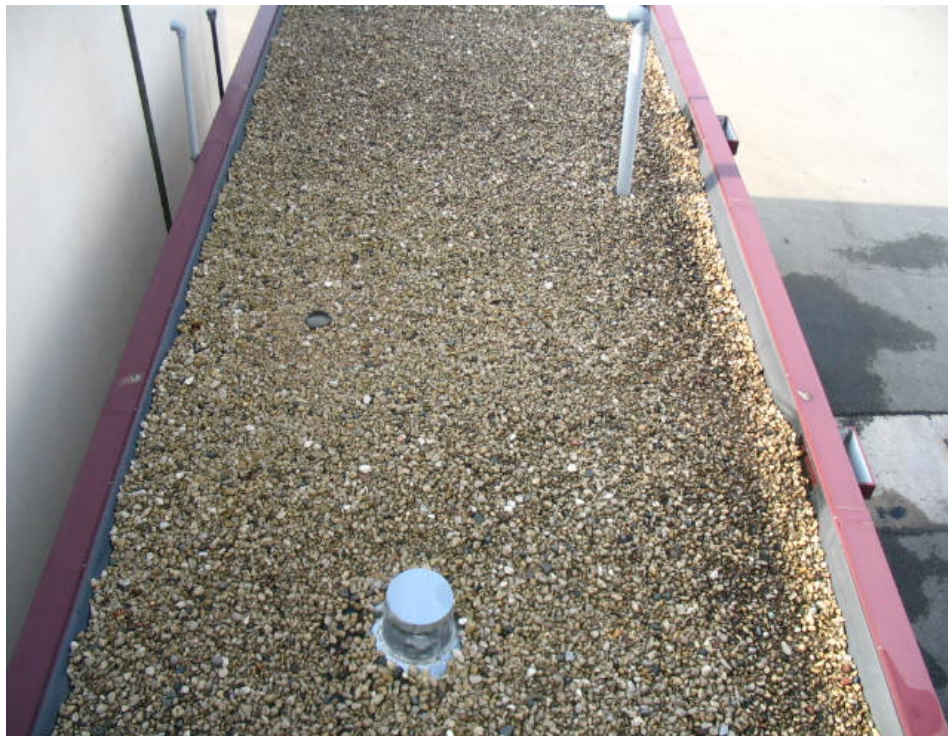
This roof area covers approximately 560 square feet and is composed of a structural steel framework with a metal roof deck. Covering the roof deck is an EPDM ballasted roof system. This roof system is approximately 14 years of age and is fair condition.

There are a few deficiencies in this roof system that should be taken care of before the problems worsen. The wall flashings around this roof section have become un-adhered from the wall, and are starting to tent. When wall flashings tent they will pull out from under the termination which in turn will cause water to enter the facility at the perimeters.
