**RE: LAKE PARK APARTMENT HOMES
DEMOLITION ASSESSMENT
451 W. WILSON AND 315 S. BASSETT**

EXHIBIT A

**Photos of Buildings to Demo
Building A - 315 S Bassett Street**

EXHIBIT B

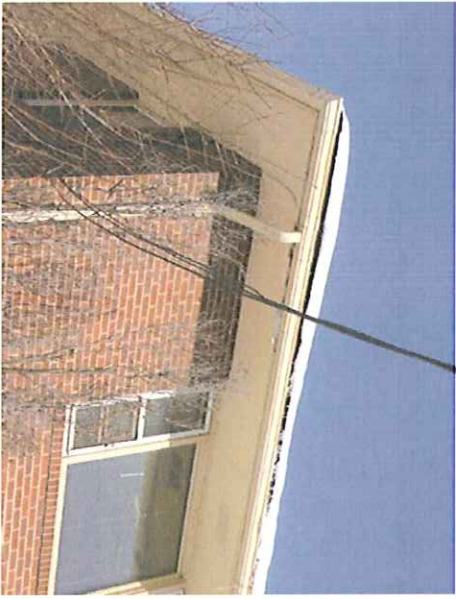
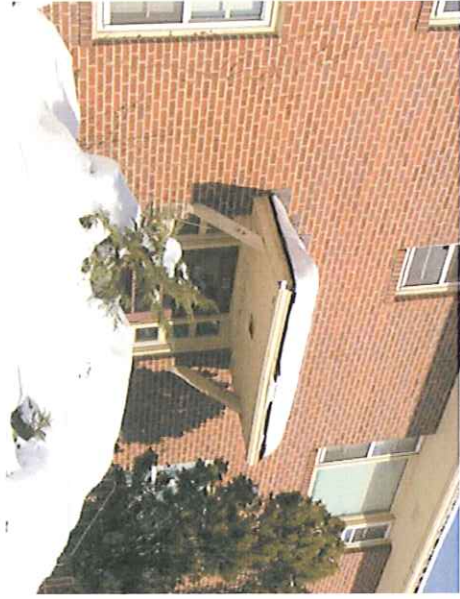
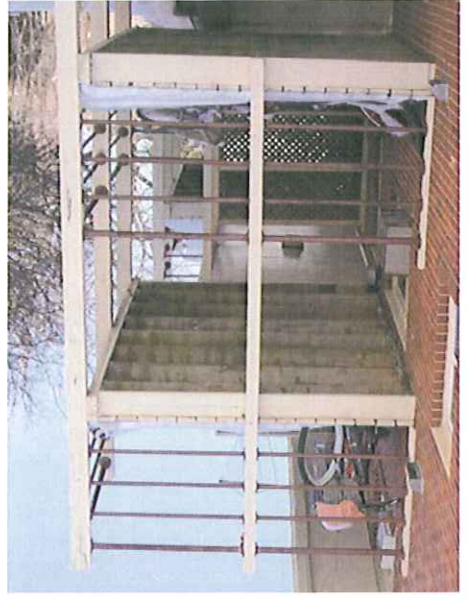
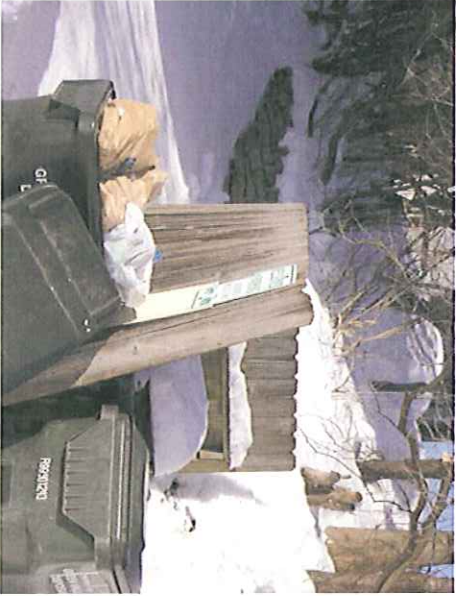
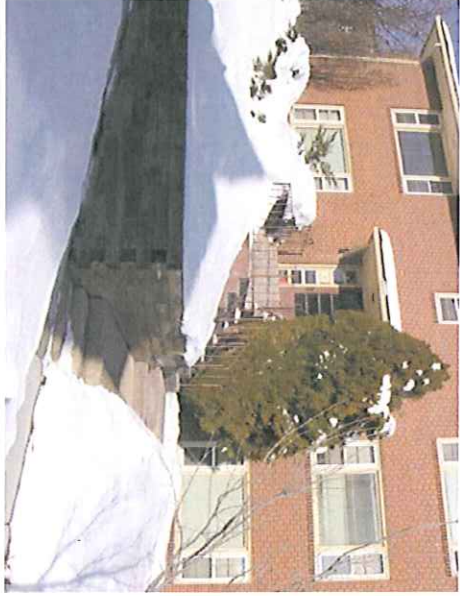
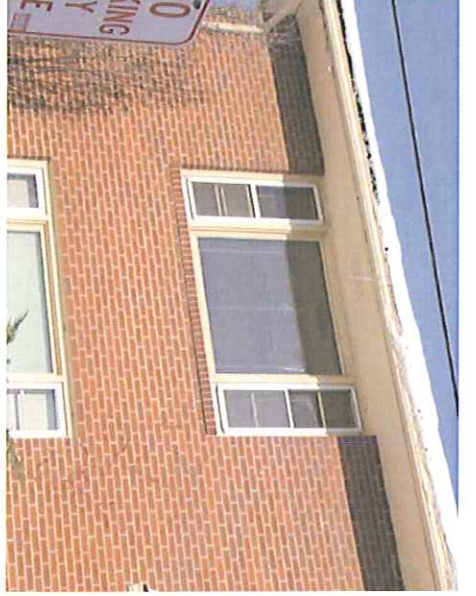
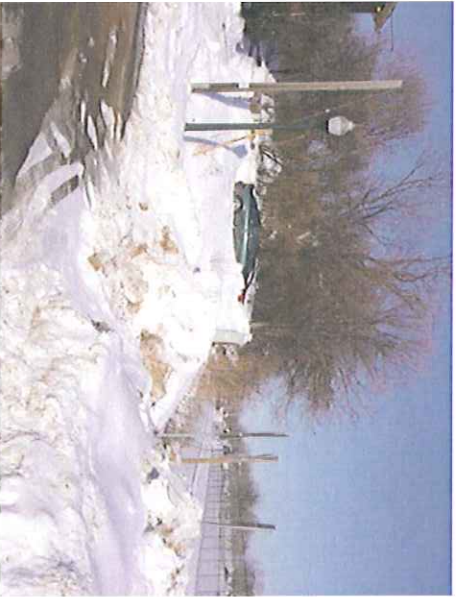
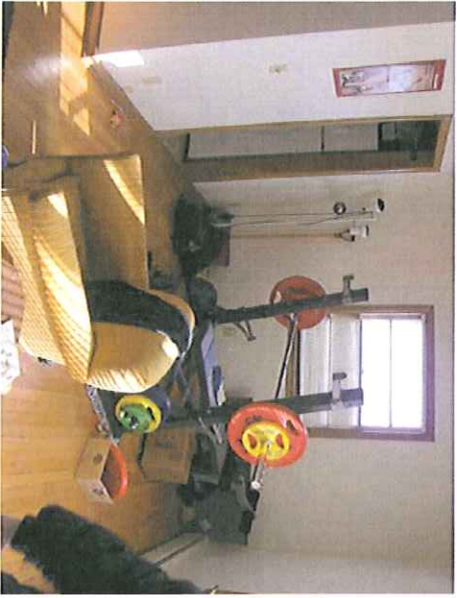
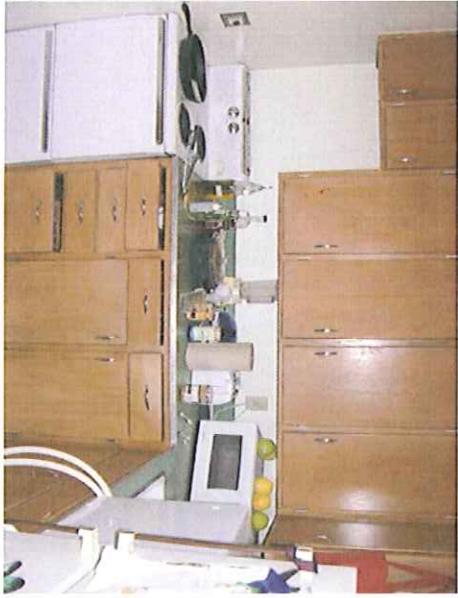
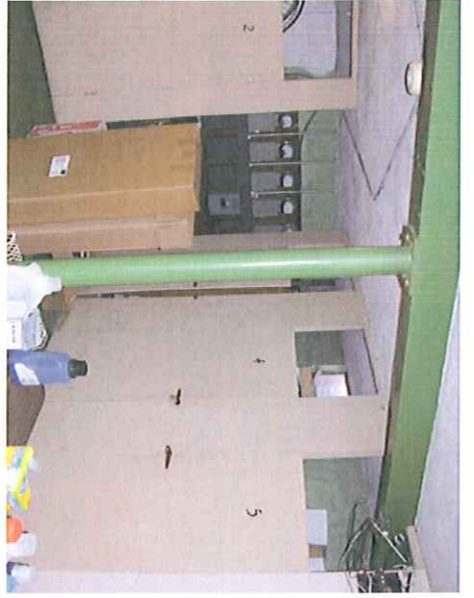
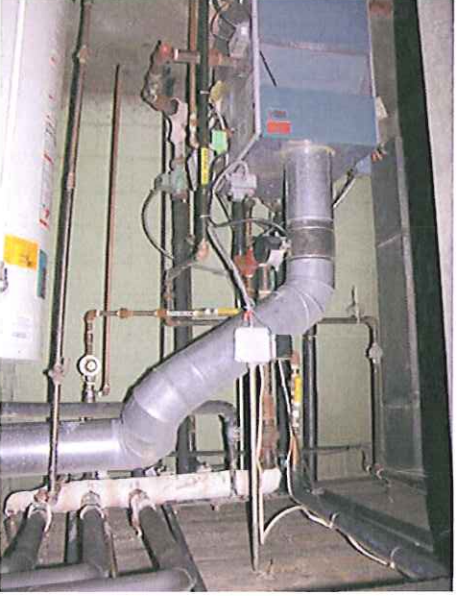
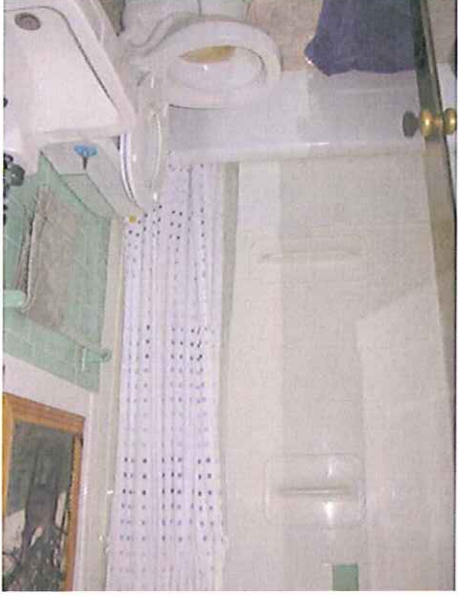
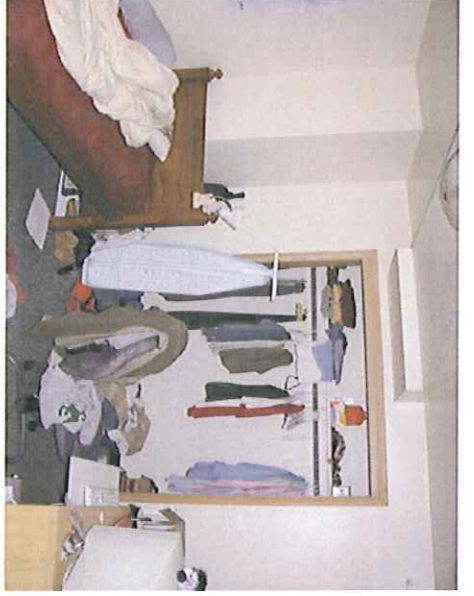
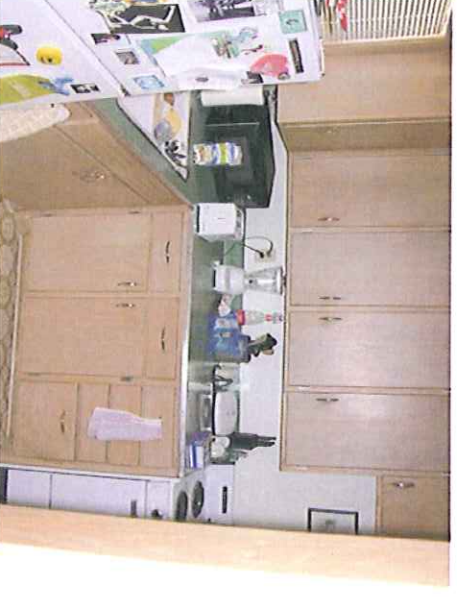
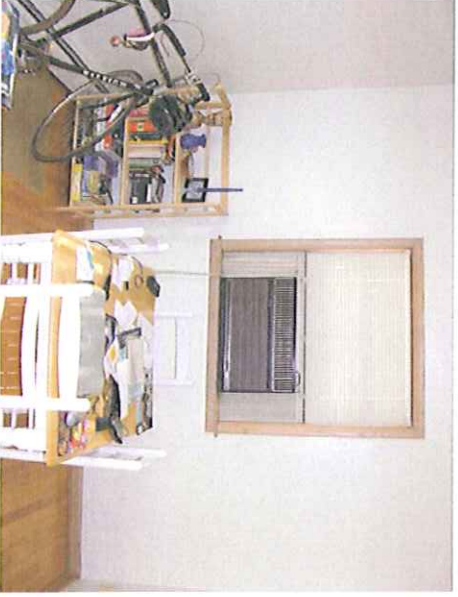
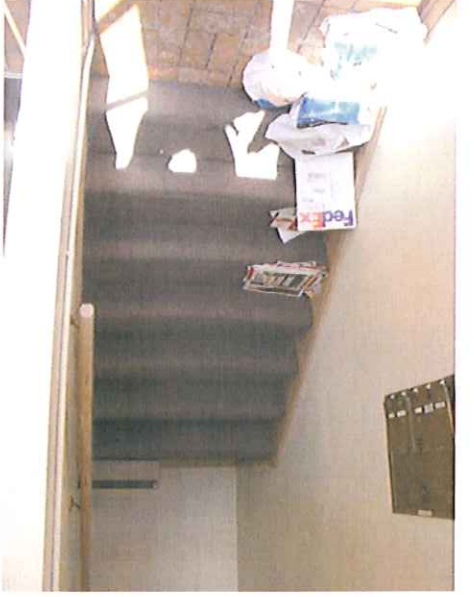
The four upper apartments have wood floors in the bedroom and living area and vinyl flooring in the kitchen and bathroom. There is insufficient storage – only one closet in each unit. The kitchens are in poor condition and have the original cabinets and countertops which were not of high quality when originally installed. Each kitchen has a refrigerator and an 18-inch range – there is no dishwasher in any of the units. The bathrooms contain original plumbing fixtures for the most part, and do not have ventilation fans. There is also typically significant rot around the bathtub. The HVAC system is a baseboard radiant hot water system with no air conditioning. There is minimal sound separation between units.

The building itself is in need of a new roof and the wood decks have reached the end of their useful life and are rotting and in need replacement. The parking lot is asphalt and needs to be replaced (especially after this winter). There is a retaining wall along the railroad corridor property line and it is listing at about 15 degrees – there are concerns that it could fail in the near future. There is also a timber retaining wall along the sidewalk that should also be replaced in the near future – it is showing some signs of bulging and rot. The building is not very energy efficient and probably lacks adequate insulation. Storm windows were added to some of the windows but the large “picture windows” in each unit are just single panes of glass. The front stoop is a concrete structure and needs constant caulking to prevent water infiltration into the basement apartment (which has flooded twice due to this defect).

In general, this building is need of substantial repairs and would require significant remodeling to get it into a marketable condition.

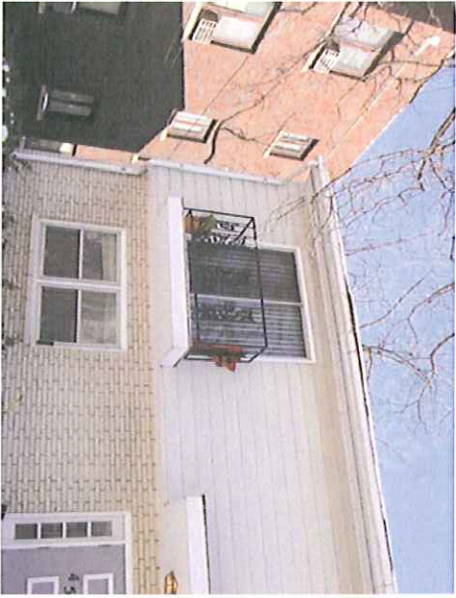
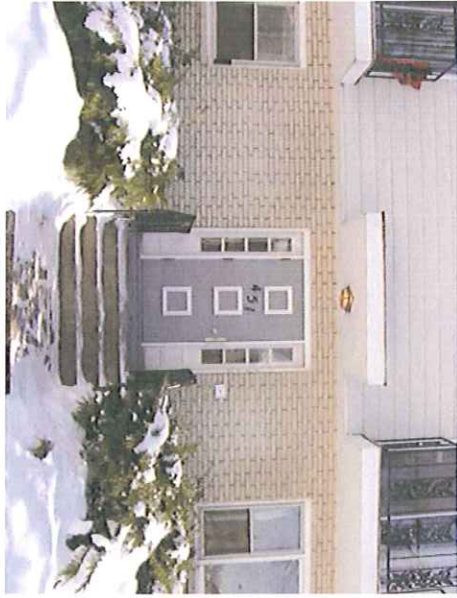
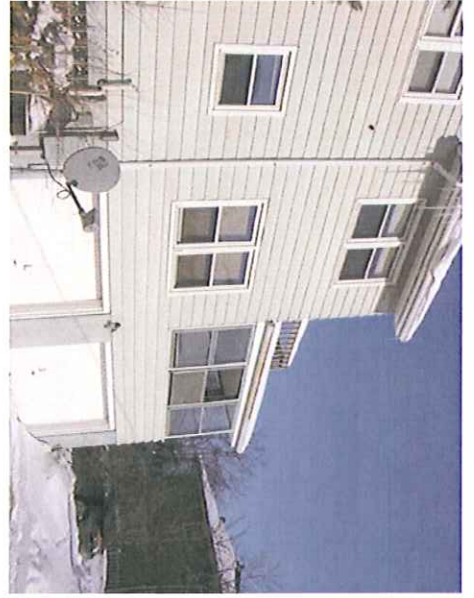
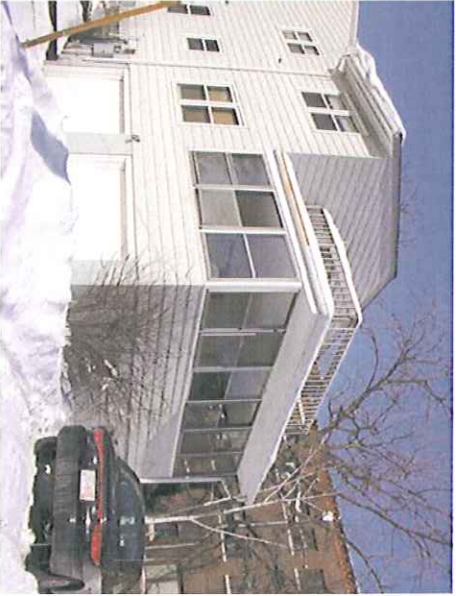
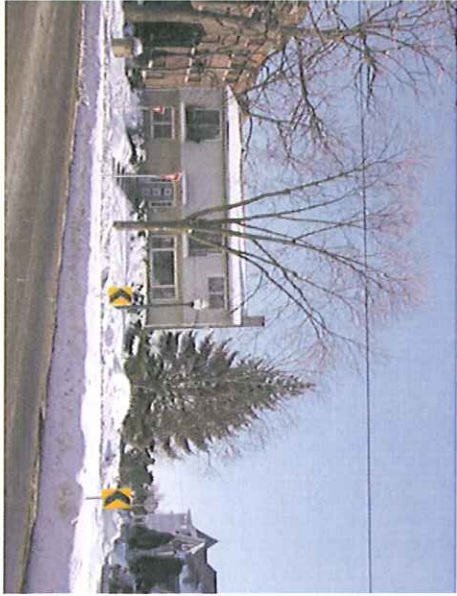
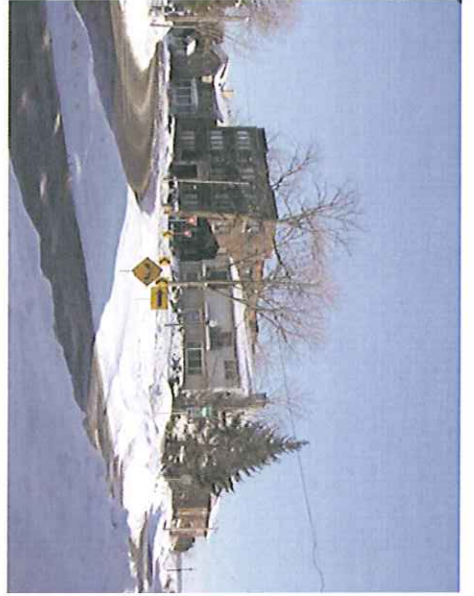
Photos of Buildings to Demo
Building B - 451 W Wilson Street

The apartments have multiple flooring products – all in very poor shape. There is insufficient storage. The kitchens are in poor condition and have the original cabinets and countertops which were not of high quality when originally installed. Typically, each kitchen has a refrigerator and an 18-inch range – there is no hood fan or dishwasher in any of the units. The bathrooms are in very poor shape. The HVAC system for the upper three apartments is a baseboard radiant hot water system with thru-wall air conditioning units. The first floor apartment has a forced air system. There is minimal sound separation between units.

The building itself is in need of a new roof. The three season porch is in very poor condition and the small projected balconies on upper floor facing Wilson Street are also in poor condition. There is a small parking lot and its asphalt is in poor condition. The building is not very energy efficient and probably lacks adequate insulation.

In general, this building is need of substantial repairs and would require significant remodeling to get it into a marketable condition.
