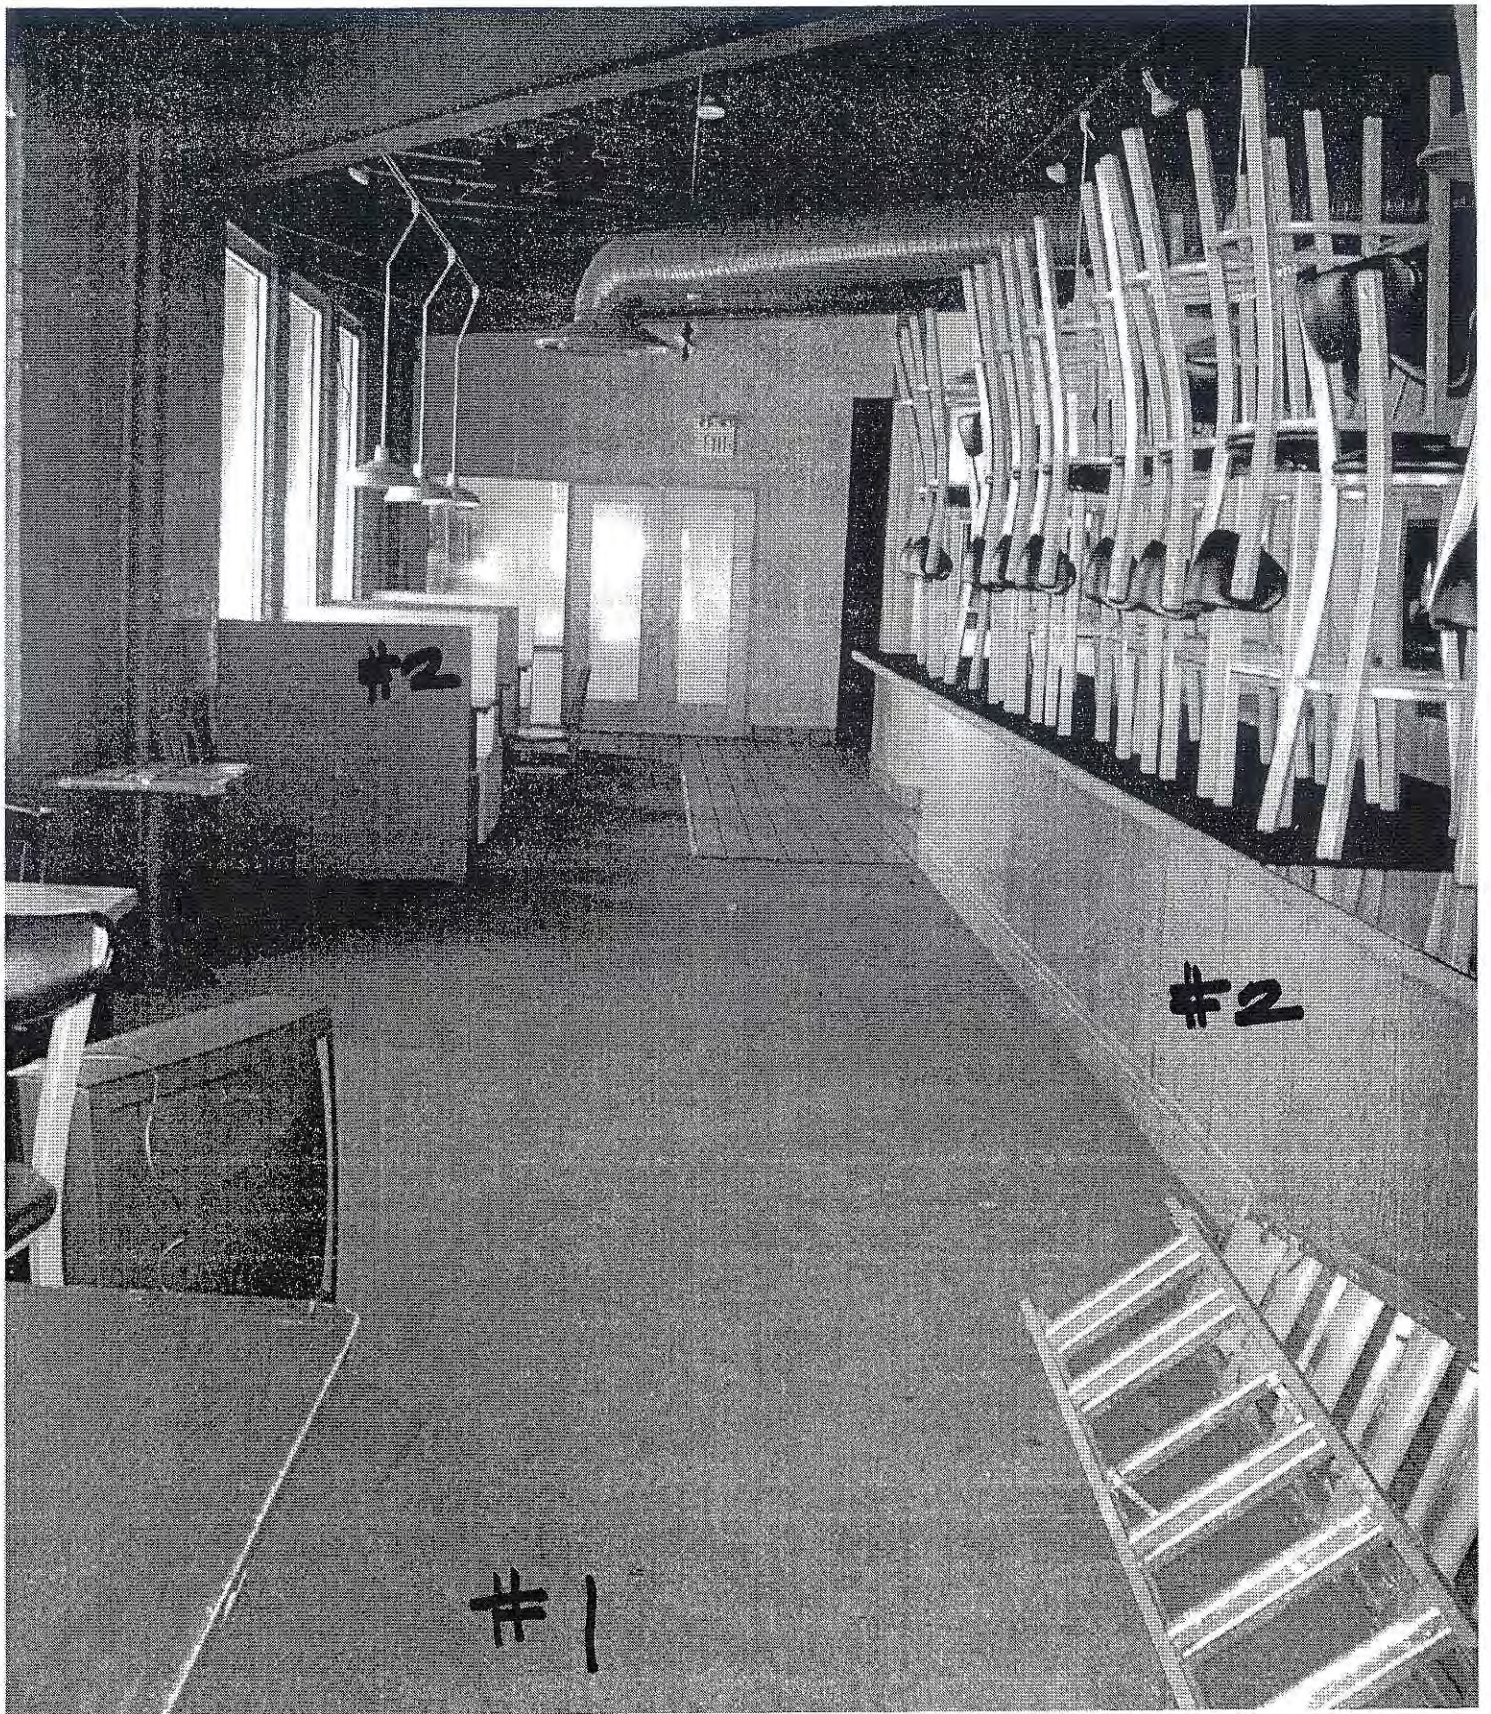
PHOTO # 23 FINISHES.

#1 TYPICAL TENANT SPACE FLOOR FINISHES - WORN BEYOND USE ... REQUIRE REPLACEMENT

#2 TYPICAL FIXTURES REQUIRE REPLACEMENT 14-
