Proposed Associated Bank – Mineral Point
Northeast Corner of South High Point Road and West Mineral Point Road: Madison, WI

Tree & Vegetation Assessment:

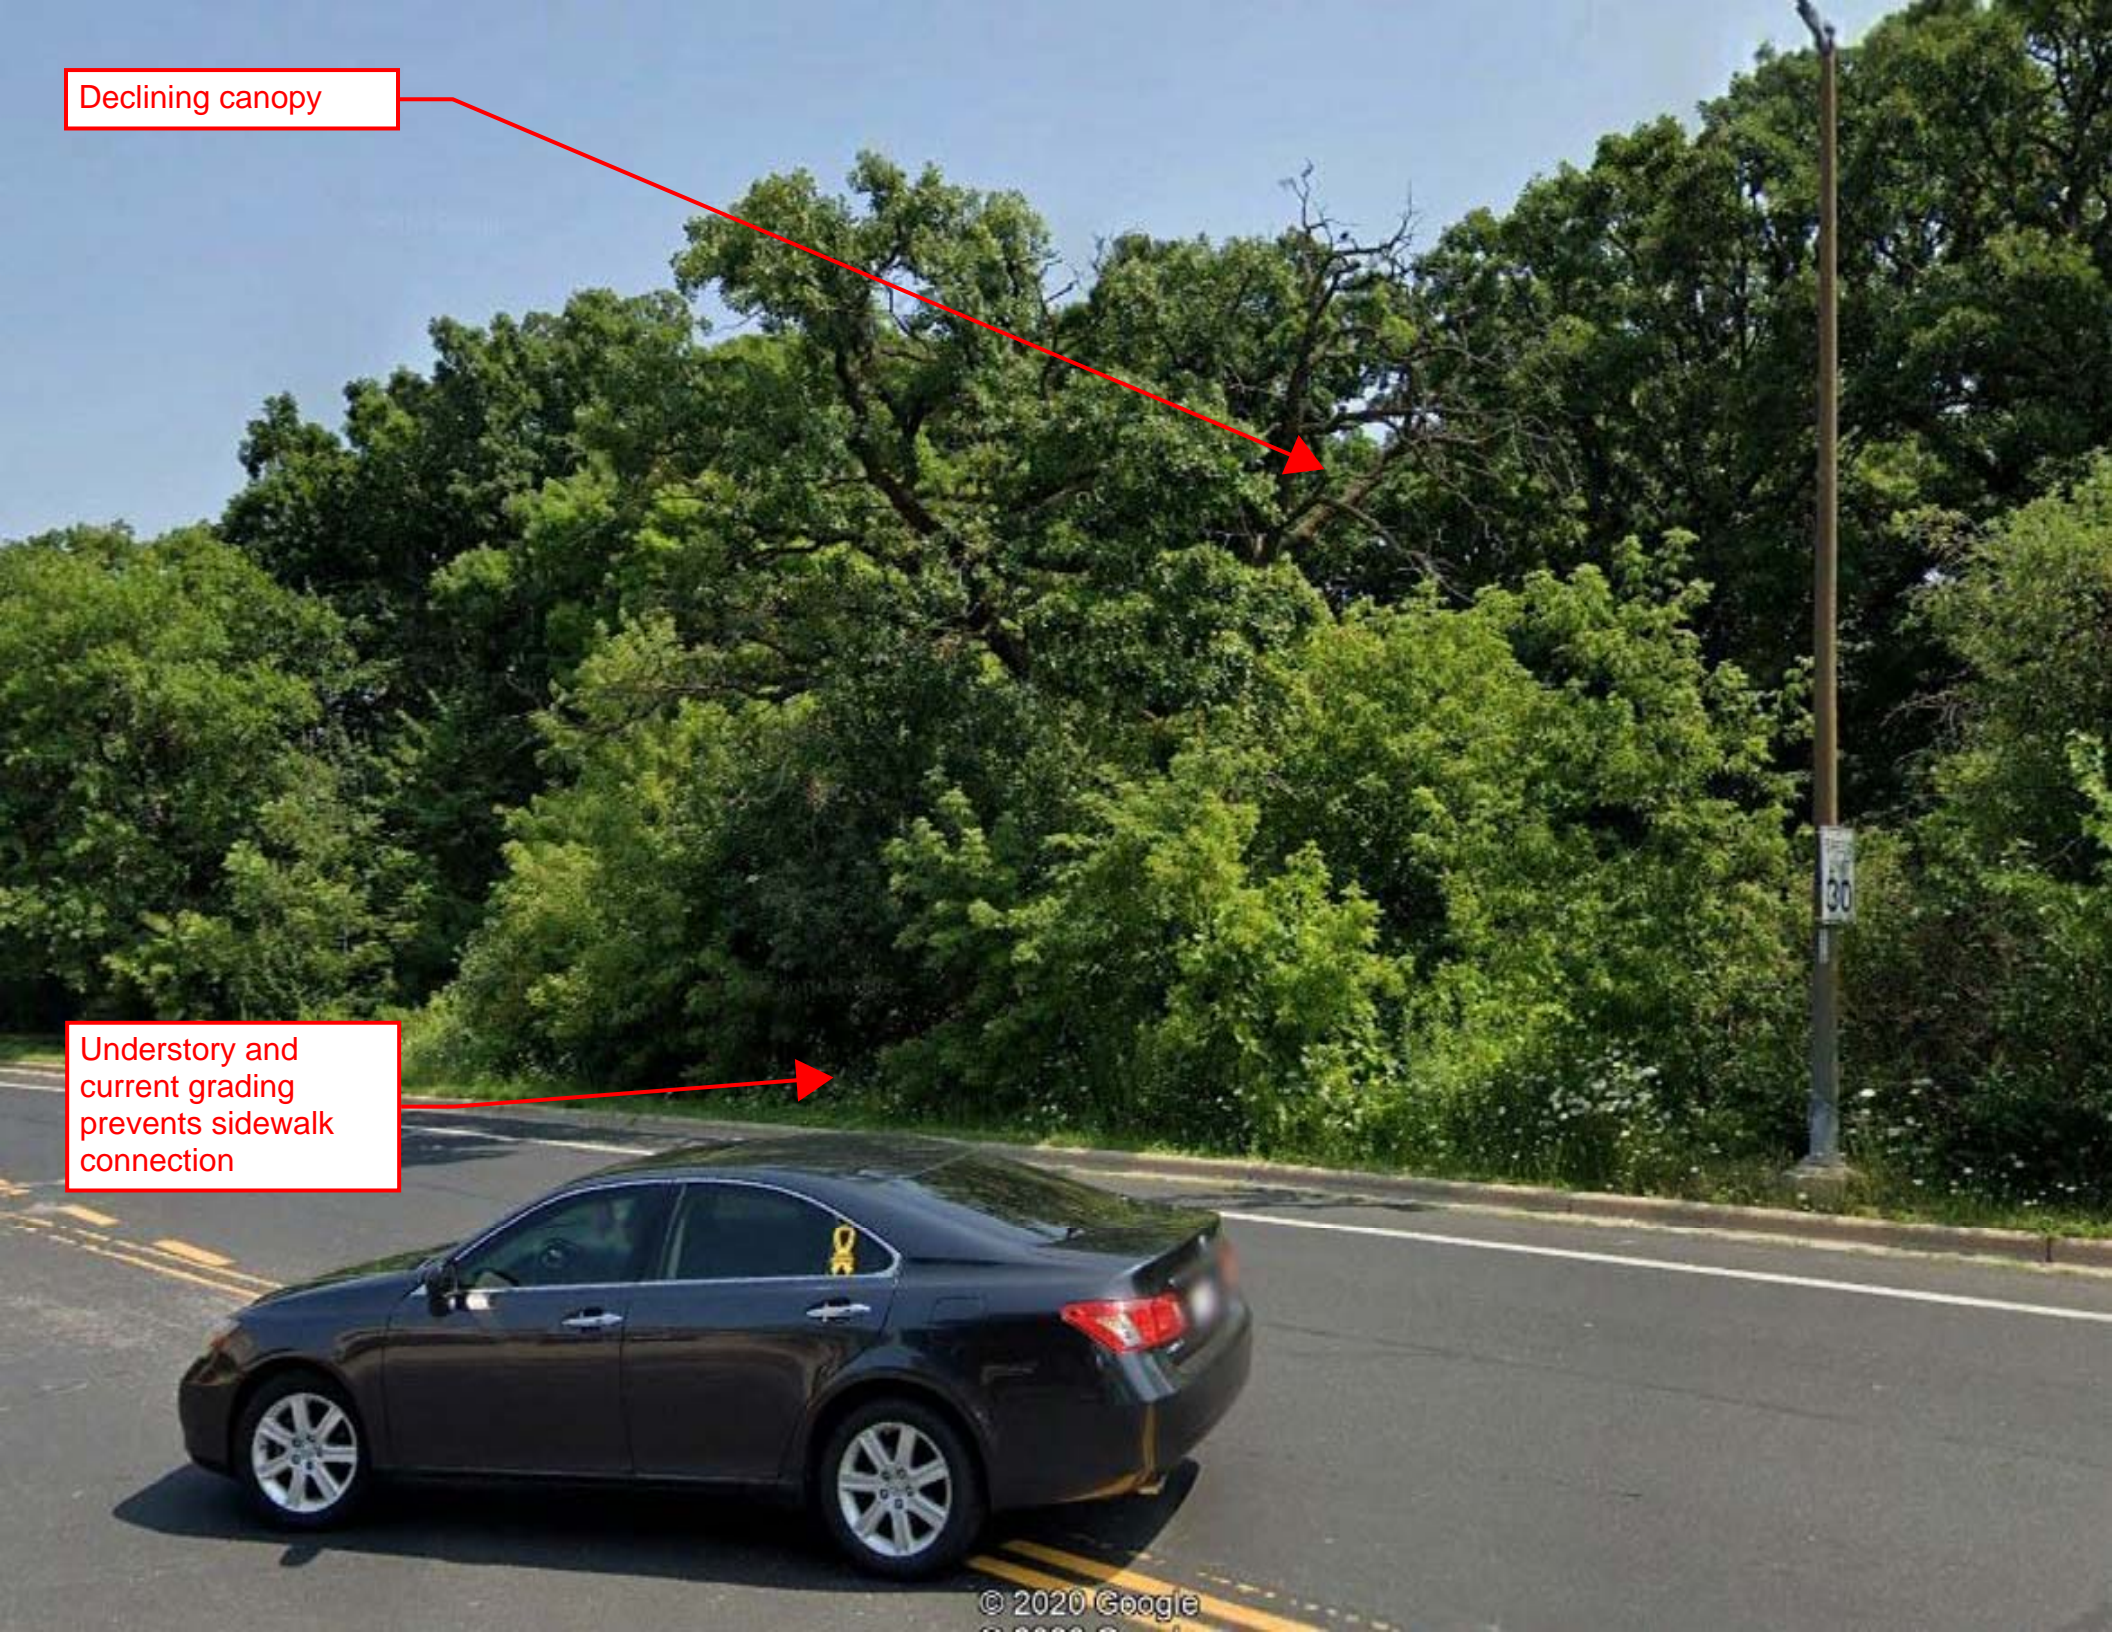
Tree is significantly lower than road / connecting walk grade, limbs are low in the site side and overhang low over High Point Road

Declining canopy

Understory and current grading prevents sidewalk connection
