## Certificate of Appropriateness for 2115 Kendall Ave.

September 16, 2019

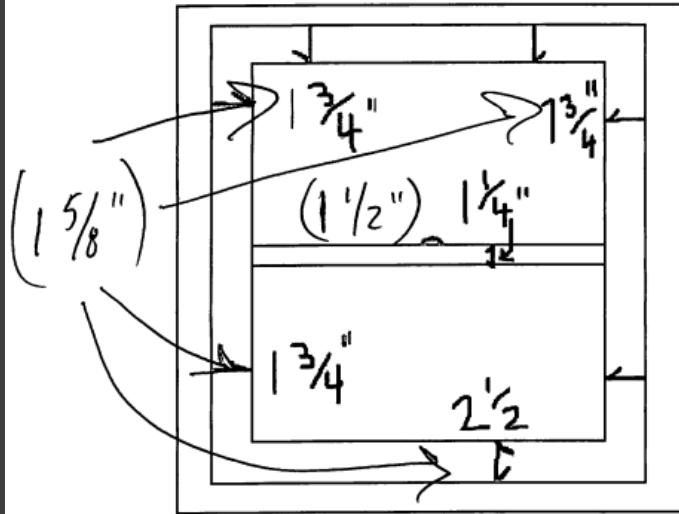
# UPSTAIRS WINDOW DIMENSIONS 2115 Kendall Ave Madison WI 53726

These measures are for upstairs windows 11, 12, 13, 14, 15, 16.

Frame measures for windows (as measured by Jordan Exteriors) are: 28" by 55"

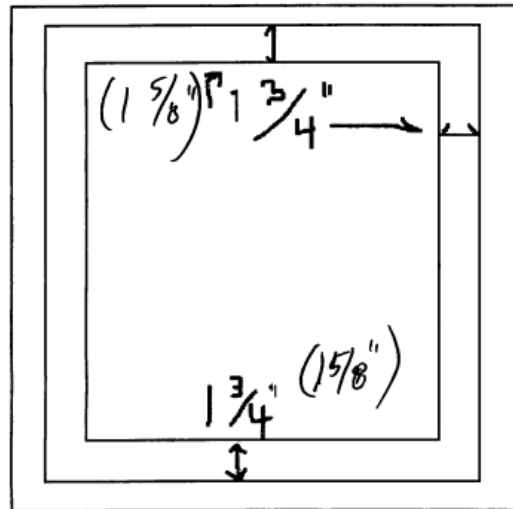
These measures are for window 10 the picture window on the stairway, 28" by 28".
