# LANDMARKS COMMISSION APPLICATION

Project Address: 644 FRANCES STREET Aldermanic District: 8

Project Title/Description: DELTA UPSILON EXTERIOR RESTORATION

**Letter of Intent  
City of Madison  
Landmarks Commission**

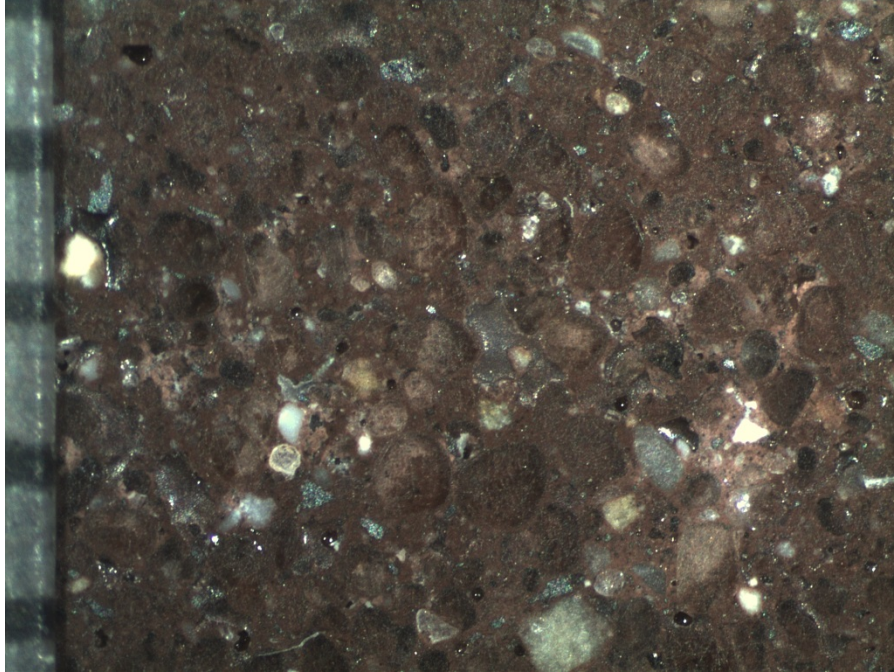
5. The mortar aggregate is a mixed siliceous and carbonate natural sand containing quartz, dolomite, feldspar, sandstone, chert and minor amounts other rock and mineral types (Photographs 3 and 4).
6. Measured maximum aggregate size is 2.0 mm or No. 10 US standard mesh sieve screen. The aggregate gradation appears similar to today's ASTM C 144 (Standard Specification for Aggregate for Masonry Mortar) gradation requirements. Overall, the sand appears to be performing as intended in the mortar.
7. Using the results of our petrographic and insoluble residue analyses, we determined the relative constituent proportions as follows:

Photograph 3. This is a lapped surface of mortar interior showing the transparent to translucent quartz and feldspar sand particles, white lime balls and yellowish dolomite sand particles constituting the aggregate. Note the uniform aggregate gradation and distribution. Scale is in millimeters.

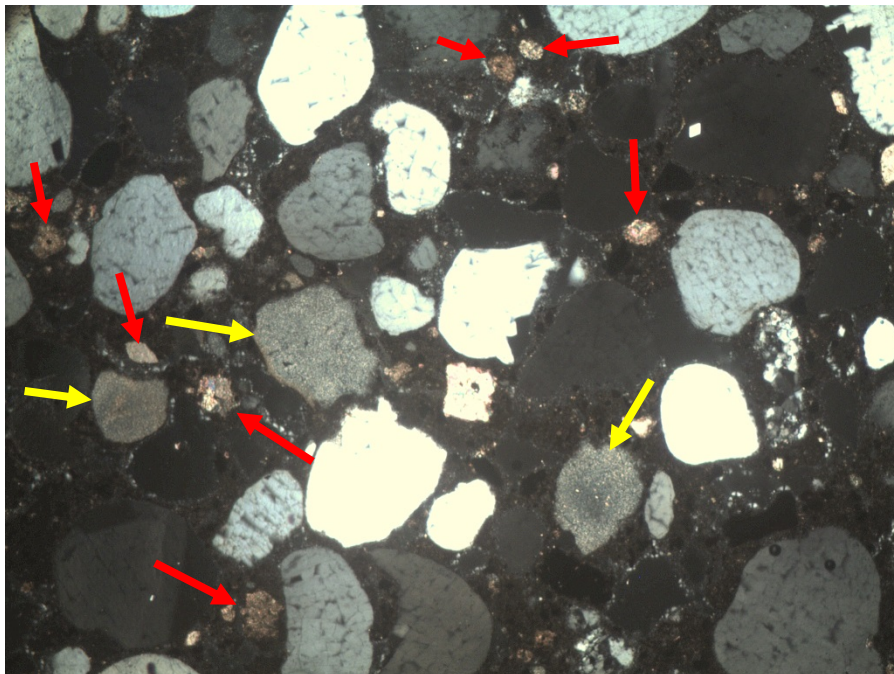
9. Portland cement is not present in the binder. The binder matrix is lime (Photograph 6) and contains the characteristic microscopic shrinkage cracking typical of lime based mortars (Photograph 7). Lime balls and relicts of lime balls are present (Photographs 4 and 8), suggesting incomplete and uneven mixing of the lime. These observations are typical of the period of construction and level of materials technology of the time.

Photograph 4. This thin section photomicrograph depicts the presence of gray and white quartz and feldspar sand particles, gold dolomite sand particles (red arrows), and lime balls (yellow arrows) all embedded in a brownish lime matrix. Crossed-polarized light. 40x magnification.
