LANDMARKS COMMISSION APPLICATION

Project Address: 644 FRANCES STREET

Project Title/Description: DELTA UPSILON EXTERIOR RESTORATION

Letter of Intent
City of Madison
Landmarks Commission

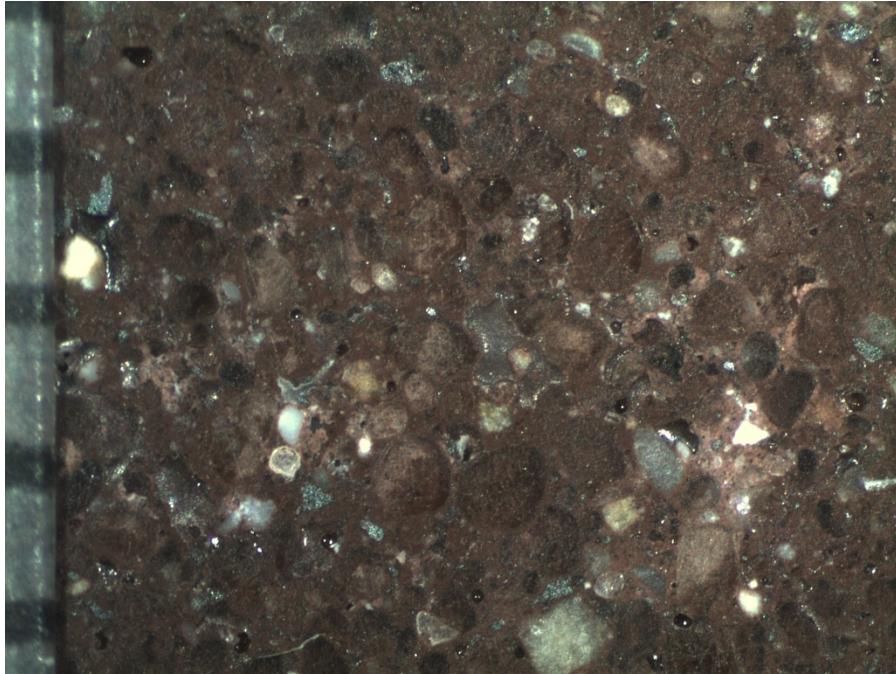
5. The mortar aggregate is a mixed siliceous and carbonate natural sand containing quartz, dolomite, feldspar, sandstone, chert and minor amounts other rock and mineral types (Photographs 3 and 4).
6. Measured maximum aggregate size is 2.0 mm or No. 10 US standard mesh sieve screen. The aggregate gradation appears similar to today's ASTM C 144 (Standard Specification for Aggregate for Masonry Mortar) gradation requirements. Overall, the sand appears to be performing as intended in the mortar.
7. Using the results of our petrographic and insoluble residue analyses, we determined the relative constituent proportions as follows:

Photograph 3. This is a lapped surface of mortar interior showing the transparent to translucent quartz and feldspar sand particles, white lime balls and yellowish dolomite sand particles constituting the aggregate. Note the uniform aggregate gradation and distribution. Scale is in millimeters.

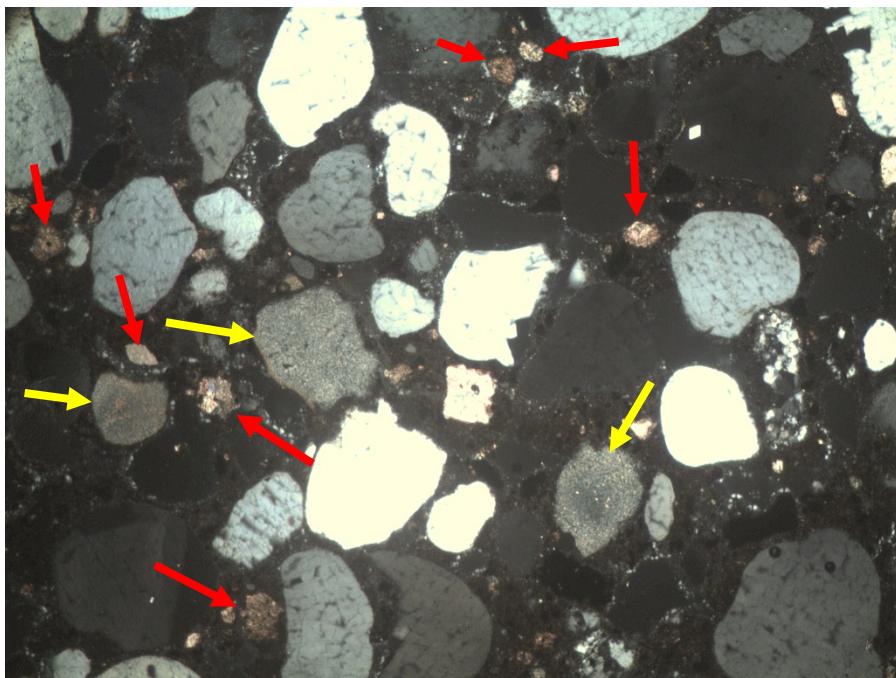
9. Portland cement is not present in the binder. The binder matrix is lime (Photograph 6) and contains the characteristic microscopic shrinkage cracking typical of lime based mortars (Photograph 7). Lime balls and relicts of lime balls are present (Photographs 4 and 8), suggesting incomplete and uneven mixing of the lime. These observations are typical of the period of construction and level of materials technology of the time.

Photograph 4. This thin section photomicrograph depicts the presence of gray and white quartz and feldspar sand particles, gold dolomite sand particles (red arrows), and lime balls (yellow arrows) all embedded in a brownish lime matrix. Crossed-polarized light. 40x magnification.

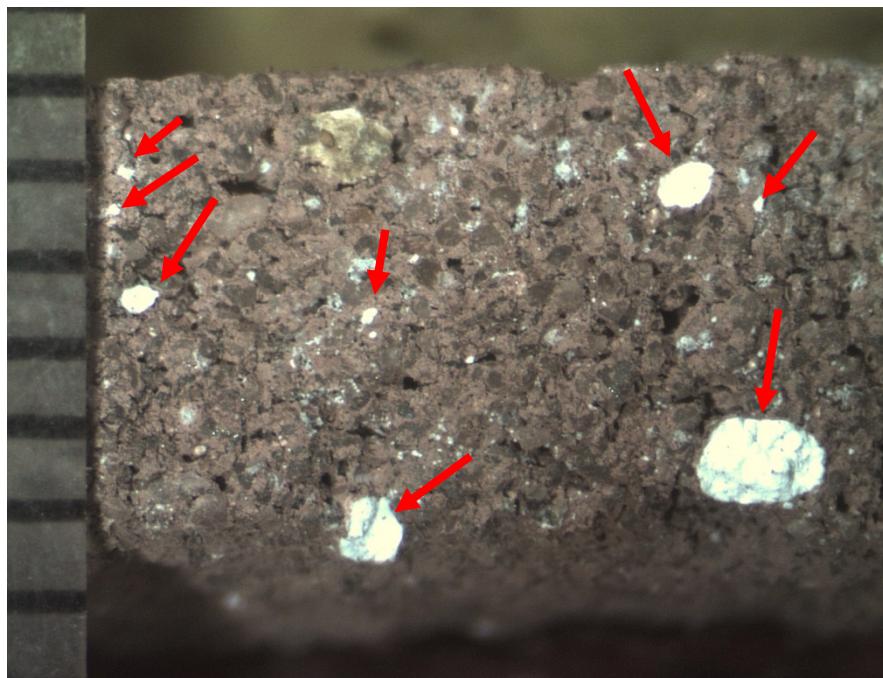
Photograph 8. Photomicrograph illustrating lime balls (red arrows) in the mortar matrix. Scale is in millimeters.
