D3. Demolition Context Images

901 E. Washington Ave Hotel - 2016.36.01

July 25, 2017

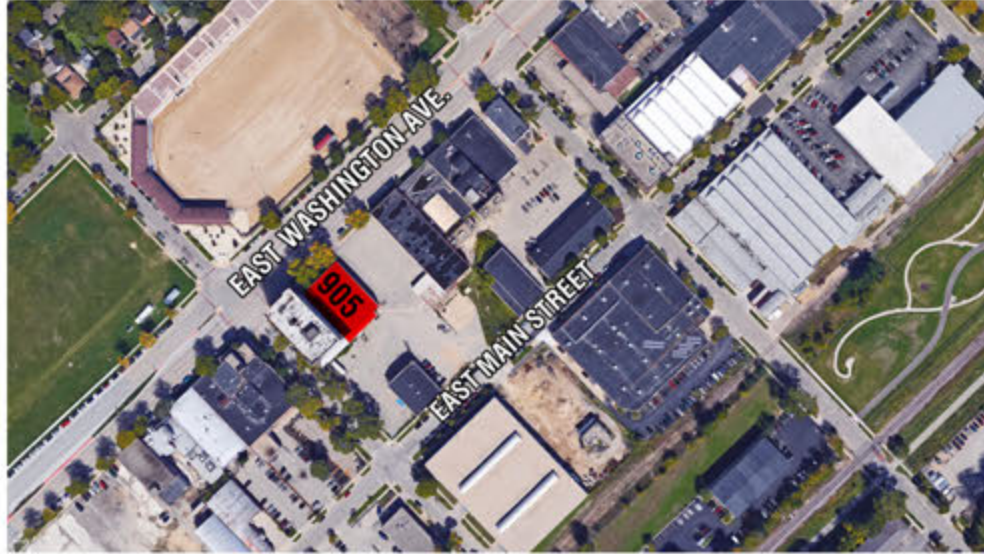
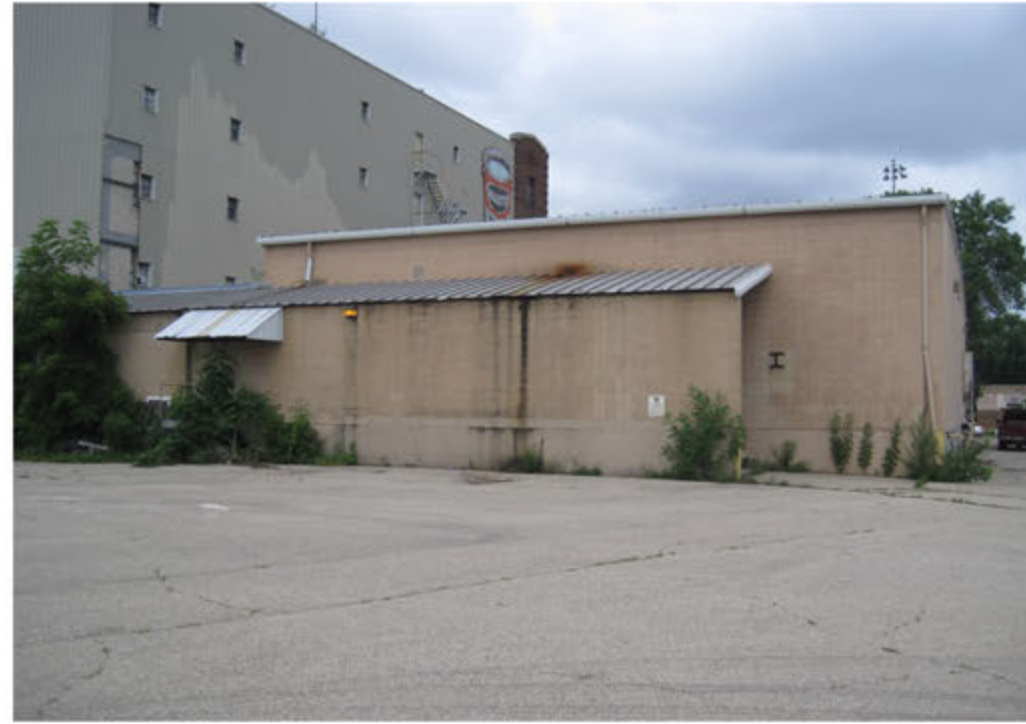
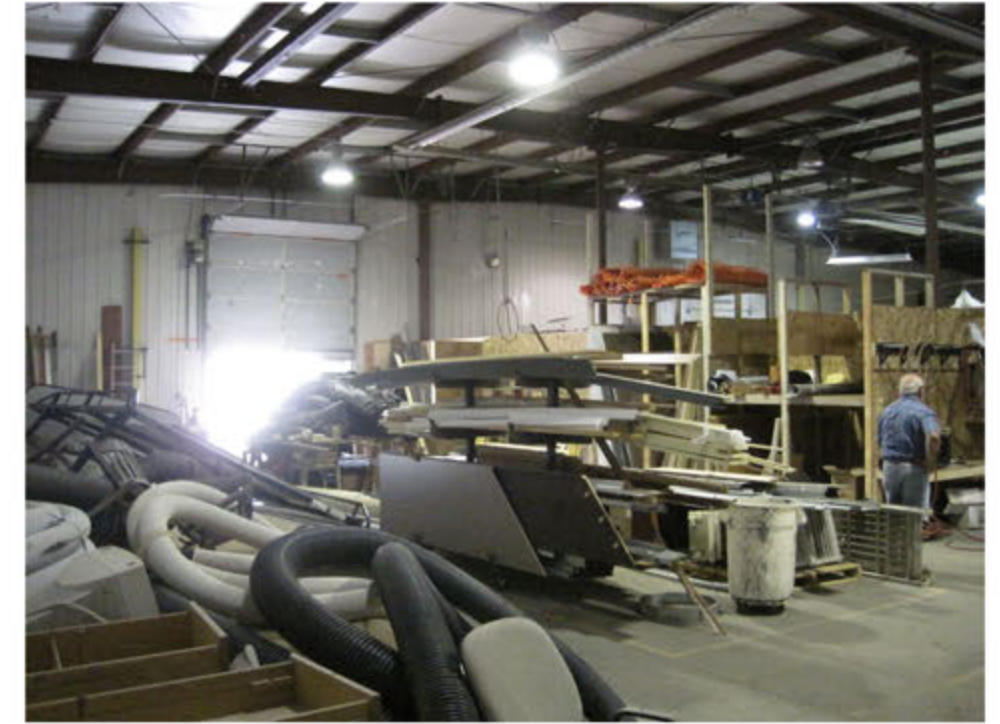
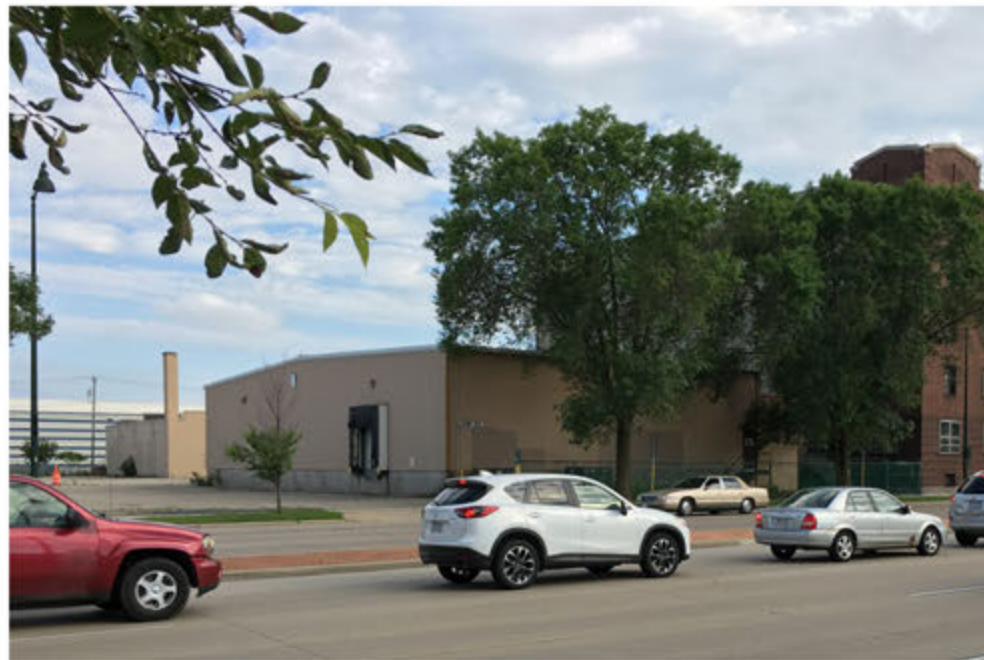
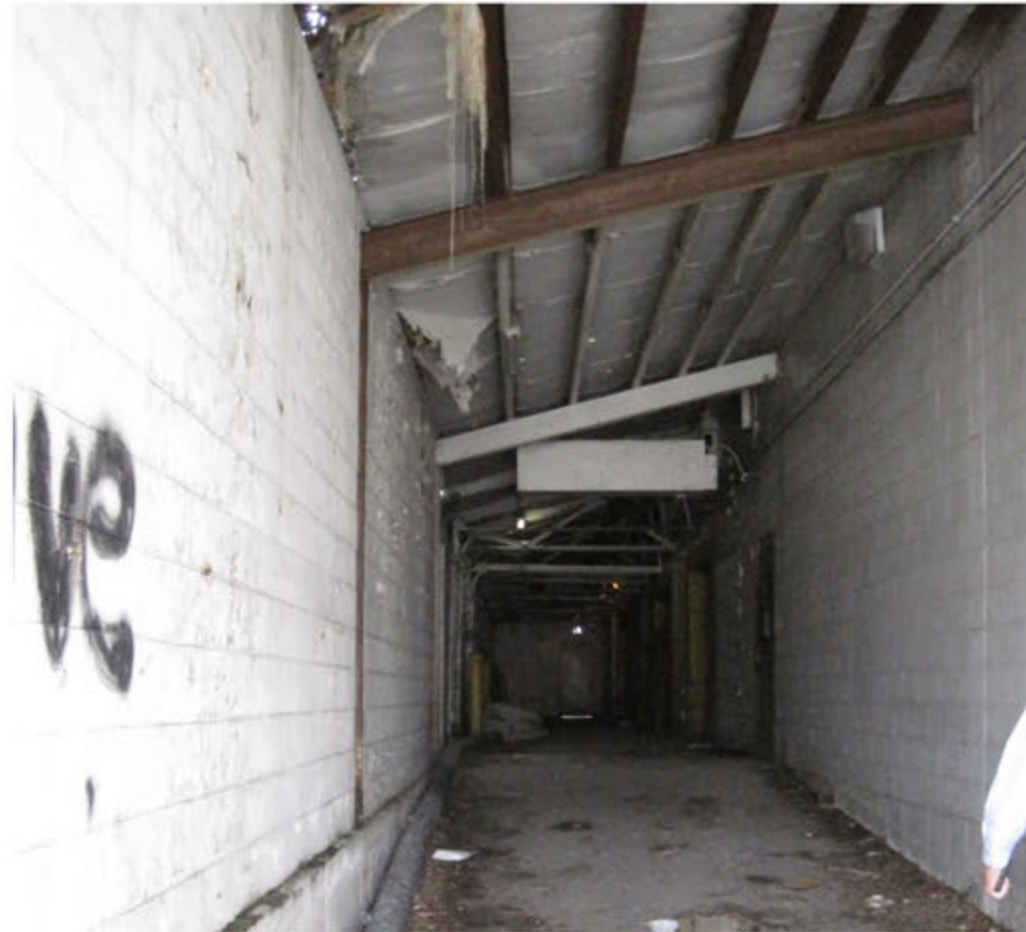
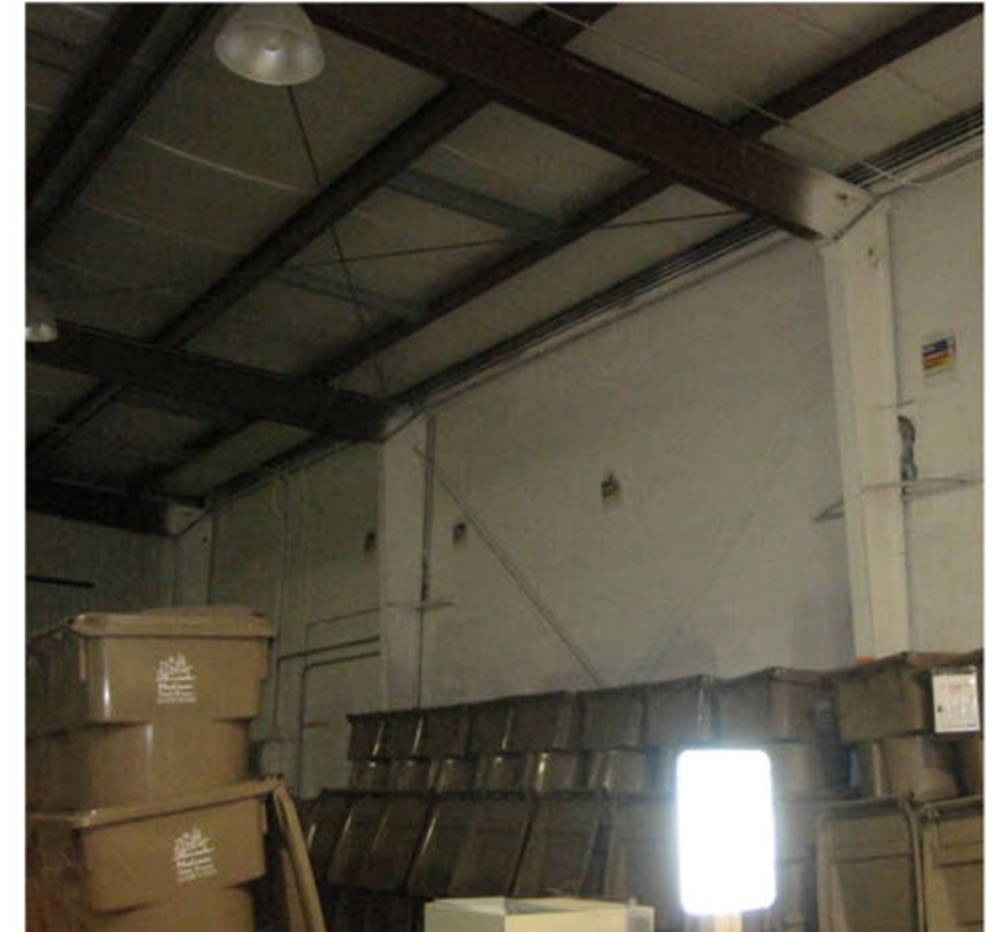
905 East Washington Ave.

Building Description: The building is a single story building and is currently used for on-site storage. The façades are void of openings other than a loading dock located along the North-East façade. A covered loading corridor is located at the rear of the building. This building is an addition to the existing Kleuter building and spans over its basement.
