APPLICATION FOR DEMOLITION OF PRINCIPAL BUILDINGS

The existing buildings are unsafe and uninhabitable due to severe structural deterioration. Rehabilitation would cost upwards of \$40,000 per property and would not result in usable or safe living or working space. In their current condition, these properties present ongoing safety risks.

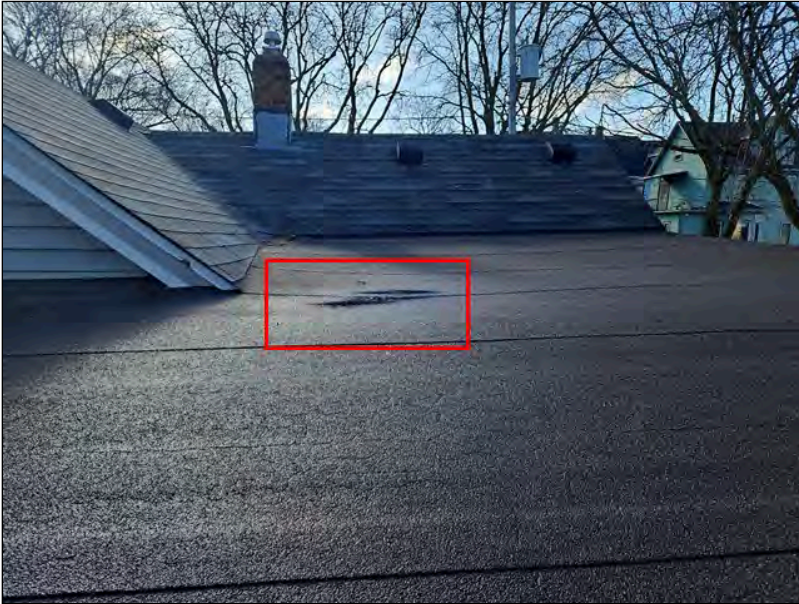
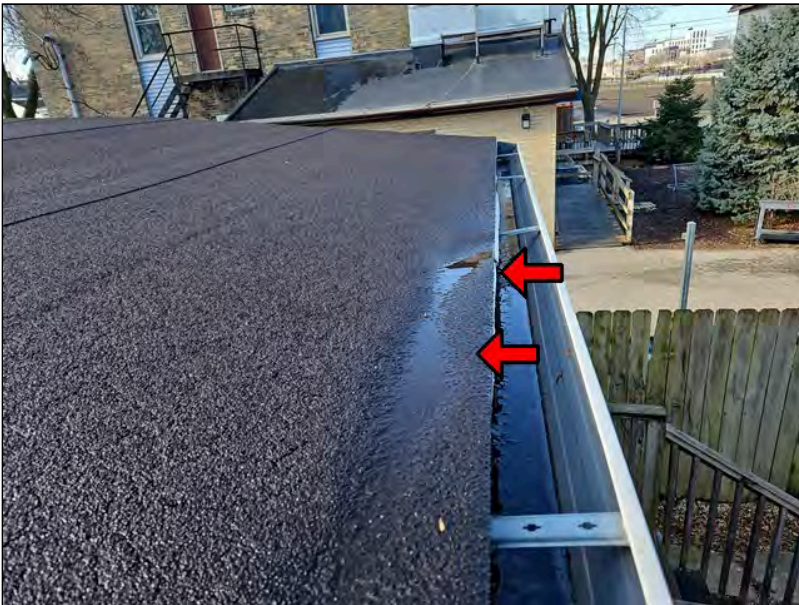
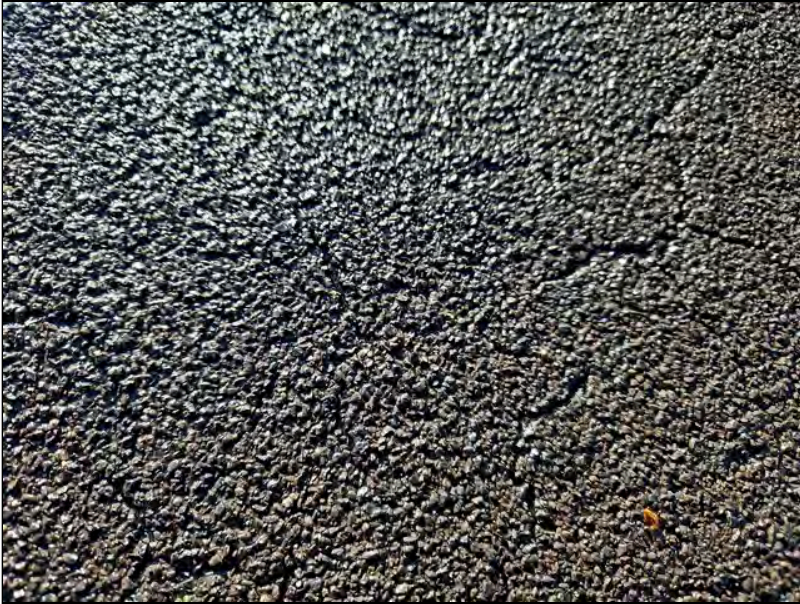
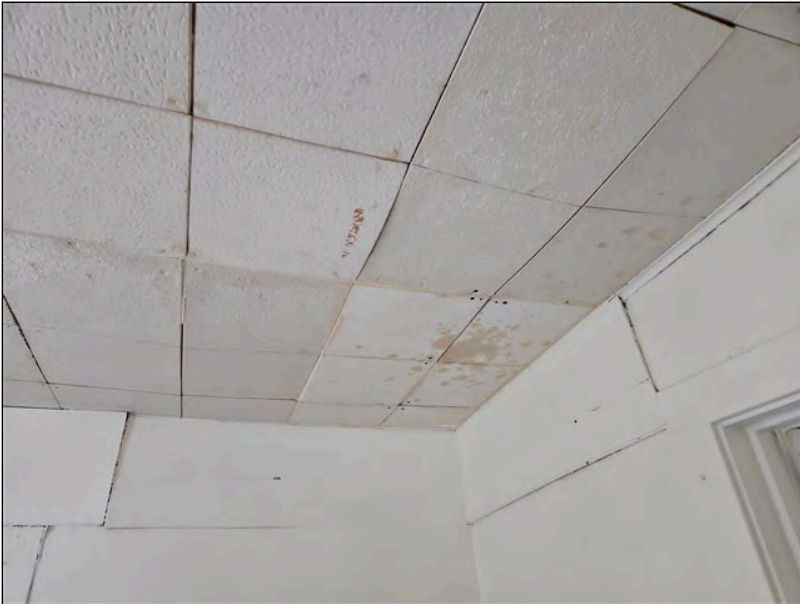
1.0 (1) Defect: Water was pooling on the flat roof - roof was not pitched correctly. Depressions were present in the roof covering.

Cracking was present. Once cracks develop into through-material splits, the roof is more likely to leak.

Moisture stains were present underneath this area of the roof with a depression. Stains represent a past or present leak in the roof covering. Depression may indicate issues with the roof structure - there was no attic space in this area to allow a view of the roof structure.

Recommend further evaluation of the roof coverings and repair/replace as necessary by qualified roofing contractor.

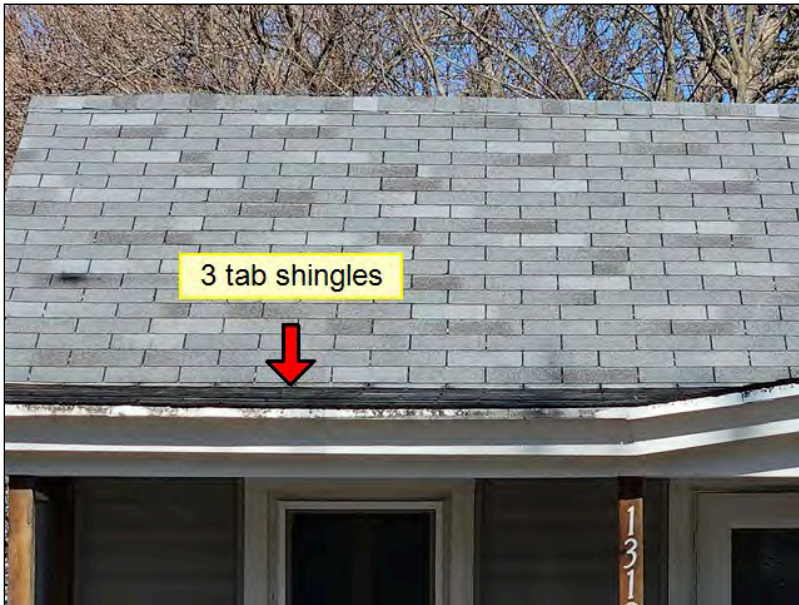
1.0 (2) Defect: The low slope roof at the on the front porch had asphalt composite shingles installed. It should have either selvage, roll roofing, rubber membrane or an approved covering for a flat roof. The roof may leak in heavy rain or ice may dam in winter causing a leak.

Recommend further evaluation of the roof coverings and repair/replace as necessary by qualified roofing contractor.

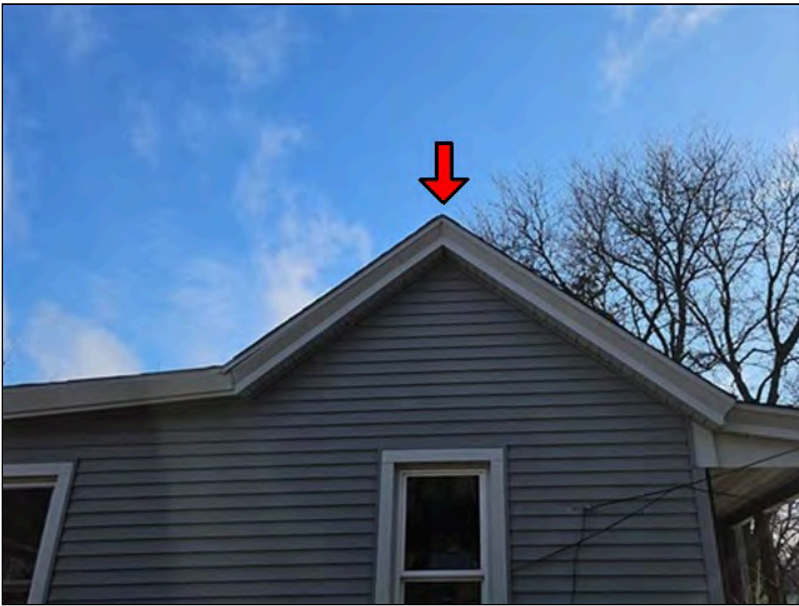
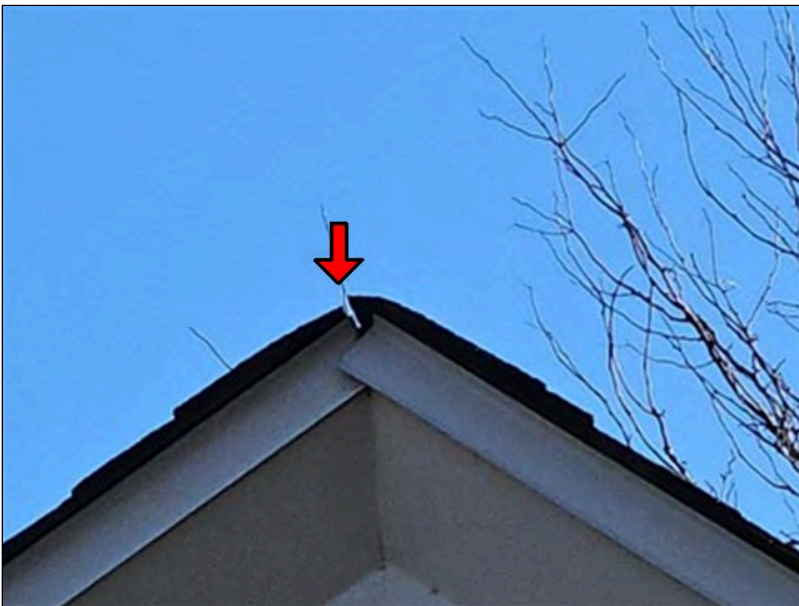
1.0 (3) Repair: Ridge cap shingle was spilt. Condition may allow moisture intrusion.

Recommend further evaluation of the roof coverings and repair as necessary by qualified roofing contractor.

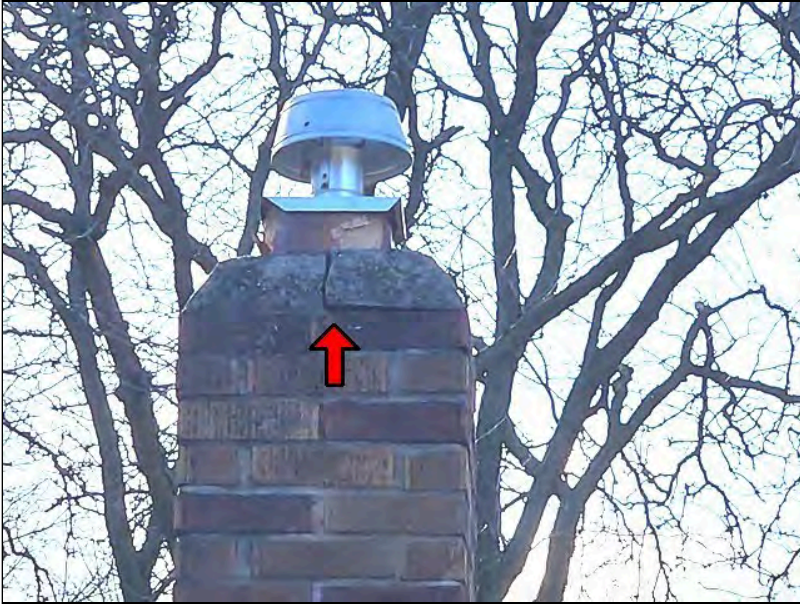
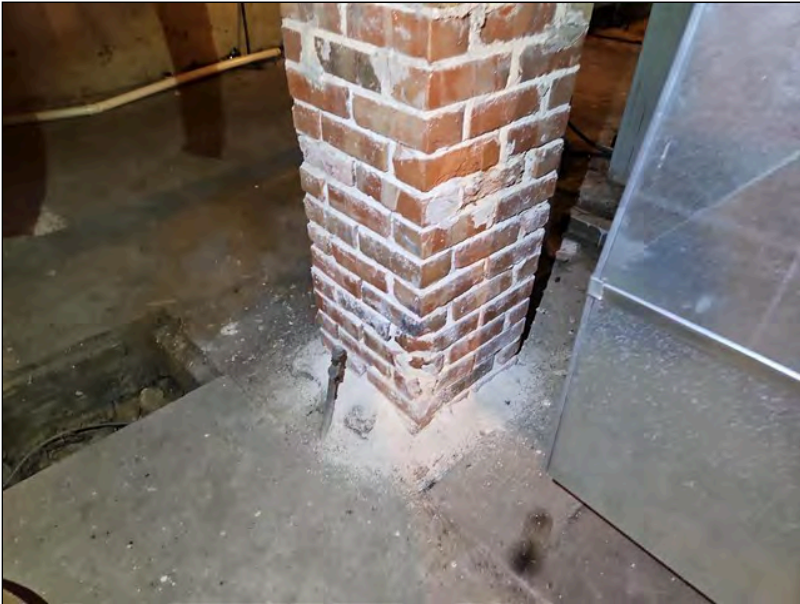
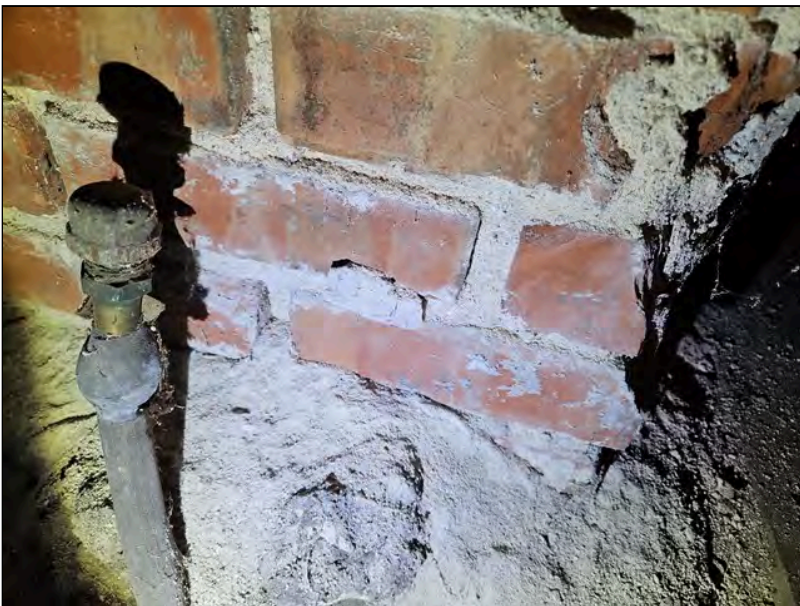
1.4 Defect: Concrete crown and flue were cracked. Mortar at the base of the chimney in the basement has turned into a powder.

Recommend further evaluation and repair as necessary by qualified chimney contractor.

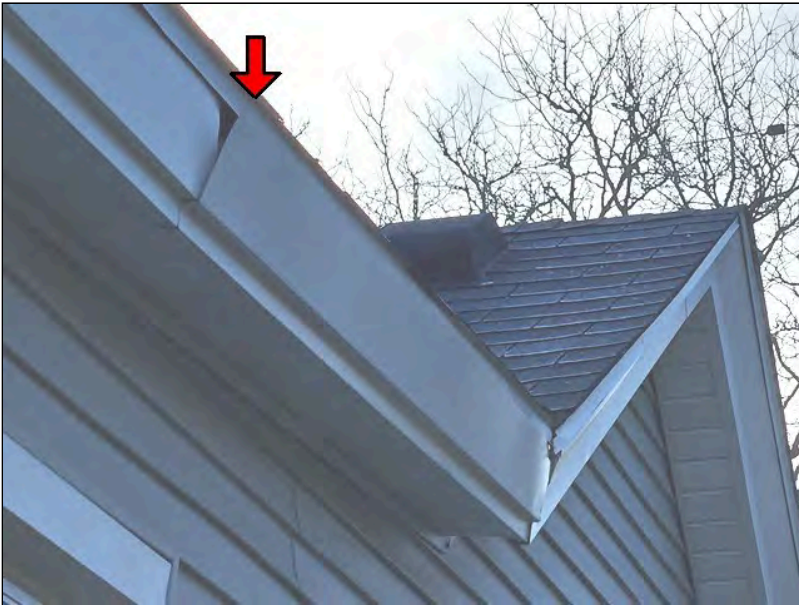
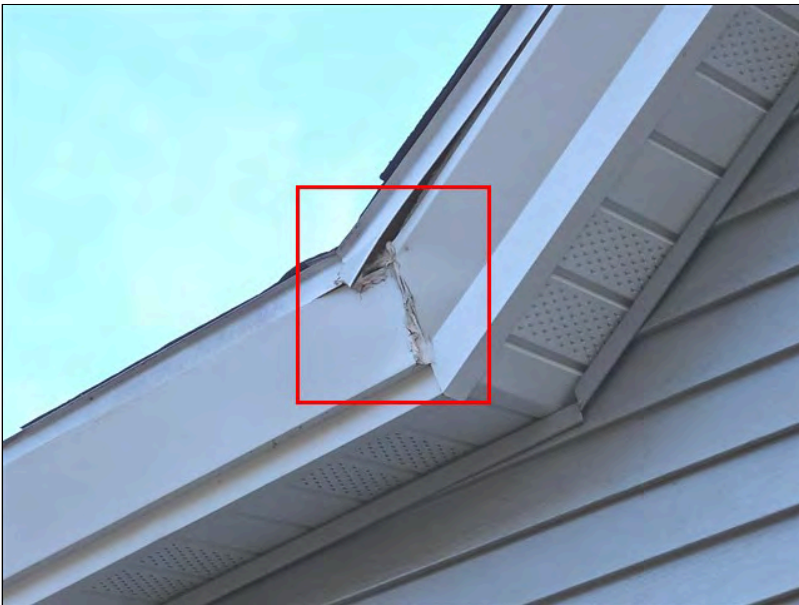
2.1 Repair: Disengaged fascia was present at the left side (facing front) of the home. Sealant was deteriorated. Area is vulnerable to the entry of vermin and moisture.

Recommend further evaluation and repair as necessary by a qualified contractor.

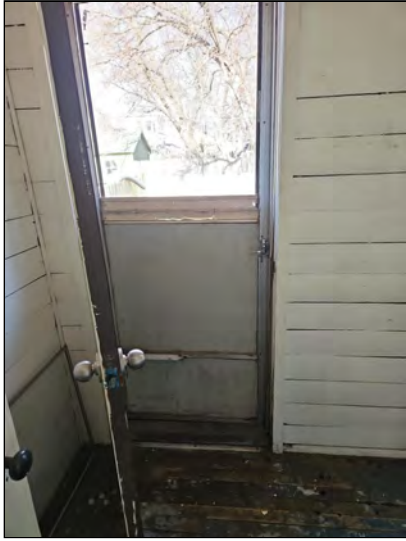
2.2 Repair: Both storm doors were damaged.

Recommend further evaluation and repair as necessary by a qualified contractor.

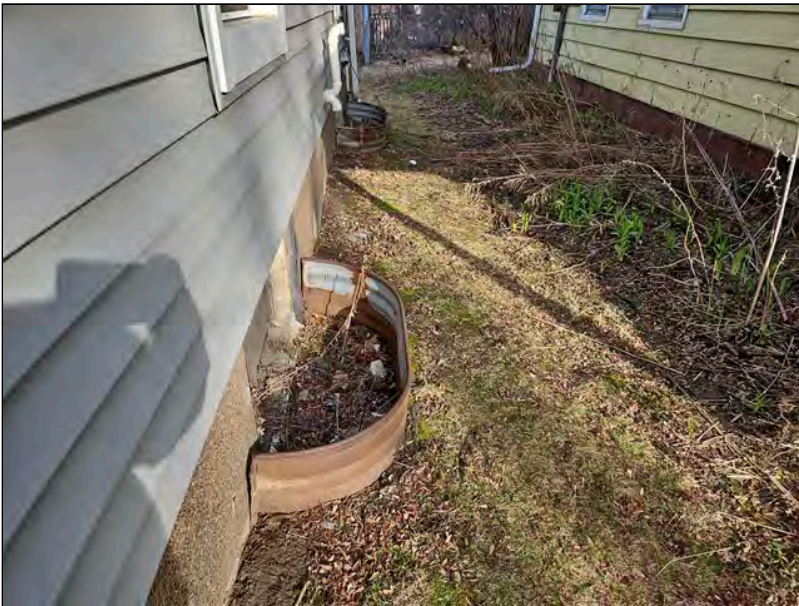
2.3 (2) Repair: Basement window frames were deteriorated. Their deterioration will result in moisture intrusion into the basement.

Recommend further evaluation and repair as necessary by a qualified contractor.

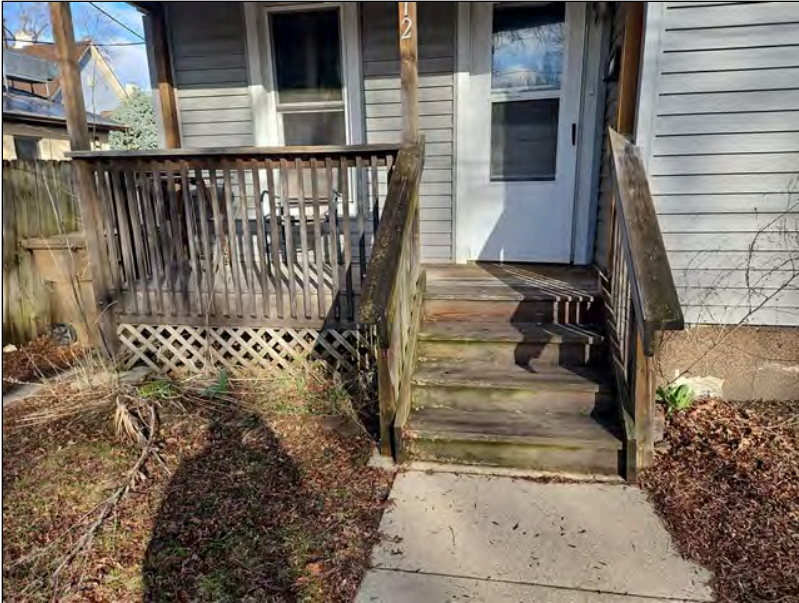
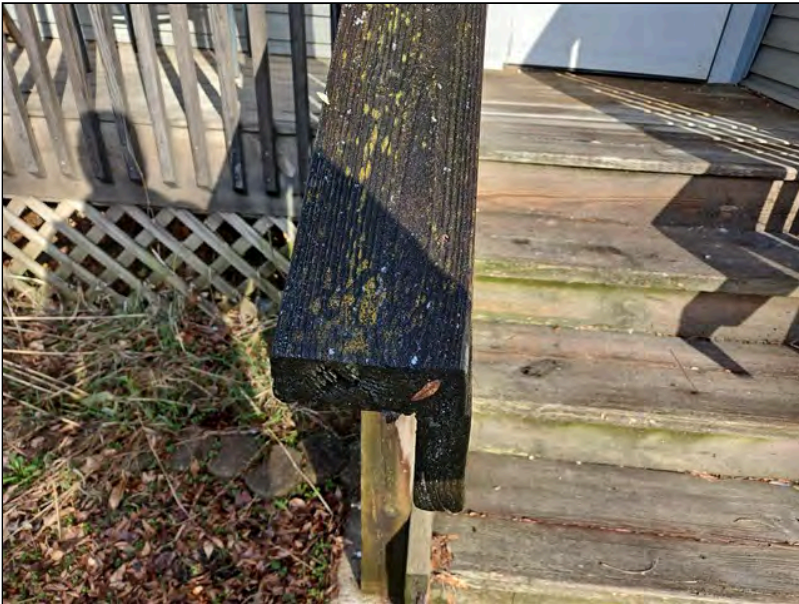
2.4 (1) Defect: The handrail on the porch was not "graspable". "Graspable" refers to the ability of the user to get a secure grip on the handrail. This is a fall hazard.

Recommend further evaluation and repair as necessary by a qualified contractor.

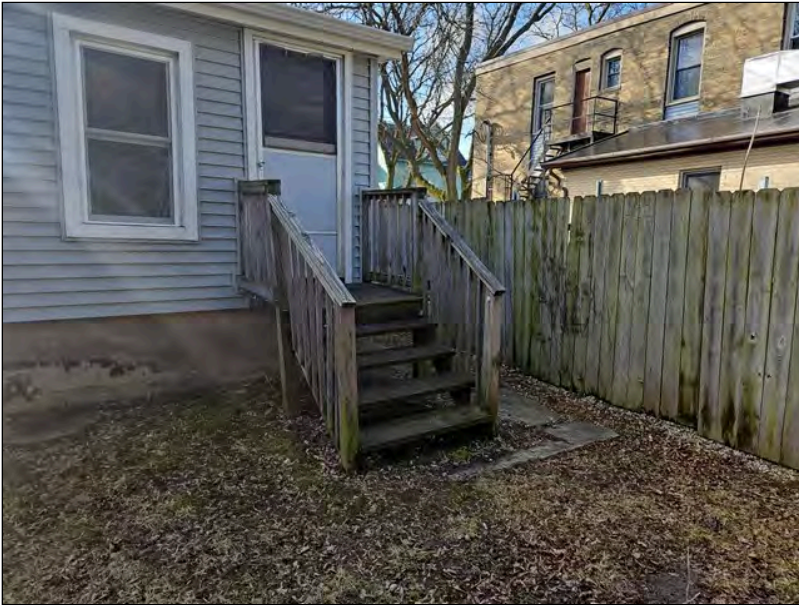
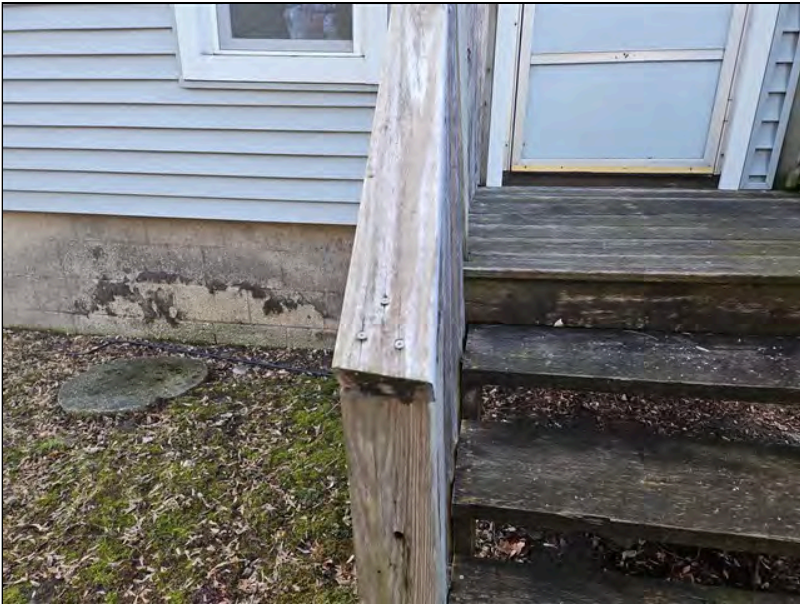
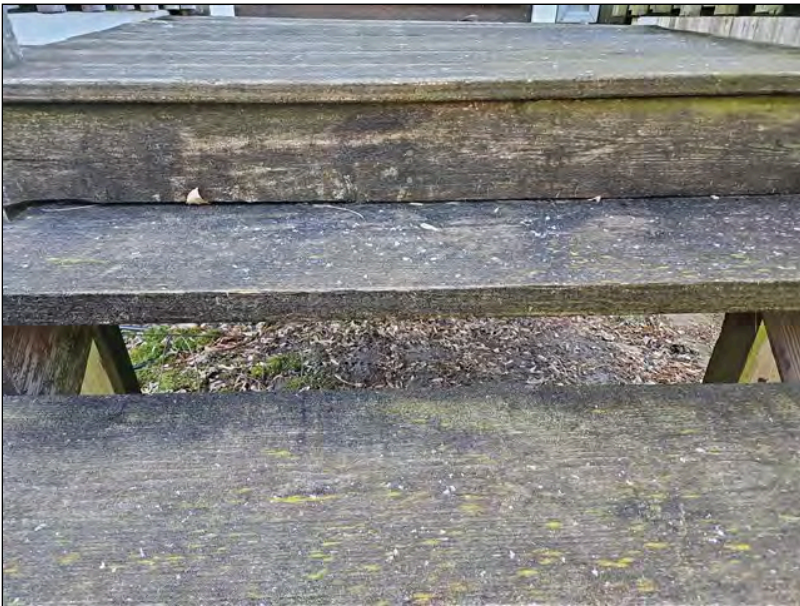
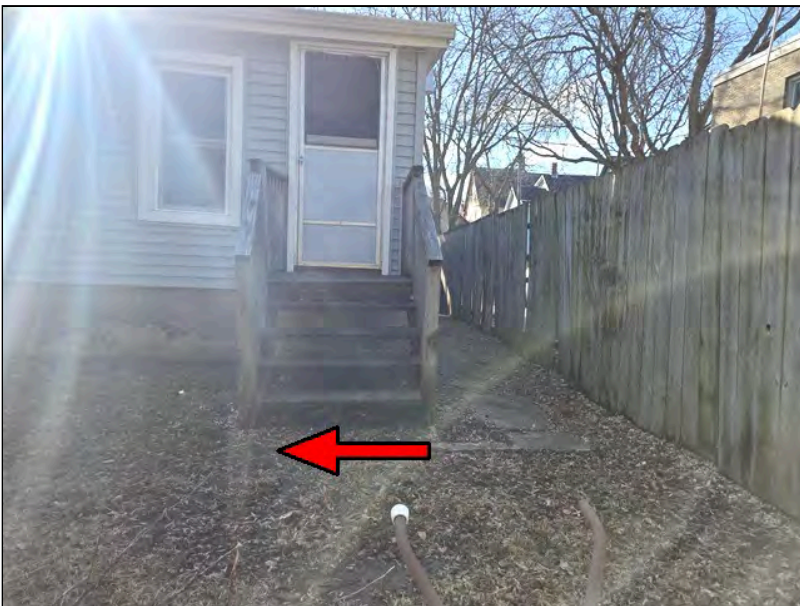
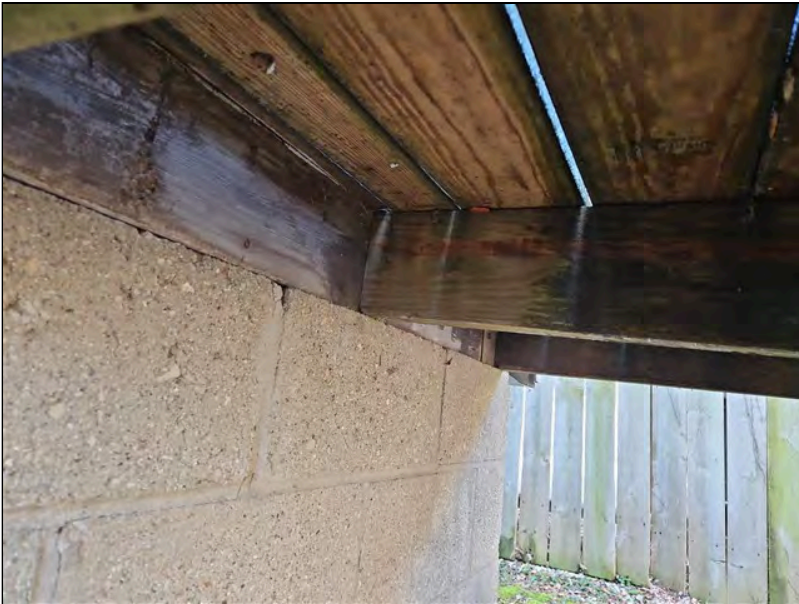
2.4 (2) Defect: The following conditions were present on the rear porch:

The handrail was not "graspable". "Graspable" refers to the ability of the user to get a secure grip on the handrail. This is a fall hazard.

The paint/stain was in a deteriorated condition. Deterioration from moisture intrusion will occur if not corrected.

The ledger board was incorrectly fastened to the home with nails instead of threaded fasteners. This condition can result in the ledger board pulling away from the structure.

Open risers with a space in excess of 4" were present. This is a fall hazard.

Above conditions can jeopardize the structural integrity of the porch, reduce its life expectancy and/or is a safety hazard. List above may not be exhaustive documentation of all conditions that could be considered a "Defect".

Recommend further evaluation of the structure and repair as necessary by a qualified professional.

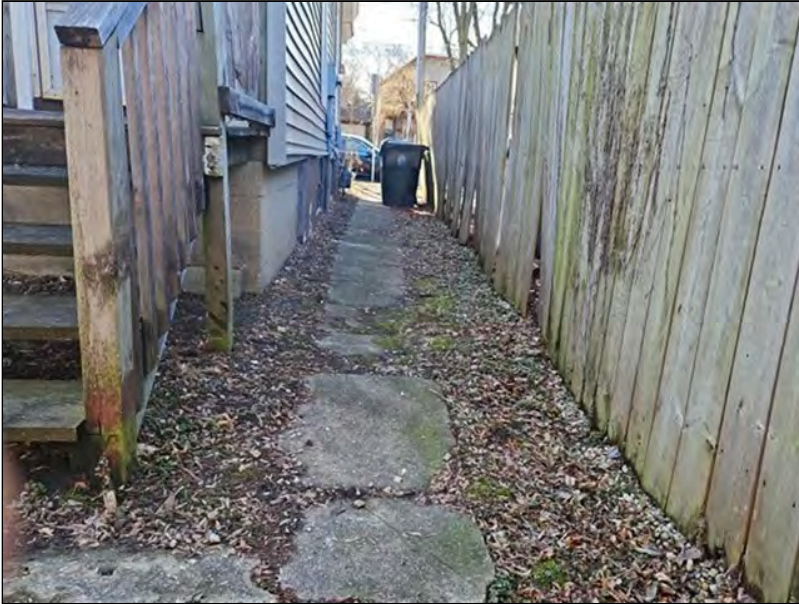
2.5 Defect: The heaving, settling and cracking of the sidewalk has created a trip hazard.

Recommend further evaluation and repair as necessary by a qualified contractor.

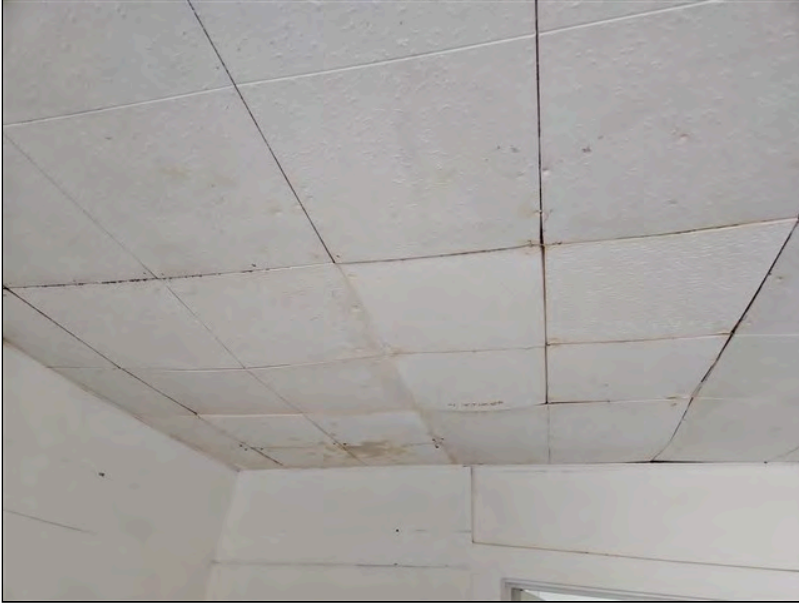
3.0 (1) Further Evaluation: Given the age of the home, the ceiling tile may contain asbestos. Testing would need to be conducted to confirm the presence of asbestos with certainty. Please refer to the EPA website for more information: <https://www.epa.gov/asbestos/protect-your-family>

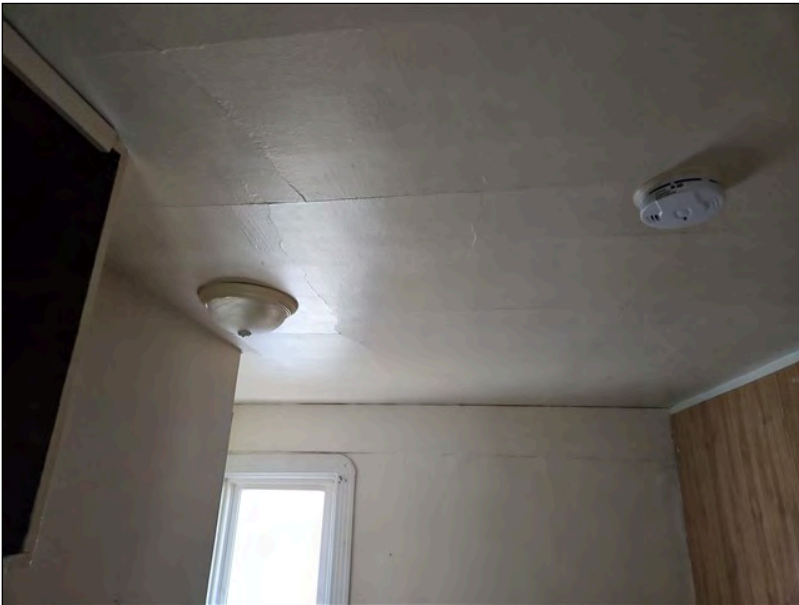
3.0 (2) Repair: The plaster was disengaged/cracked in multiple locations. Recommend further evaluation and repair as necessary by a qualified contractor.

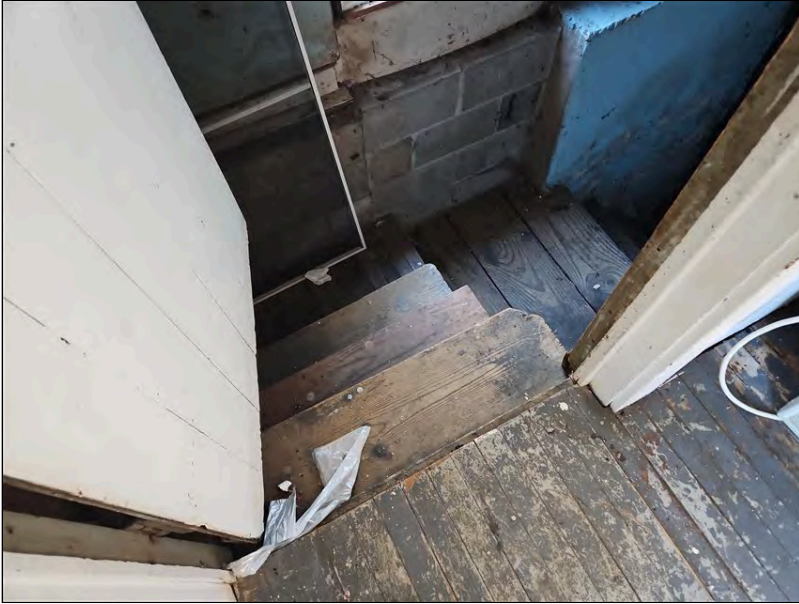
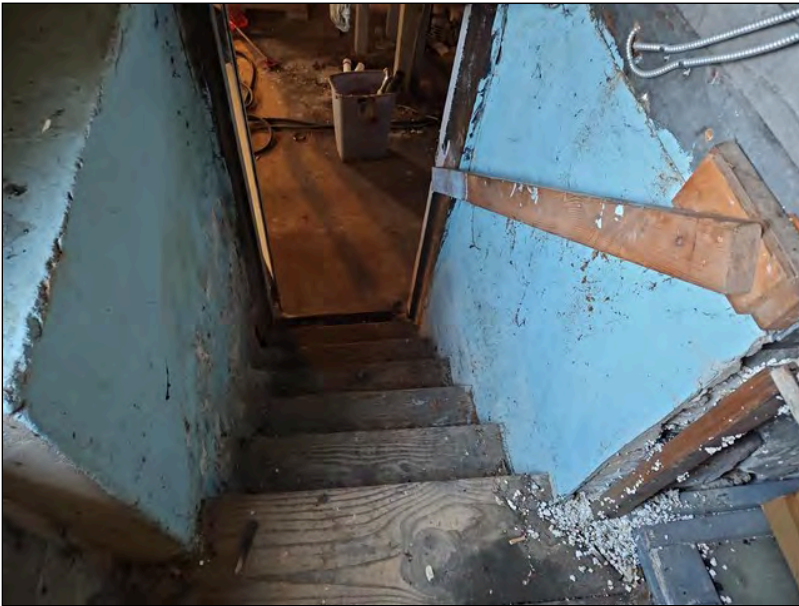
3.2 (1) Defect: The stairs to the basement were not constructed in a manner that are consistent with today's safety standards. This can be a fall hazard.

It may not be possible to make all the changes necessary that will make the stairs meet today's standards but action can be taken to make them safer. One improvement that can be made is the installation of a handrail and correcting the installation of the current handrail.

Recommend further evaluation and repair by a qualified contractor.

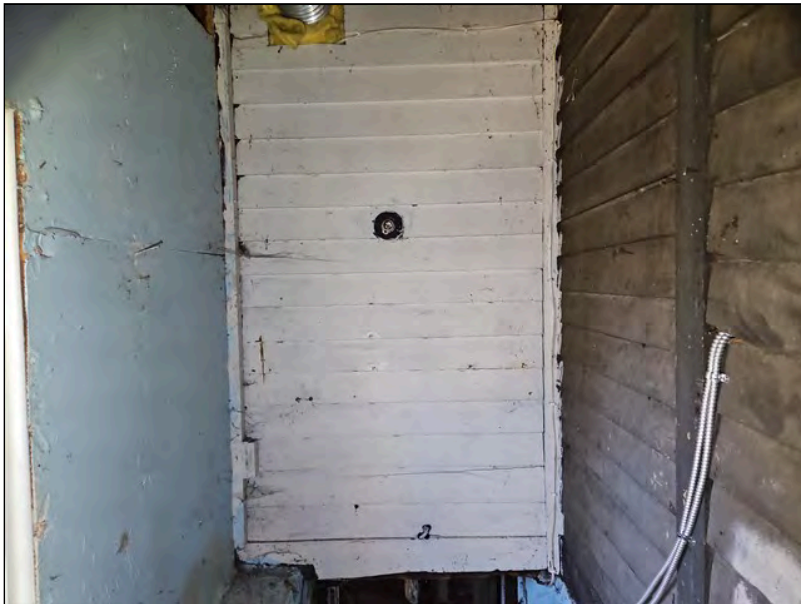
3.2 (3) Defect: There were no switches at the bottom and top of the stairs that would have turned on the light in the stairs to the basement - if there was a light bulb.

Recommend further evaluation and repair as necessary by a licensed electrician.

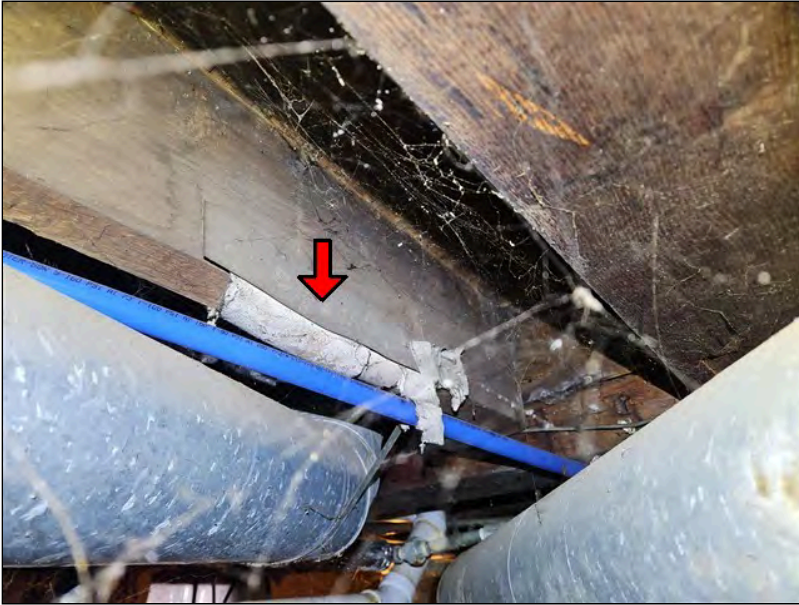
3.6 (2) Further Evaluation: A material that has the appearance of asbestos was present. Recommend further evaluation by a qualified professional.

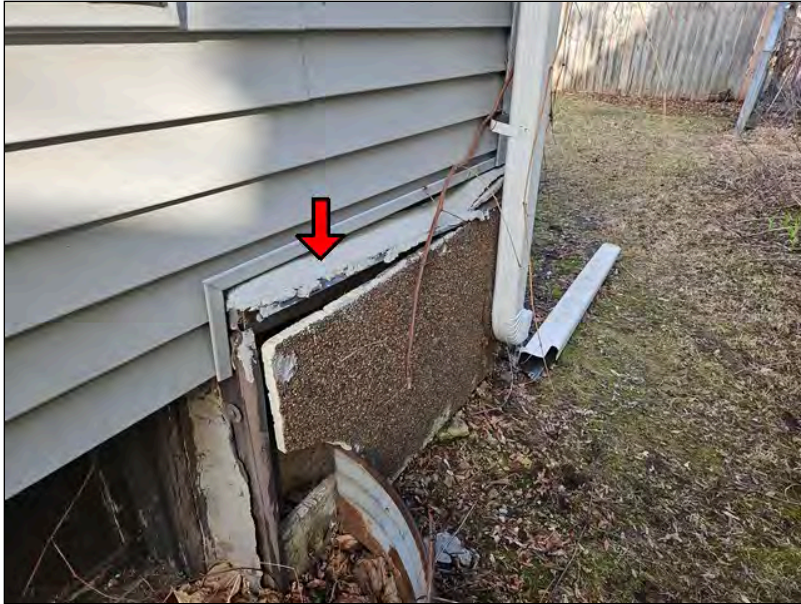
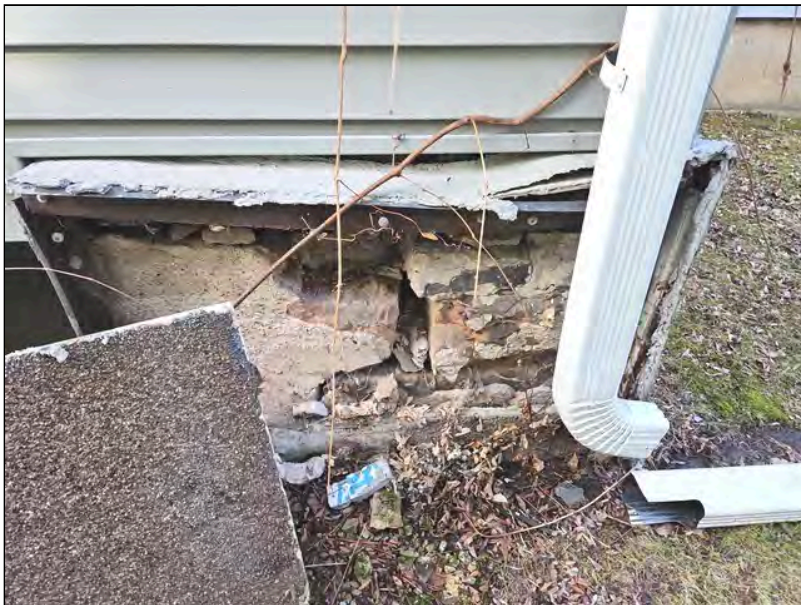
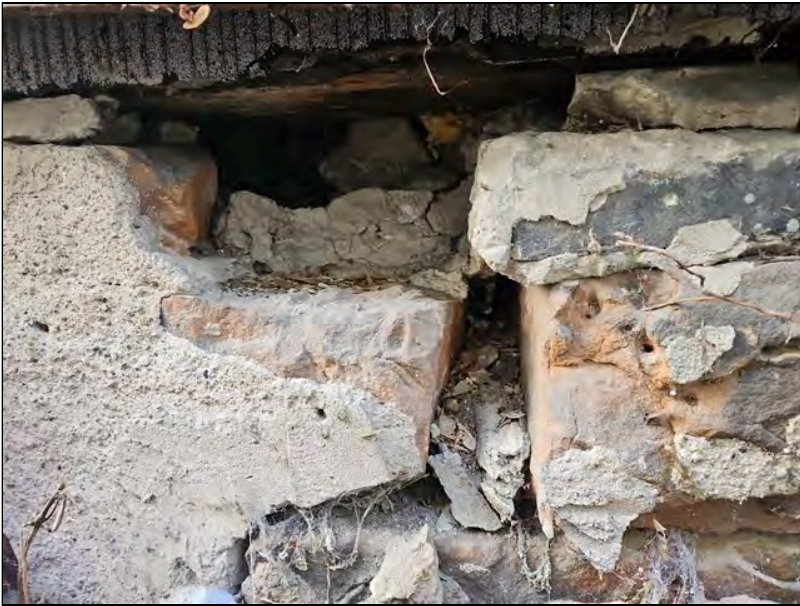
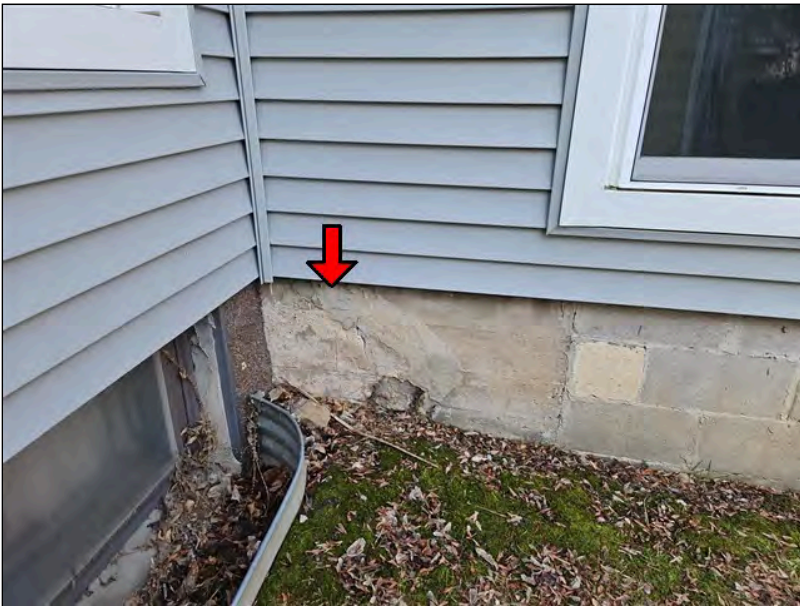
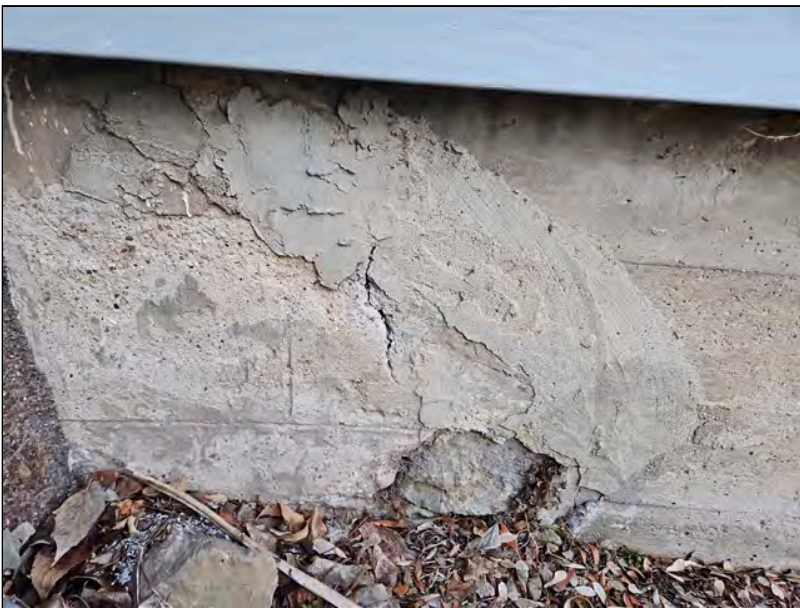
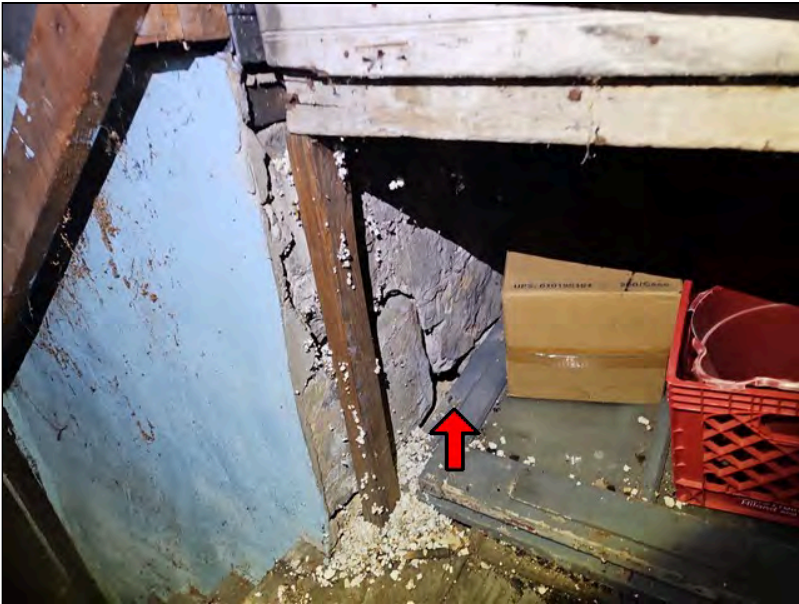
4.0 Defect: Foundation was damaged. Gaps present in the foundation walls indicate the need for tuckpointing. Evidence of moisture intrusion was present. Foundation walls were bowed. Extensive presence of efflorescence was observed. Efflorescence is indicative of excessive pooling of water at the foundation, which can lead to its damage and water intrusion.

Please note that the presence of skim coating prevented a complete determination of all the materials used to build the foundation. Poured concrete may also have been used.

Recommend further evaluation and repair as necessary by a qualified foundation specialist.

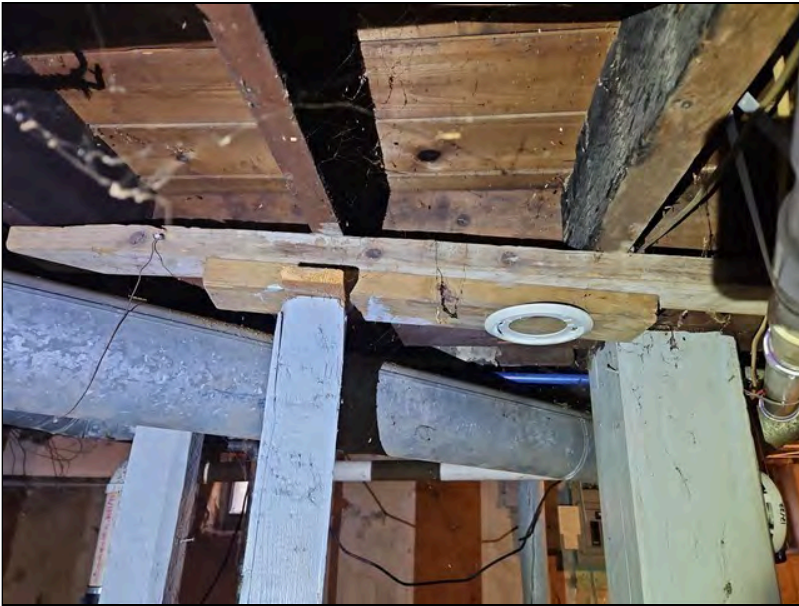
4.2 Defect: Columns were not constructed in a manner or in a condition to adequately support the floor structure.

Recommend further evaluation and repair as necessary by a qualified professional.

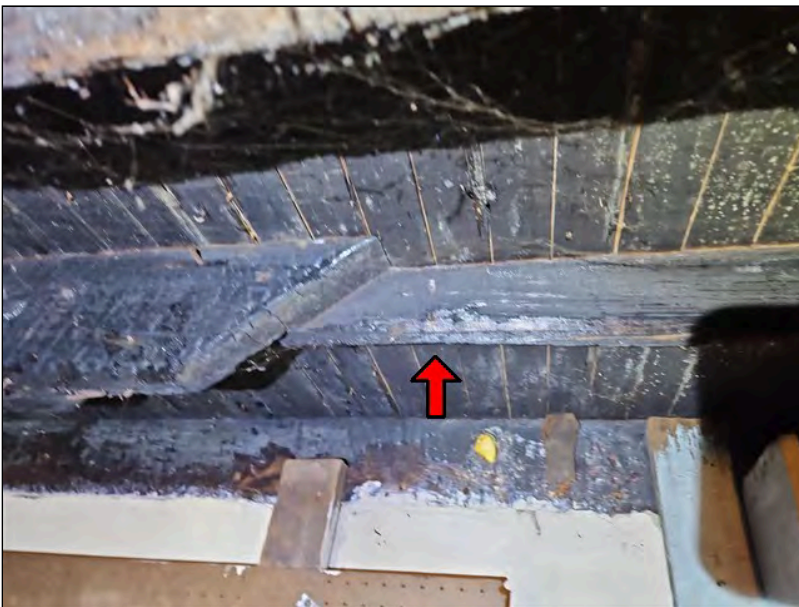
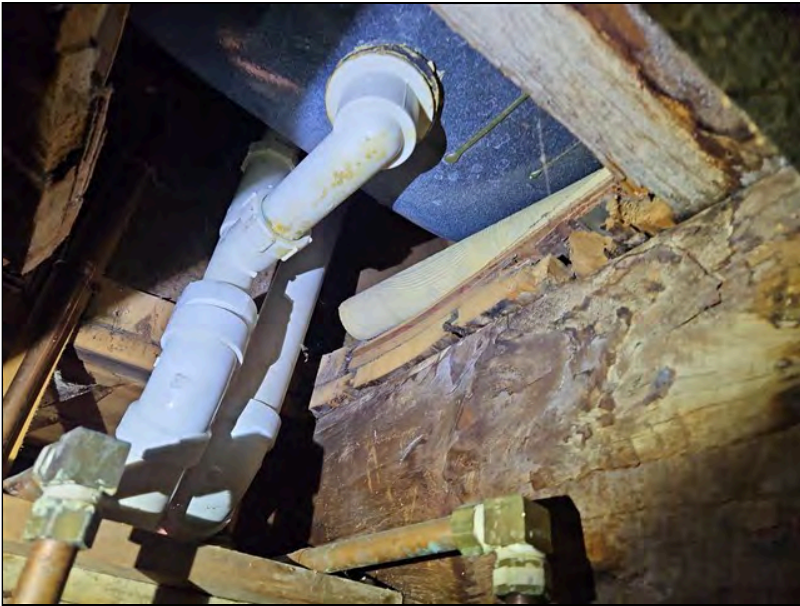
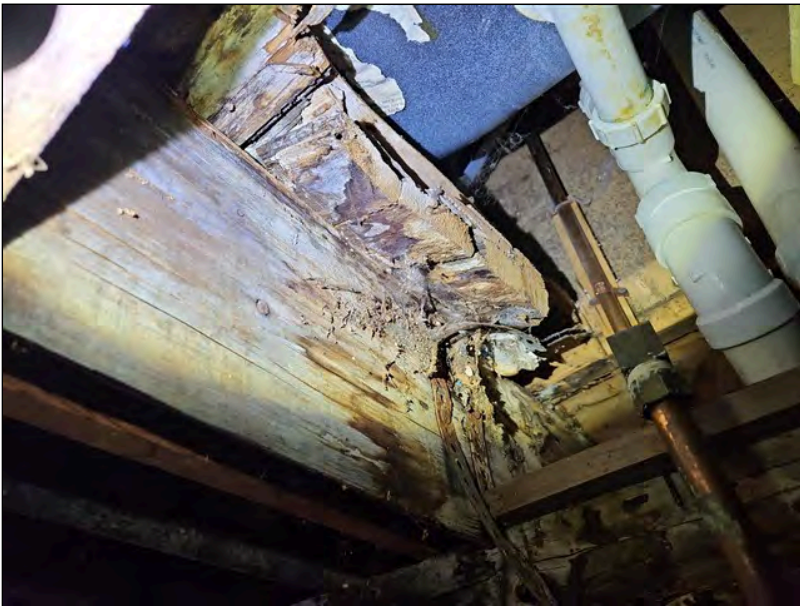
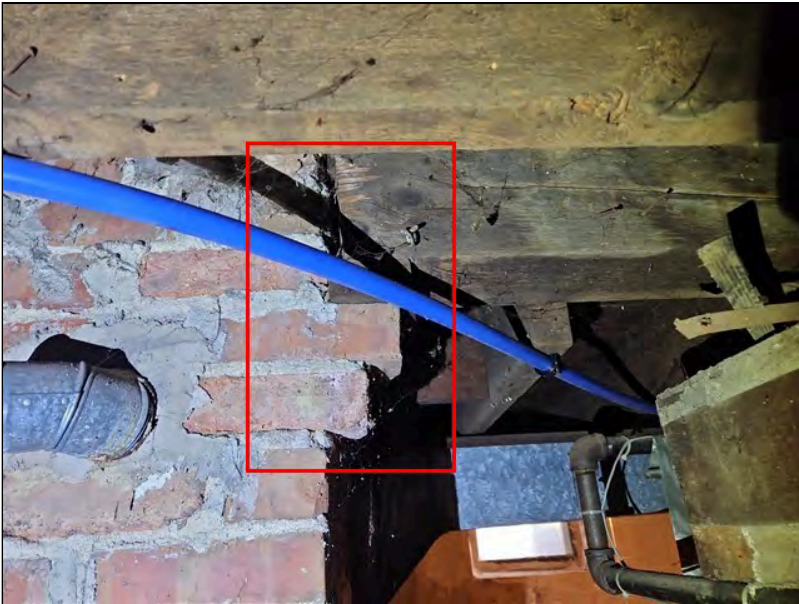
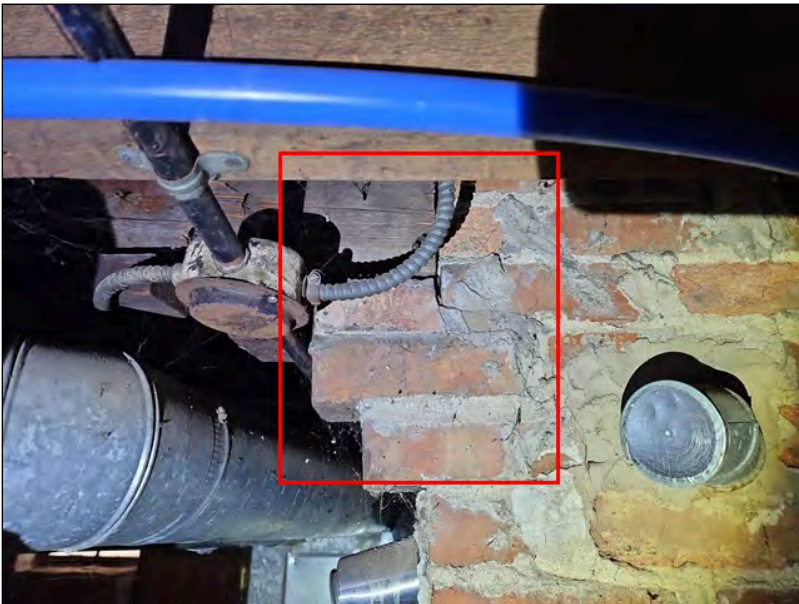
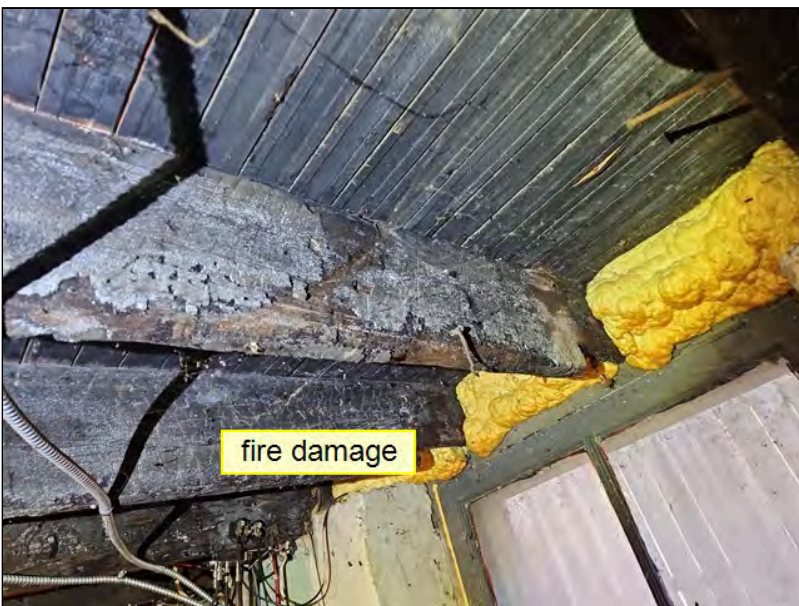
4.3 Defect: Joist(s) were altered in a manner that impact their structural integrity. Main beam was resting on chimney corbels - cracks were present. Please see note 1.4 about the condition of the bottom of the chimney. Subfloor was deteriorated.

Fire damage was present - structural integrity of these floor components need to be confirmed.

Recommend further evaluation and repair as necessary by a qualified professional.

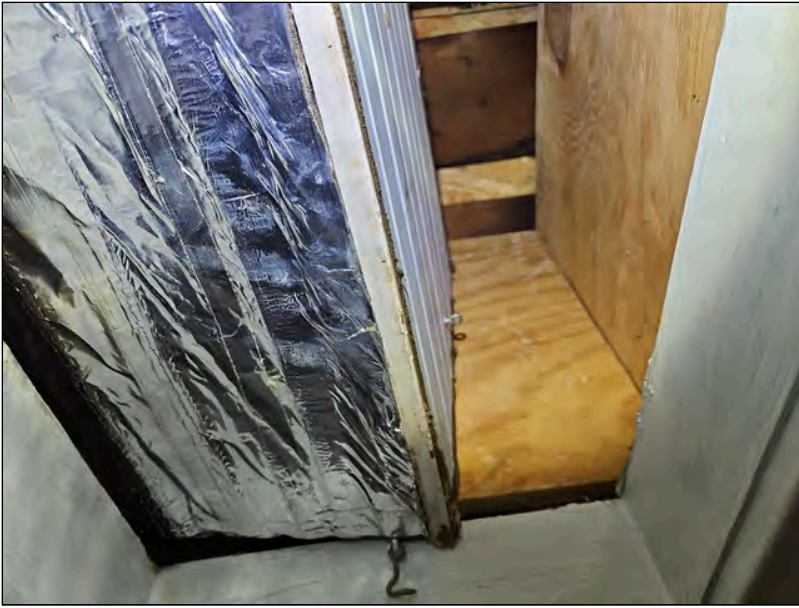
4.4 (2) Further Evaluation: The attic hatch was covered in foam board insulation. After repeated attempts, the Inspector was not able to raise the hatch completely - it was bumping into the roof decking - or pull it through the opening.

As a result, the view of the attic space under the pitched roof was very limited.

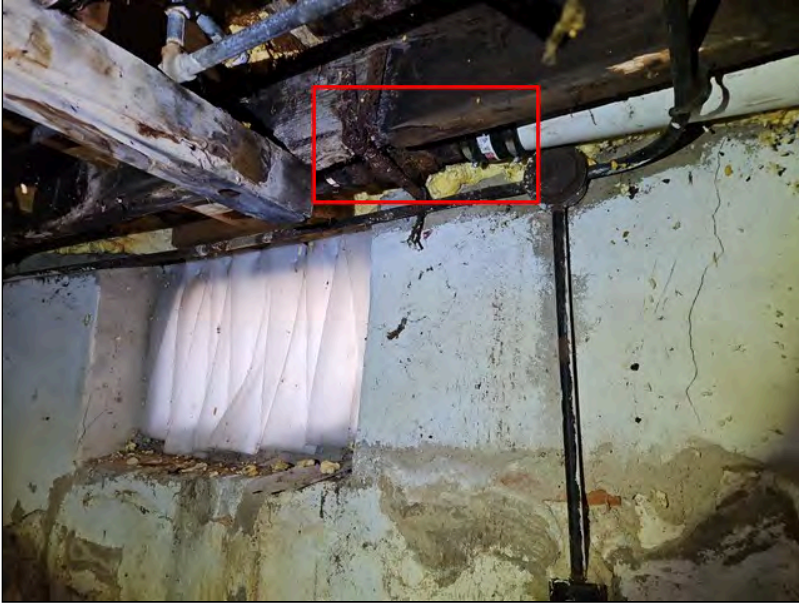
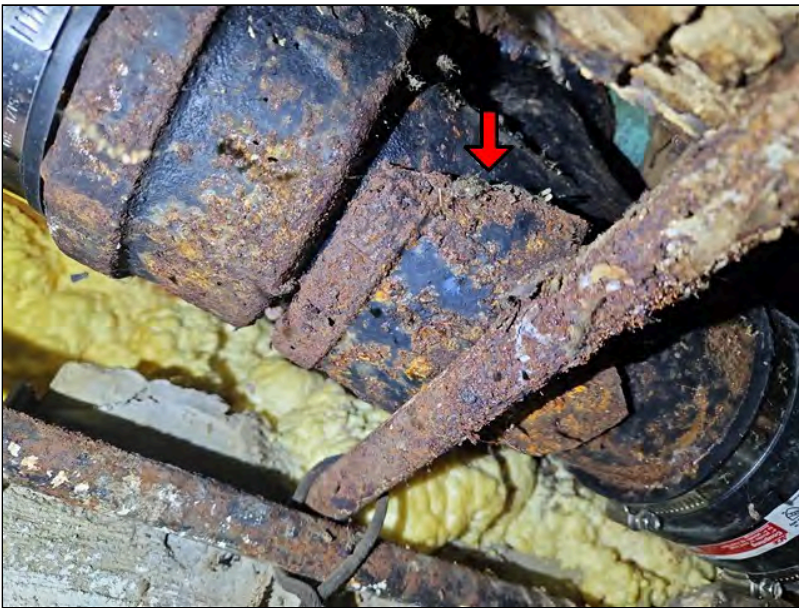
5.0 (1) Further Evaluation: Was a broken piece of cast iron pipe used to make a "repair"?

Recommend further evaluation by licensed plumber.
