APPLICATION FOR DEMOLITION OF PRINCIPAL BUILDINGS

The existing buildings are unsafe and uninhabitable due to severe structural deterioration. Rehabilitation would cost upwards of \$40,000 per property and would not result in usable or safe living or working space. In their current condition, these properties present ongoing safety risks.

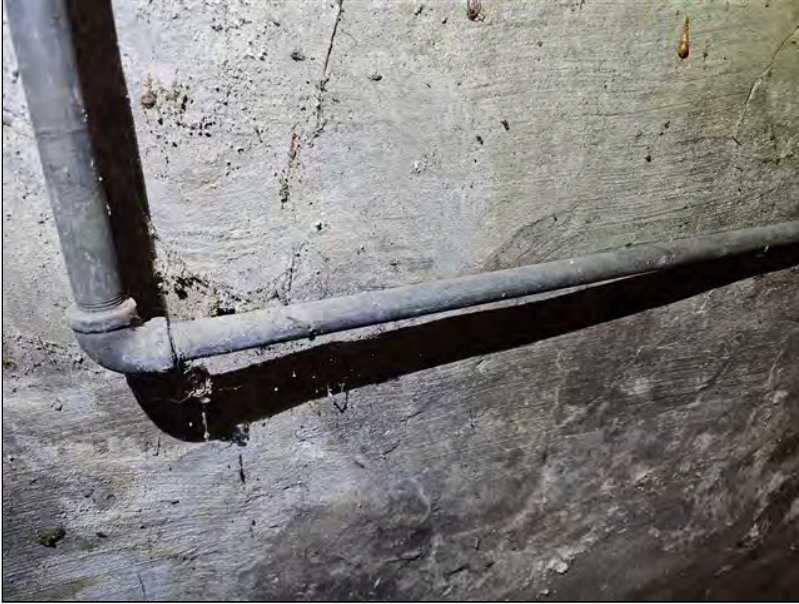
5.1 (1) Monitor: Galvanized steel pipe was in use for the water distribution lines. This style of pipe will rust from the inside out. The accumulation of rust/minerals on the inside of the pipe may restrict water flow. Recommend monitoring condition.

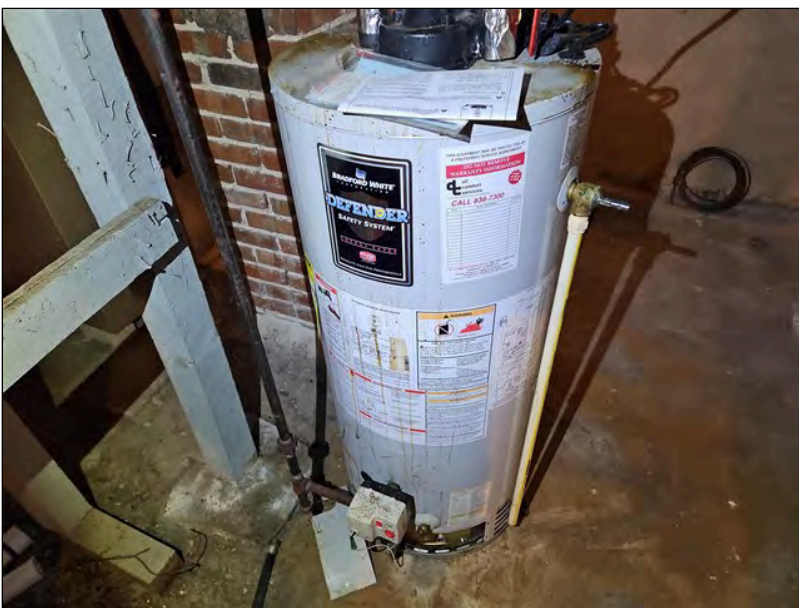
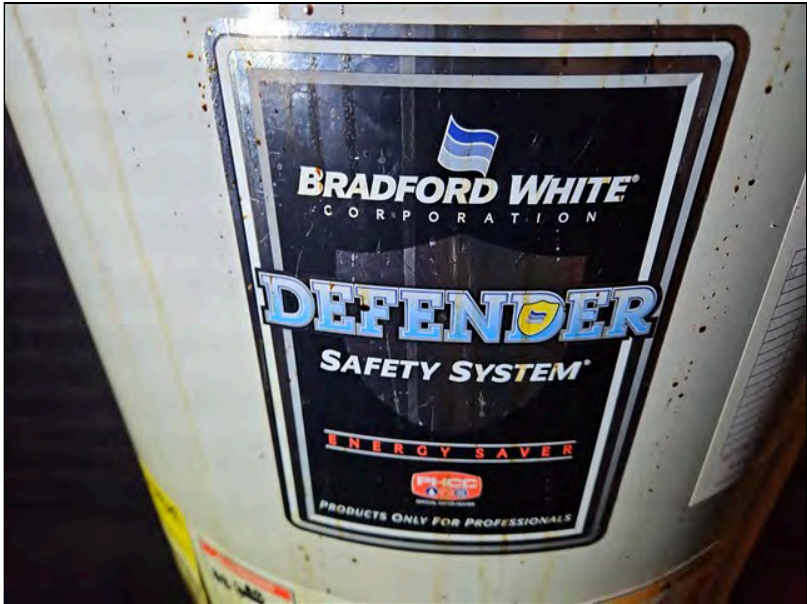
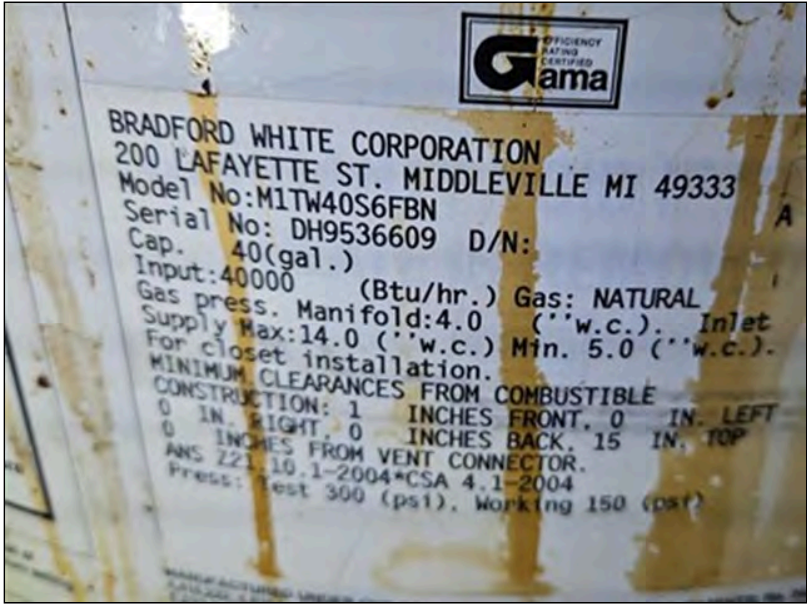
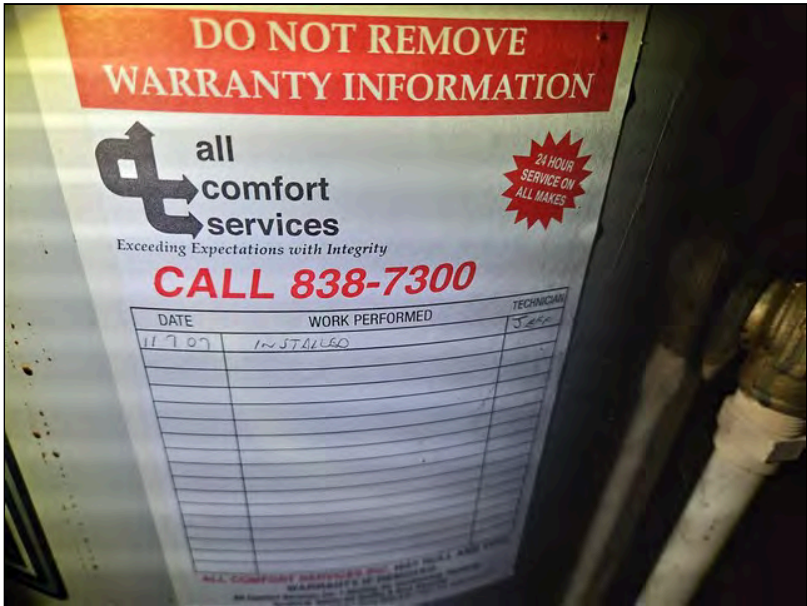
5.2 Bradford White water heater - year of manufacture was 2007.

Equipment was older than the typical expected lifespan of 8-12 years. Recommend creating budget for replacement.

Further Evaluation: Unit was not plugged in and working at the time of the inspection.

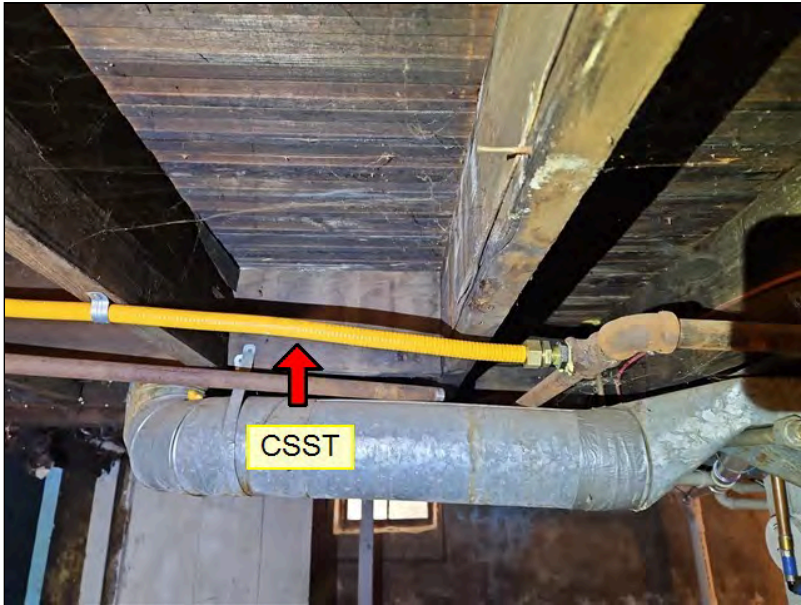
5.5 (1) Defect: CSST is a flexible fuel line. When installed inside or attached to a building it should be bonded to the electrical grounding system of the building. This is to help mitigate the potential of an electrical surge from forming holes in the CSST resulting in the leaking of fuel.

Bonding is attaching a conductor between the rigid fuel line before its connection to the CSST and the home's electrical grounding system.

The CSST was not bonded. Recommend further evaluation and repair as necessary by licensed electrician.

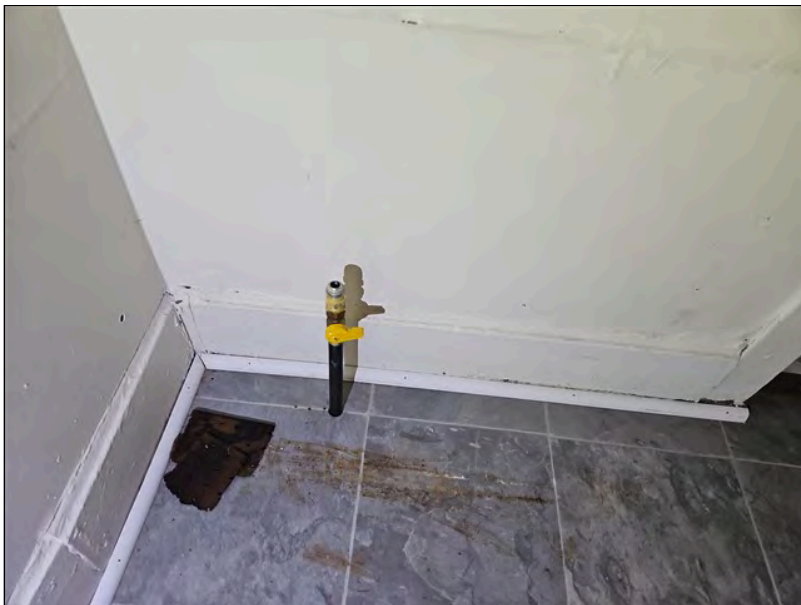
5.5 (2) Defect: A gas supply line was shut off at the valve but was not capped. If the valve is opened, gas will flow into the home and create a dangerous condition.

Recommend further evaluation and repair as necessary by licensed plumber.

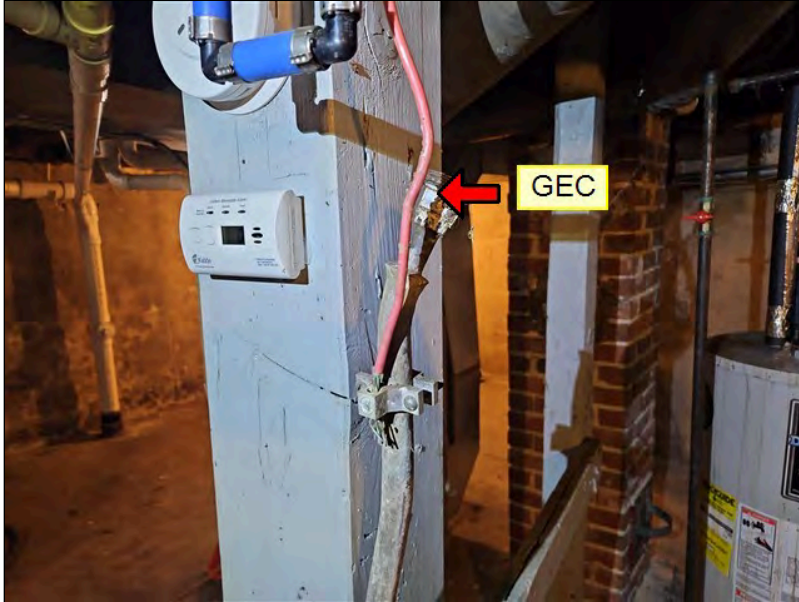
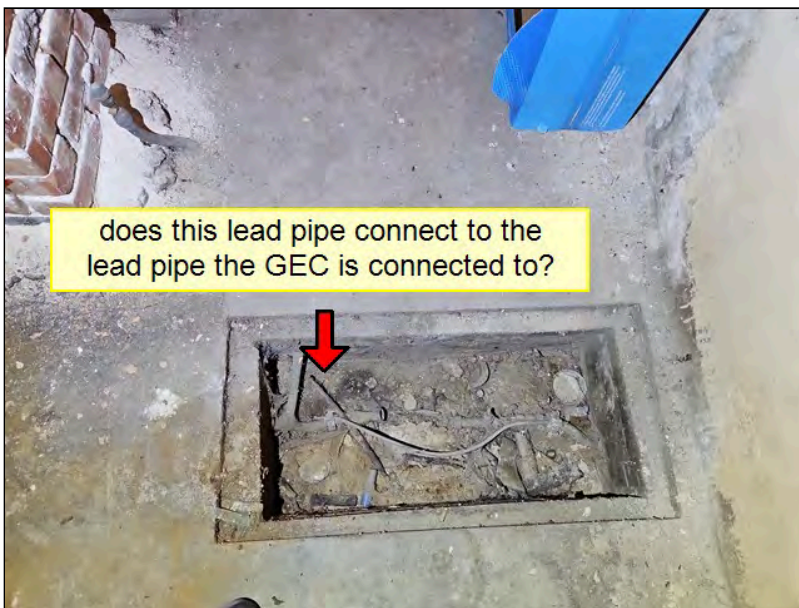
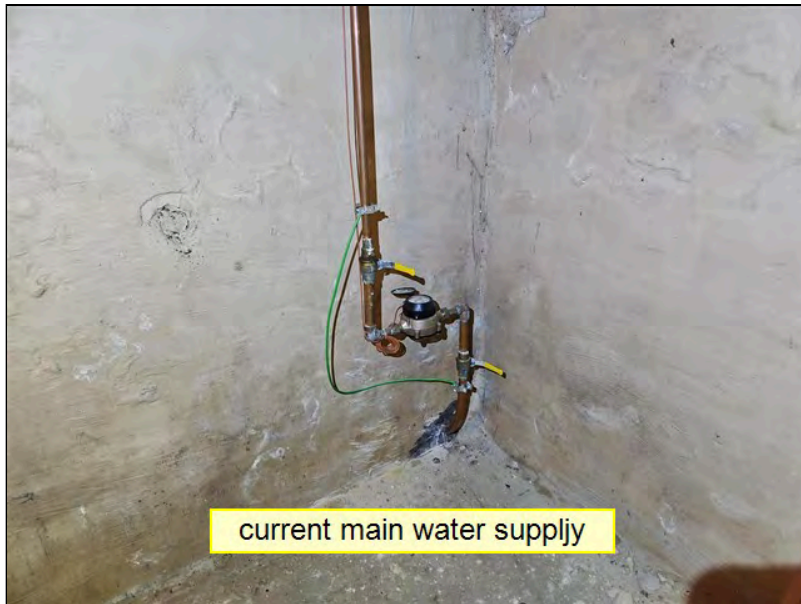
6.2 (1) Defect: A grounding electrode conductor (GEC) is the wire used to connect the grounding system of the home's electrical service to the grounding electrode (rod driven into the ground on the outside, main water supply pipe...).

The GEC was connected to a legacy lead water line - continuity to ground outside was not able to be confirmed.

Recommend connecting the clamp for the GEC to the current main water supply line by a licensed electrician.

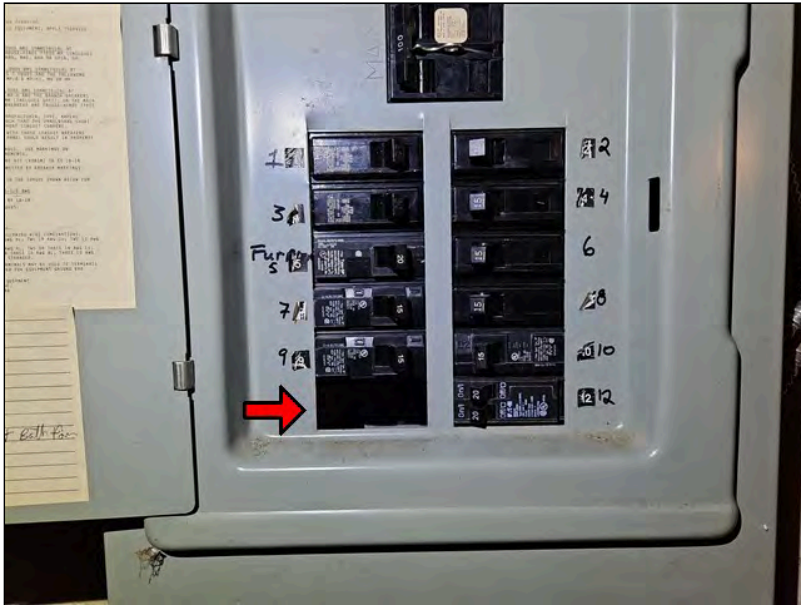
6.2 (2) Defect: The main panel had knockout(s) removed and gap(s) present. A gap in the deadfront panel provides direct access to the live conductors in the panel. This is a electrocution hazard.

Recommend further evaluation and repair as necessary by a licensed electrician.

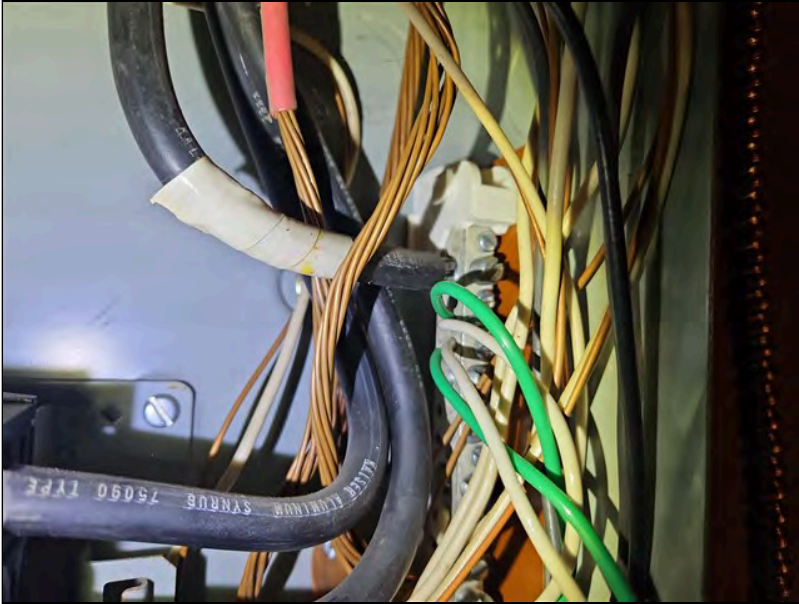
6.4 (1) Defect: Cover plate(s) were missing. This condition leaves energized electrical components exposed to touch and is a shock/electrocution hazard.

Photo provided may not be exhaustive documentation of all locations.

Recommend further evaluation and repair as necessary by licensed electrician.

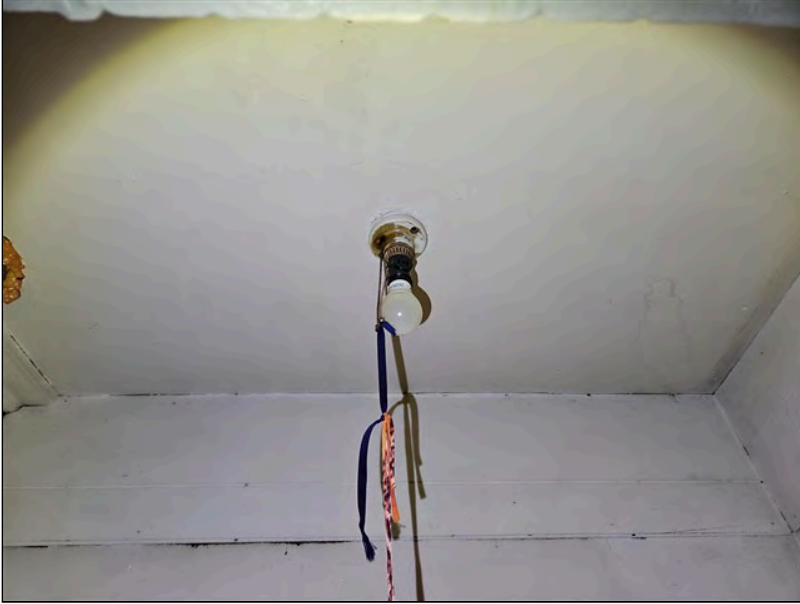
6.4 (2) Repair: A incandescent light bulb without a cover was present in a closet. This can be a safety hazard when flammable items stored in a closet come in contact with the light bulb. Recommend the use of fluorescent light bulbs and the addition of covers.

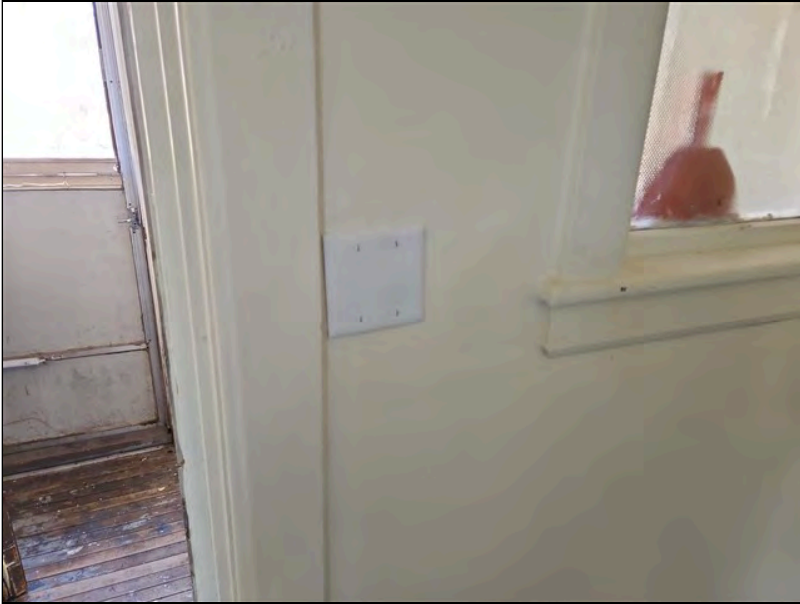
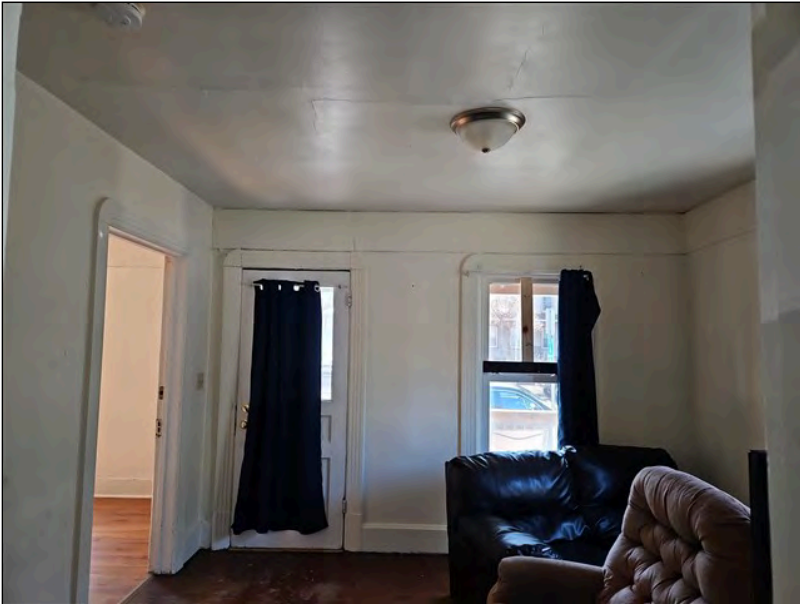
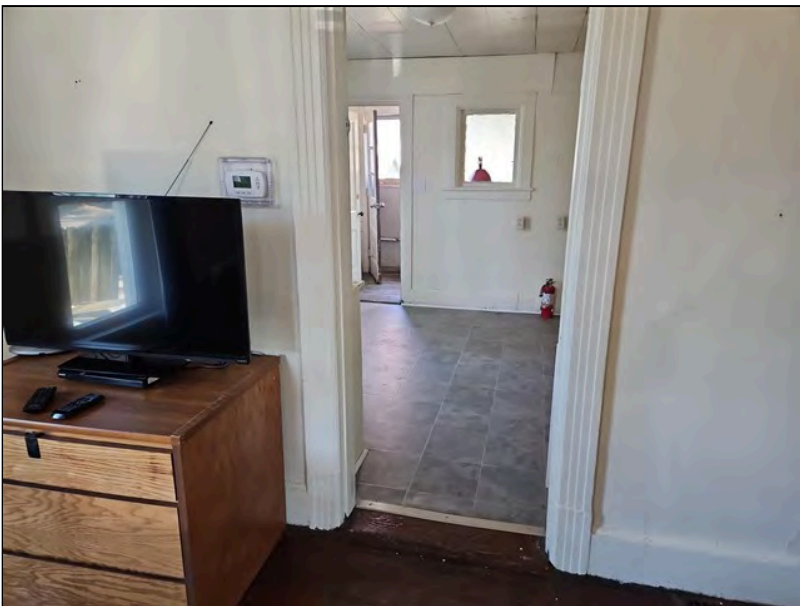
6.4 (3) Defect: In multiple rooms, there was not a way to turn on a light when entering a room through a doorway.

Recommend further evaluation and repair as necessary by licensed electrician.

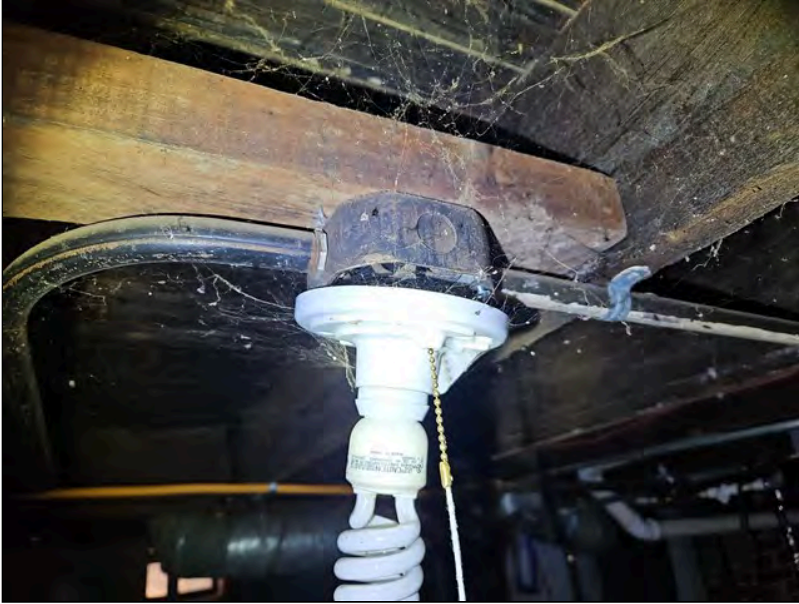
6.4 (4) Defect: Light fixture was not securely attached to the structure in the basement.

Recommend further evaluation and repair as necessary by licensed electrician.

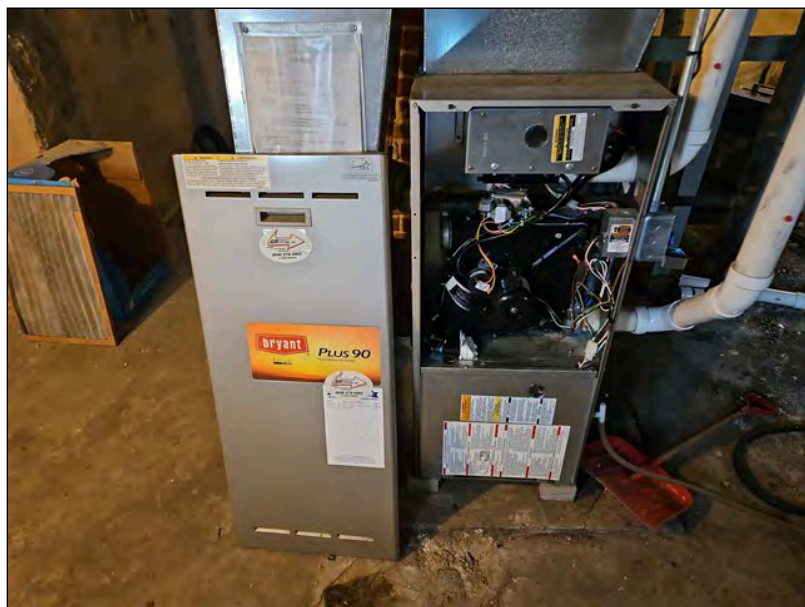
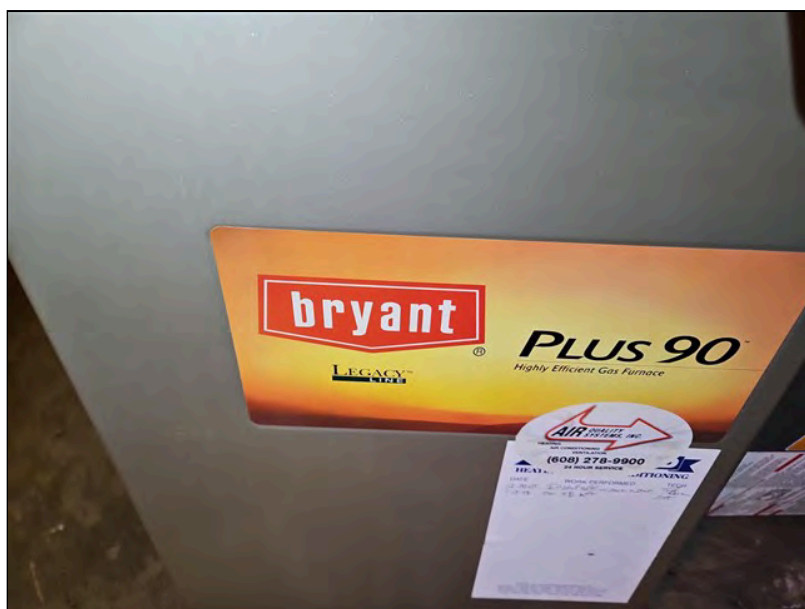
Furnace responded to call for heat from thermostat, fired up and circulated warm air.

Equipment was older than the typical expected lifespan of 15-20 years. Recommend creating budget for replacement.

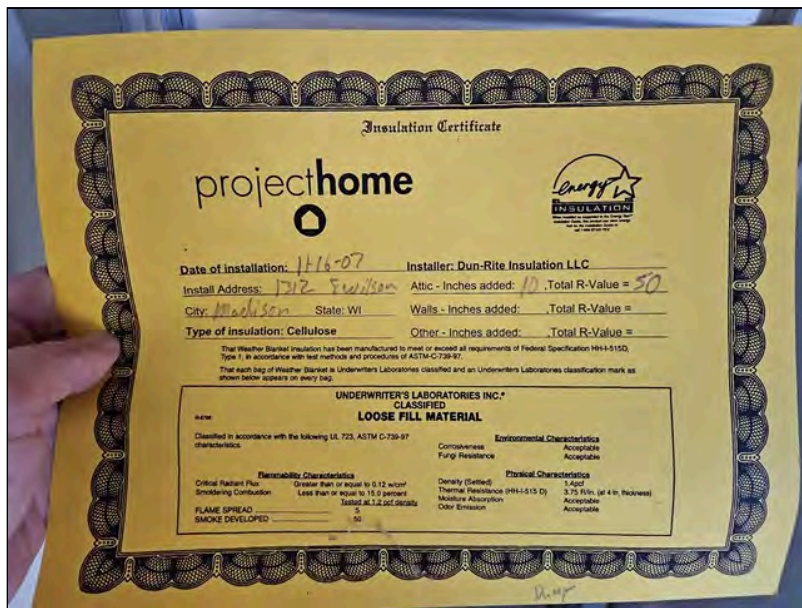
8.0 (1) Project Home was the contractor that installed insulation in the attic space under the pitched roof.

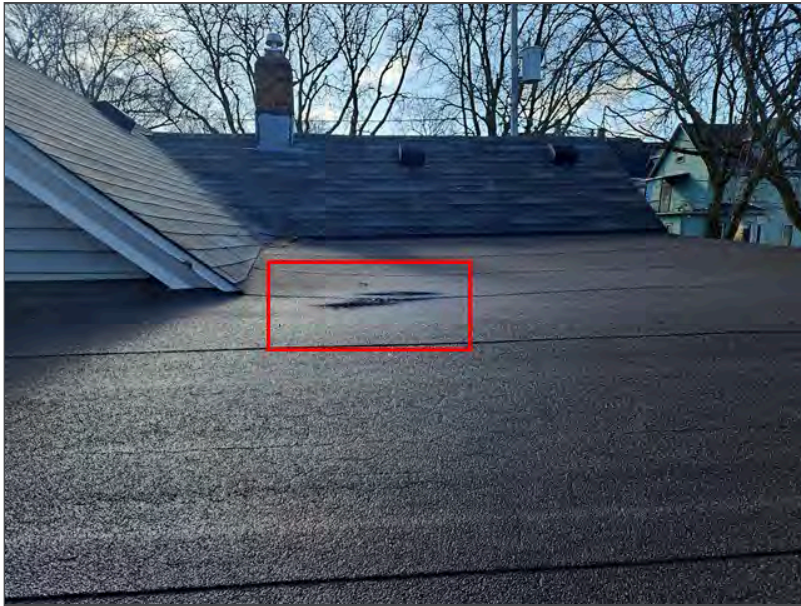
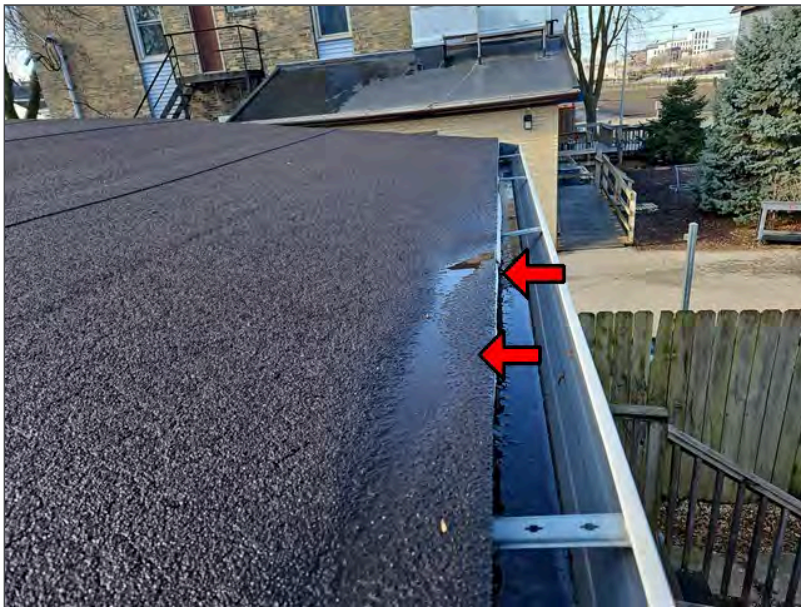
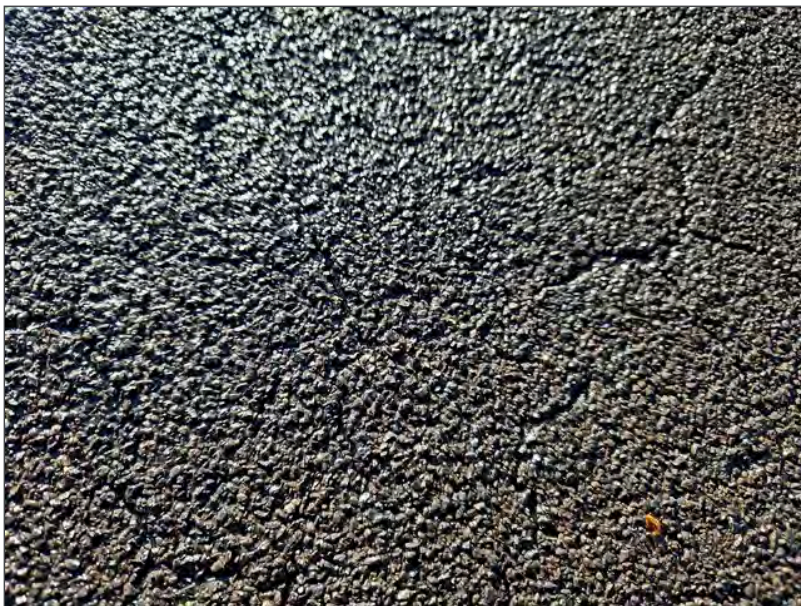
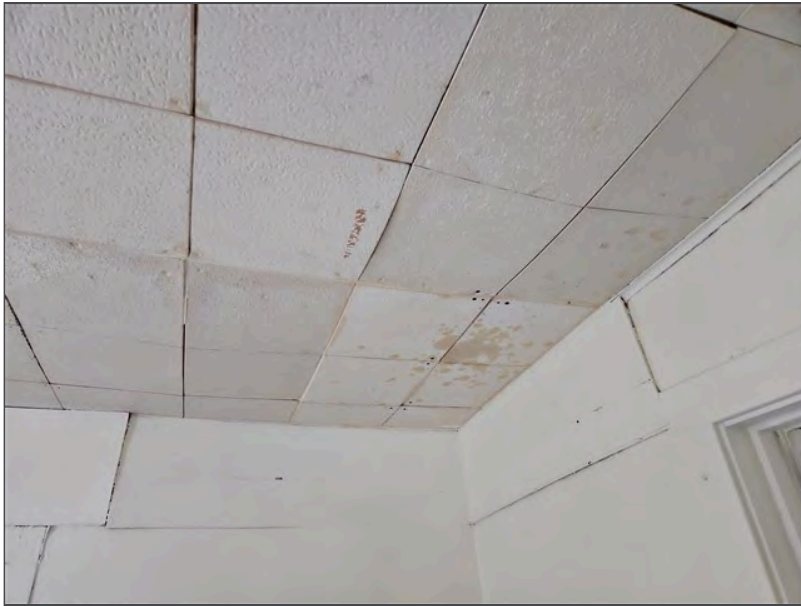
(1) **Defect:** Water was pooling on the flat roof - roof was not pitched correctly. Depressions were present in the roof covering.

Cracking was present. Once cracks develop into through-material splits, the roof is more likely to leak.

Moisture stains were present underneath this area of the roof with a depression. Stains represent a past or present leak in the roof covering. Depression may indicate issues with the roof structure - there was no attic space in this area to allow a view of the roof structure.

Recommend further evaluation of the roof coverings and repair/replace as necessary by qualified roofing contractor.

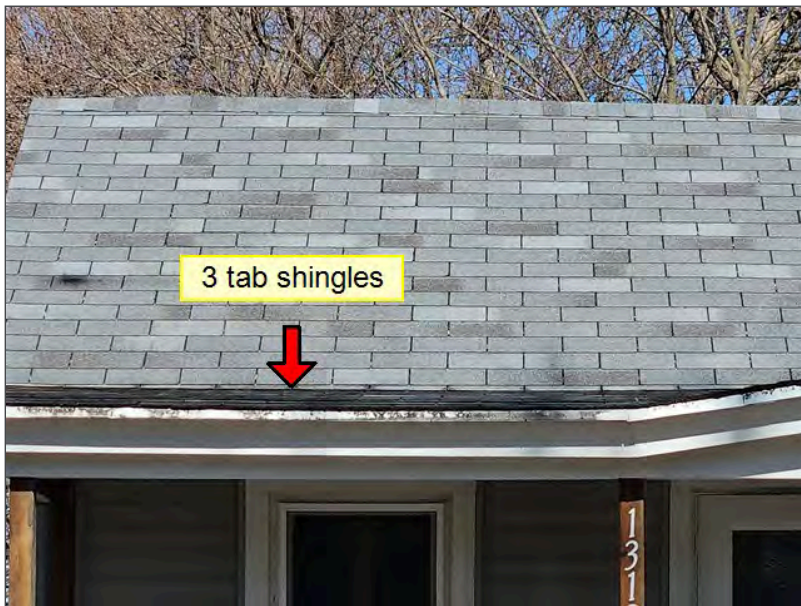
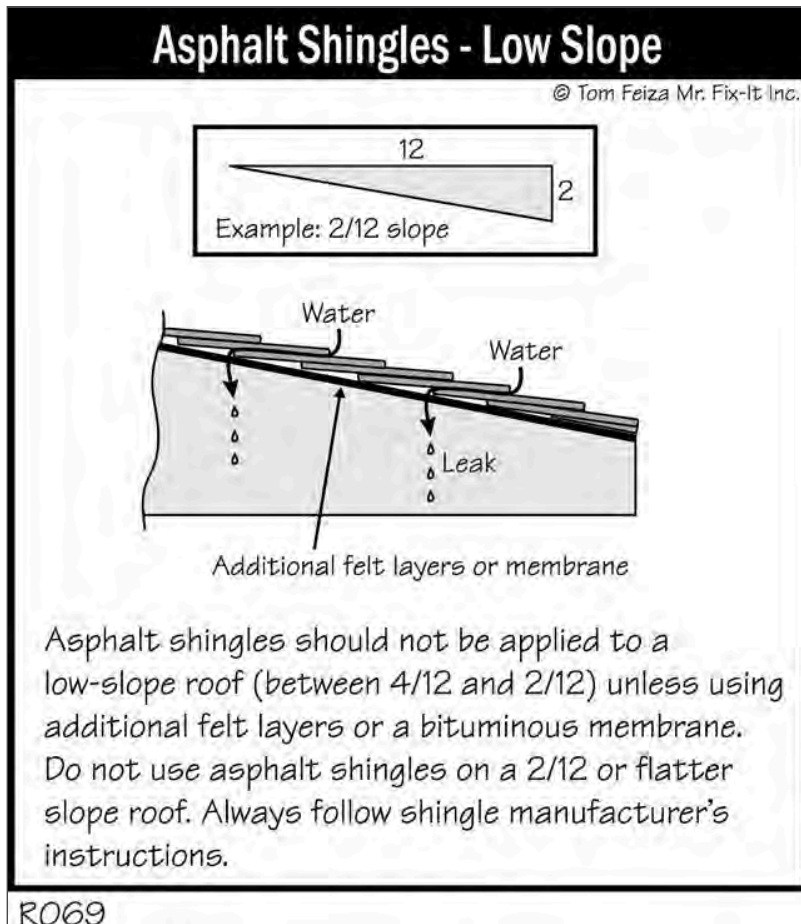
(2) **Defect:** The low slope roof at the on the front porch had asphalt composite shingles installed. It should have either selvage, roll roofing, rubber membrane or an approved covering for a flat roof. The roof may leak in heavy rain or ice may dam in winter causing a leak.

Recommend further evaluation of the roof coverings and repair/replace as necessary by qualified roofing contractor.

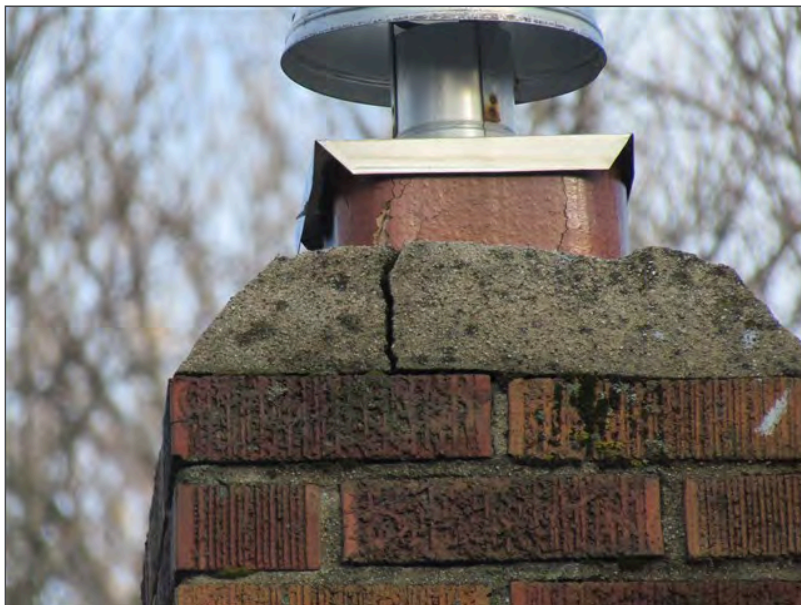
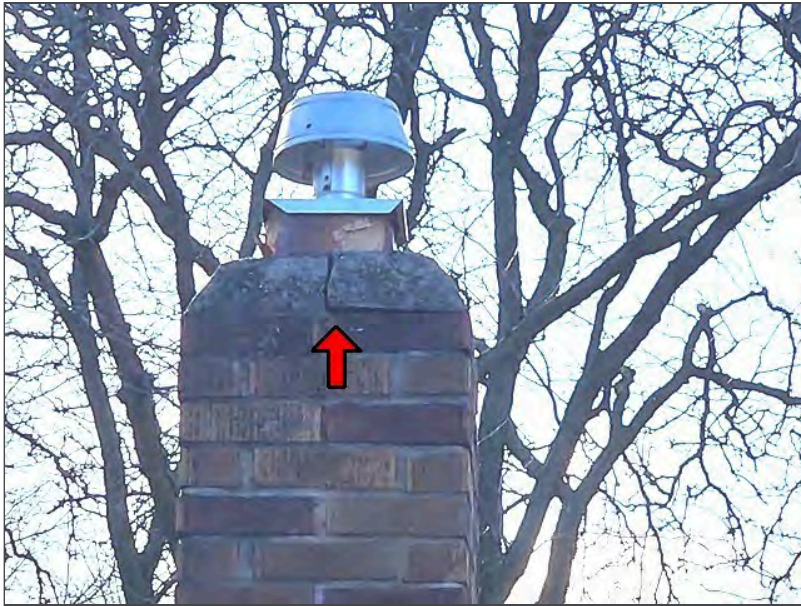
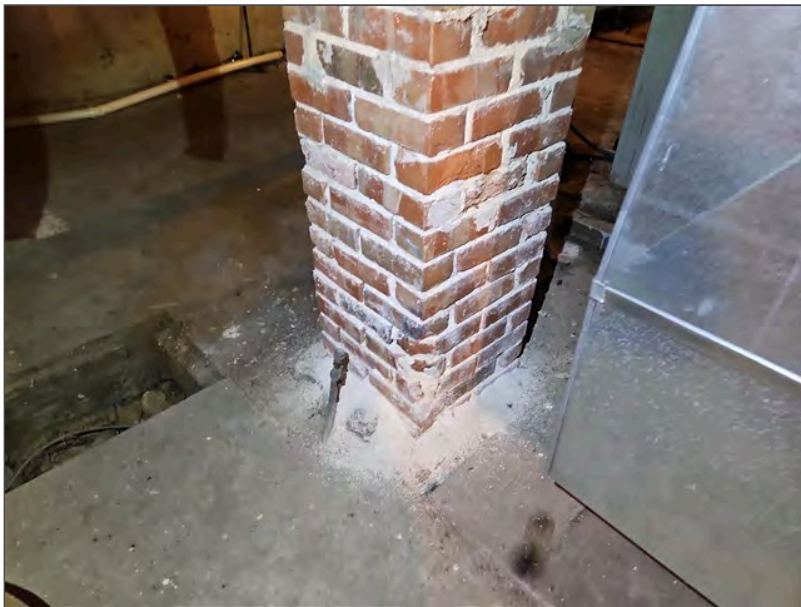
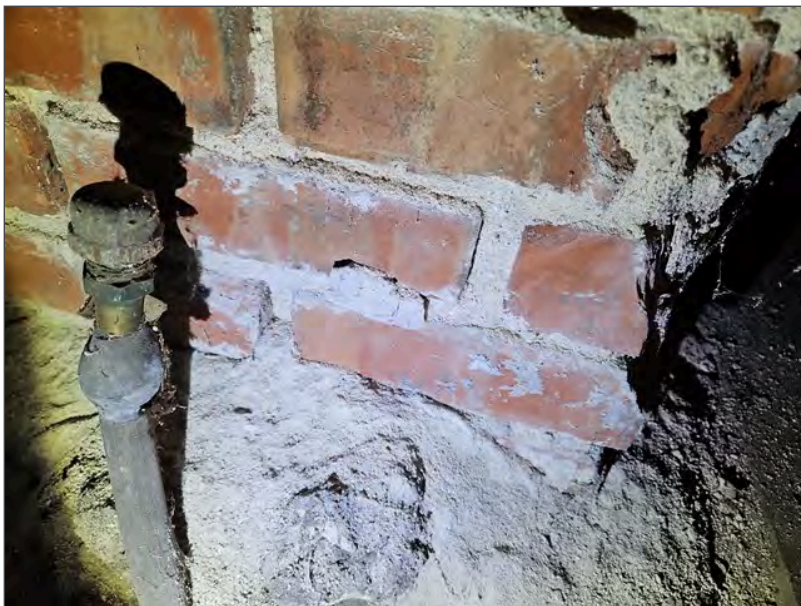
1.4 Chimney(s)

Defect: Concrete crown and flue were cracked. Mortar at the base of the chimney in the basement has turned into a powder.

Structural integrity of chimney is compromised.

Recommend further evaluation and repair as necessary by qualified chimney contractor.

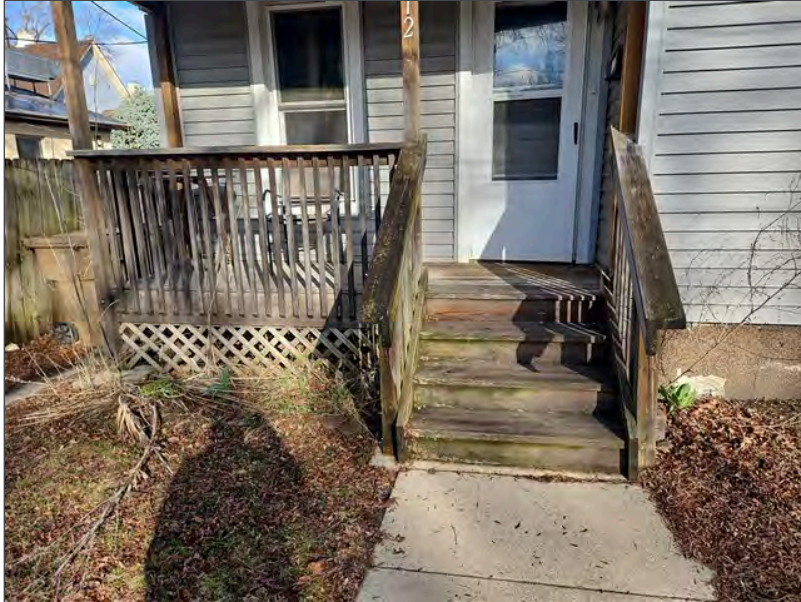
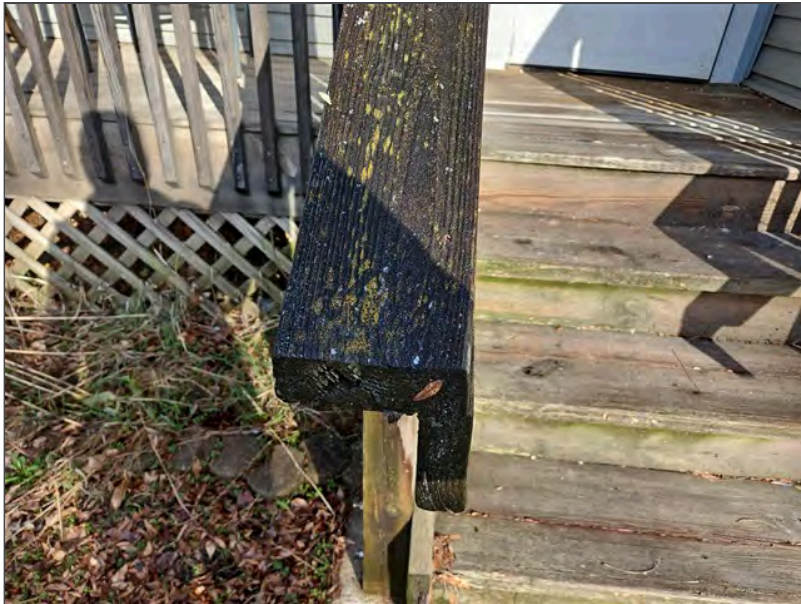
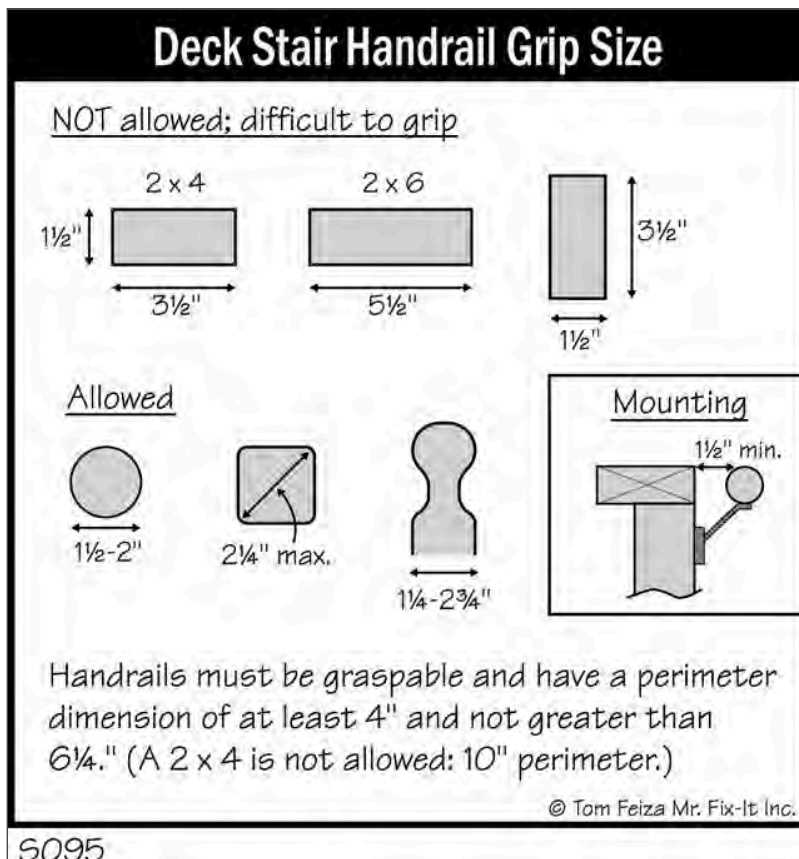
(1) **Defect:** The handrail on the porch was not "graspable". "Graspable" refers to the ability of the user to get a secure grip on the handrail. This is a fall hazard.

Recommend further evaluation and repair as necessary by a qualified contractor.

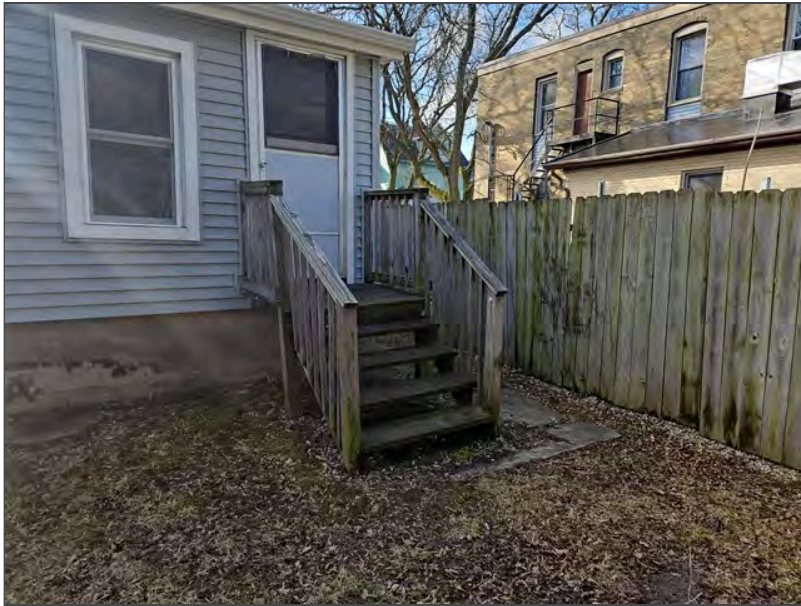
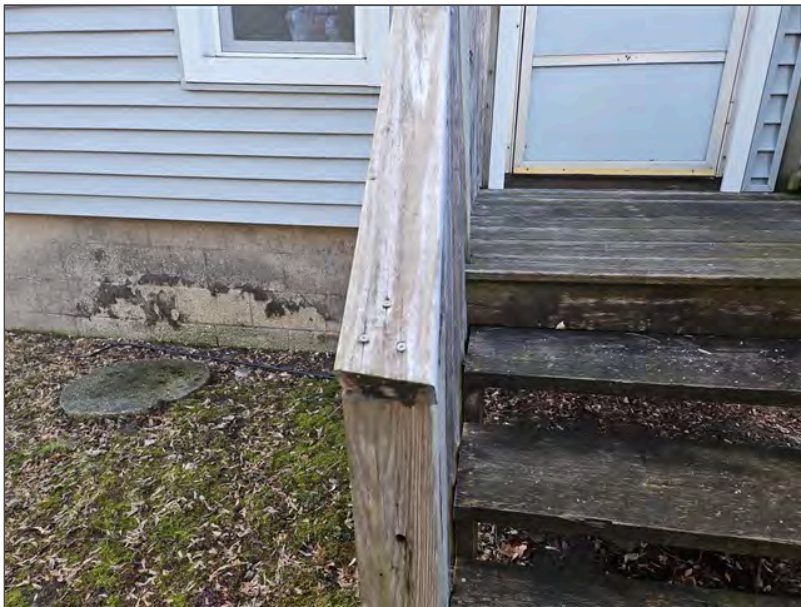
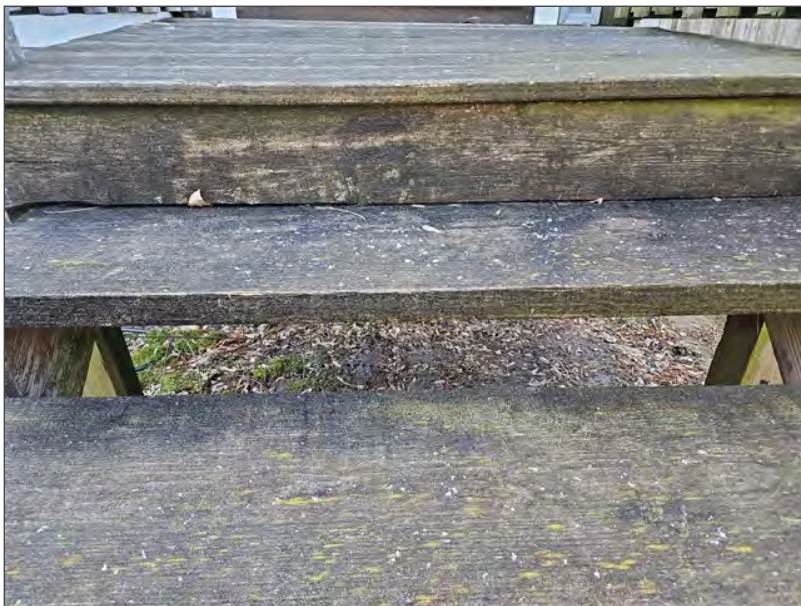
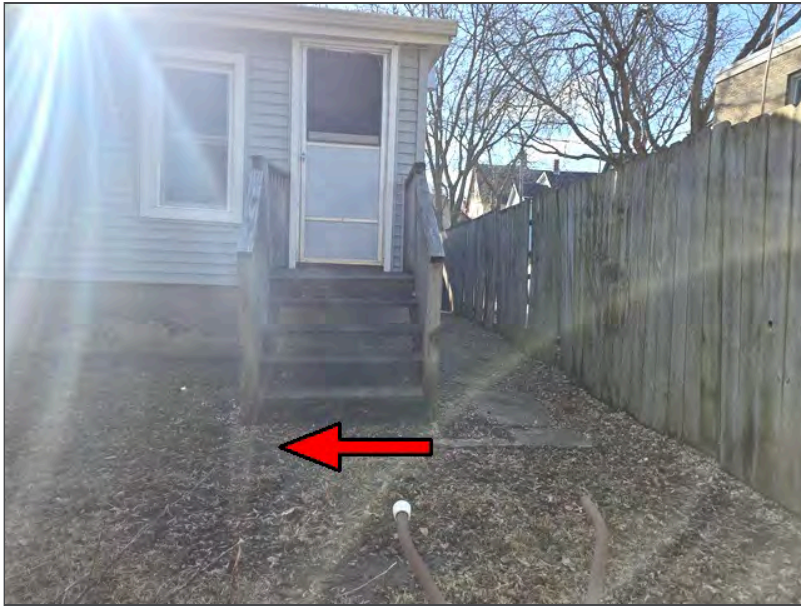
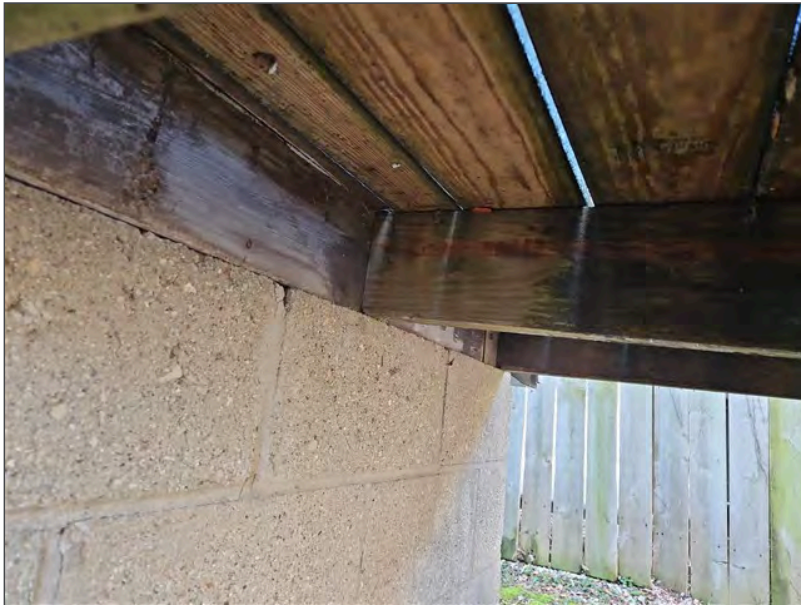
(2) **Defect:** The following conditions were present on the rear porch:

The handrail was not "graspable". "Graspable" refers to the ability of the user to get a secure grip on the handrail. This is a fall hazard.

The paint/stain was in a deteriorated condition. Deterioration from moisture intrusion will occur if not corrected.

The ledger board was incorrectly fastened to the home with nails instead of threaded fasteners. This condition can result in the ledger board pulling away from the structure.

Open risers with a space in excess of 4" were present. This is a fall hazard.

Above conditions can jeopardize the structural integrity of the porch, reduce its life expectancy and/or is a safety hazard. List above may not be exhaustive documentation of all conditions that could be considered a "Defect".

Recommend further evaluation of the structure and repair as necessary by a qualified professional.

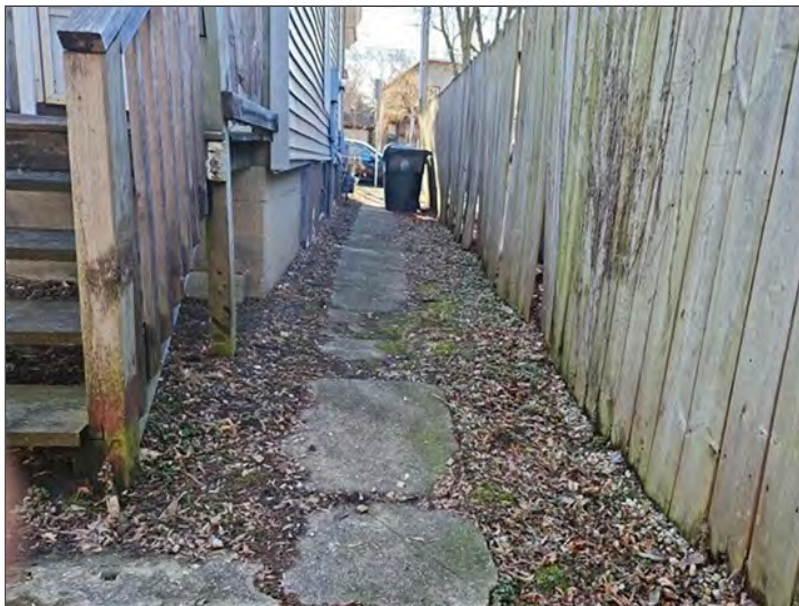
Defect: The heaving, settling and cracking of the sidewalk has created a trip hazard.

Recommend further evaluation and repair as necessary by a qualified contractor.

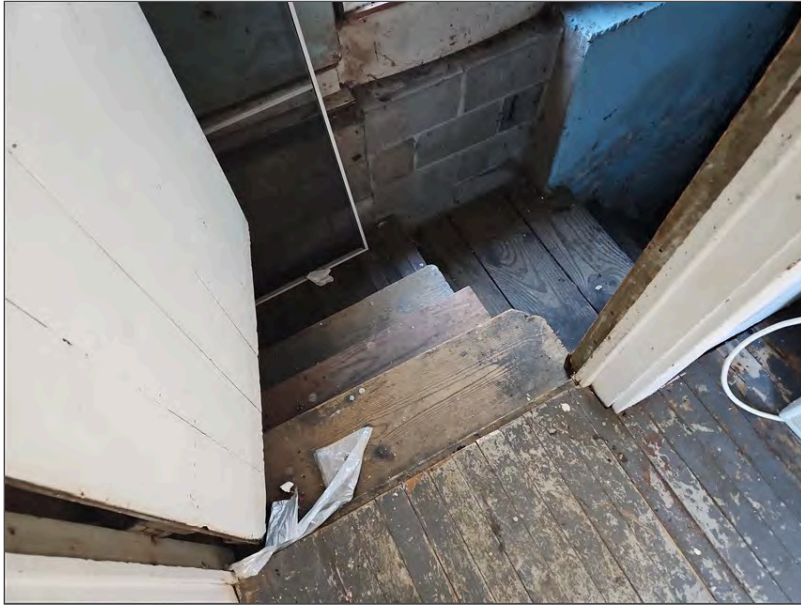
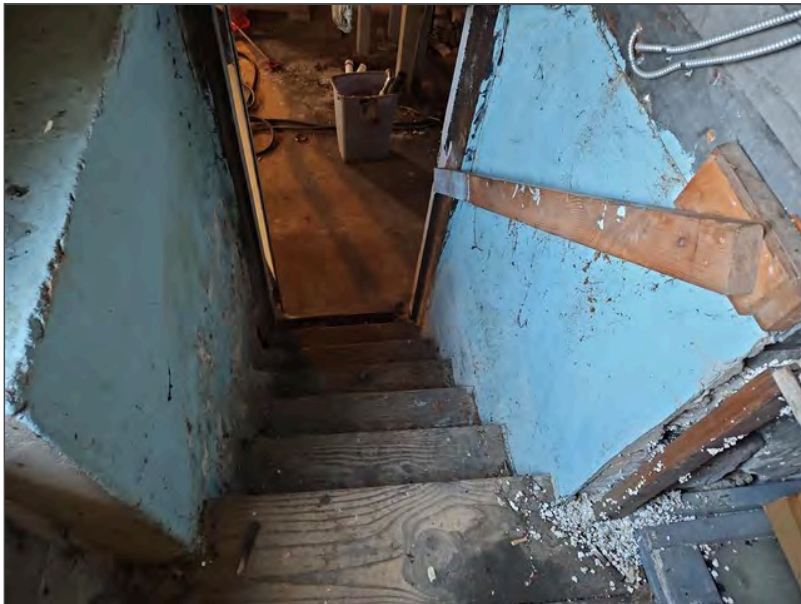
(1) **Defect:** The stairs to the basement were not constructed in a manner that are consistent with today's safety standards. This can be a fall hazard.

It may not be possible to make all the changes necessary that will make the stairs meet today's standards but action can be taken to make them safer. One improvement that can be made is the installation of a handrail and correcting the installation of the current handrail.

Recommend further evaluation and repair by a qualified contractor.

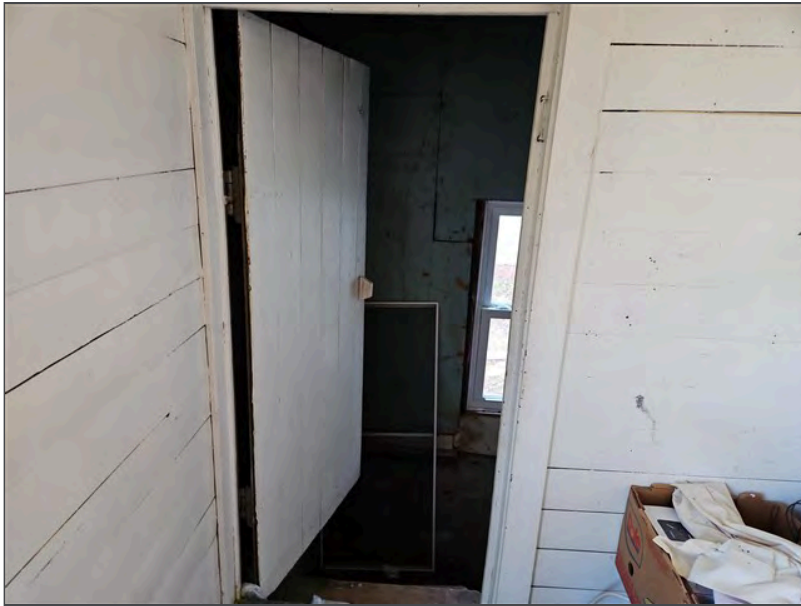
(2) **Defect:** A door opens over stairs without a landing being present. This is a fall hazard.

Recommend further evaluation and repair by a qualified contractor.
