APPLICATION FOR DEMOLITION OF PRINCIPAL BUILDINGS

The existing buildings are unsafe and uninhabitable due to severe structural deterioration. Rehabilitation would cost upwards of \$40,000 per property and would not result in usable or safe living or working space. In their current condition, these properties present ongoing safety risks.

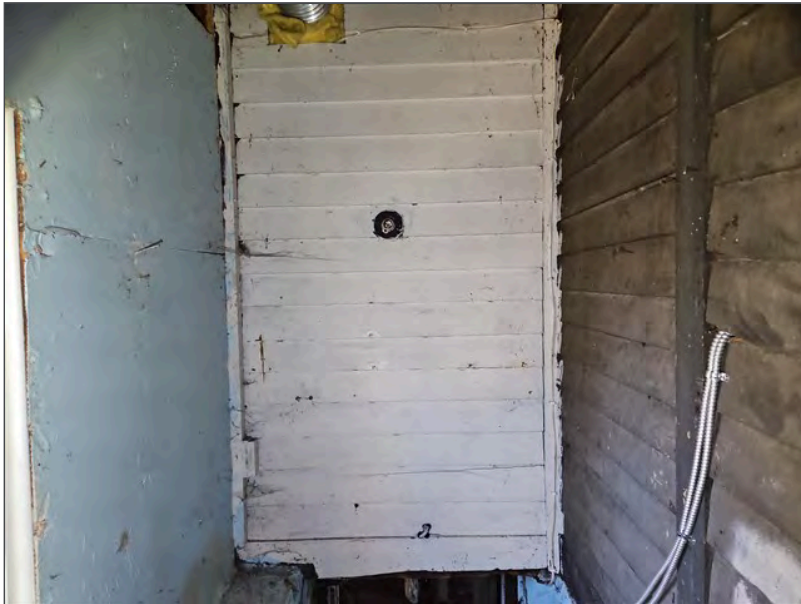
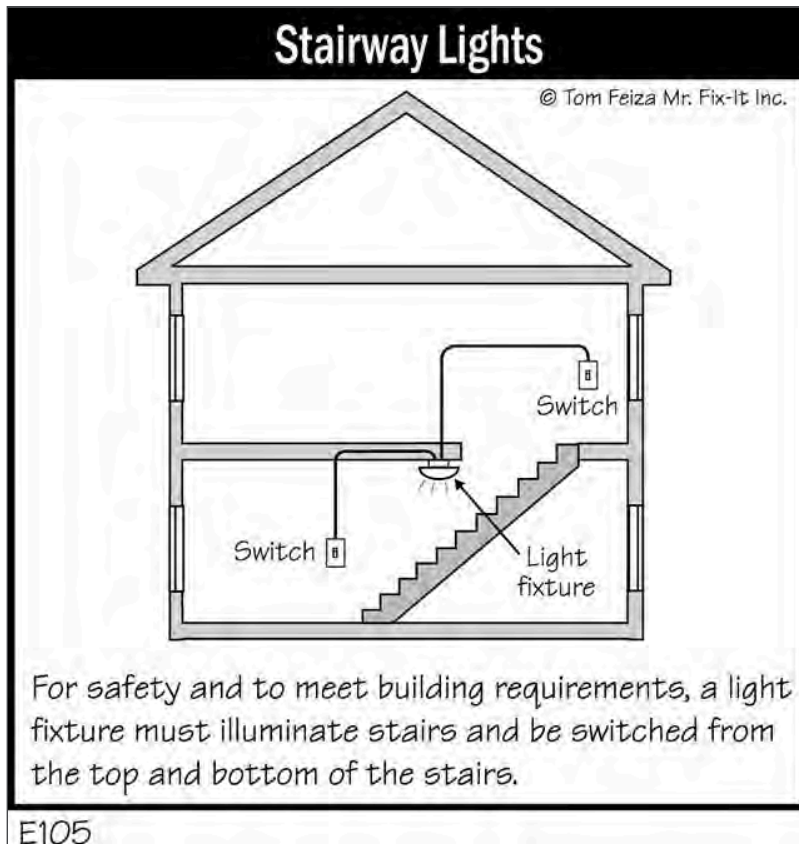
(3) **Defect:** There were no switches at the bottom and top of the stairs that would have turned on the light in the stairs to the basement - if there was a light bulb.

Recommend further evaluation and repair as necessary by a licensed electrician.

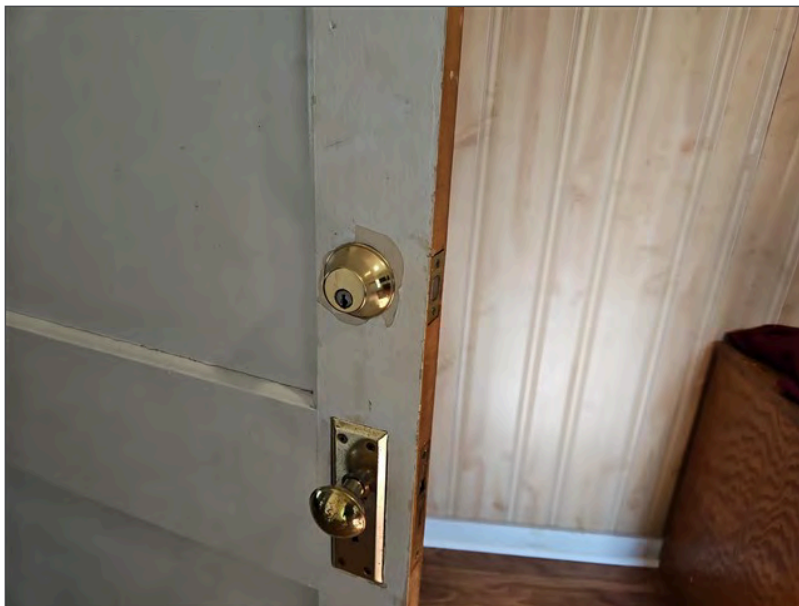
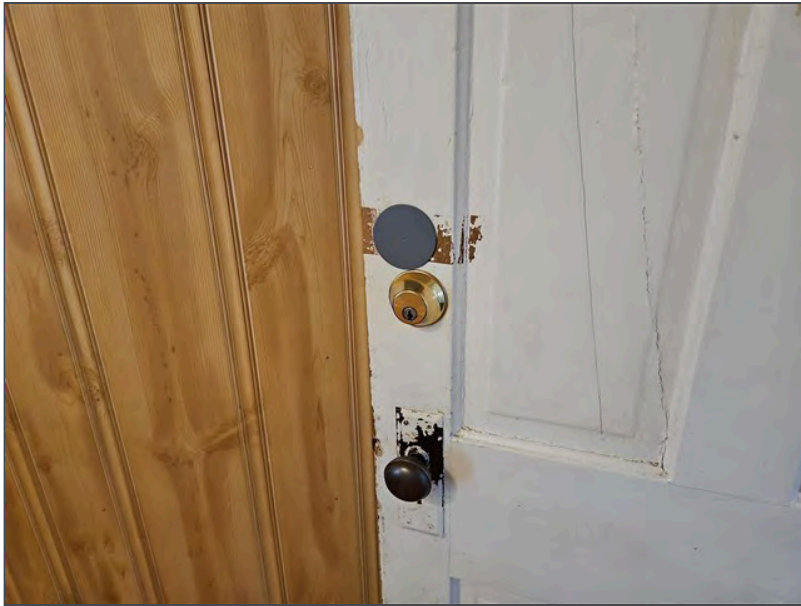
Defect: Bedroom doors could be locked using a deadbolt. The exterior of the doors could only be opened with a key. This is a potential safety hazard.

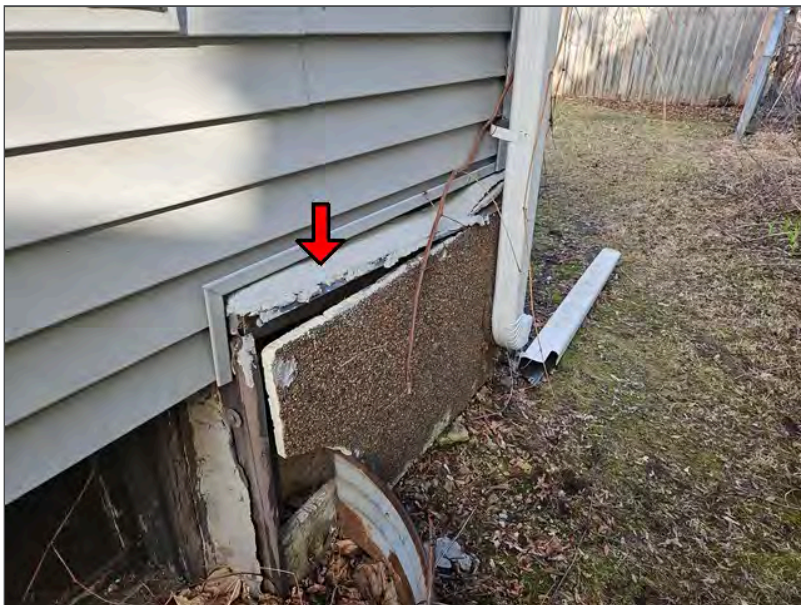
Defect: Foundation was damaged. Gaps present in the foundation walls indicate the need for tuckpointing. Evidence of moisture intrusion was present. Foundation walls were bowed. Extensive presence of efflorescence was observed. Efflorescence is indicative of excessive pooling of water at the foundation, which can lead to its damage and water intrusion.

Please note that the presence of skim coating prevented a complete determination of all the materials used to build the foundation. Poured concrete may also have been used.

Recommend further evaluation and repair as necessary by a qualified foundation specialist.

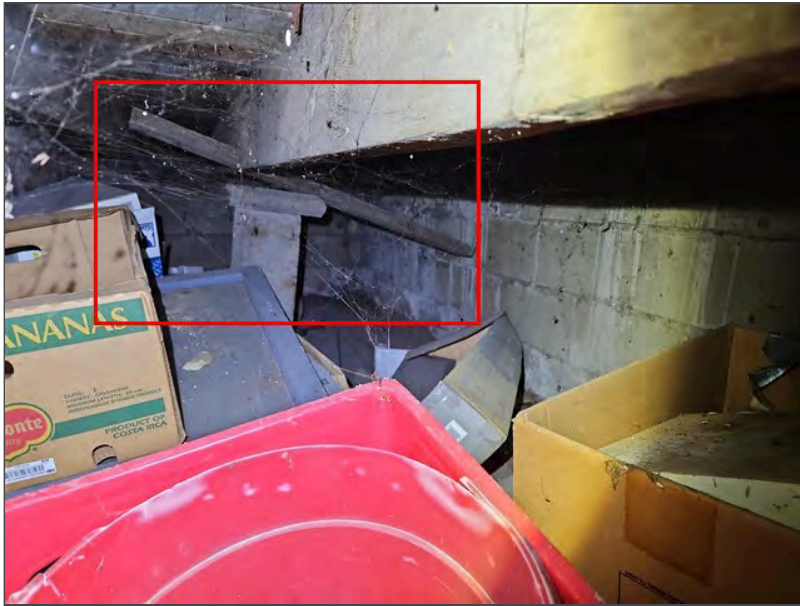
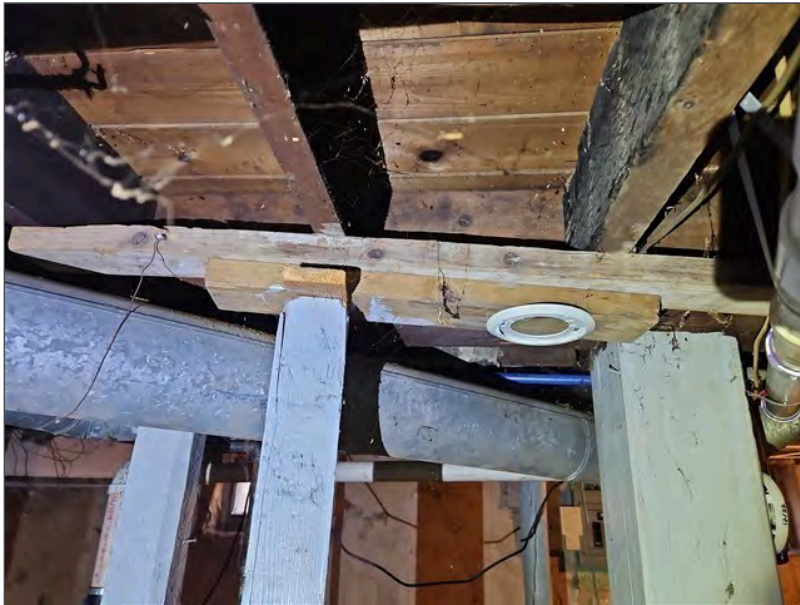
4.2 Columns

Defect: Columns were not constructed in a manner or in a condition to adequately support the floor structure.

Recommend further evaluation and repair as necessary by a qualified professional.

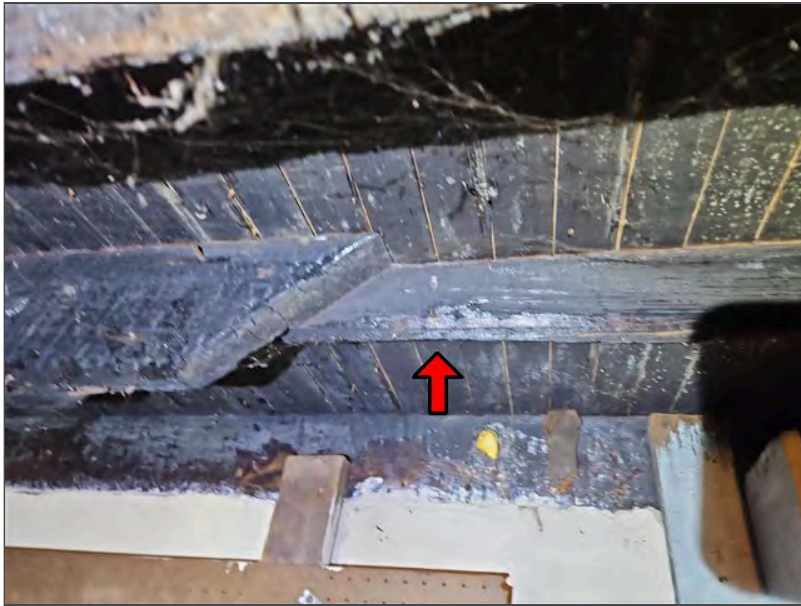
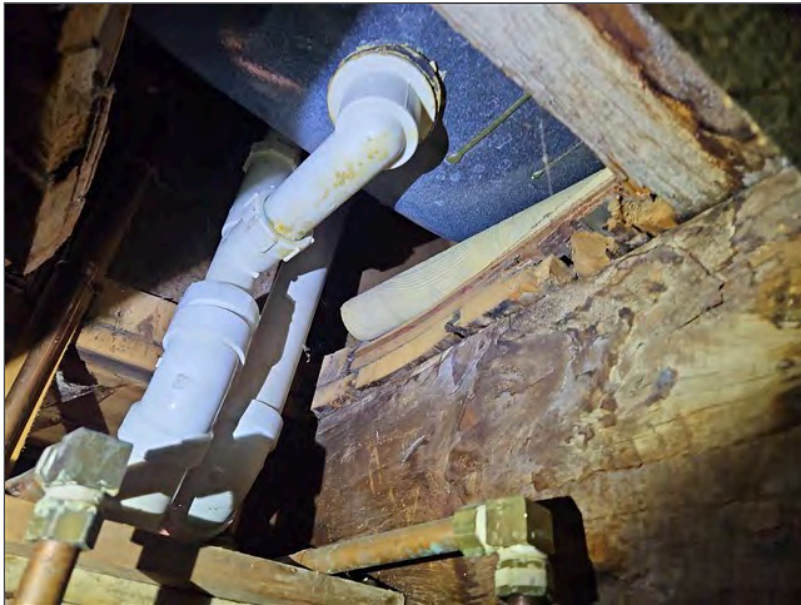
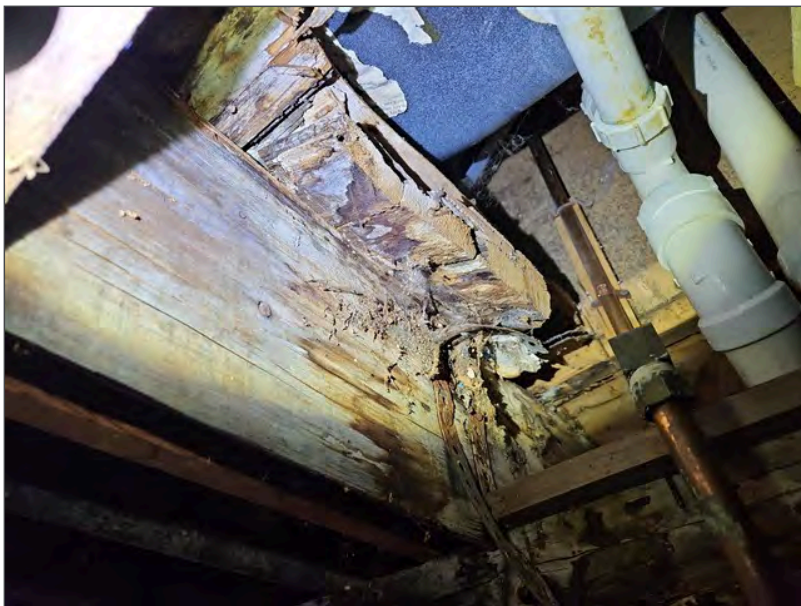
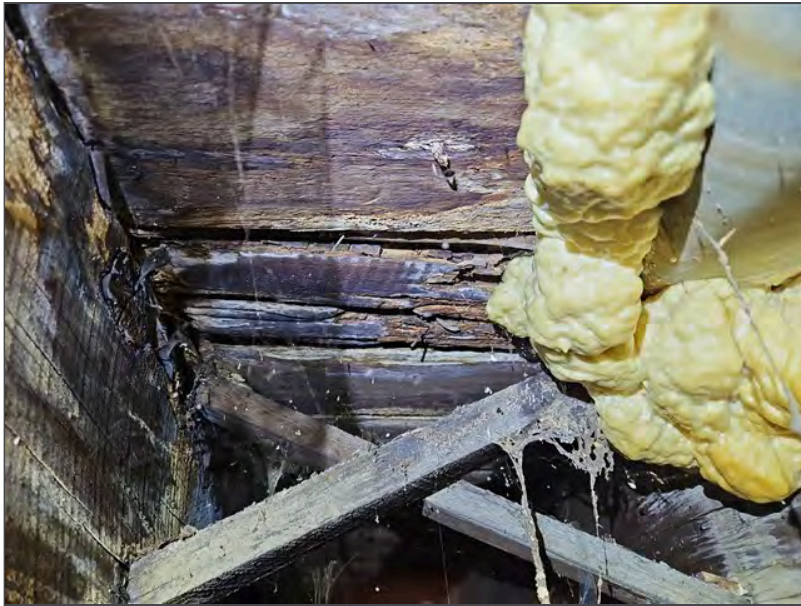
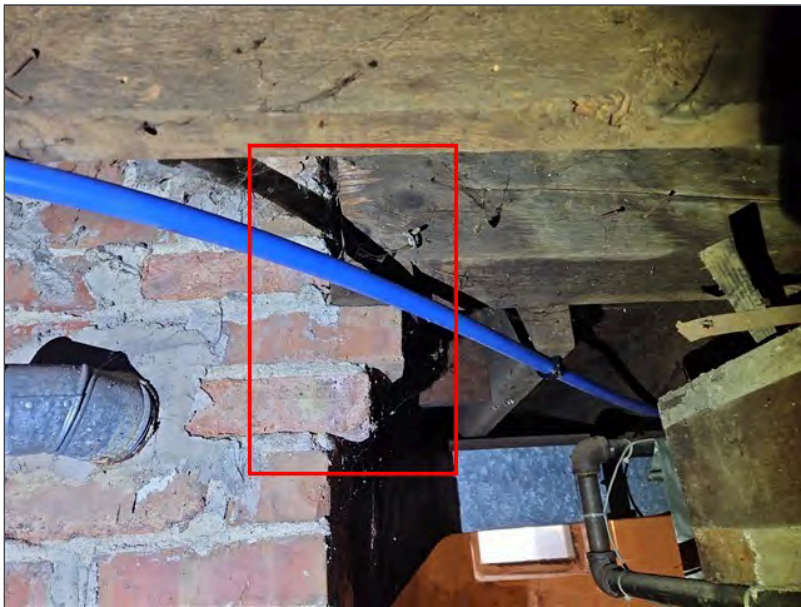
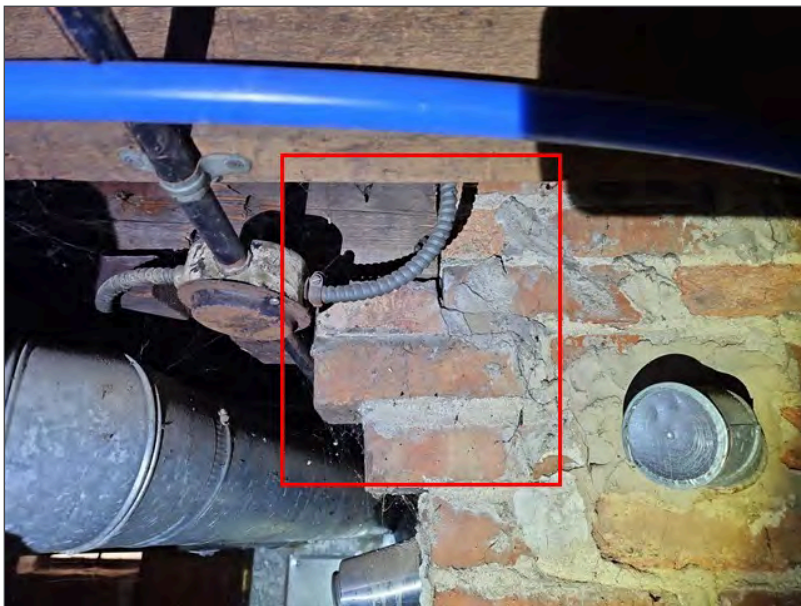
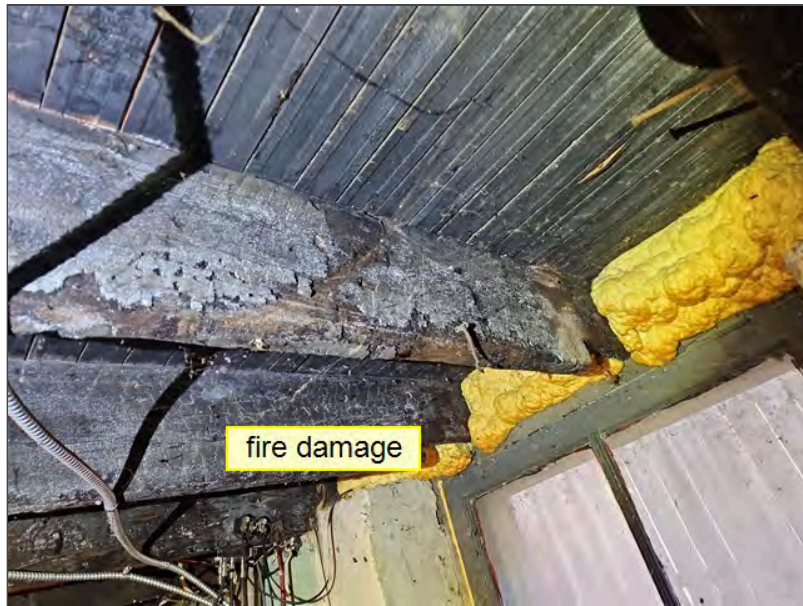
4.3 Floors (Structural)

Defect: Joist(s) were altered in a manner that impact their structural integrity. Main beam was resting on chimney corbels - cracks were present. Please see note 1.4 about the condition of the bottom of the chimney. Subfloor was deteriorated.

Fire damage was present - structural integrity of these floor components need to be confirmed.

Recommend further evaluation and repair as necessary by a qualified professional.

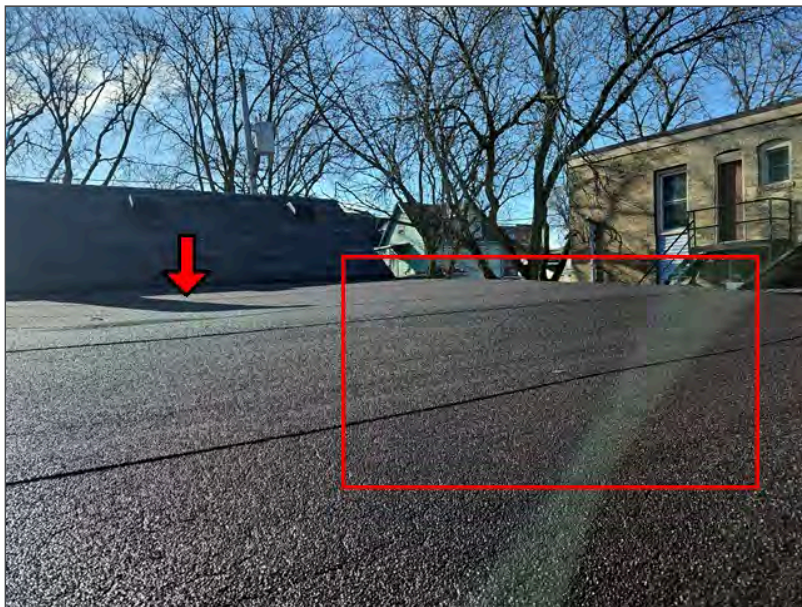
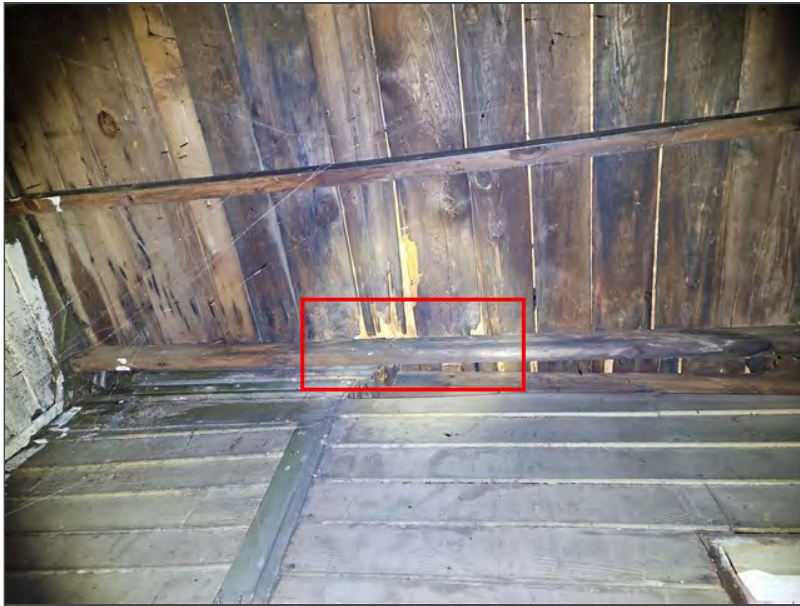
4.4 Roof Structure and Attic

(1) **Defect:** Roof decking was wavy and depressions were present. Above the stairs to the basement, the wood planks were deteriorated and the OSB did not appear to be resting on the rafters.

Recommend further evaluation and repair as necessary by a qualified professional.

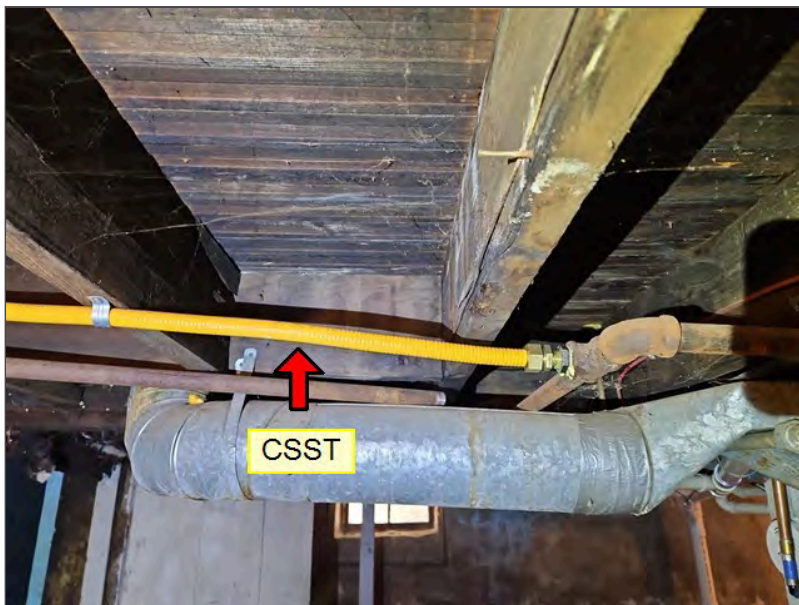
(1) **Defect:** CSST is a flexible fuel line. When installed inside or attached to a building it should be bonded to the electrical grounding system of the building. This is to help mitigate the potential of an electrical surge from forming holes in the CSST resulting in the leaking of fuel.

The CSST was not bonded. Recommend further evaluation and repair as necessary by licensed electrician.

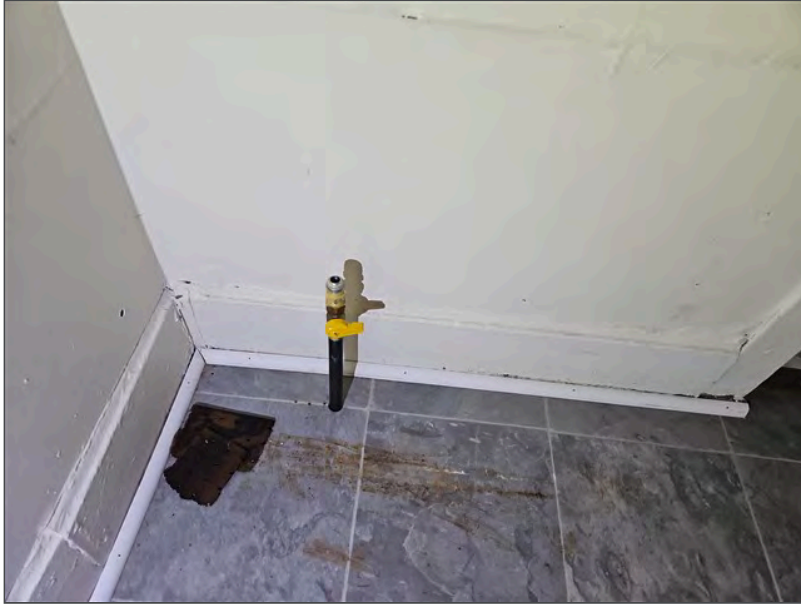
(2) **Defect:** A gas supply line was shut off at the valve but was not capped. If the valve is opened, gas will flow into the home and create a dangerous condition.

Recommend further evaluation and repair as necessary by licensed plumber.

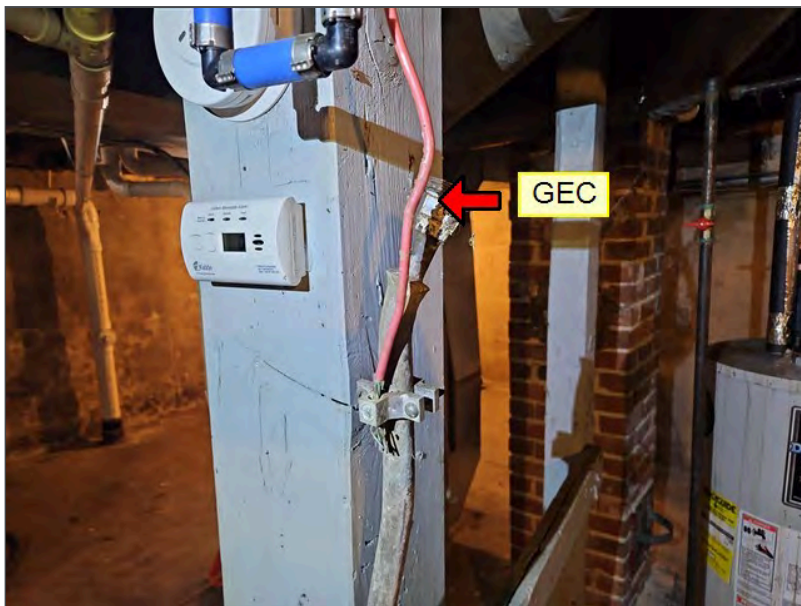
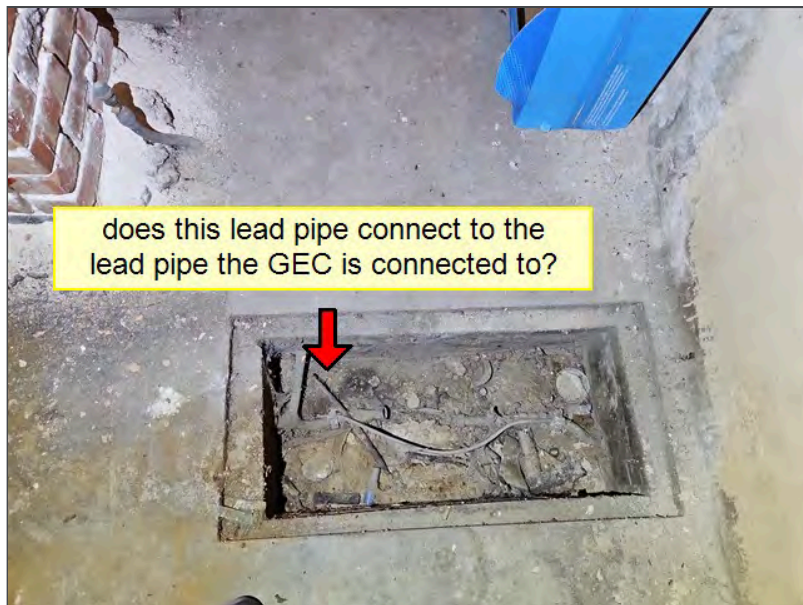
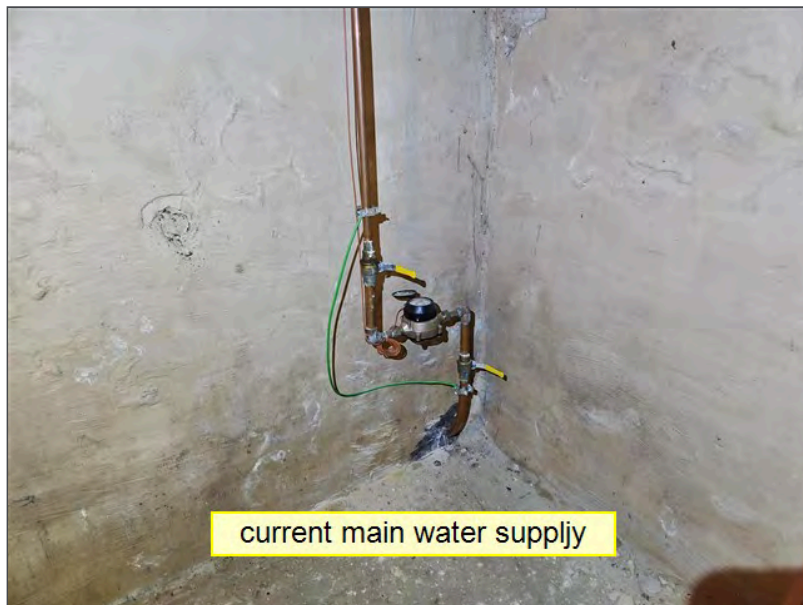
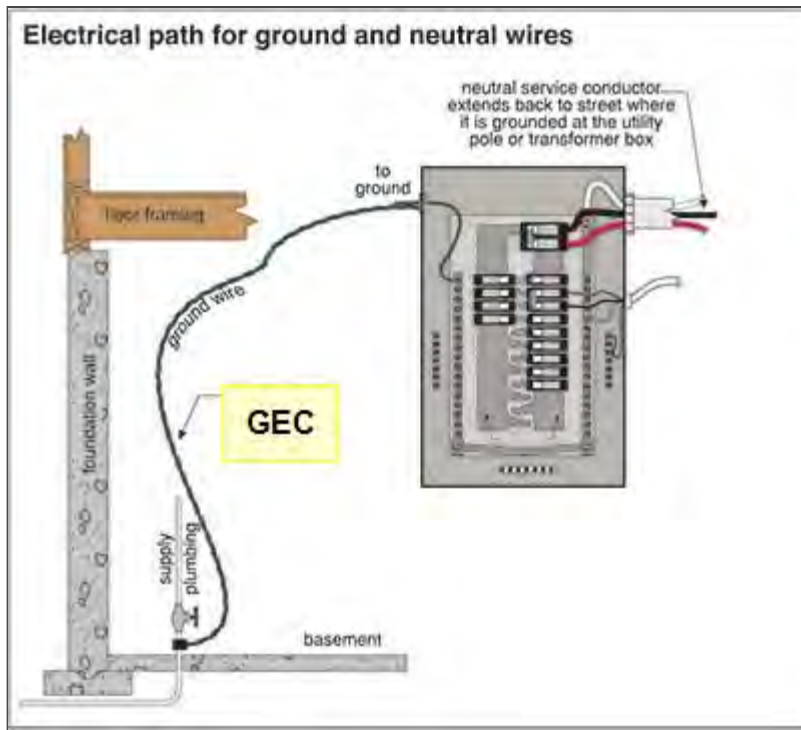
The GEC was connected to a legacy lead water line - continuity to ground outside was not able to be confirmed.

Recommend connecting the clamp for the GEC to the current main water supply line by a licensed electrician.

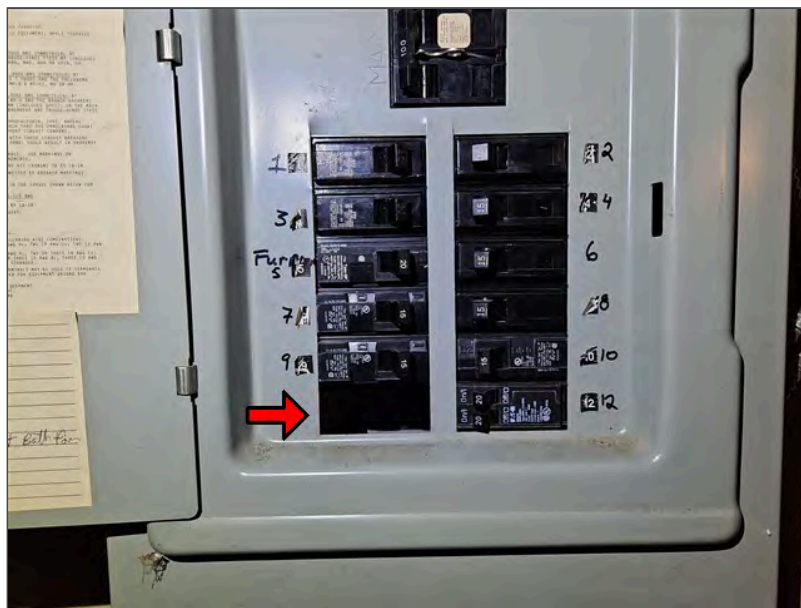
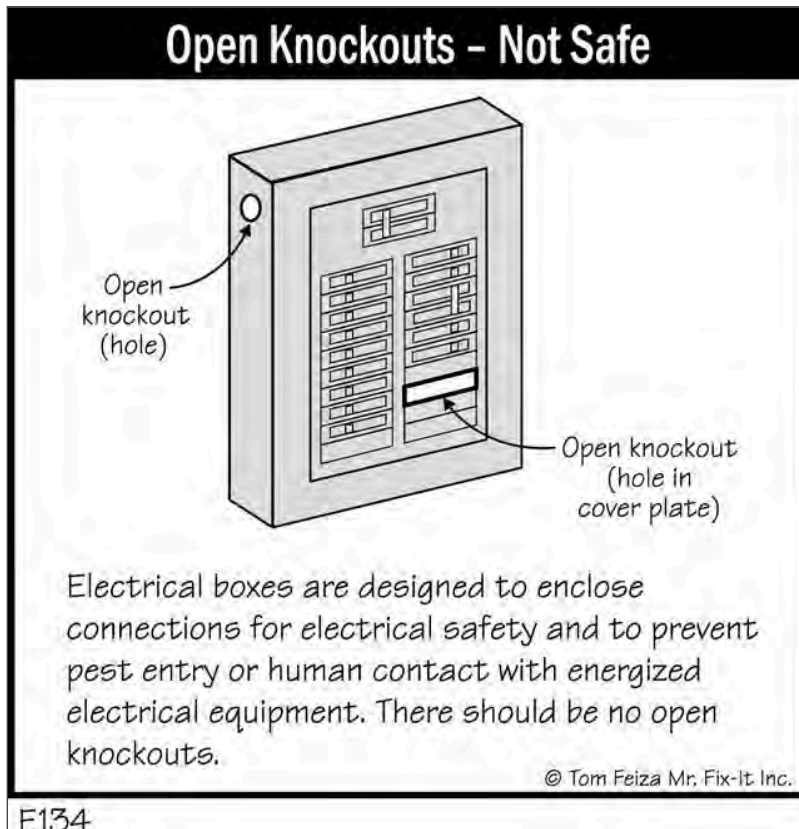
(2) **Defect:** The main panel had knockout(s) removed and gap(s) present. A gap in the deadfront panel provides direct access to the live conductors in the panel. This is an electrocution hazard.

Recommend further evaluation and repair as necessary by a licensed electrician.

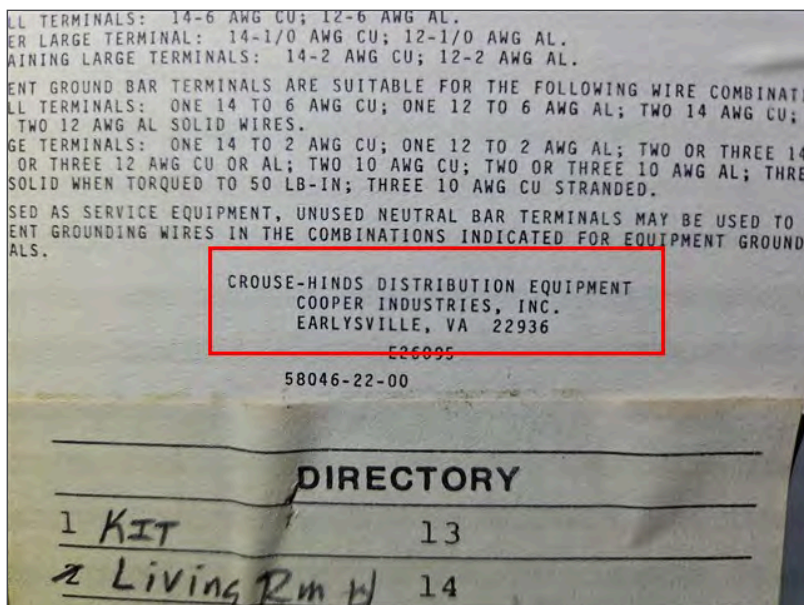
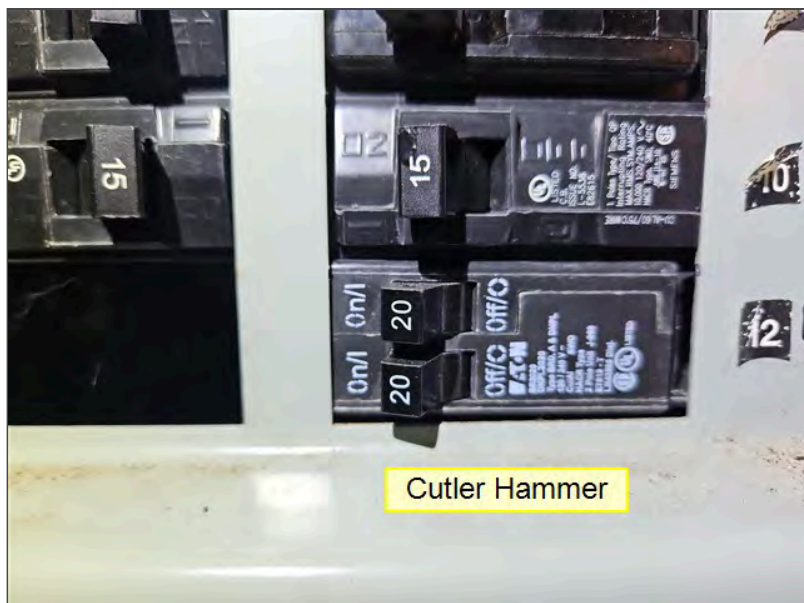
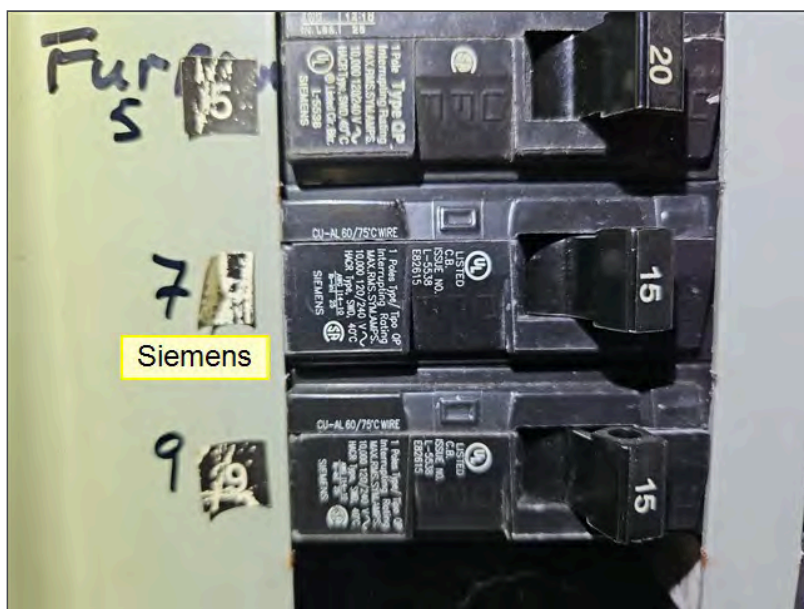
(1) **Defect:** Multiple circuit breakers in the main panel were of a different brand than the panel manufacturer. Only the breaker manufacturers and models listed on the legend on the panel can be used. Not all circuit breakers are interchangeable among the different panel manufacturers.

Using circuit breakers other than the original manufacturer's may void the United Laboratories (UL) approval and the manufacturer's warranty.

Recommend further evaluation and repair as necessary by licensed electrician.

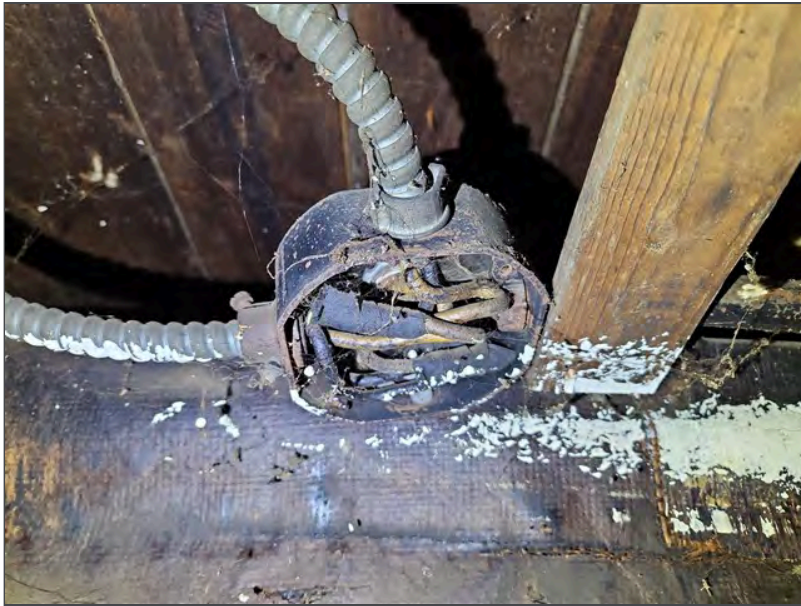
(1) **Defect:** Cover plate(s) were missing. This condition leaves energized electrical components exposed to touch and is a shock/electrocution hazard.

Recommend further evaluation and repair as necessary by licensed electrician.

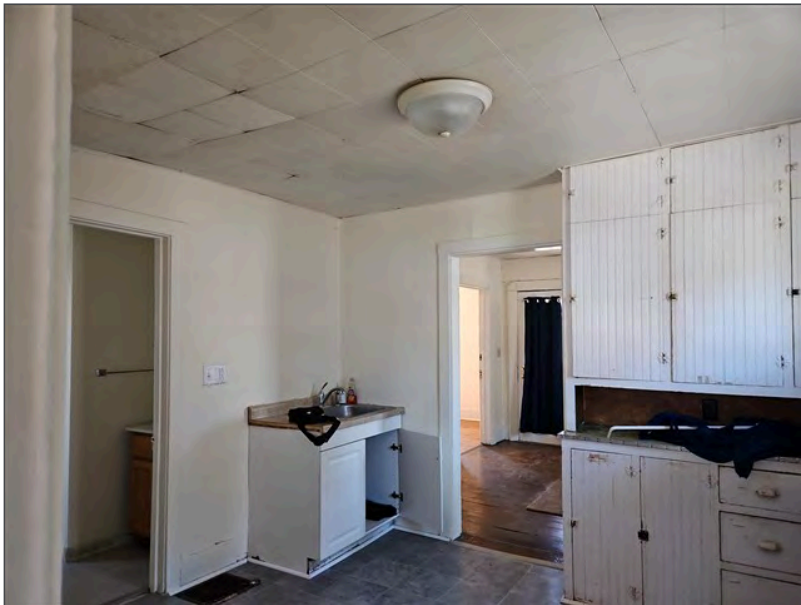
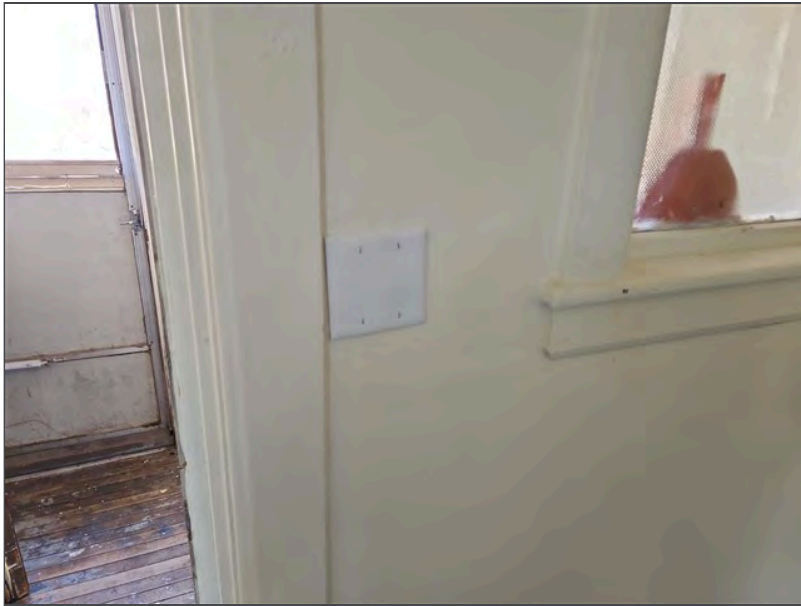
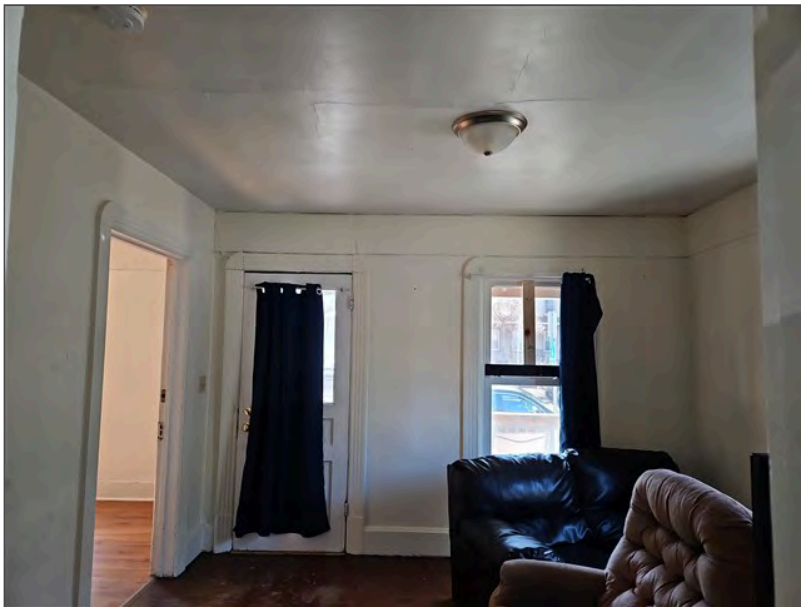
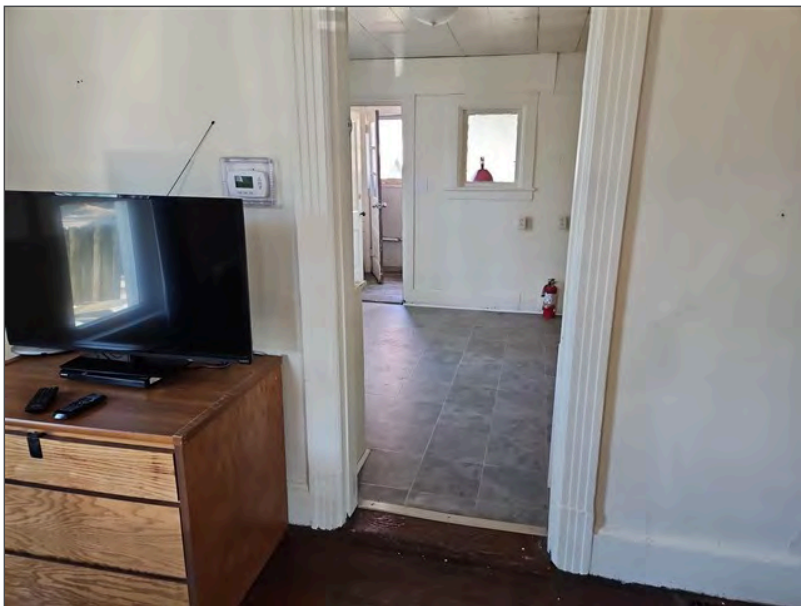
(3) **Defect:** In multiple rooms, there was not a way to turn on a light when entering a room through a doorway.

Recommend further evaluation and repair as necessary by licensed electrician.

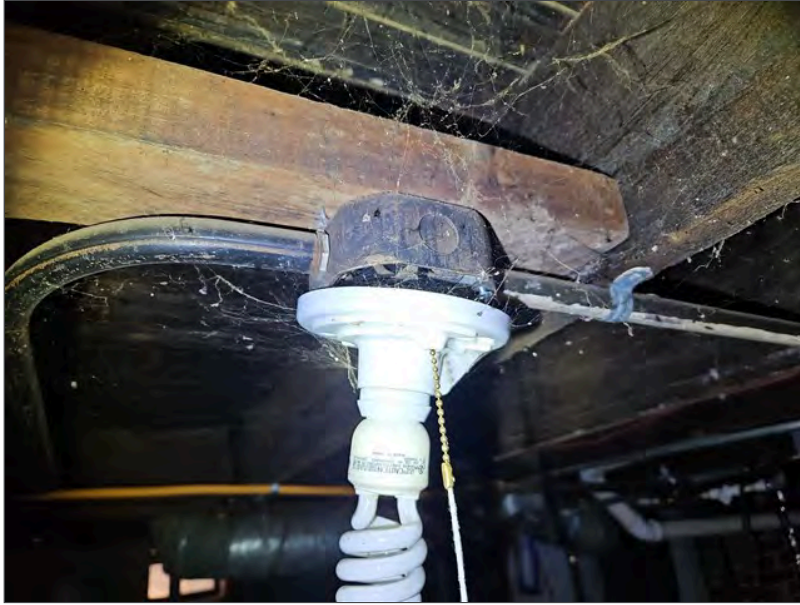
(4) **Defect:** Light fixture was not securely attached to the structure in the basement.

Recommend further evaluation and repair as necessary by licensed electrician.

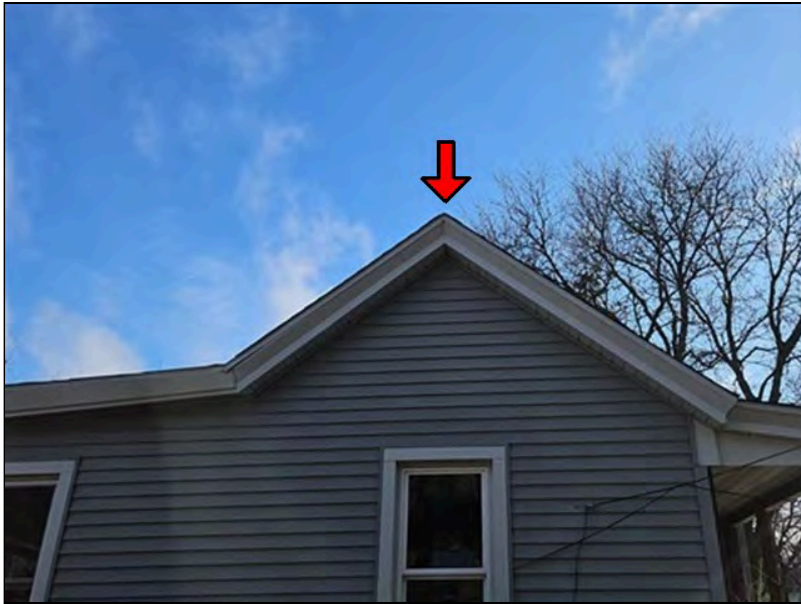
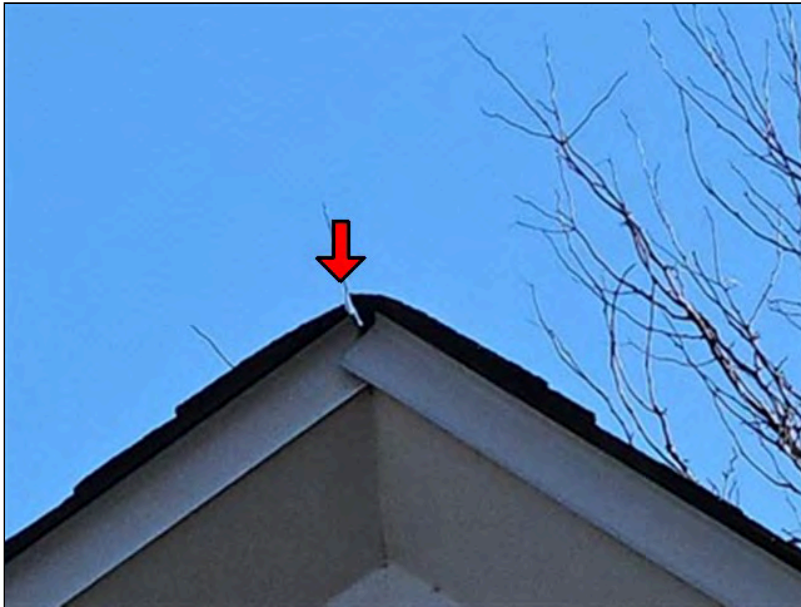
(3) **Repair:** Ridge cap shingle was spilt. Condition may allow moisture intrusion.

Recommend further evaluation of the roof coverings and repair as necessary by qualified roofing contractor.

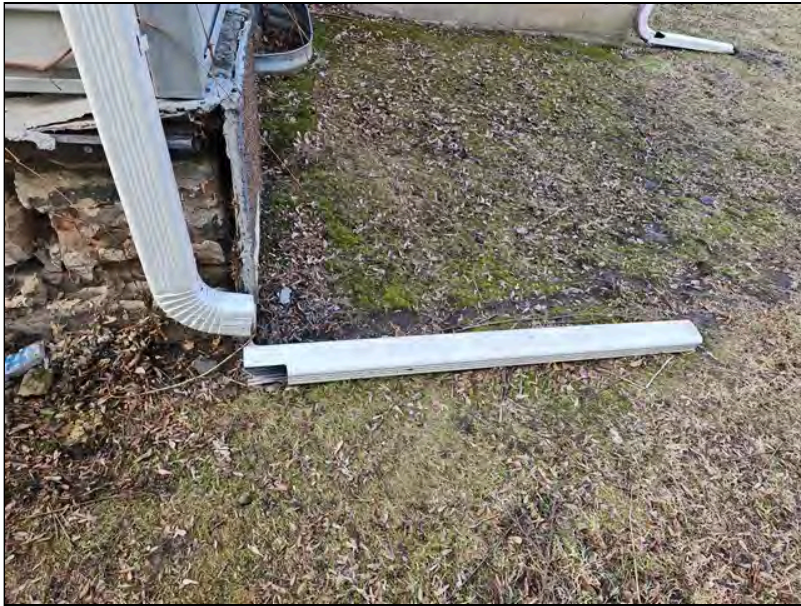
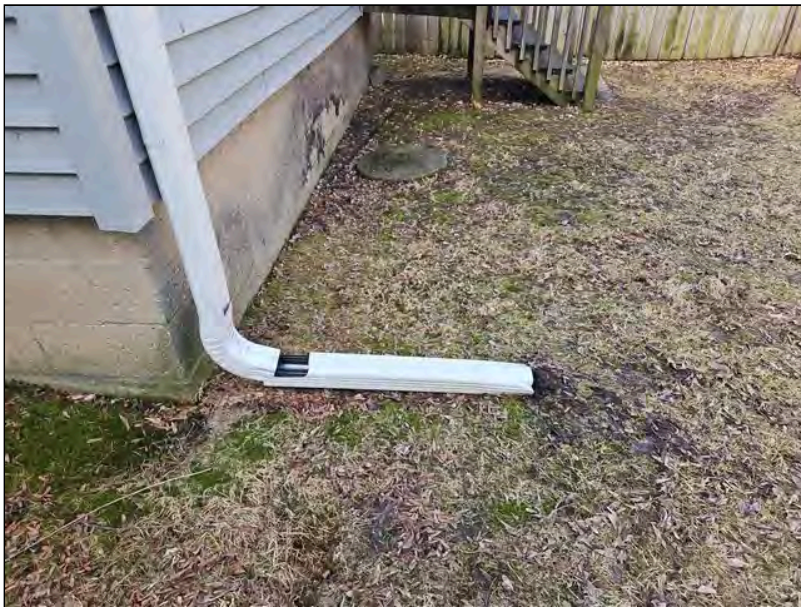
1.1 Roof Drainage Systems

Repair: Downspouts discharged roof drainage next to the foundation. This condition can result in excessively high moisture levels in the soil at the foundation and can cause damage to the foundation and moisture intrusion into the basement.

Recommend installation of downspout extensions to discharge roof drainage a minimum of (6) feet from the foundation.

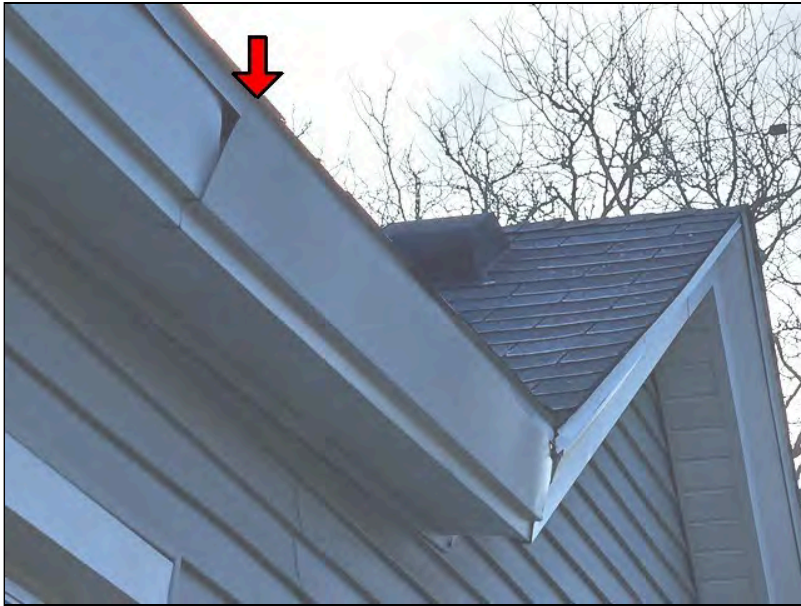
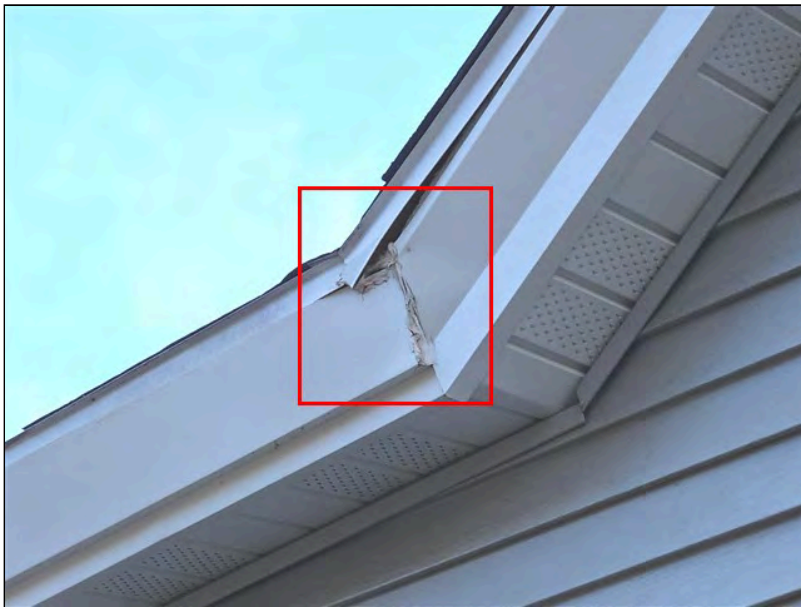
2.1 Eaves, Soffits and Fascias

Repair: Disengaged fascia was present at the left side (facing front) of the home. Sealant was deteriorated. Area is vulnerable to the entry of vermin and moisture.

Recommend further evaluation and repair as necessary by a qualified contractor.

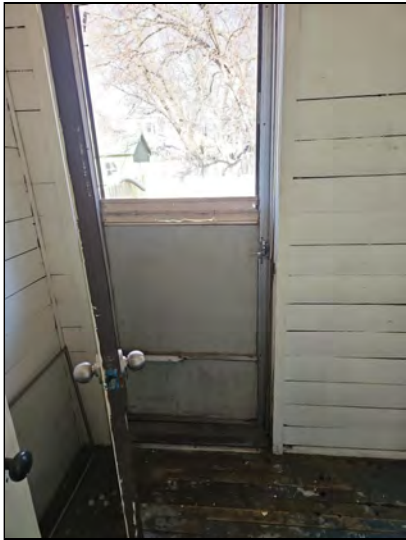
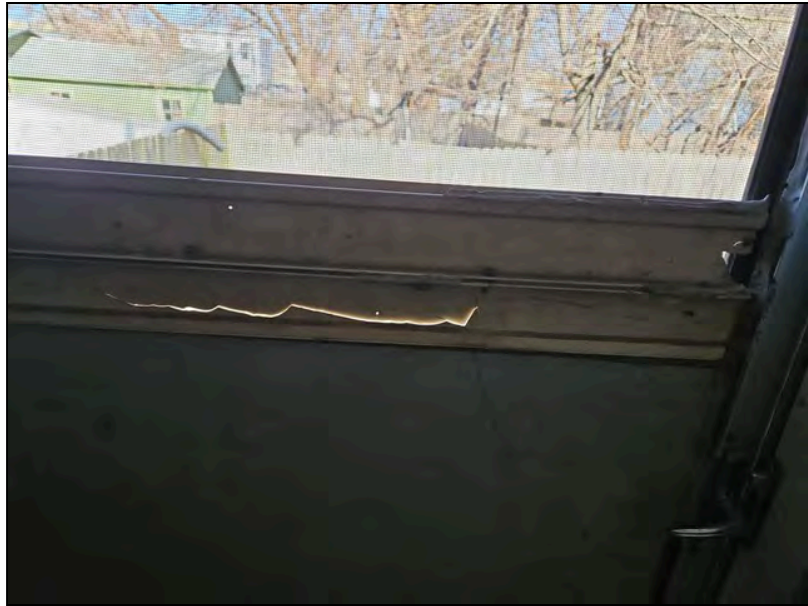
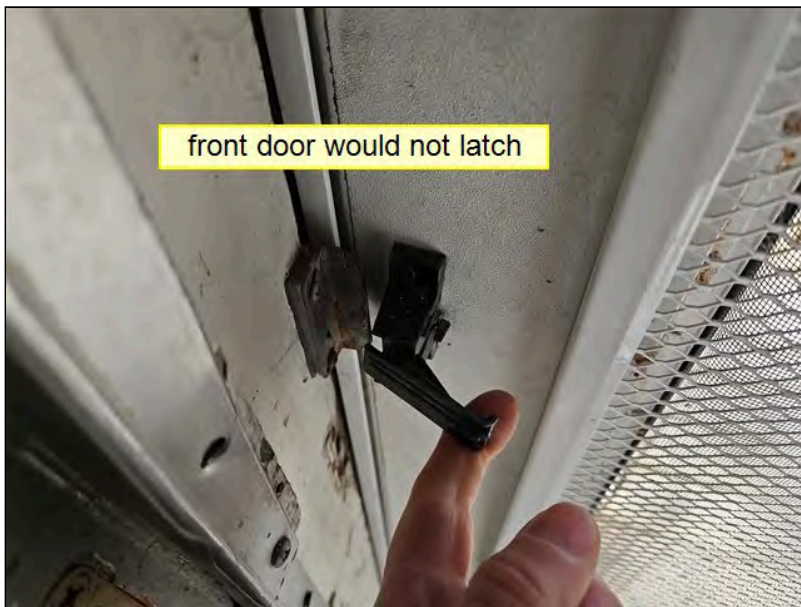
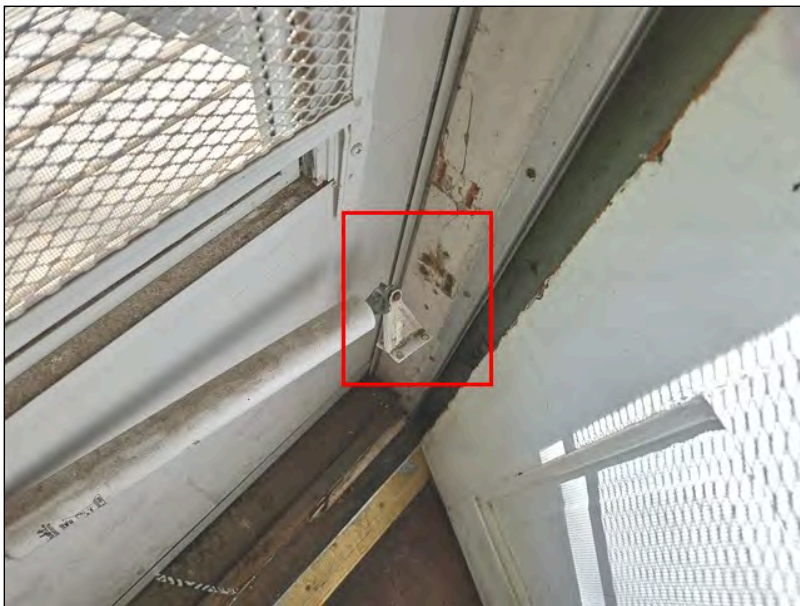
2.2 Doors

Repair: Both storm doors were damaged.

Recommend further evaluation and repair as necessary by a qualified contractor.

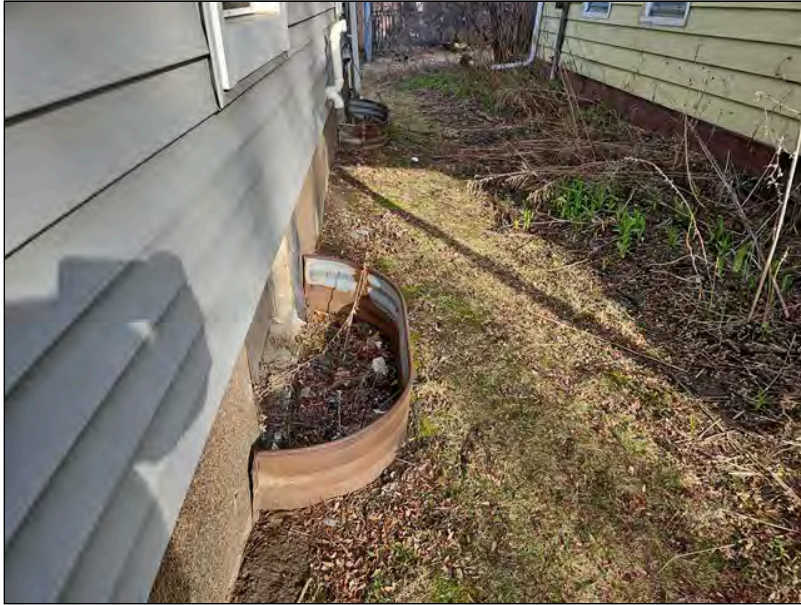
(1) **Repair:** Window well covers were not installed at the basement windows. Recommend the installation of window well covers to prevent the accumulation of snow and rain which can make the windows and foundation vulnerable to moisture intrusion.
