APPLICATION FOR DEMOLITION OF PRINCIPAL BUILDINGS

The existing buildings are unsafe and uninhabitable due to severe structural deterioration. Rehabilitation would cost upwards of \$40,000 per property and would not result in usable or safe living or working space. In their current condition, these properties present ongoing safety risks.

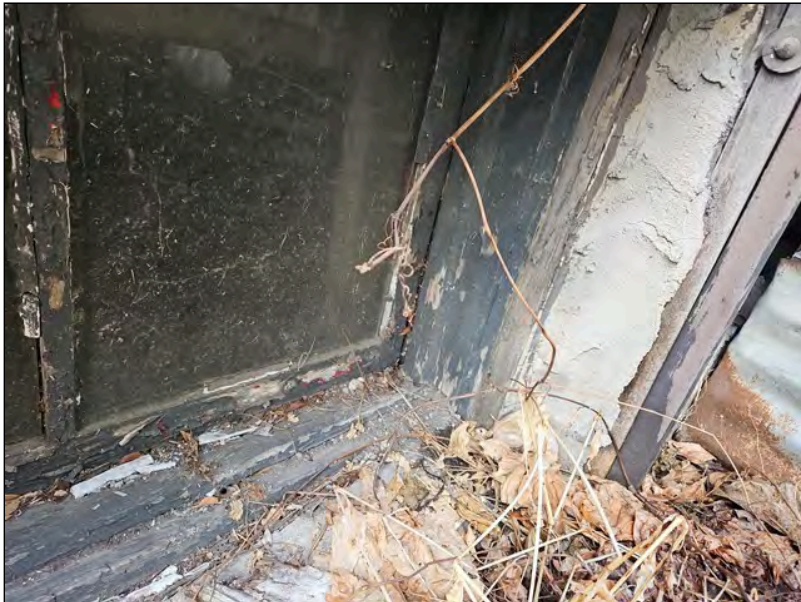
(2) **Repair:** Basement window frames were deteriorated. Their deterioration will result in moisture intrusion into the basement.

Recommend further evaluation and repair as necessary by a qualified contractor.

Given the age of the home, it is possible for lead paint to be present. Recommend testing and taking appropriate safety protocols as necessary.

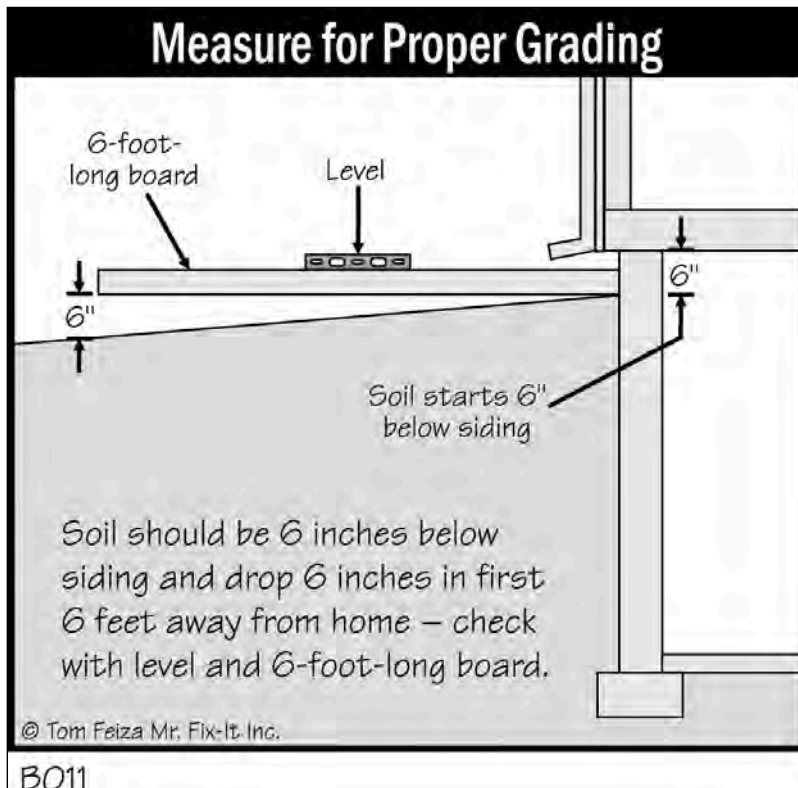
2.6 Vegetation, Grading, Retaining Walls - with respect to impact on building

Repair: The landscaping was insufficiently sloped away from the home in multiple locations. This can cause excessively high levels of moisture at the foundation and cause damage to the foundation and moisture intrusion into the basement. Recommend correcting landscape to drain water away from home.

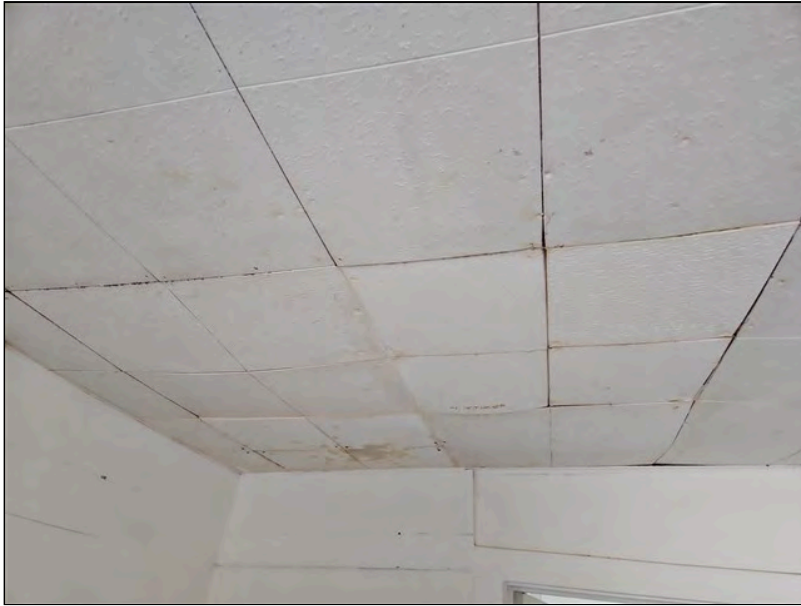
(1) **Further Evaluation:** Given the age of the home, the ceiling tile may contain asbestos. Testing

would need to be conducted to confirm the presence of asbestos with certainty. Please refer to the EPA website for more information: <https://www.epa.gov/asbestos/protect-your-family>

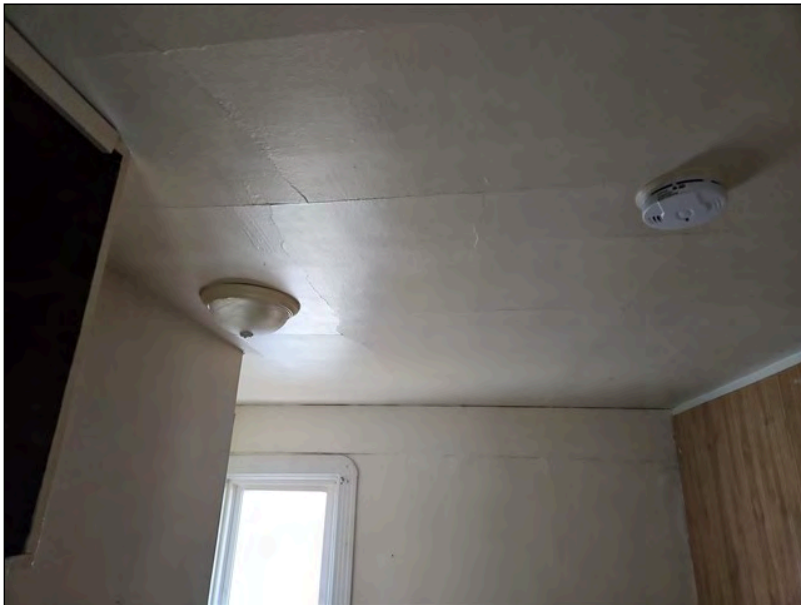
(2) **Repair:** The plaster was disengaged/cracked in multiple locations. Recommend further evaluation and repair as necessary by a qualified contractor.

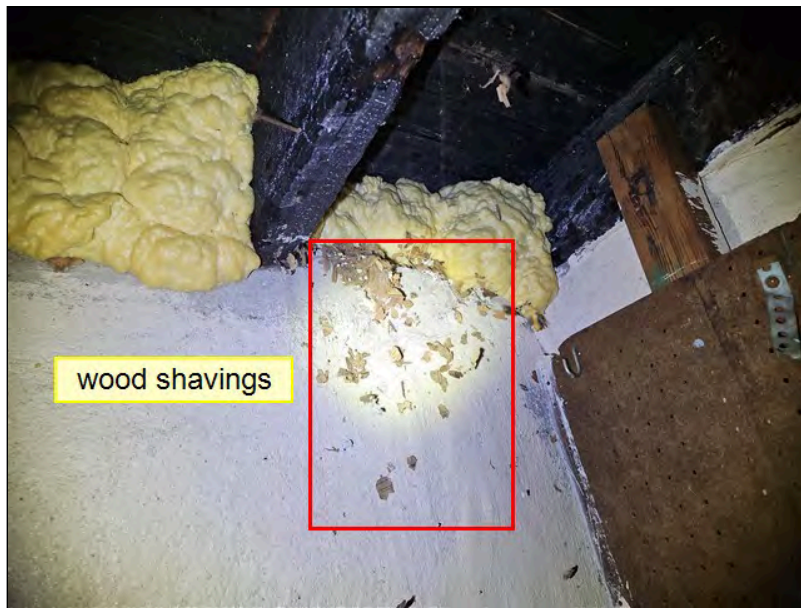
(1) **Further Evaluation:** Evidence of potential vermin/insect activity was present in the basement. Recommend further evaluation by a qualified professional.

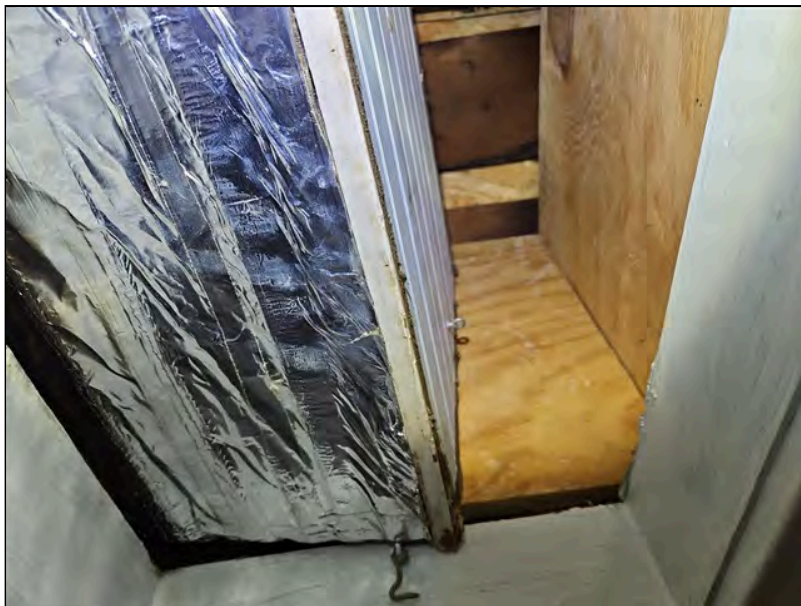
4.4 Roof Structure and Attic

(2) **Further Evaluation:** The attic hatch was covered in foam board insulation. After repeated attempts, the Inspector was not able to raise the hatch completely - it was bumping into the roof decking - or pull it through the opening.

As a result, the view of the attic space under the pitched roof was very limited.

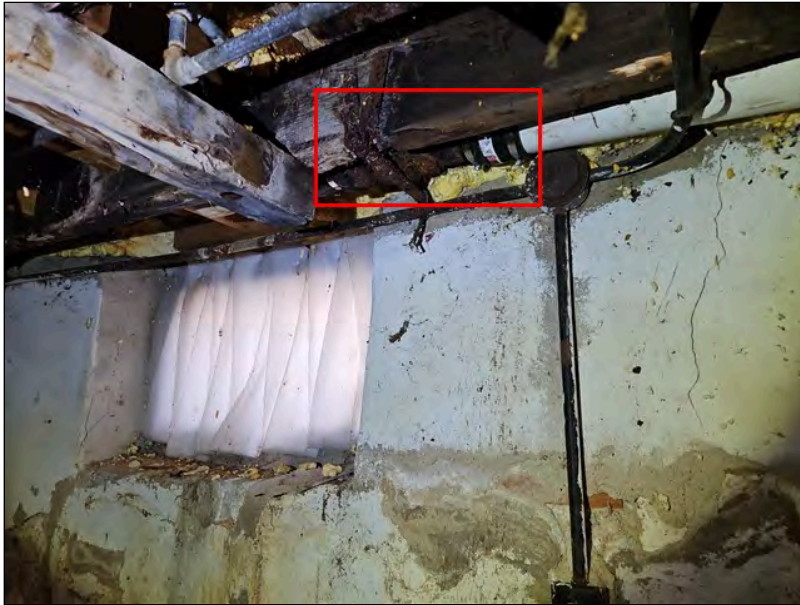
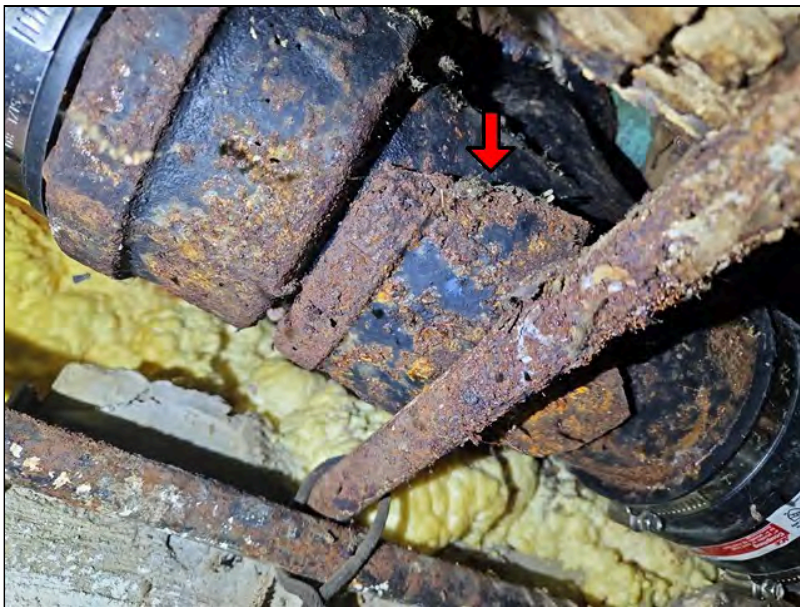
(1) **Further Evaluation:** Was a broken piece of cast iron pipe used to make a "repair"?

Recommend further evaluation by licensed plumber.

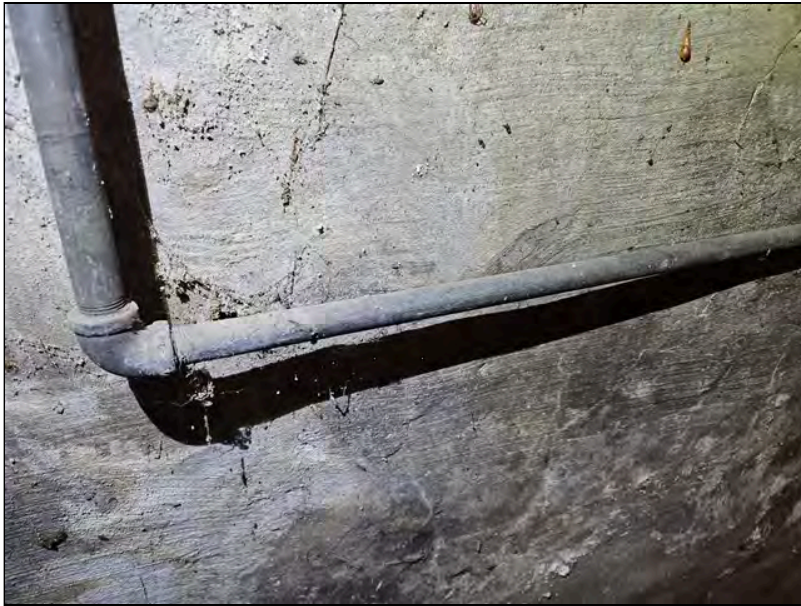
(1) **Monitor:** Galvanized steel pipe was in use for the water distribution lines. This style of pipe will rust from the inside out. The accumulation of rust/minerals on the inside of the pipe may restrict water flow. Recommend monitoring condition.

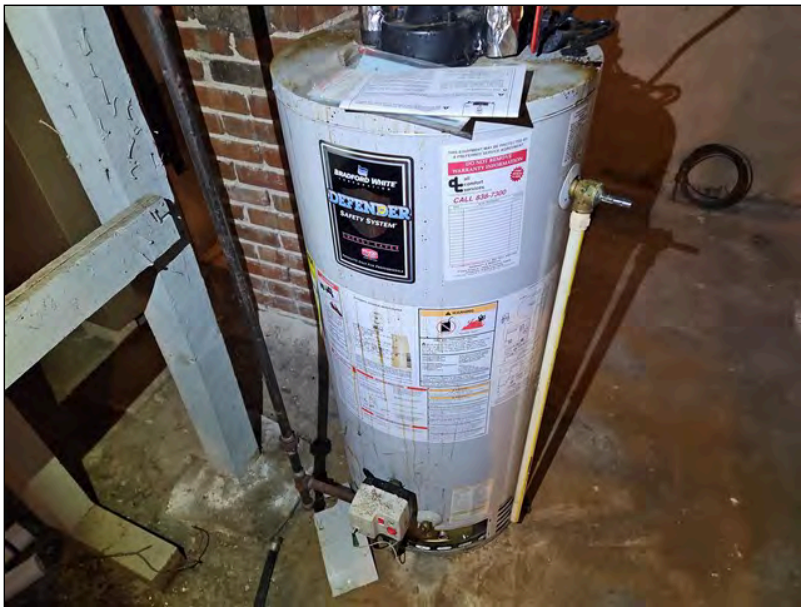
Equipment was older than the typical expected lifespan of 8-12 years. Recommend creating budget for replacement.

Further Evaluation: Unit was not plugged in and working at the time of the inspection.

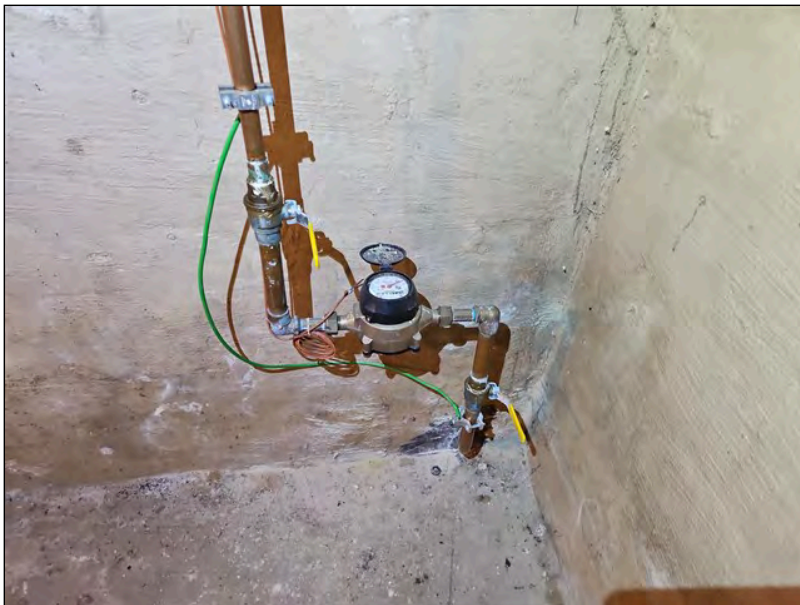
5.3 Main Water Shut-off Device

Further Evaluation: The main water supply was shut off at the time of the inspection. The inspection of the plumbing system was incomplete.

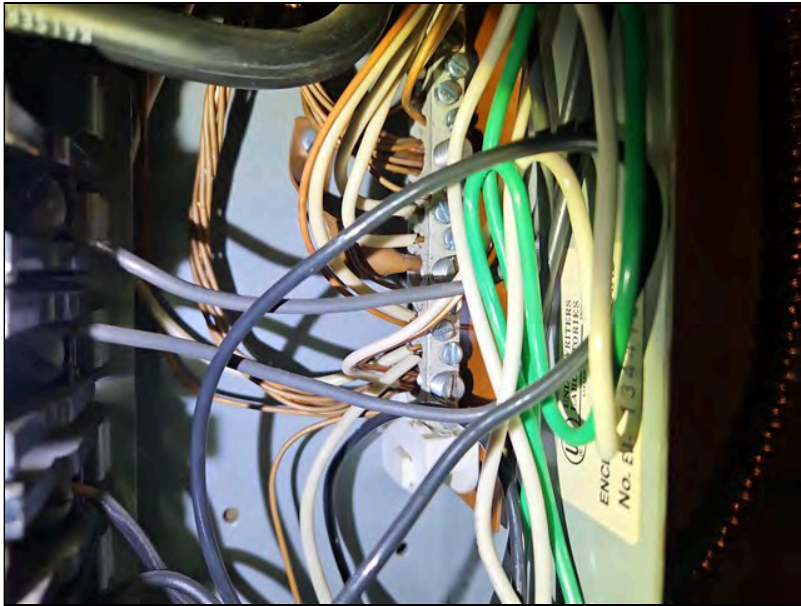
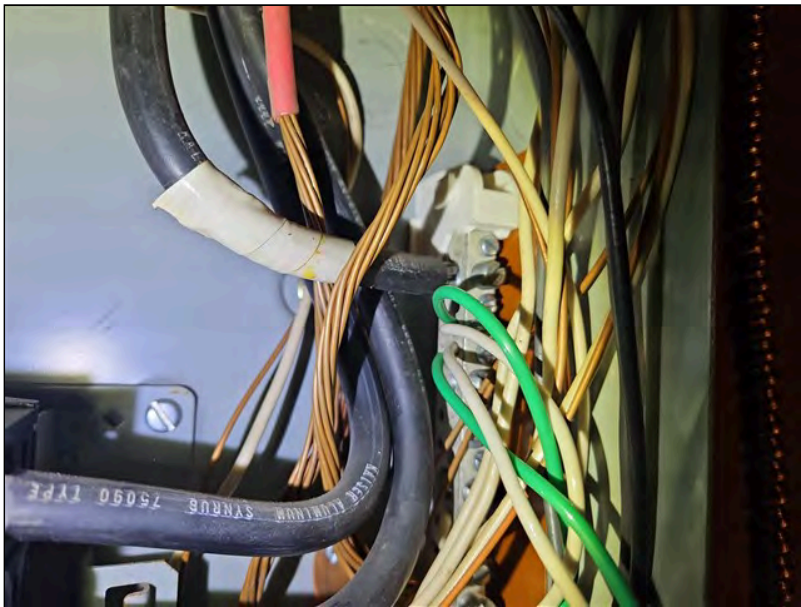
(2) **Repair:** Double lugged neutral and grounding conductors and double lugged neutral conductors were installed on the bus bar inside the main panel.

Lugs can loosen over time because of the electromagnetic force created by electrical current and the constant subtle heating and cooling of electrical circuits. A loose lug can result in arcing of the neutral wires against the bus bar and present a potential fire hazard.

Recommend further evaluation of the panel and repair as necessary by licensed electrician.

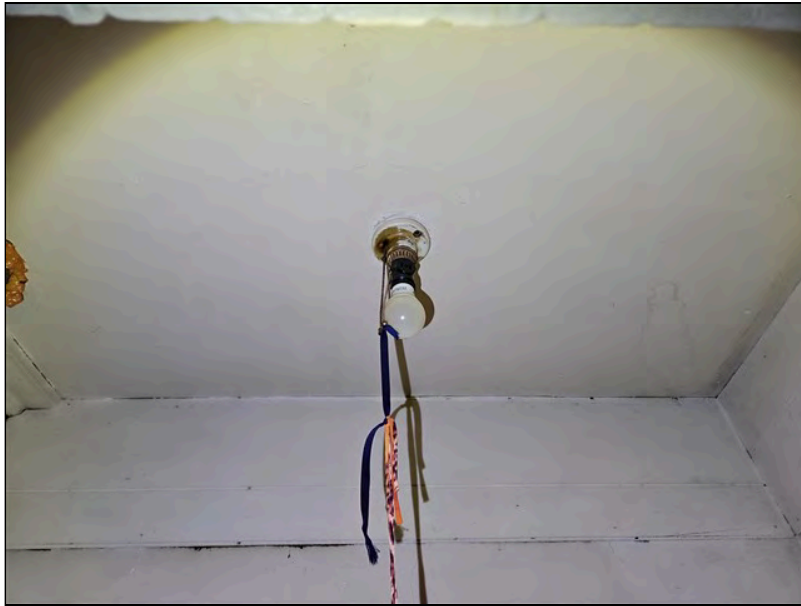
(2) **Repair:** A incandescent light bulb without a cover was present in a closet. This can be a safety hazard when flammable items stored in a closet come in contact with the light bulb. Recommend the use of fluorescent light bulbs and the addition of covers.
