City of Madison

**Madison Municipal
Building
Conceptual
Schematic
Design Study**

November 2013

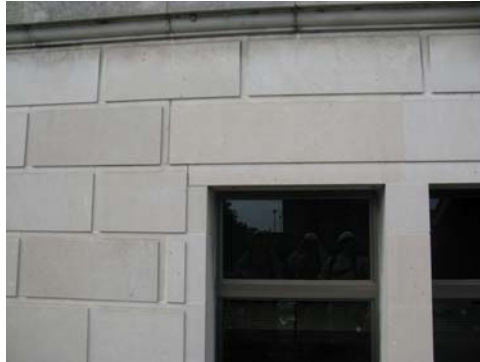
Exposed stone face sizes also vary; from a standard 39" width x 16 ½" height at the second and third floors to a 30" width x 16 ½" height with 2" reveals on the first floor.

Figure 7 – Stone Face

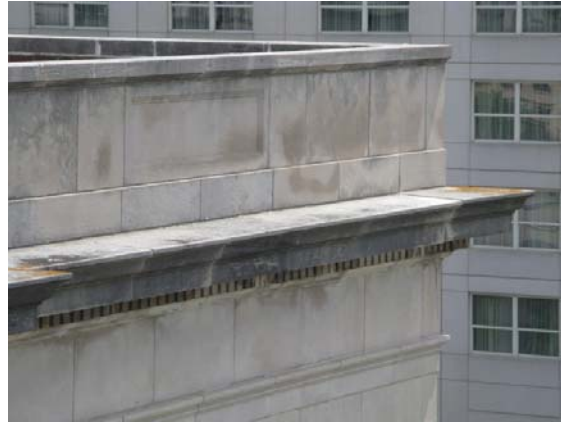
Figure 9 – Stone Cornice and Parapet

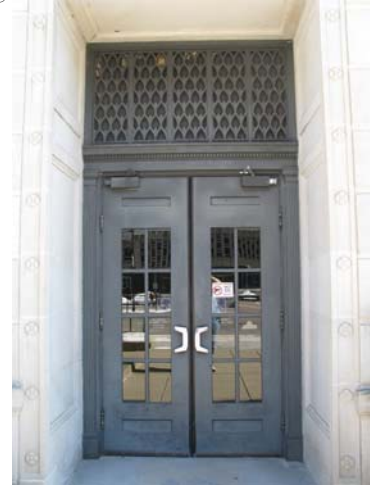
Figure 16 – Original Cast Iron and Steel Double Door and Transom Openings remain Intact

The doors and frames are original to the building; only the door pulls and locking mechanisms have been changed. Made of steel and similar in design to the steel windows, the door frames and decorative transom grilles are cast iron while the doors are steel. The horizontal divider between the doors and transom is a cast iron lintel shaped like a cornice supported on each side with skinny, ionic type fluted columns. The glass has been replaced with tempered glass without disturbing the original grille work.

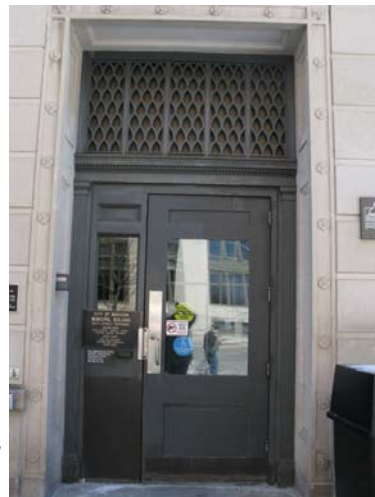
The secondary entrance located on the east elevation is similar to the main double doors. The west door opening still has the original cast iron frame and decorative grille transom; however, a new single acting door with a sidelight has replaced the double doors. The door is equipped with accessibility hardware as this is an accessible entrance to the building. Utility entrances range from hollow metal, aluminum frame and steel overhead doors; all are not original to the building.

Figure 17 – Modified for Accessibility, the West Entrance still retains much of the Original Cast Iron Framing

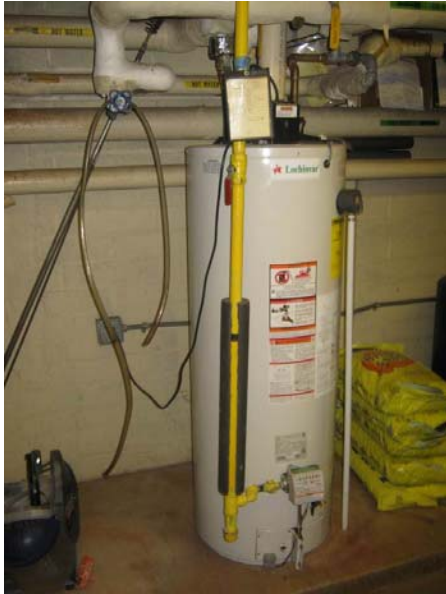
Figure 40 – Water Heater

One gas fired water heater, located in the lower level mechanical room, provides hot water to the building. All hot water is softened by a water softener located in the same mechanical room. The domestic hot water system is currently stored and circulated at approximately 115°F. Both the water heater and softener appear to be a newer vintage and are said to be in good working condition.

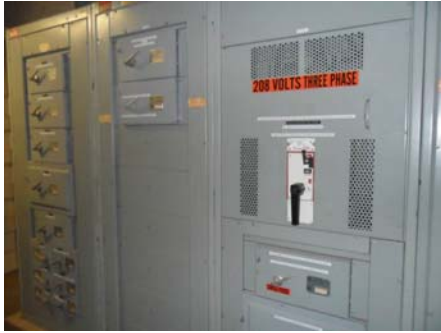
Figure 48 – Current Electrical Service

As mentioned before, the existing service is 4000 Amp, 120/208V 3-phase, 4-wire service, GE Service Entrance switchgear, in good condition. The incoming utility service is served from exterior transformers on the northwest side of the building. The existing main electrical service equipment is in good condition, and large portions of the branch panels are undergoing an upgrade. Most of the second and third floor panels are being completely overhauled with new branch panels and splice boxes replacing the original 1920s panels in the corridors. In addition, the distribution has been upgraded to include an individual feeder for each panel located on the upper floors, greatly expanding the available capacity.

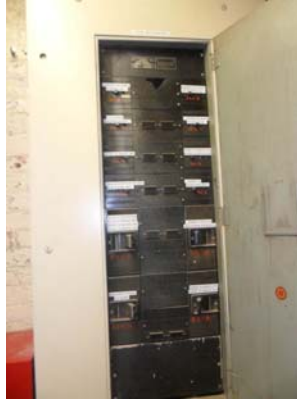
Figure 49 – Electrical Branch Panels

Although the second and third floor panels have been recently upgraded, the other areas of the building have also seen one or two renovations, and branch panels vary in type, quality, and condition throughout. Some of the existing to remain panels is Westinghouse; these can be difficult to find parts for and even though they are in good operating condition now, they eventually will need replacement.

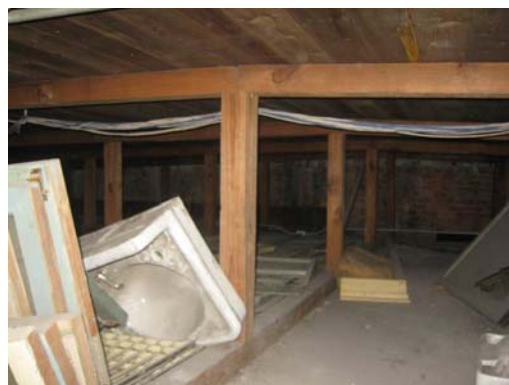
Figure 55 – Underside of Pitched Wood Roof Framing

At the high roof and low roof on second floor, there is a pitched wood post and beam roof system built-up on top of the existing concrete slab.
