Re: Agenda Item 8, Legistar File #85527
Appeal of the Plan Commission action on the demolition permit for 2121 Jefferson St. and
1007 Edgewood Ave.
October 29 Common Council Meeting

AmeriSpec Inspection Service

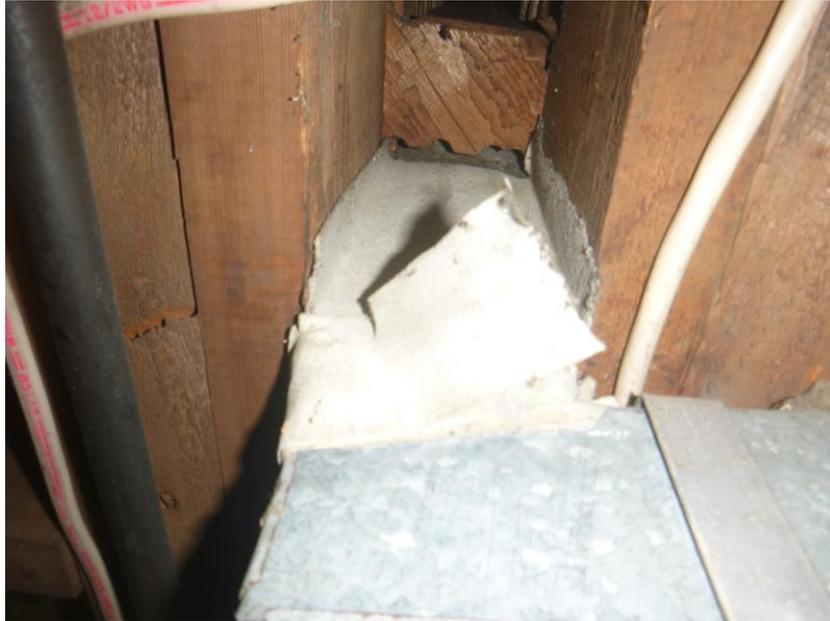
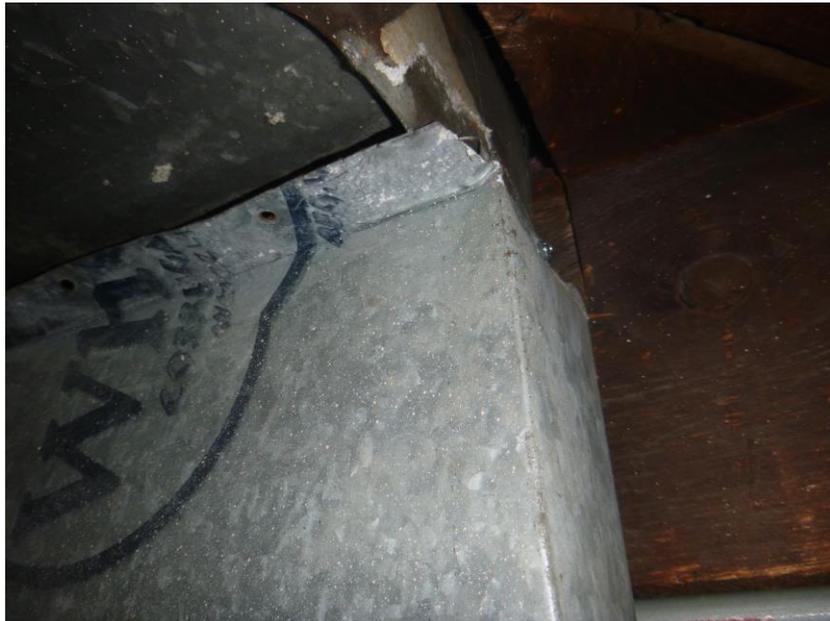
1909. Distribution /
Ducting

Defect. Ducts/Registers. Possible asbestos materials observed. The materials were torn, ripped, or damaged at the time of inspection. This is a possible safety hazard. Suggest further review by a licensed asbestos testing lab be performed prior to closing for repairs/replacement needed to ensure safety. Ducts noted poorly installed/connected. Recommend review for repairs for efficient heating of the house.

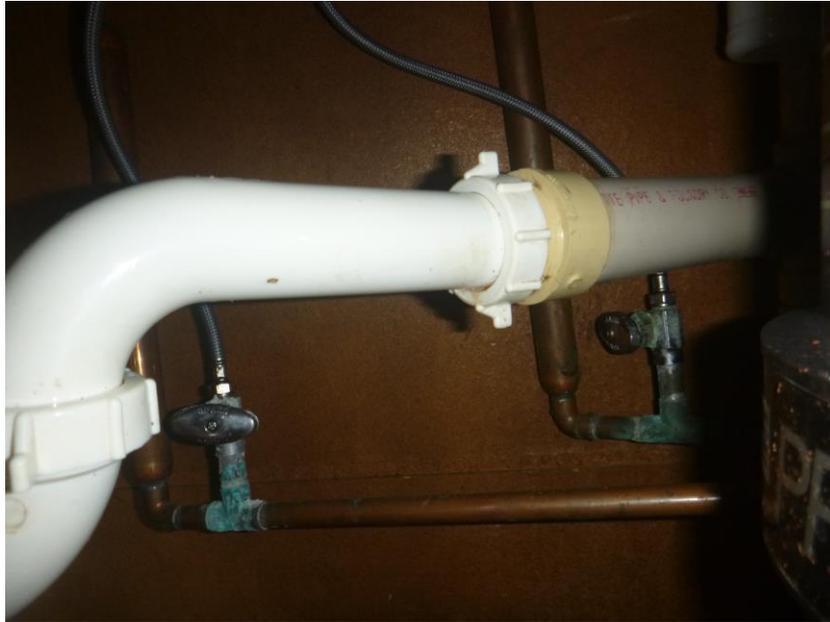
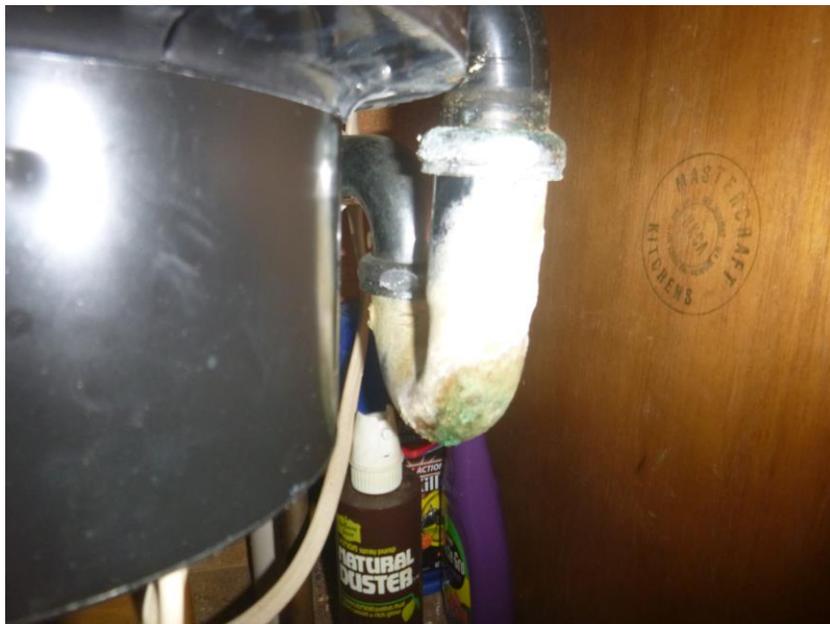
2213. Traps / Drains / Supply **Defect. Improper slope noted on the left sink trap arm. Past leakage noted on supply pipe assembly. The right trap is corroded and has leaked. Recommend review by a licensed plumber for repair or replacement, as necessary.**

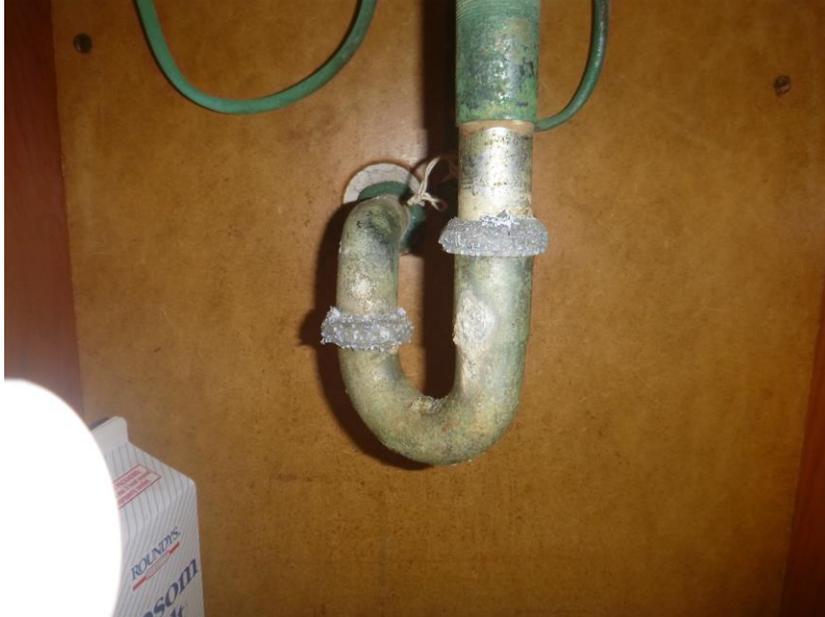
2320. Traps / Drains / Supply **Defect. The sink drain assembly is corroded and shows evidence of leakage. Recommend review by a qualified plumber for replacement of the drain assembly.**

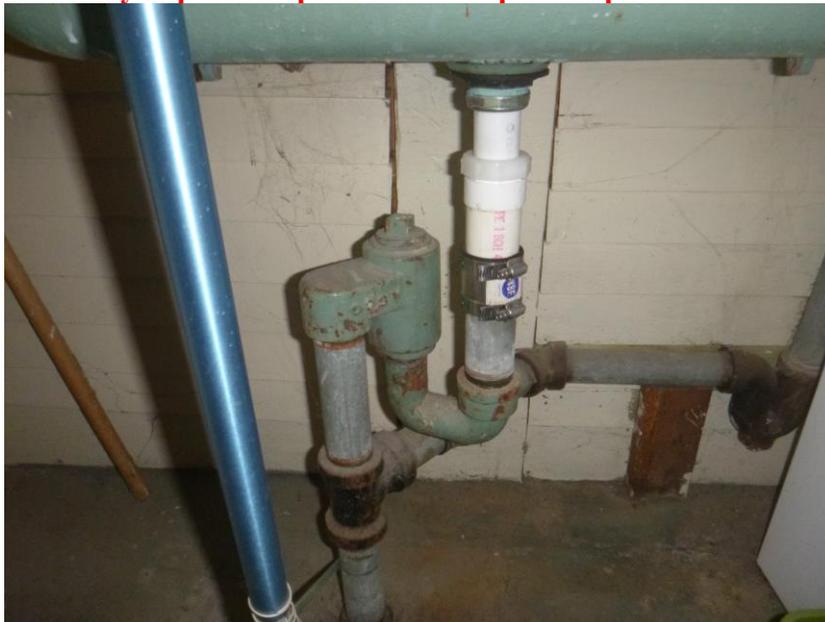
2504.	Doors	Not Present.
2505.	Closet / Wardrobe	Not Present.
2506.	Windows	See basement windows section.
2507.	Cabinets	Not Present.
2508.	Laundry Tub / Sink	Defect. Improper trap and venting of the drain assembly noted. The washer drain pipe is also not vented. Recommend review by a qualified plumber for repairs/replacement.

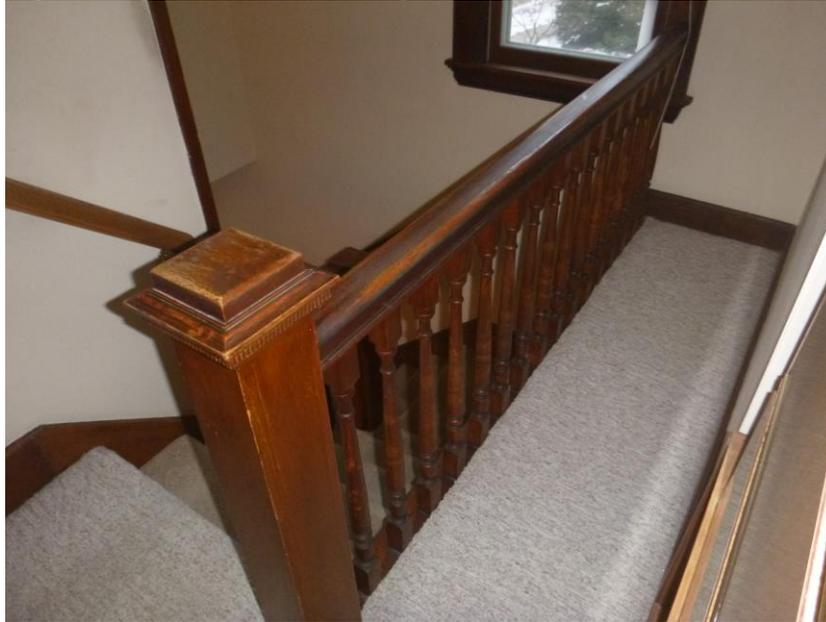
2609. Stairs

Defect. The upper guardrail is too short. Recommend repairs/replacement for safety.

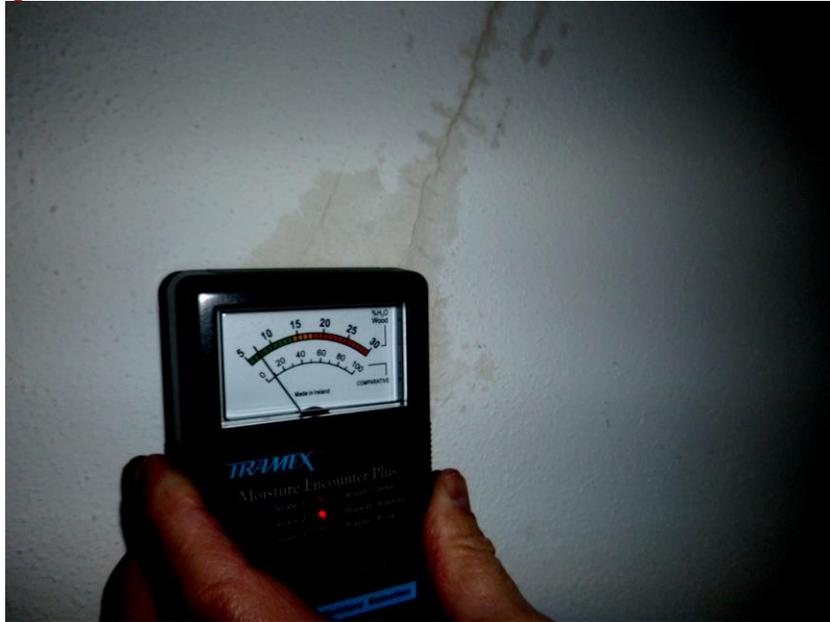
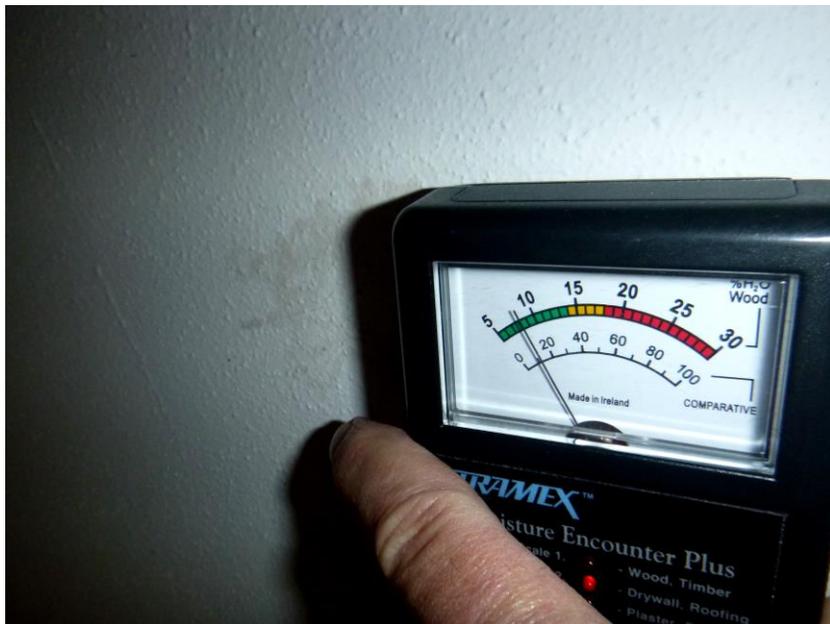
2663. Ceilings

Defect. Stains noted in the ceiling. The inspector probed the stains with a moisture meter and found normal levels of moisture present. Recommend contacting the sellers for more information and monitoring or have reviewed by a qualified contractor.

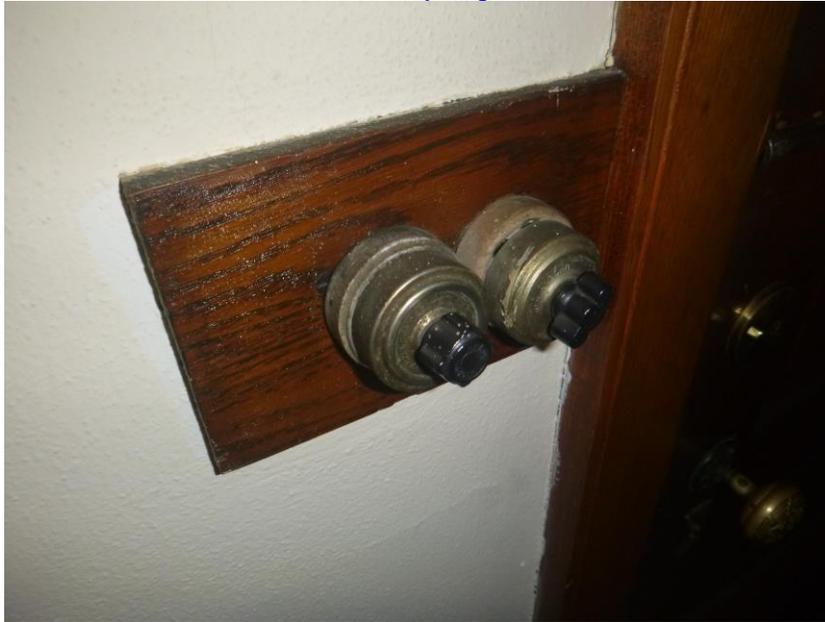
2667. Heat / Cooling Source Central heating.
2668. Electrical [Maintenance. The switches on the rear wall are an older style and may or may not be wired using knob and tube wiring. Recommend further evaluation by a qualified electrician.](#)
