Re: Gilman Street Development
Evaluation of two properties
Madison, WI

The following is my report on the properties at 123 and 127 West Gillman Street.

127 W. Gilman St.
Madison, WI 53703

Conceptual Budget/Recommendations Report

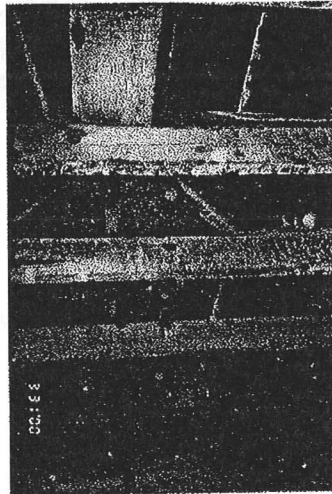
(Figure 2)

Per your request, I have thoroughly inspected your building at 127 W. Gilman St. with the hopes of renovating it. The purpose of my inspection was to create an estimate for the amount of work required to make the units habitable. However, once I began going through the building, I realized that it would be extremely costly to renovate this building. Typically, if a building has good mechanicals and a sound structure, we can gut the finishes and start over. However, this building has inadequate mechanicals as well as many structural problems in various areas. Several areas within the building have settled so much, that there are 1" or more gaps between the door slabs and the door frames (See figure 1 below.) Also, a fire that swept through the attic of the house has severely compromised the integrity of the existing roof structure (See figures 2 & 3 below.)

Interior partitions	\$9,500 - \$13,750
✓ Build new interior steel stud and wood partitions to replace damaged and rotten walls	
Roof demo and rebuilding	\$8,500-\$11,750
✓ Demo and remove all charred structural members damaged in fire (See figures 2 & 3 above)	
✓ Rebuild roof structure with trusses and stick framing	
✓ Install new plywood roof sheathing to replace fire damaged and water damaged roof	
Roof shingles	\$9,500 - \$12,500
✓ Install new roof felt 15 lb	
✓ Install ice and water shield in valleys and all roof edges to prevent future leaks	
✓ Install 40 year architectural shingles	
✓ Vent roof as required per codes
