Madison Landmarks Commission APPLICATION

Project Title / Description: Chabad House-Jewish Student Center - Expansion

CHABAD HOUSE JEWISH STUDENT CENTER – Addition and Renovation
223 and 219 West Gilman
Madison, Wisconsin

Re: 219 Gilman Street Evaluation

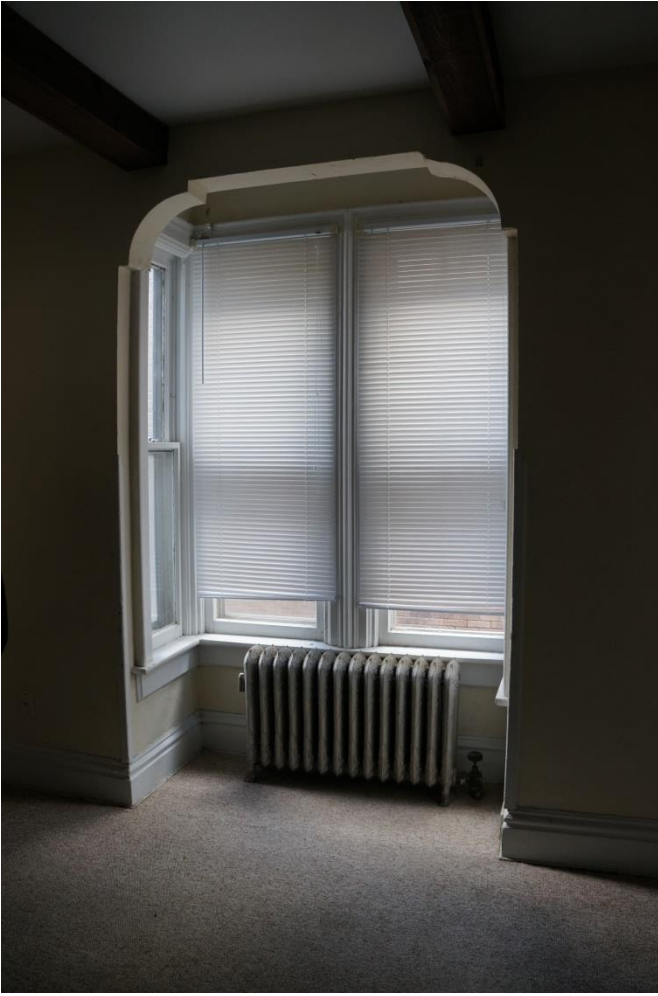
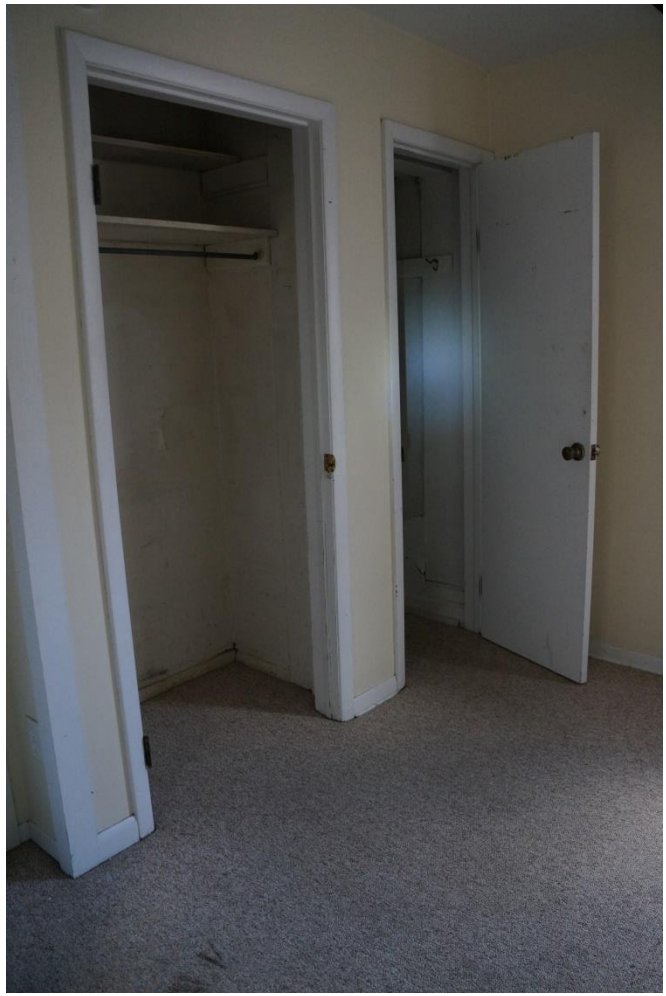
5. Interiors – Typical

Most of the first floor is carpeted. This covers 2 ¼" wide maple flooring in generally good condition. Rear addition features a differ type of base, trim and casing than that found in the original house.

Walls and ceilings of the first floor are plaster on lath. Multiple repairs are evident but overall the condition is fair to good.

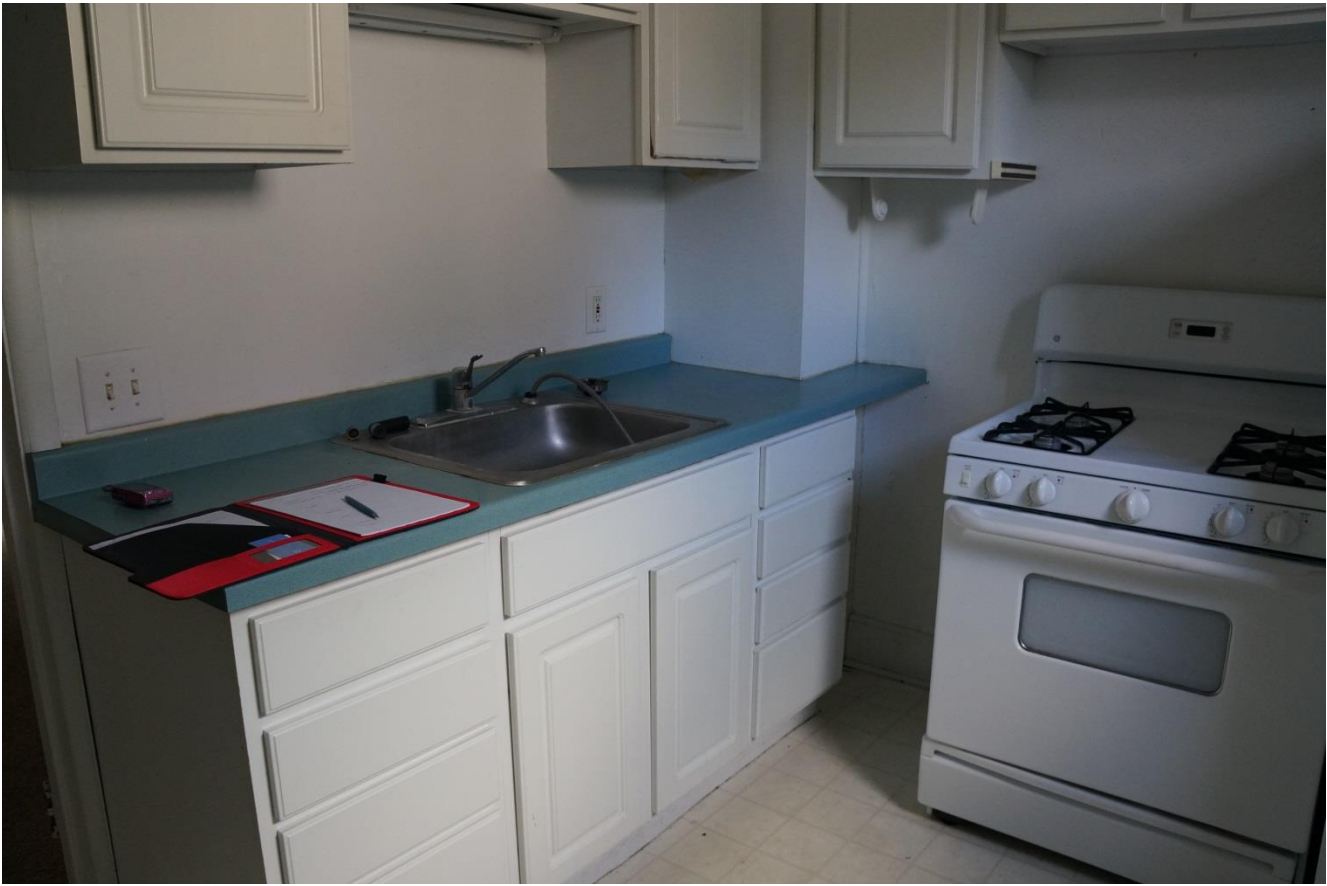
7. Interior – Typical

Walls and ceilings of the second floor are all plaster over lath. These walls are in good condition. Ceilings are in fair condition with some cracking and water damage evident

The simple wood painted trim at base, windows and doors is in generally good condition. Most appears to be original to the time of initial construction.
