APPLICATION FOR DEMOLITION OF PRINCIPAL BUILDINGS

City of Madison

Building Inspection Division

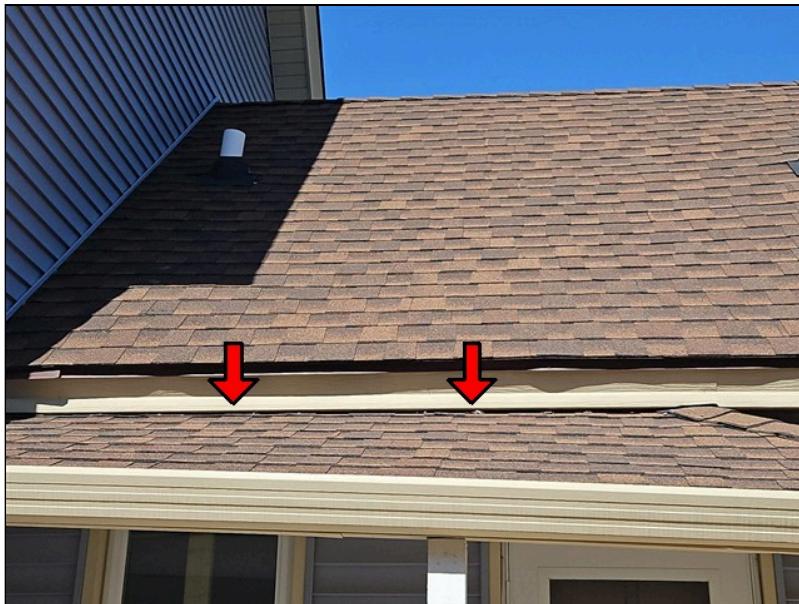
1.2 Repair: Headwall flashing was not installed in required areas. Areas are vulnerable to moisture intrusion and the resulting damage from it.

example of one location

Recommend further evaluation and repair as necessary by a qualified roofing contractor.

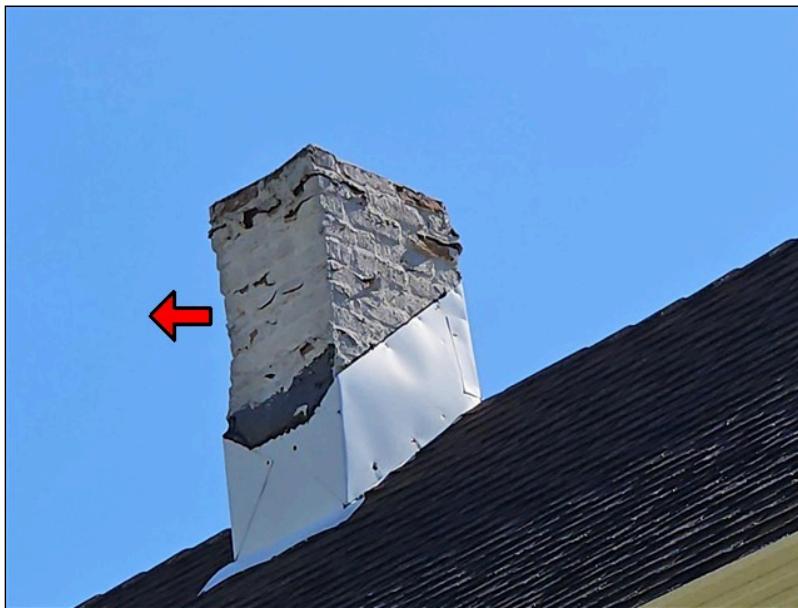
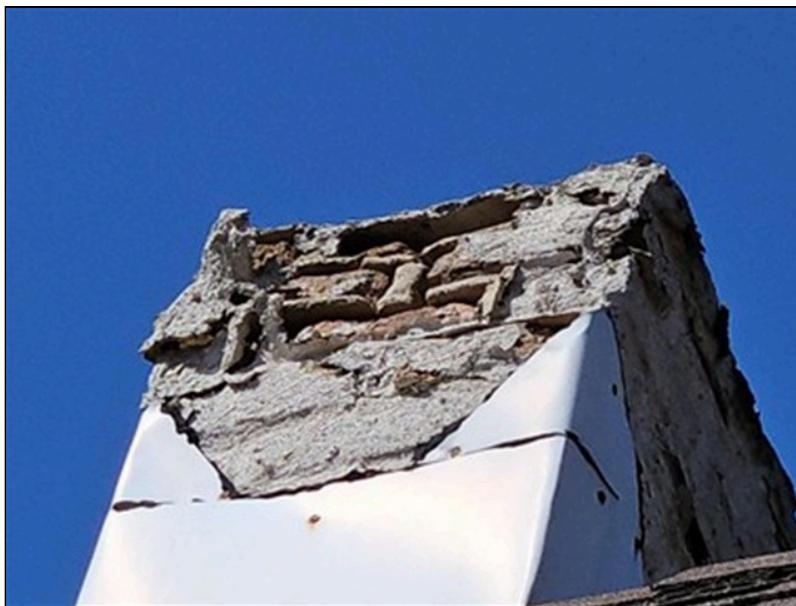
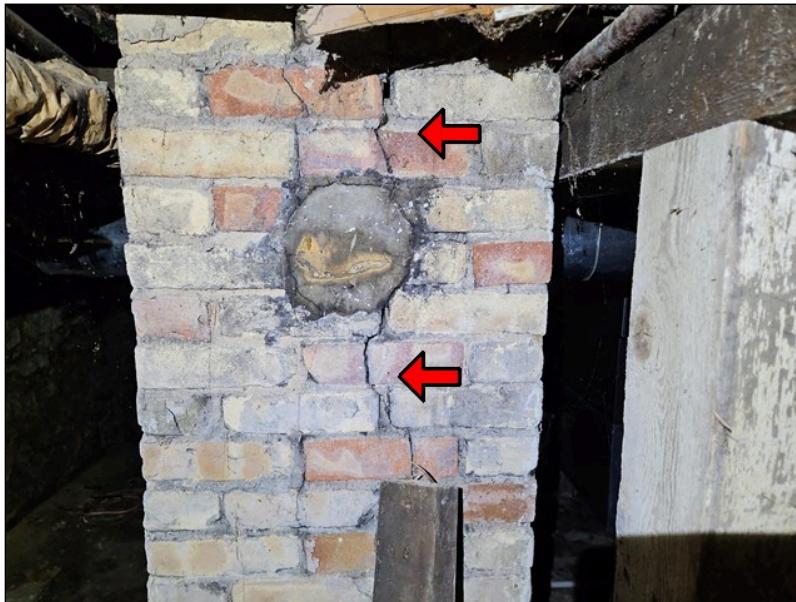
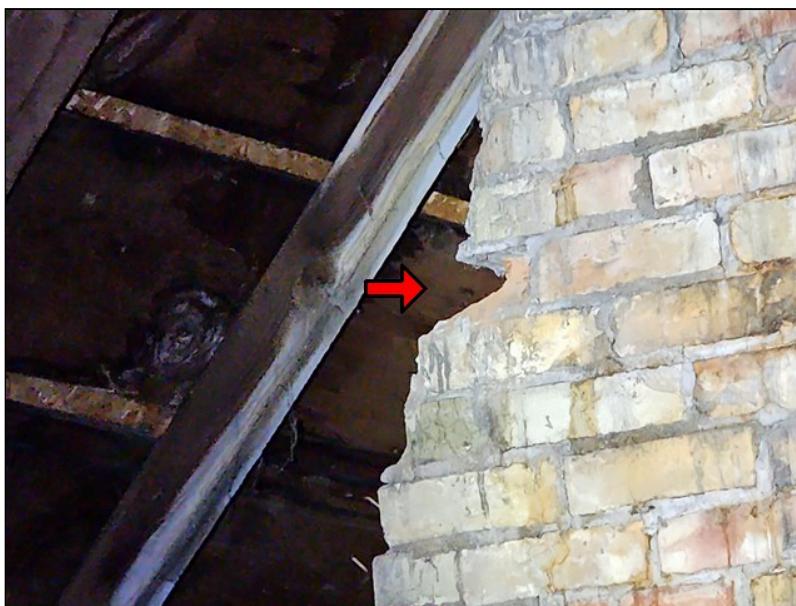
1.4 Defect: Chimney structure was deteriorated. In the basement, cracks were present. Chimney was leaning on the exterior. Moisture stains are indicative of a current or past leak in the flashing.

Please note the chimney is not venting the HVAC systems or water heater and serves no purpose.

Recommend further evaluation and repair/remove as necessary by qualified chimney contractor.

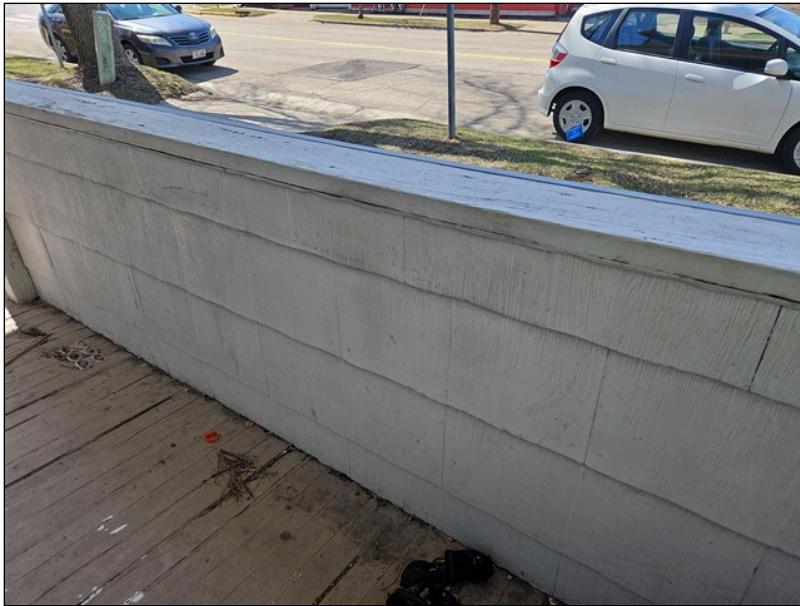
2.0 Wall cladding on a porch appeared to be made of asbestos. The mishandling of this type of wall cladding can be hazardous to your health. All work should be completed by a qualified contractor.

Please also be aware that the removal and disposal of asbestos siding typically costs more than wood/vinyl/metal siding.

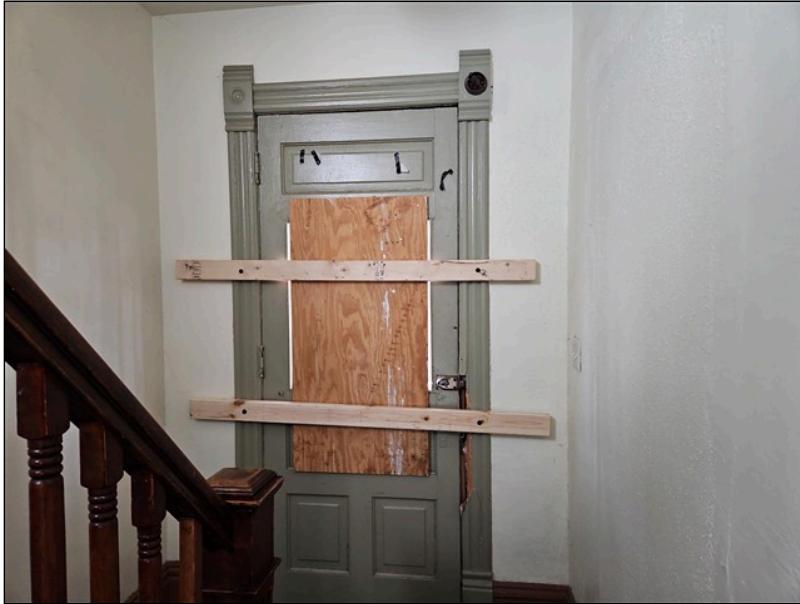
2.2 (1) Defect: Access to front door was blocked. There was only one exit to the exterior of the main floor.

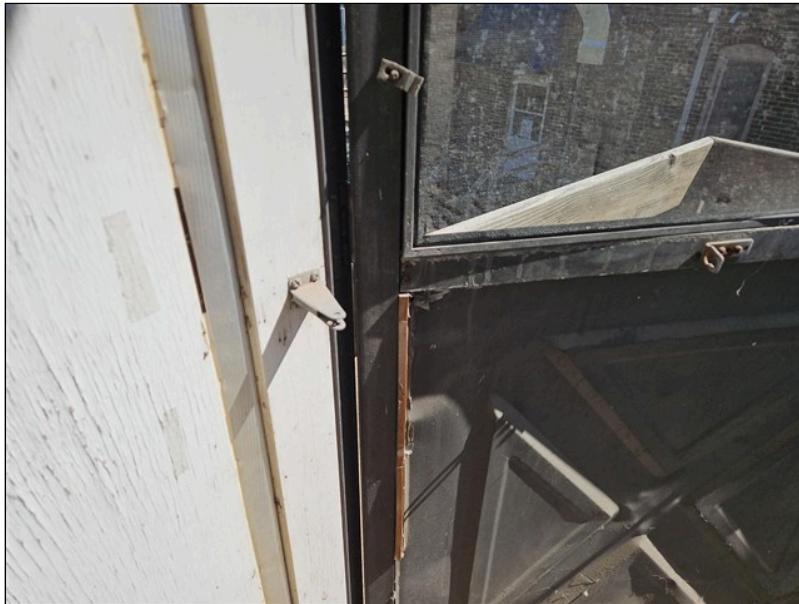
2.2 (2) Repair: Storm door to balcony was damaged.

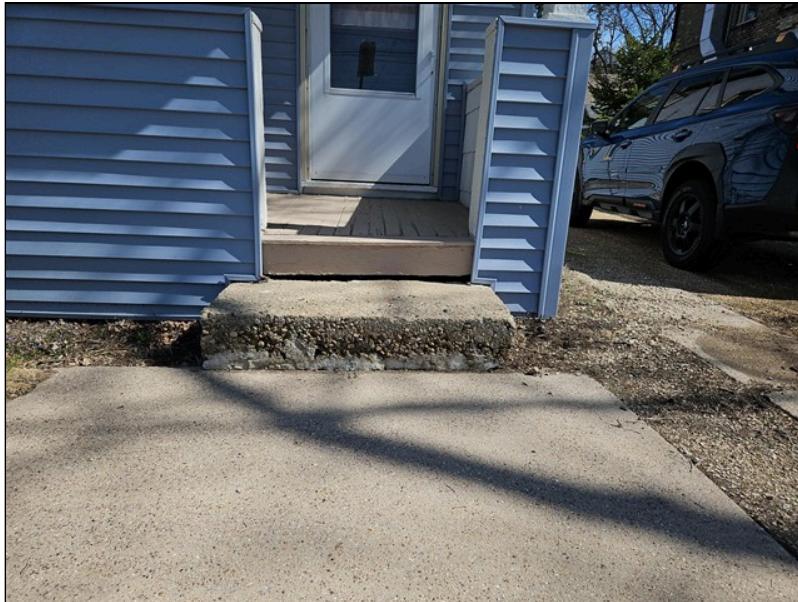
2.4 (1) Defect: Rise of step to rear porch was excessive. Rise of steps was inconsistent. Conditions present are a trip hazard.

Recommend further evaluation and repair as necessary by qualified contractor.

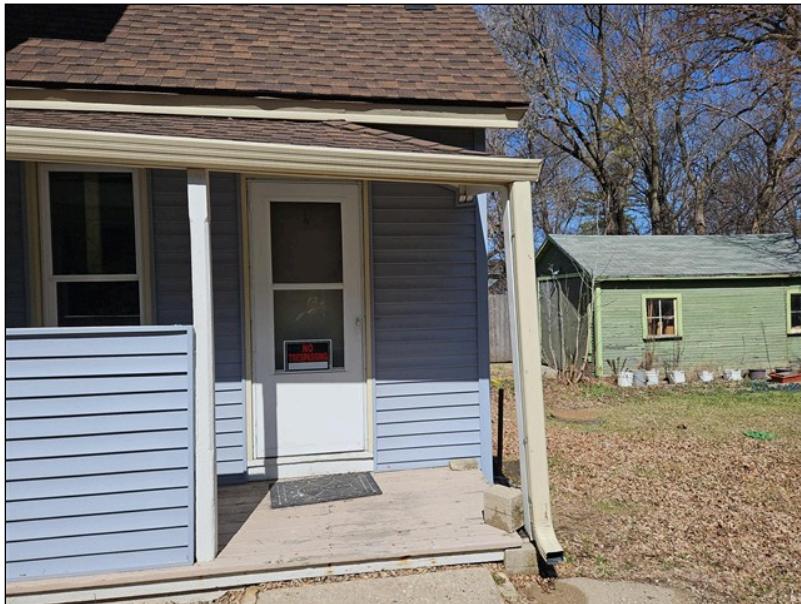
2.4 (3) Defect: Post supporting porch roof was not centered on footing. Footing was not set below the frost line and may move with frost heave.

Recommend further evaluation and repair as necessary by qualified contractor.

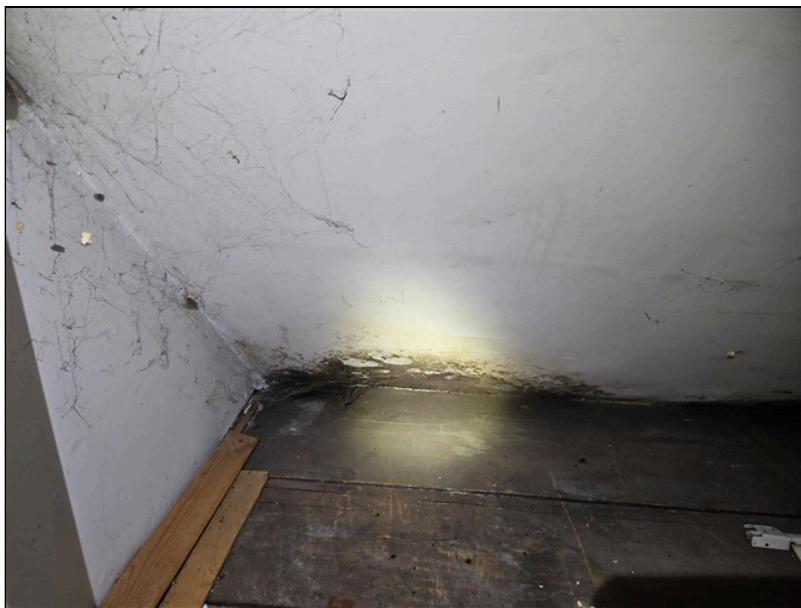
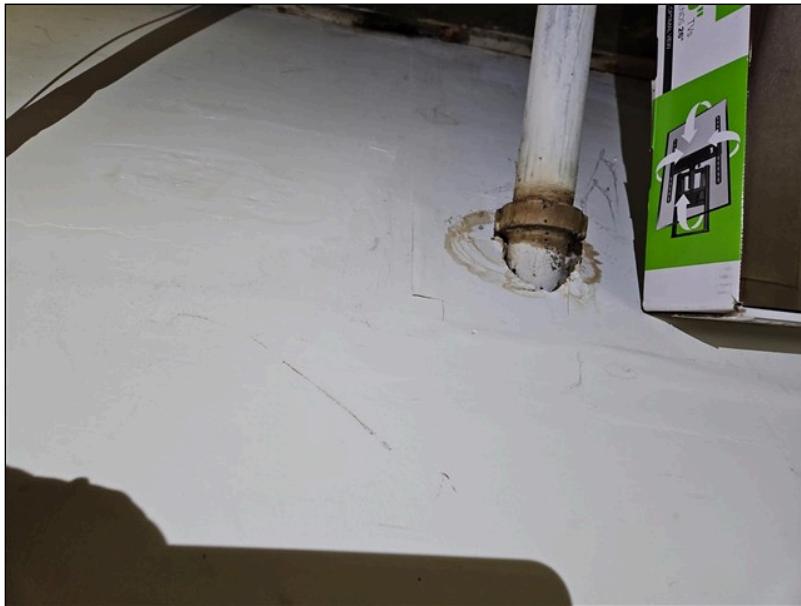
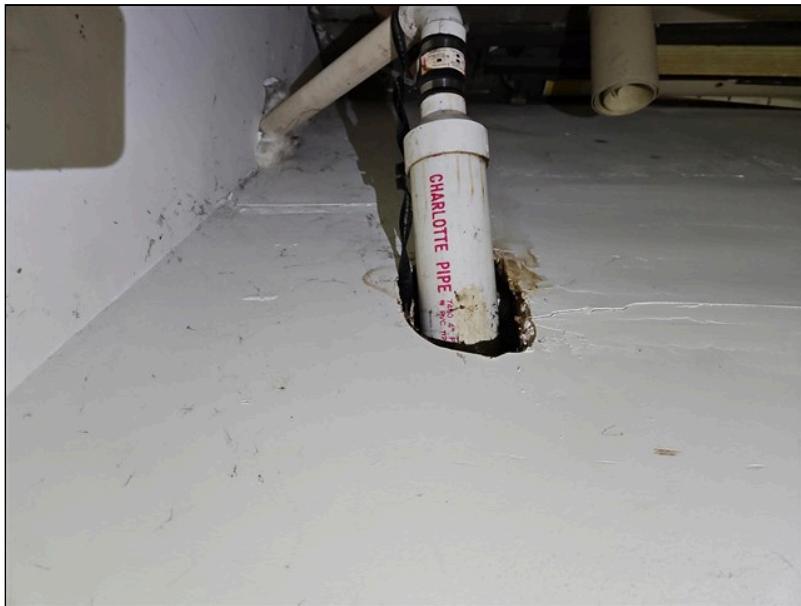
3.0 (2) Moisture stains were present on the ceiling in the attic space - at the time of the inspection, no moisture was present.

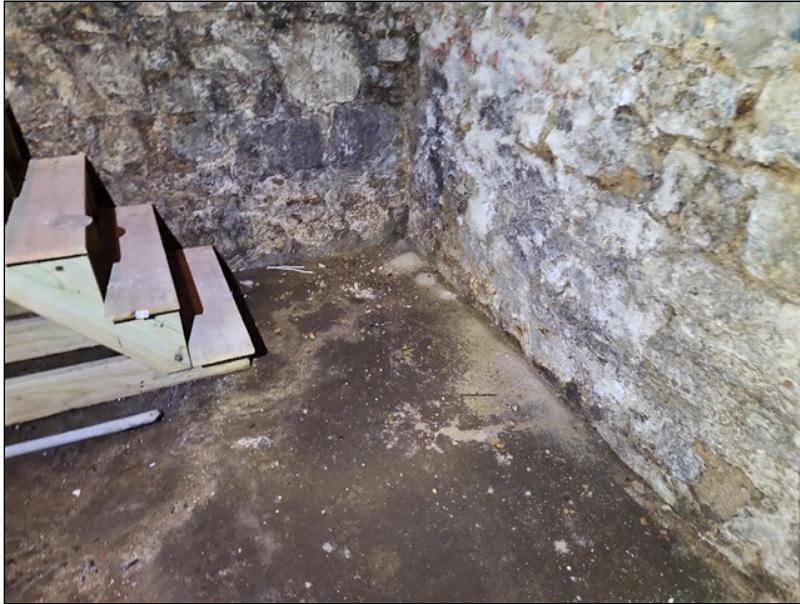
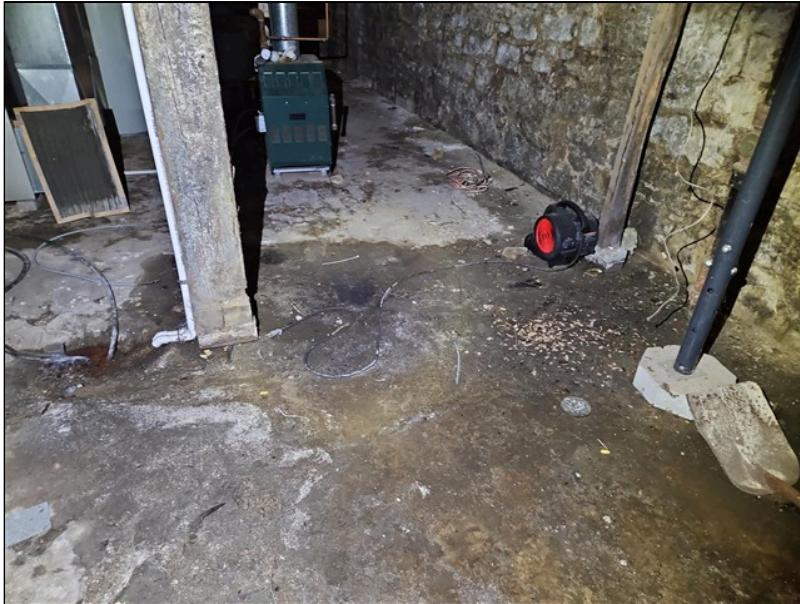
4.0 Defect: Pooling water and moisture stains were present in the basement. The mortar was deteriorated between the rocks/stones in the foundation wall in areas. The deterioration of the mortar in a rock/stone foundation wall makes it vulnerable to moisture intrusion and may result in the structural integrity of the wall being compromised.

Recommend further evaluation and repair as necessary by a qualified foundation specialist.

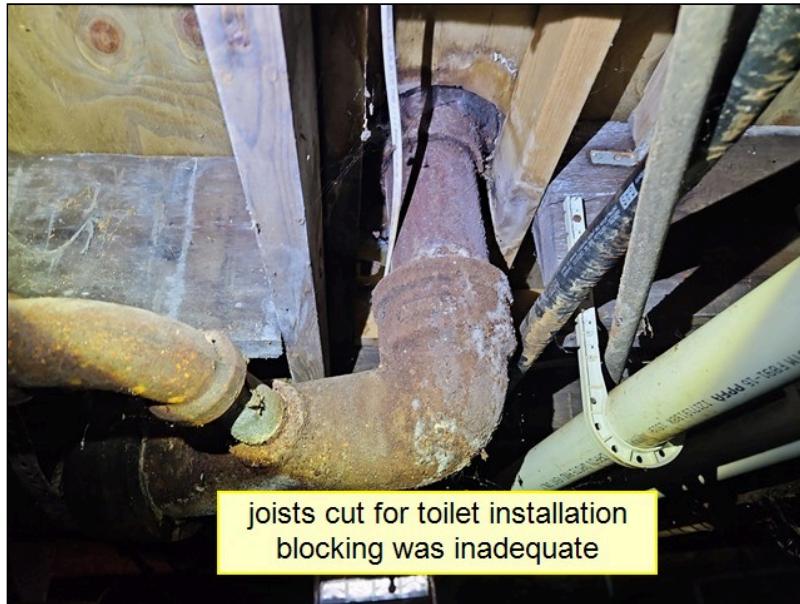
4.3 Defect: Joist(s) were altered in a manner that impact their structural integrity. Beam was sagging.

Recommend further evaluation and repair as necessary by a qualified professional.

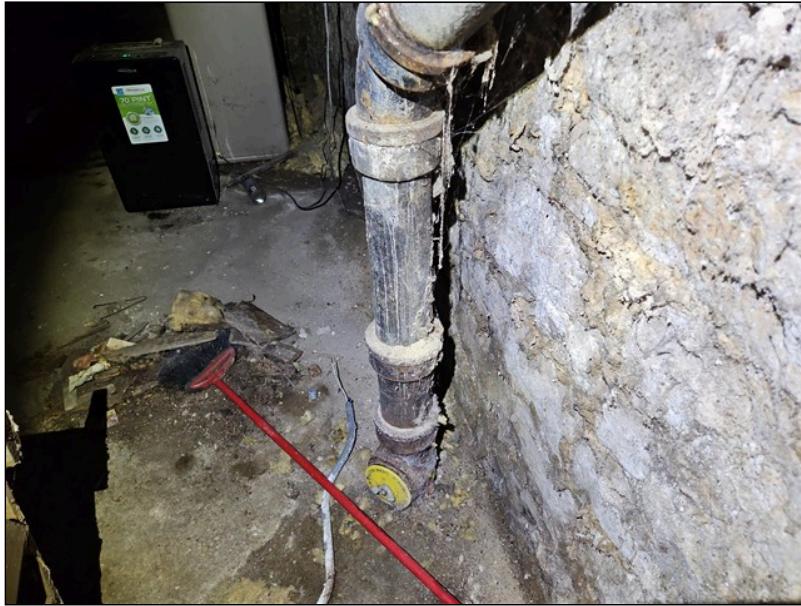
5.0 (1) Monitor: Cast iron and galvanized waste pipes will corrode from the inside to the outside over time and will need to be replaced eventually.

Recommend monitoring condition.

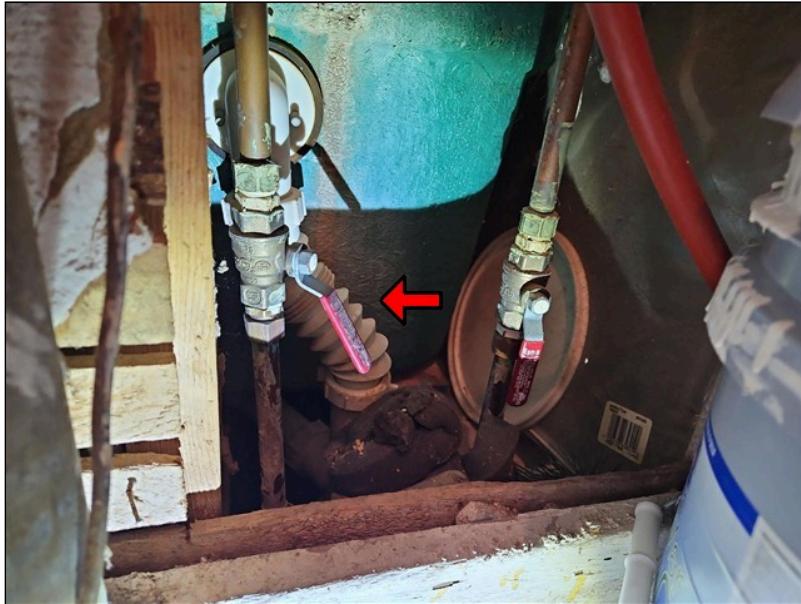
5.0 (3) Repair: An expandable drain line was installed under the main level shared bath tub. Expandable waste lines will trap debris making them prone to clogging.

Recommend further evaluation and repair as necessary by licensed plumber.

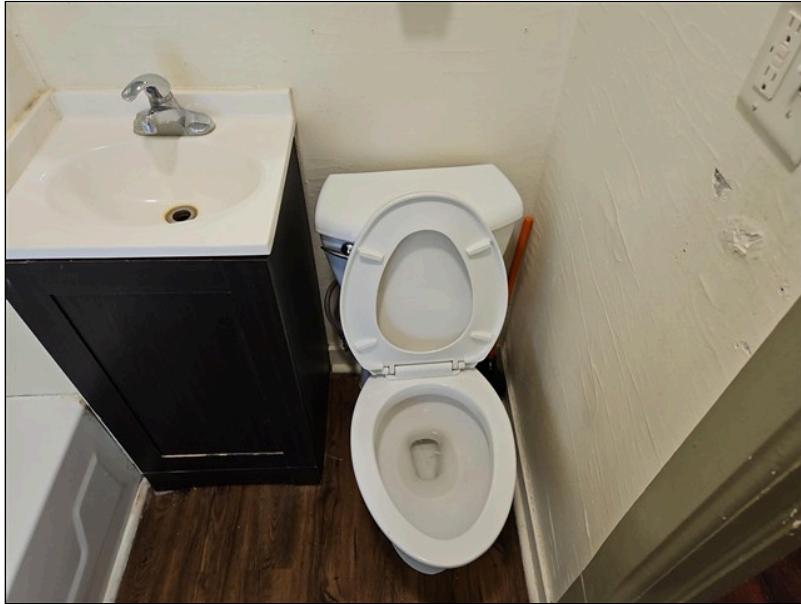
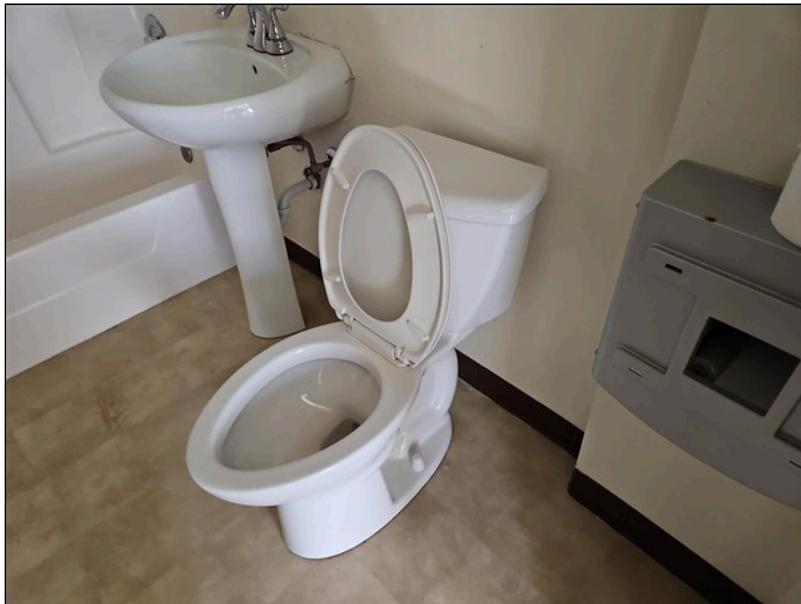
5.1 (1) Repair: Toilets in both bathrooms were not firmly attached to floor. This could be indicative of a worn wax ring, damaged subfloor, flange bolts needing to be tightened or other reason.

Recommend further evaluation and repair as necessary by a licensed plumber.

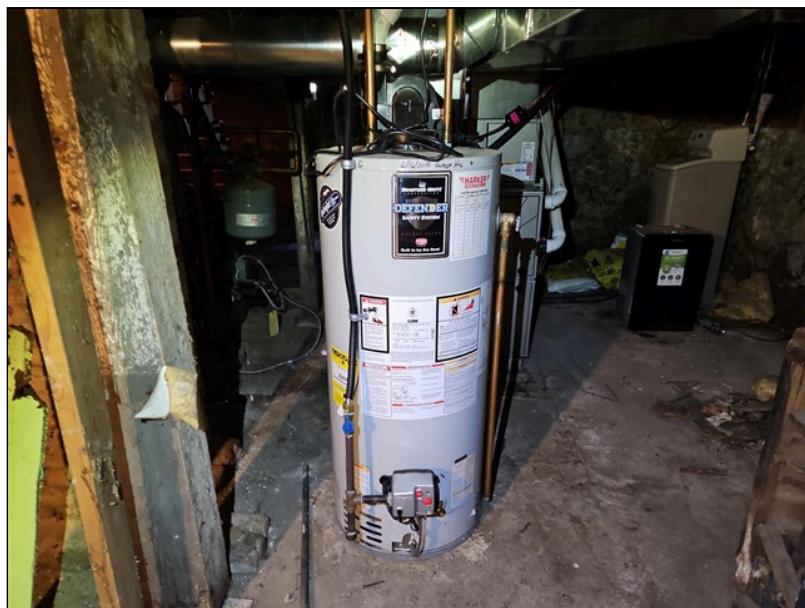
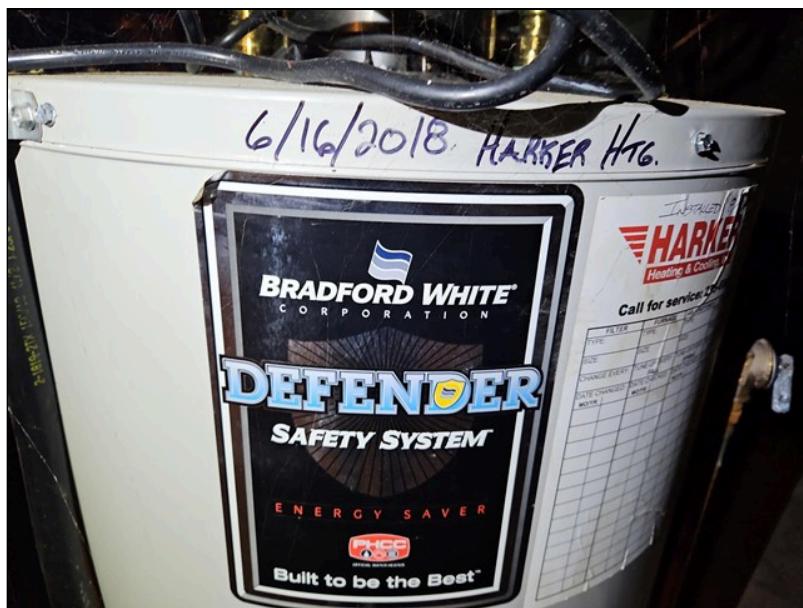
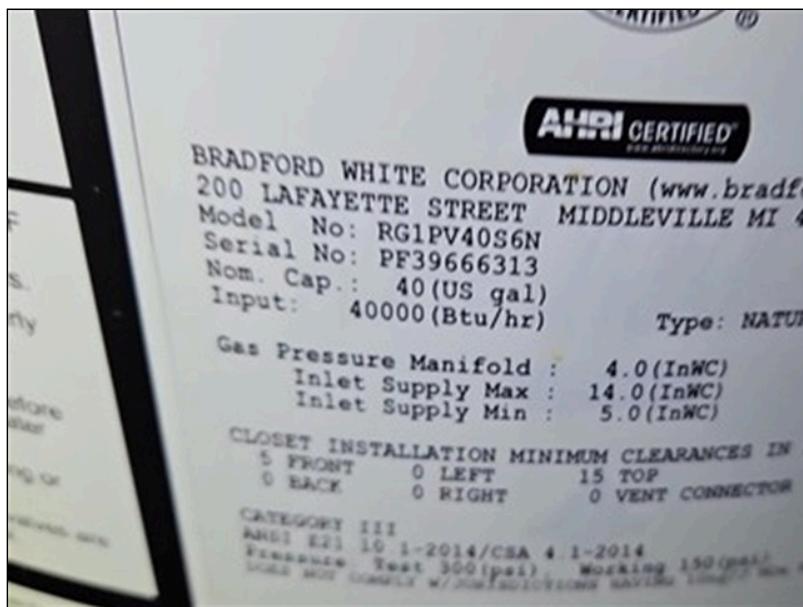
5.2 (1) Bradford White water heater - year of manufacture was 2017.

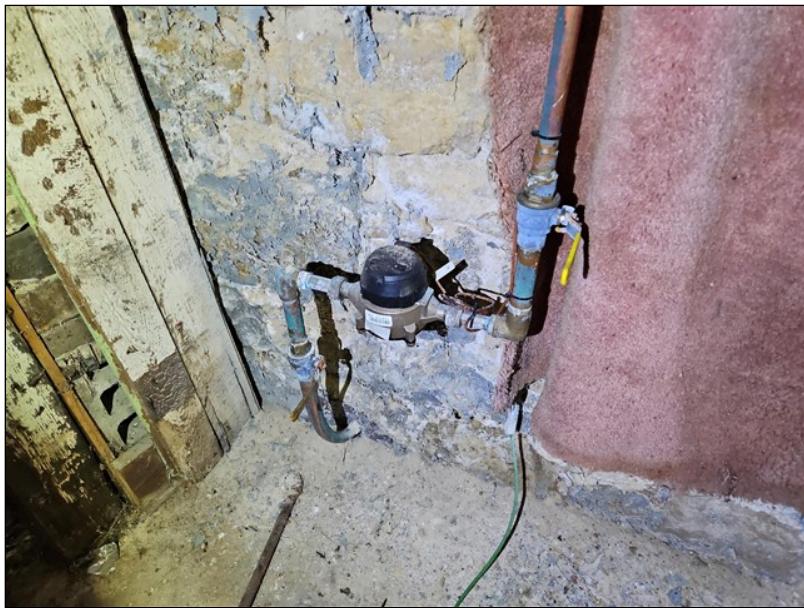
5.3 (1) The main water shut off was located in the basement.

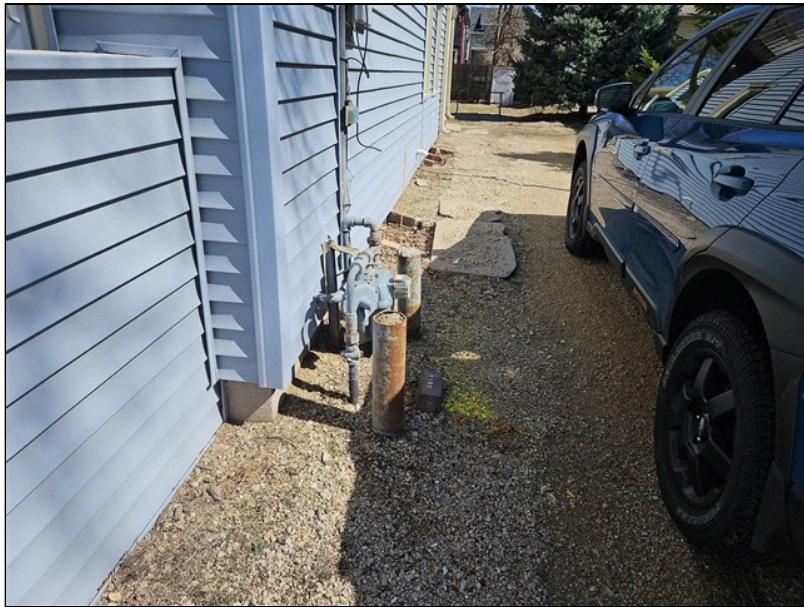
5.4 The main fuel shut off was located at the gas meter on the right side (facing front) of the home.

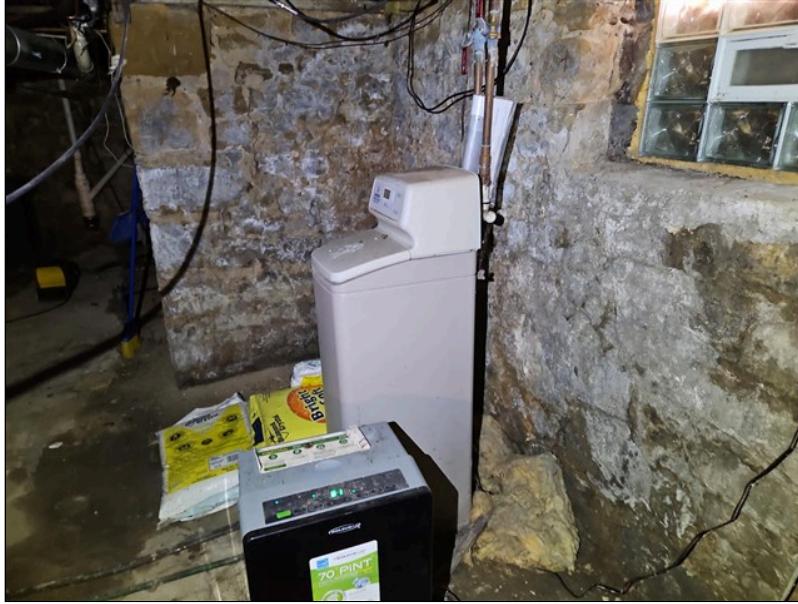
5.7 Not Inspected: A water softener was present. The duration and scope of a standard home inspection prevents confirmation of the unit's proper operation.

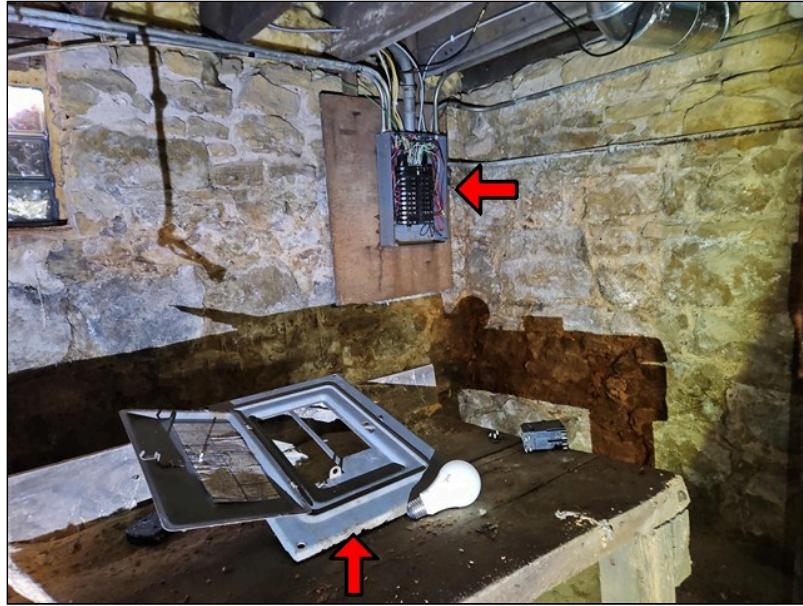
6.2 (1) Defect: The deadfront cover was not installed on the panel box.

Recommend further evaluation and repair as necessary by licensed electrician.

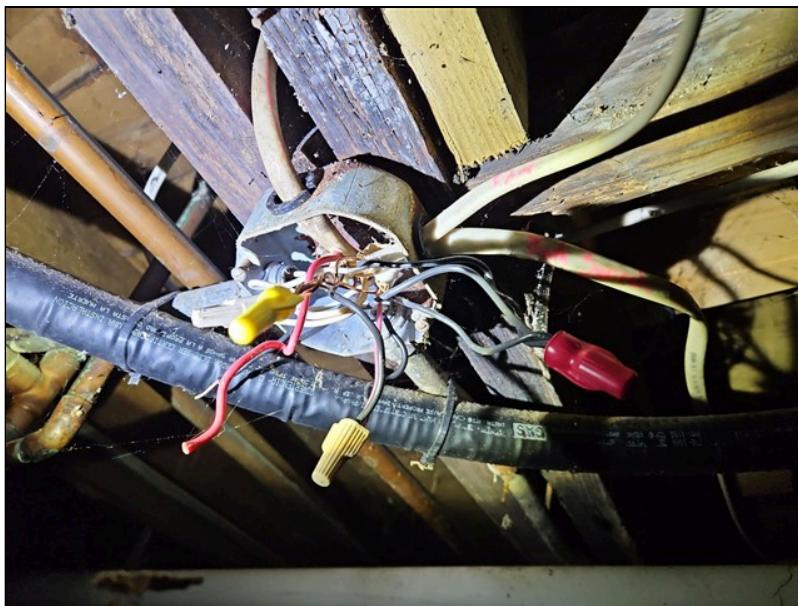
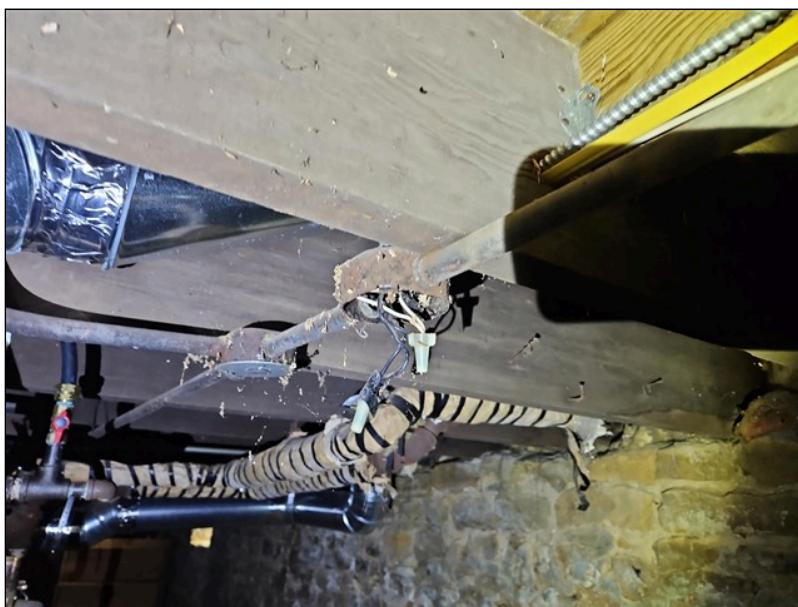
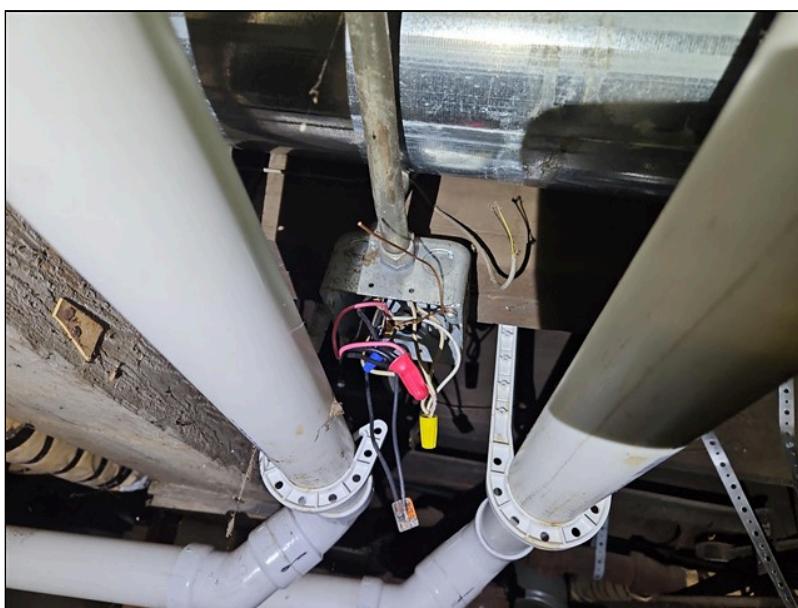
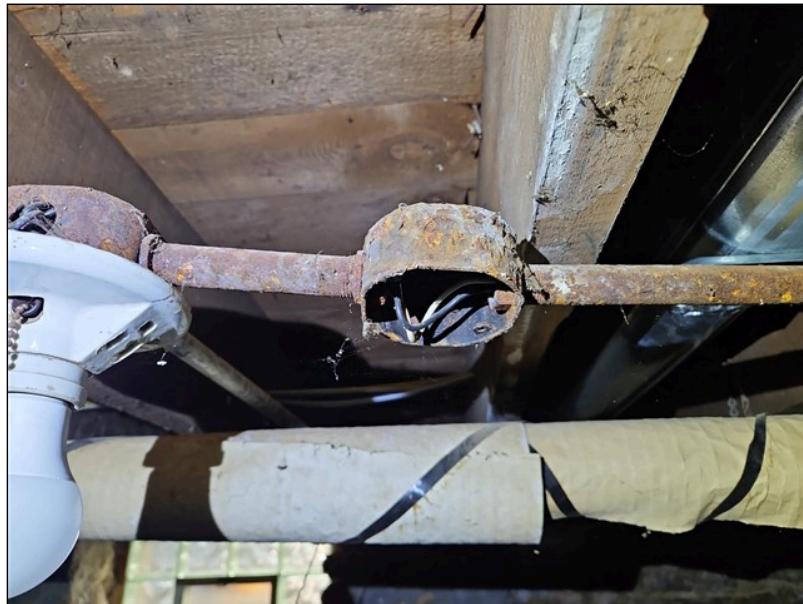
6.4 (2) Defect: Cover plates were missing. This condition leaves energized electrical components exposed to touch and is a shock/electrocution hazard.

Recommend further evaluation and repair as necessary by licensed electrician.

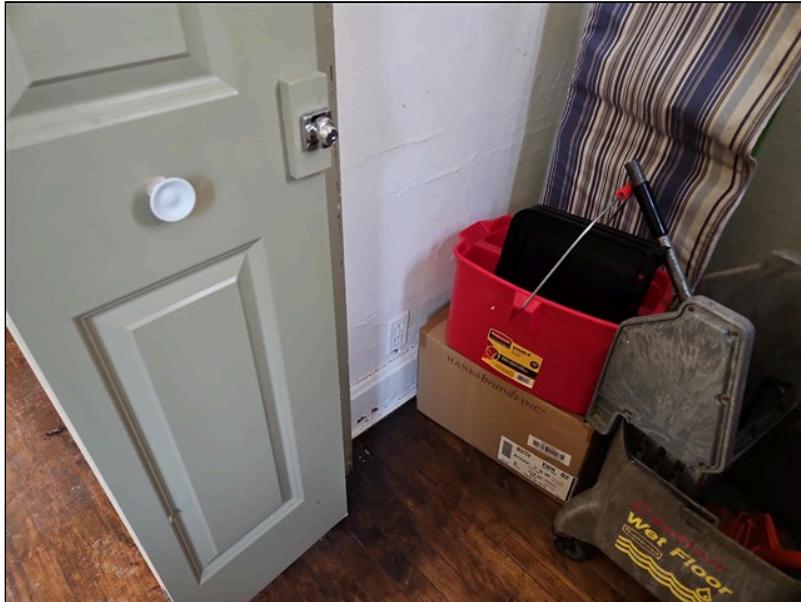
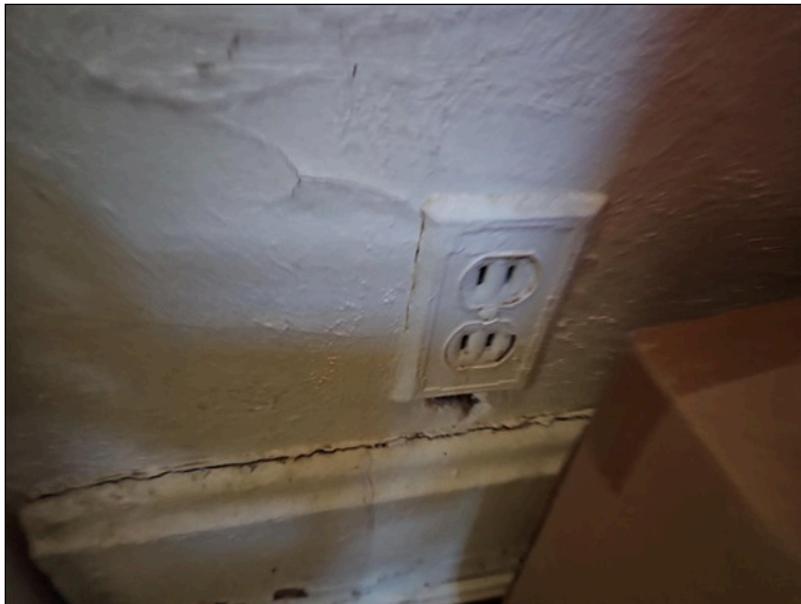
6.5 (1) Defect: Non-grounded, 2-prong electrical receptacles were present. The lack of a grounding conductor will limit the use of items that require a ground. If there is an electrical surge in the home, items not plugged into a grounded receptacle will be damaged. The use of grounded receptacles increases the safety of the electrical system for the occupants of the home.

Recommend updating receptacles to include a grounding system or safety disconnect such as a GFCI protected receptacle/breaker. Work should be completed by a licensed electrician.

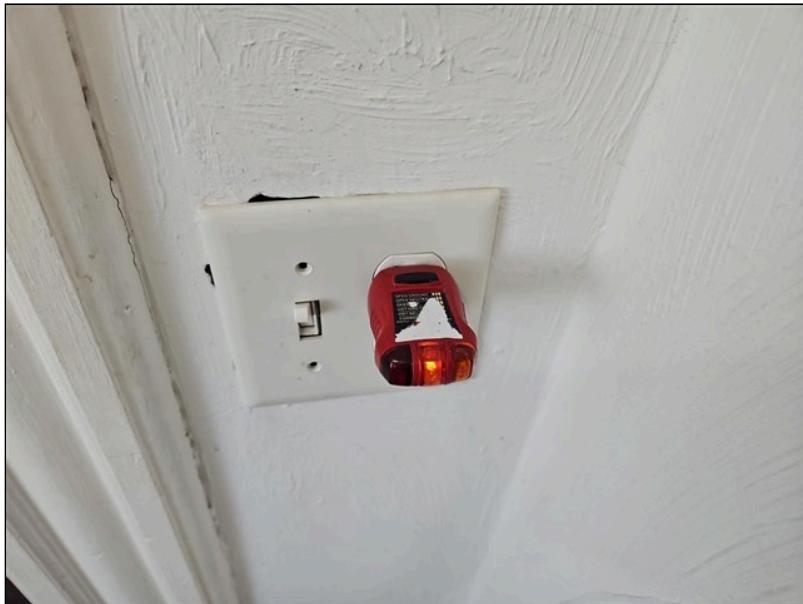
example of one location

6.5 (2) Defect: Electrical receptacles had an open ground. There is an increased potential of electrical shock hazard as well as damage to electronics due to a power surge if a receptacle is not grounded.

Recommend further evaluation and repair as necessary by licensed electrician.

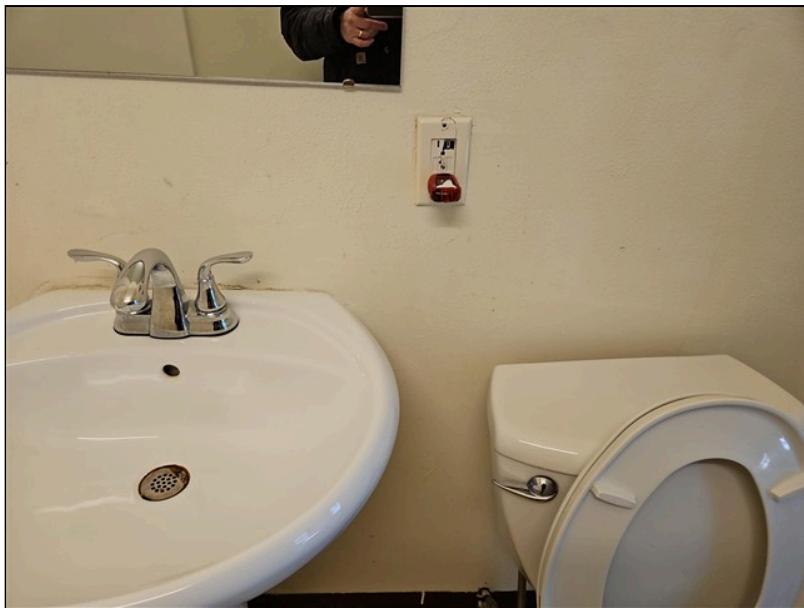
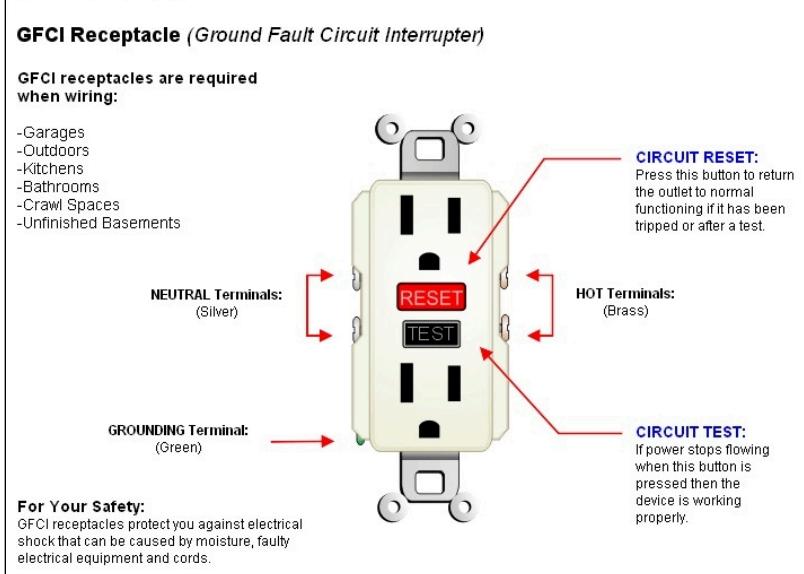
6.6 Defect: GFCI receptacle was not energized when Inspector arrived. The reset button did not energize.

Recommend further evaluation and repair as necessary by a licensed electrician.

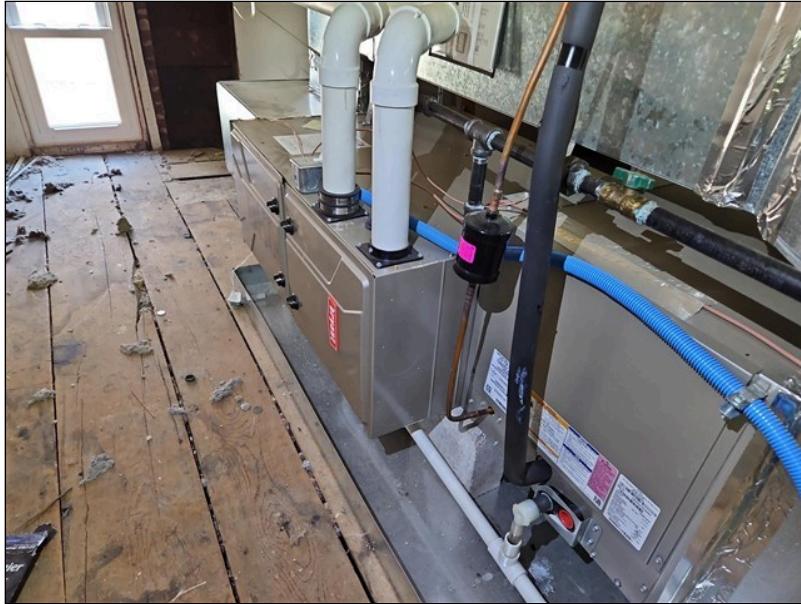
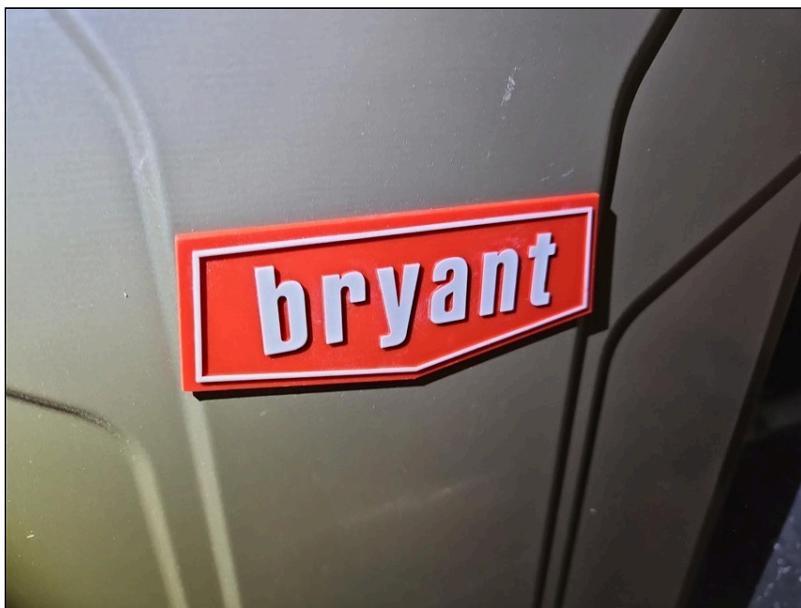
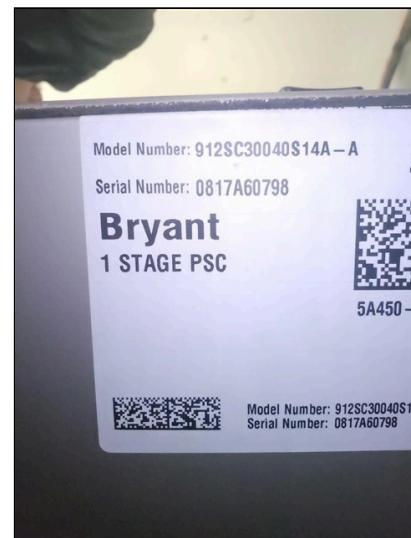
7.0 (1) Bryant furnace - year of manufacture was 2017.

Furnace responded to call for heat from thermostat, fired up and circulated warm air.

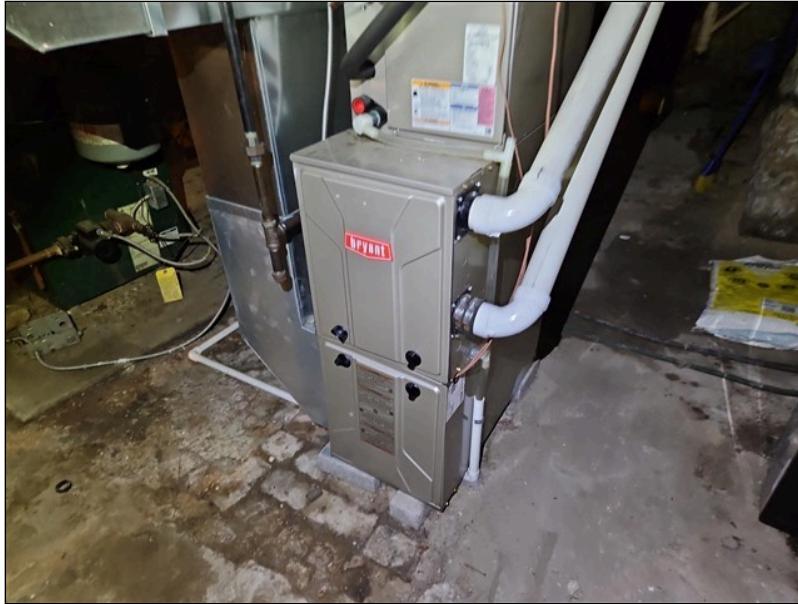
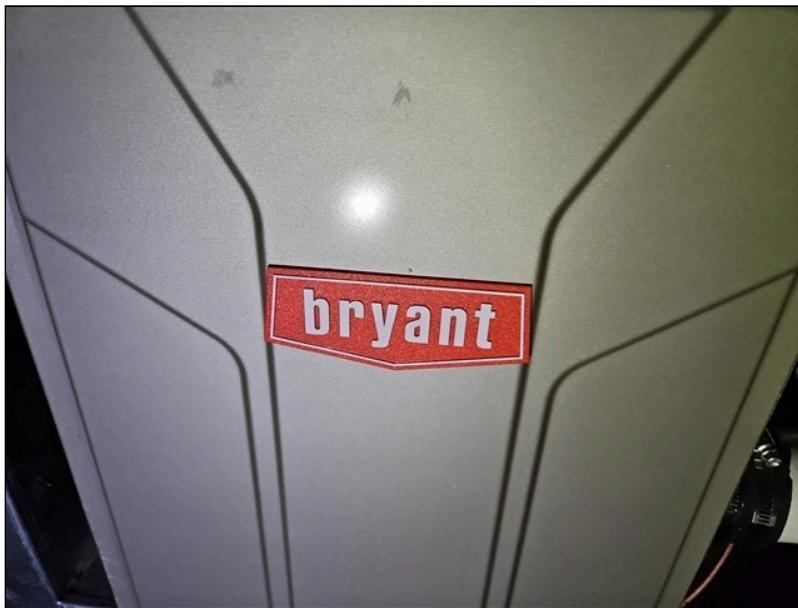
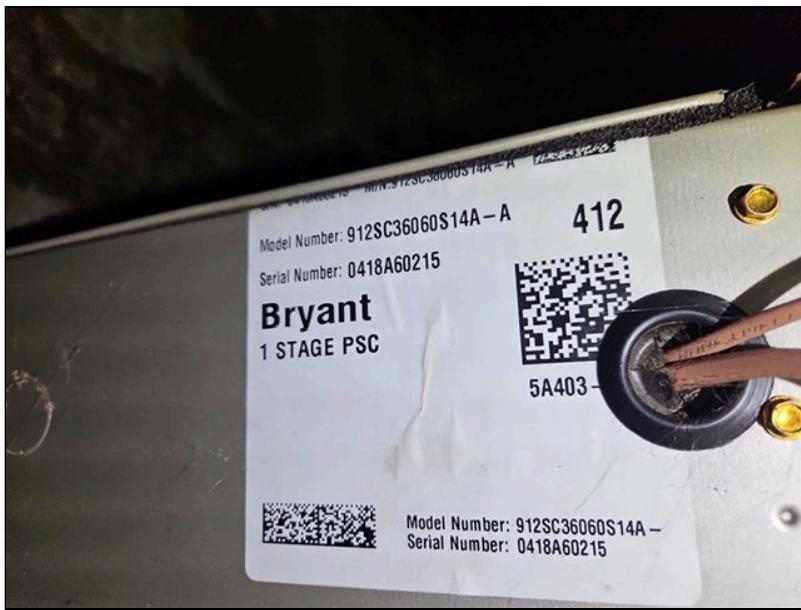
7.0 (2) Bryant furnace - year of manufacture was 2018.

Furnace responded to call for heat from thermostat, fired up and circulated warm air.

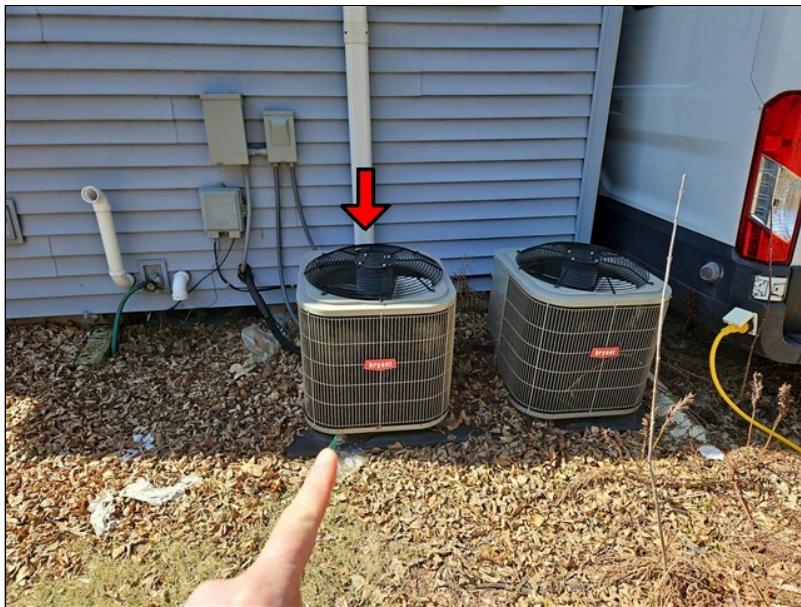
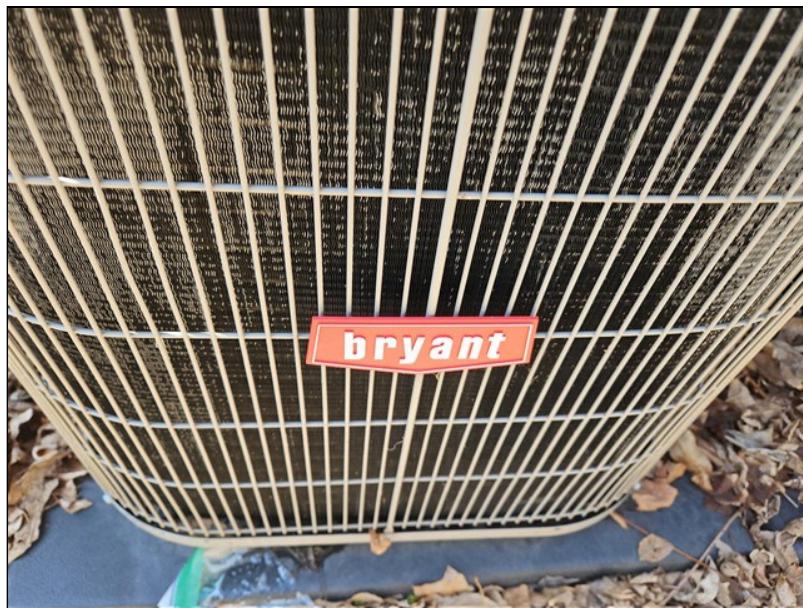
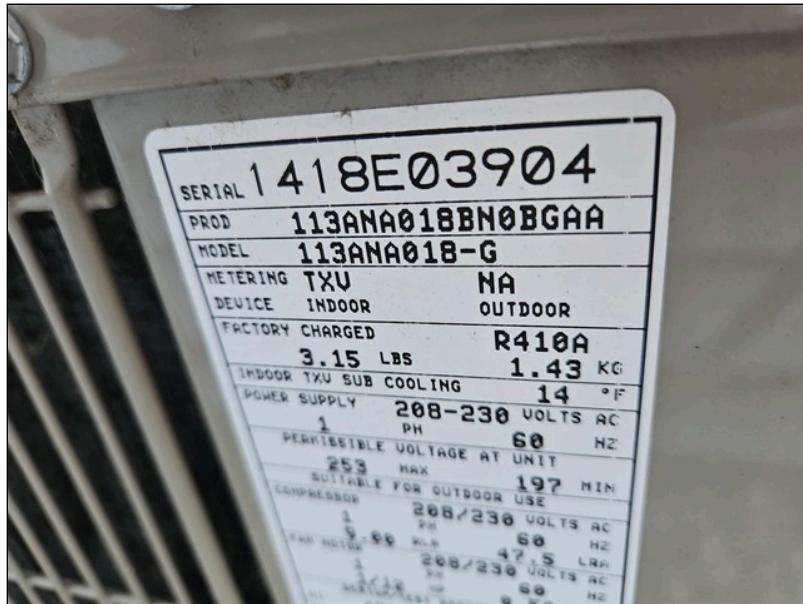
7.7 (1) Bryant AC unit - year of manufacture was 2018.

As the temperature was below 65 deg within the last 24 hours and damage can happen to the compressor if operated at low temperatures, the unit was not turned on. Physical condition was observed only.
